CLEANUP AND ABATEMENT ORDER NO. R1-2022-0045

Eagle Rock Inc.

Attachment A: Regional Water Board Staff Inspection Report/Memorandum

INSPECTION MEMO

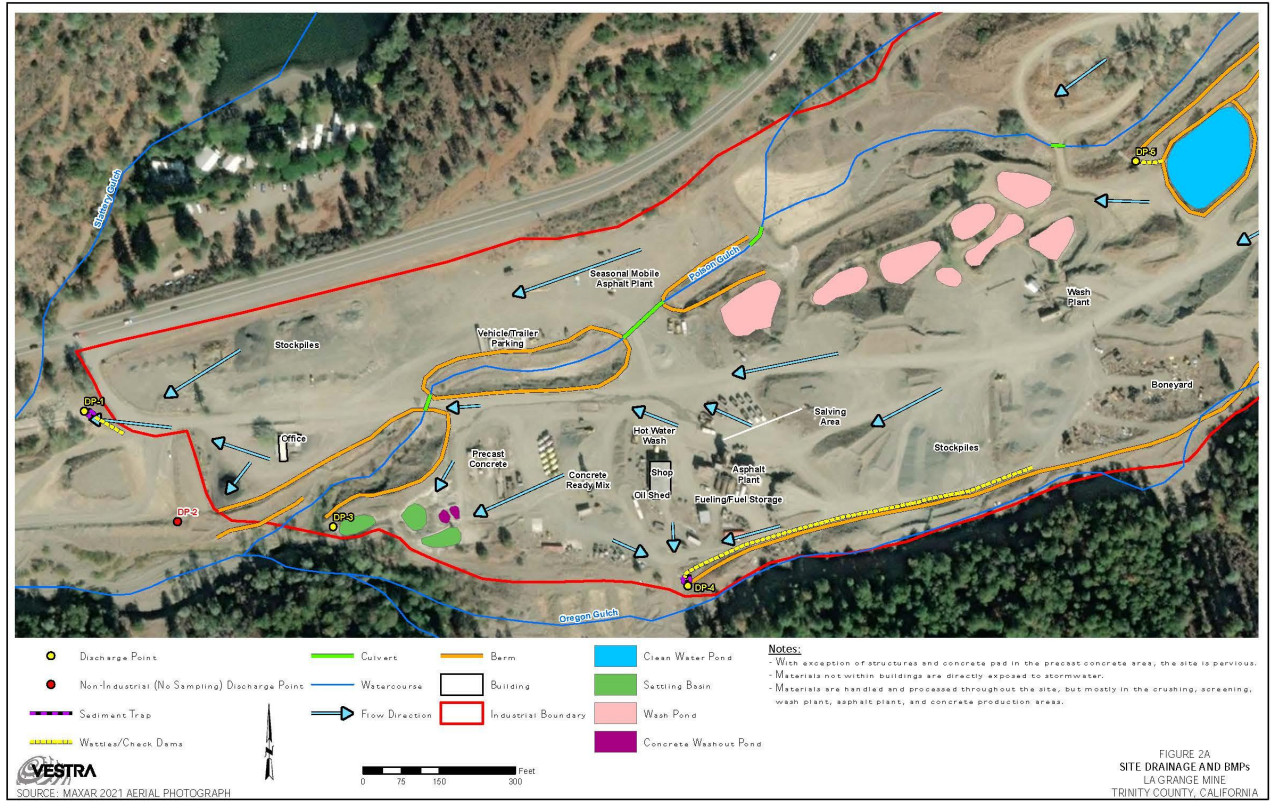
Site map must be revised to reflect the current condition of the site. All discrepancies must be addressed. The drainage areas, potential monitoring/sampling points and any stormwater features such as missing wash pond must be included on the site map. The SWPPP may need to be revised accordingly.

Site map 2: The site map has been prepared by Discharger’s consultant, indicating the central and western portions of the Facility. Stormwater flow directions, sampling locations, clean water and settling pond locations and the location of the earthen berms are shown on the site map.
