## North Coast Regional Water Quality Control Board

**Subject:** Notice of Violation of State Water Resources Control Board Order No. 2014-0057 DWQ General Permit for Storm Water Discharges Associated with Industrial Activities (Industrial General Permit), Waste Discharge Requirements (WDRs) Order No. 96-42, and the Federal Clean Water Act Section 301.

**File:** Russian River Winery, 2191 Laguna Road, Santa Rosa, Sonoma County  
WDID No. 1 49I024297

### INSPECTION MEMO

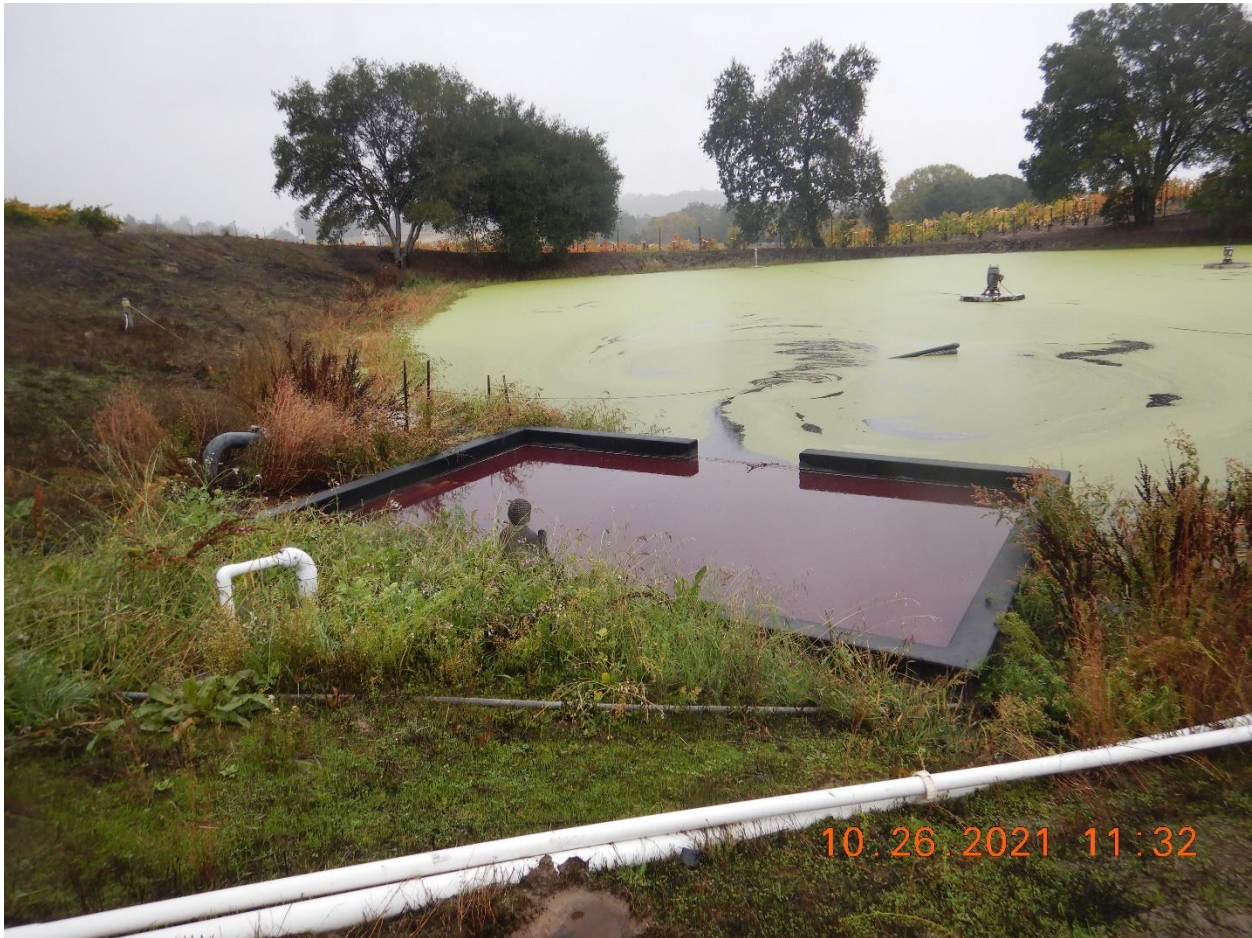
Pictures 13 – View of the process wastewater pond located on the northeast side of the Facility. Picture taken by Farzad Kasmaei.

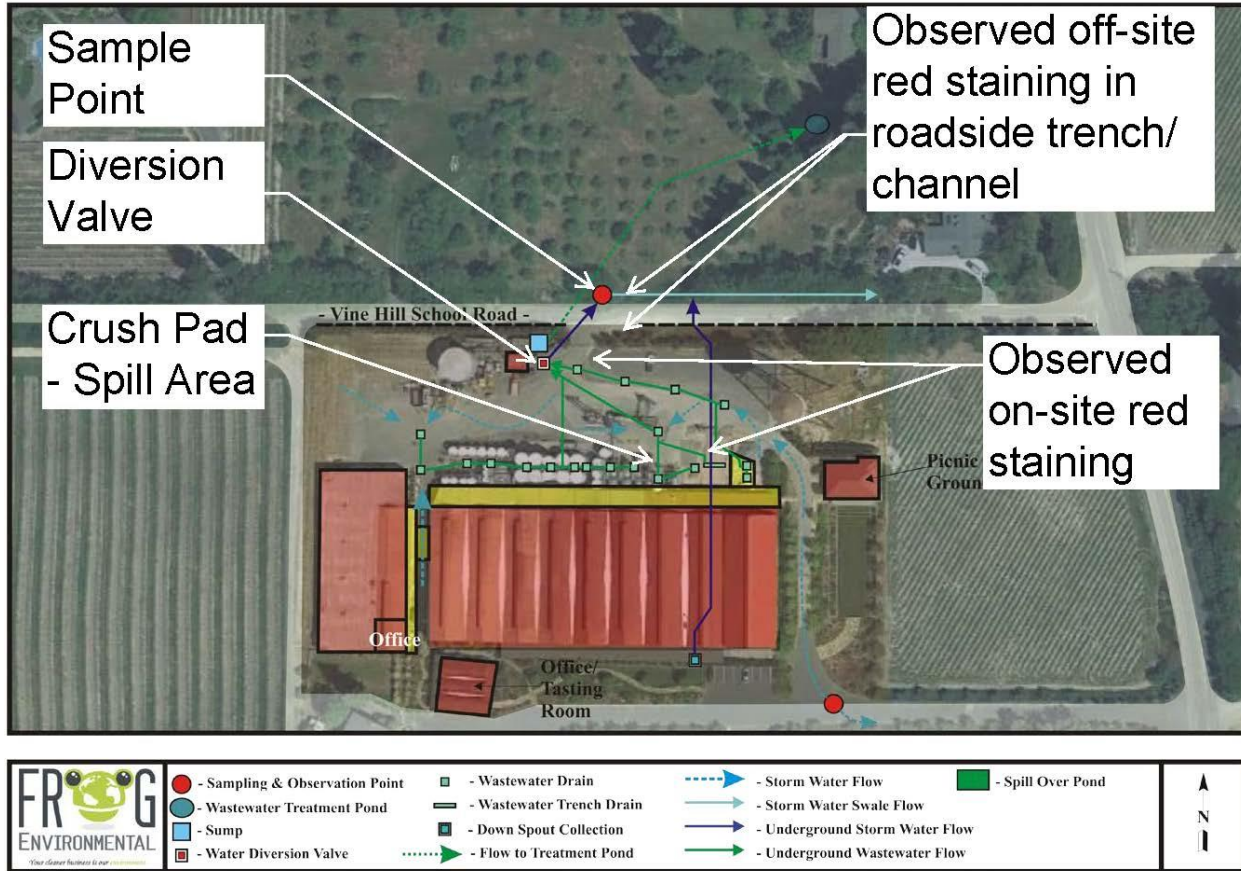
Site Map:

Picture 14 – Site map showing stormwater and wastewater drainage system, crush pad area, diversion valve, and discharge/sample location.
