North Coast Regional Water Quality Control Board

Inspection Memo

Subject: August 5, 2022, inspection of Sexton Hill Vineyard alleging rock fill in unnamed watercourse.

File: John and Teresa Balletto, Sexton Hill Vineyard, 707 Sexton Road, Sebastopol, Sonoma County, APN 077-030-012
ECM PIN: CW-887265, WDID No. 1B23023CNSO

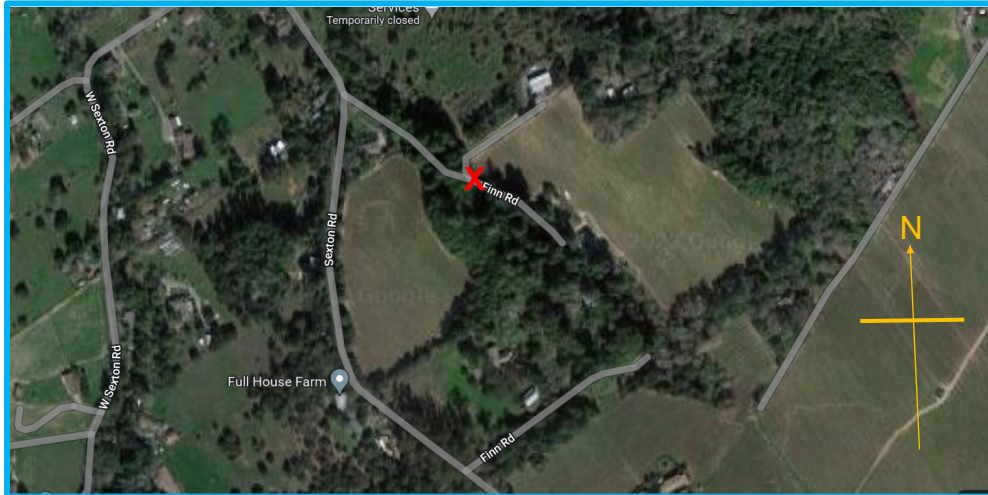
Unit, Guerneville Hydrologic Sub-area 114.11. The property is accessed by Finn Road, a private, one-lane gravel road that intersects Sexton Road at a northern location (Image 1). Finn Road is approximately 12 feet wide with a 10-foot-wide running surface. The complaint site is located in the forested area where Finn Road crosses an un-named stream.

Image 1: Complaint site located at the red "X" showing Sexton and Finn Roads, vineyards, and forested area.
