North Coast Regional Water Quality Control Board

INSPECTION MEMO

Eel River Scrap and Salvage
850 Riverwalk Dr.
Fortuna, Humboldt County

WDID #: 1 12I017276

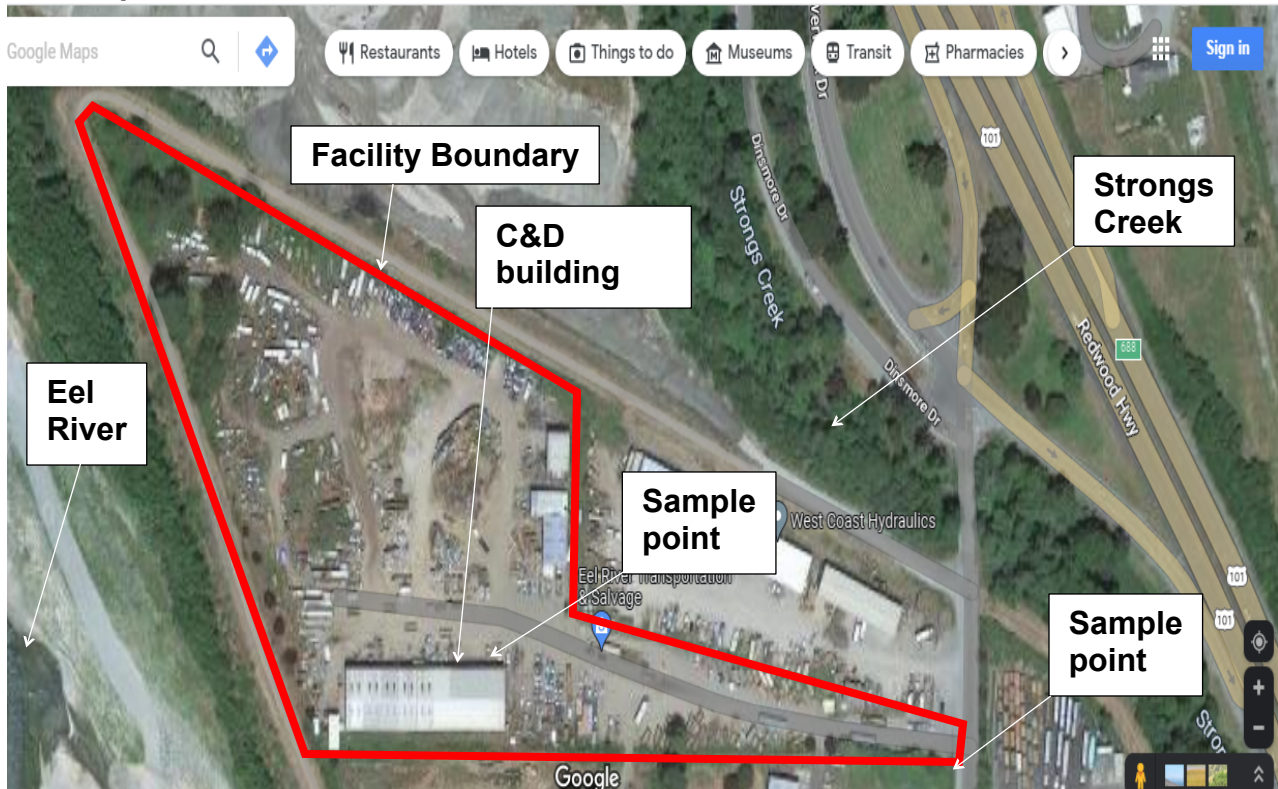
Picture 19 – Site map shows the location of the immediate receiving water (Strongs Creek) and Eel River and sample points.
