North Coast Regional Water Quality Control Board

INSPECTION MEMO

Scotia Sawmill and Cogeneration Plant, 125 Main Street, Scotia, Humboldt County

WDID #: 1 12I027974

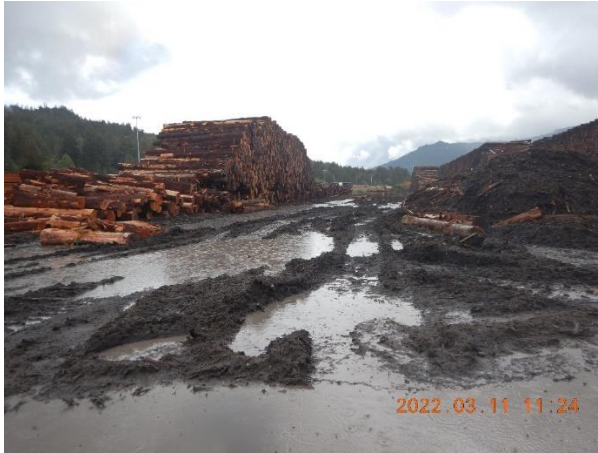
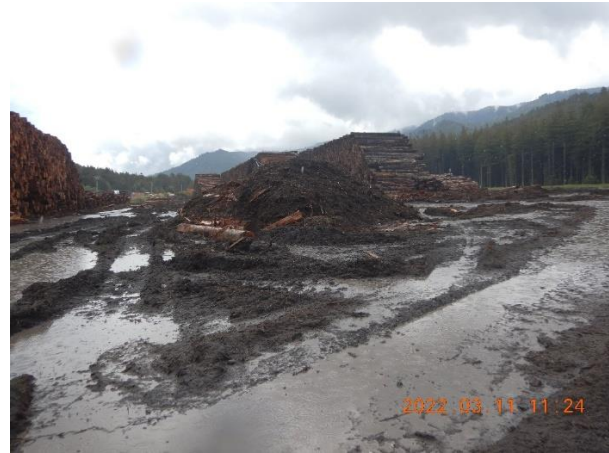
Pictures 2h and 2i: Large industrial waste material piles and stockpiles located within the log deck area of drainage area 1 exposed to rain. This paved area is covered with many inches debris, mud, wood fiber. No BMPs are present. Picture taken by Heaven Moore.

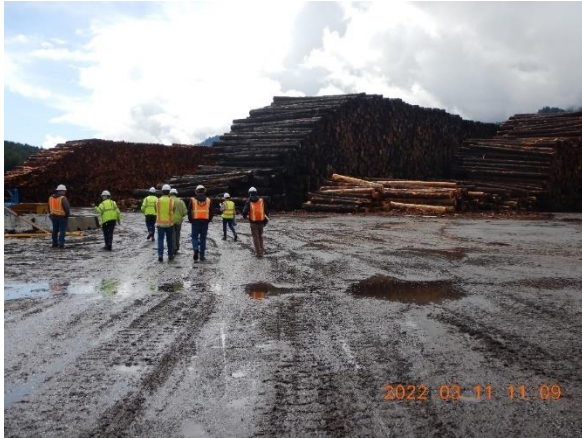
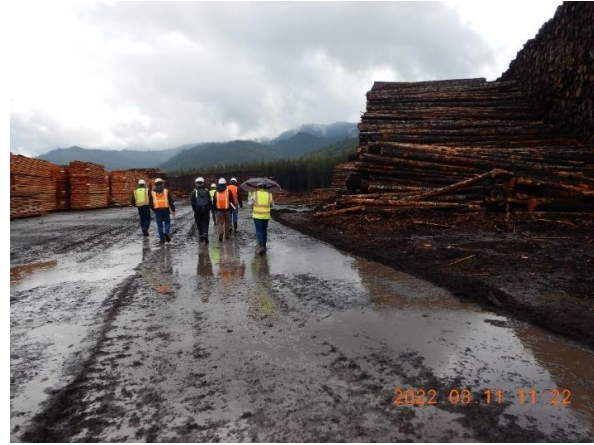
Pictures 3c and 3d: Large material stockpiles located within the log deck area of drainage area 1 exposed to rain. This paved area is covered with many inches debris, mud, wood fiber. No BMPs are present. Picture taken by Heaven Moore.

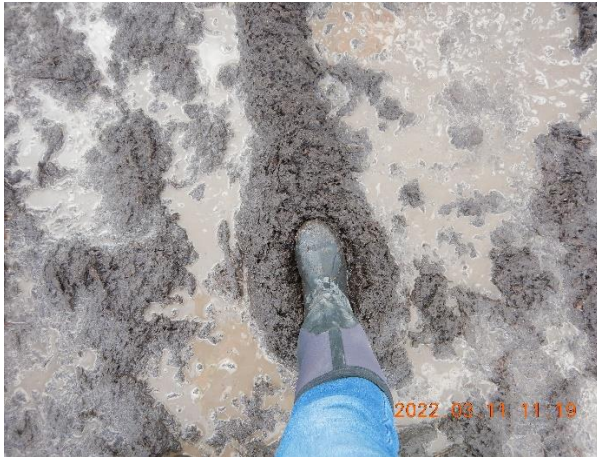
Pictures 4c and 4d: Closeup photos showing the depth of the mud, wood fiber, bark, and ponded stormwater on top of the paved log deck. The main retention pond receives runoff from this area. Picture taken by Heaven Moore.

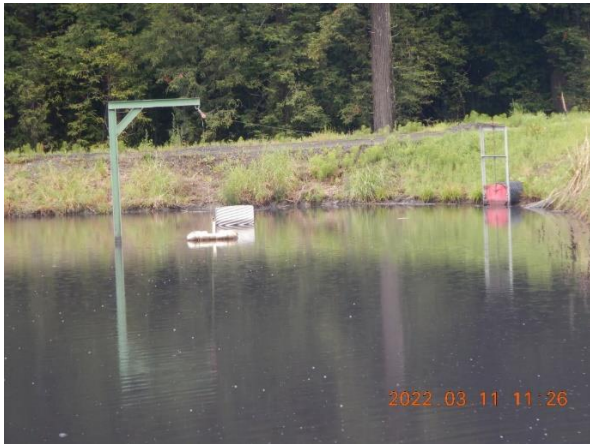
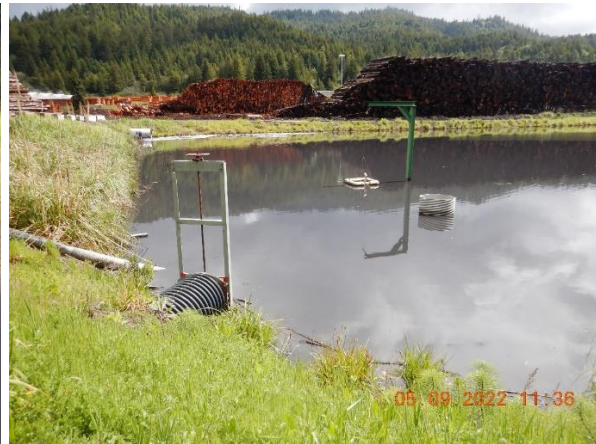
Pictures 6a and 6b: Picture of the outlet structures within retention pond to the Eel River. The outlet structure controlled by the pulley suspended by the green cantilever structure was open and discharging. The overflow with the red gate valve was closed at the time of inspection. The vertical corrugated metal riser pipe is a passive high flow bypass. Picture 6a taken by Heaven Moore. Picture 6b taken by Farzad Kasmaei.

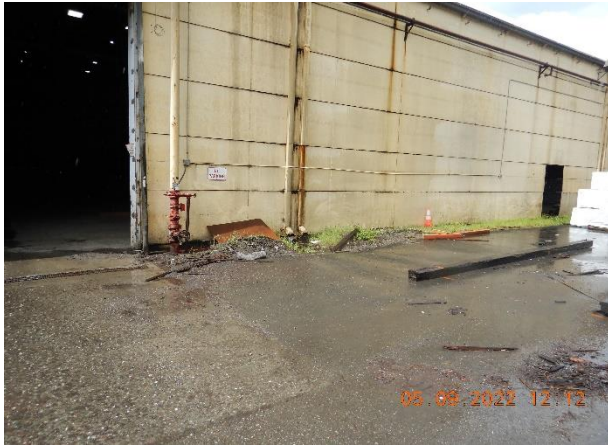
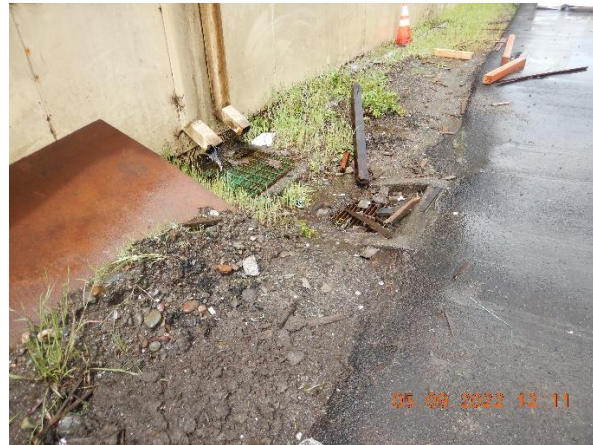
Pictures 8a, 8b: Unprotected inlet that receives runoff from the down spouts of the sawmill building and paved area within the drainage area 1. Picture taken by Farzad Kasmaei.

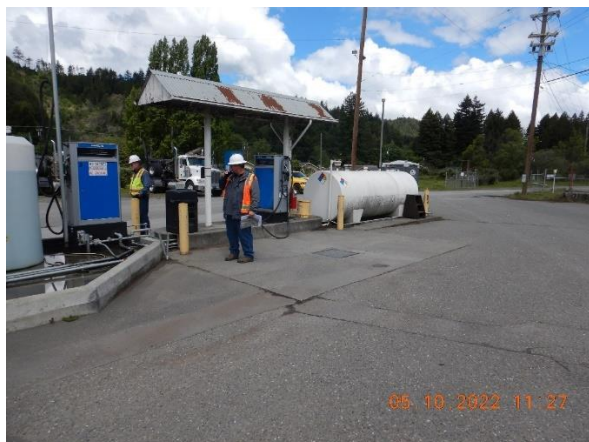
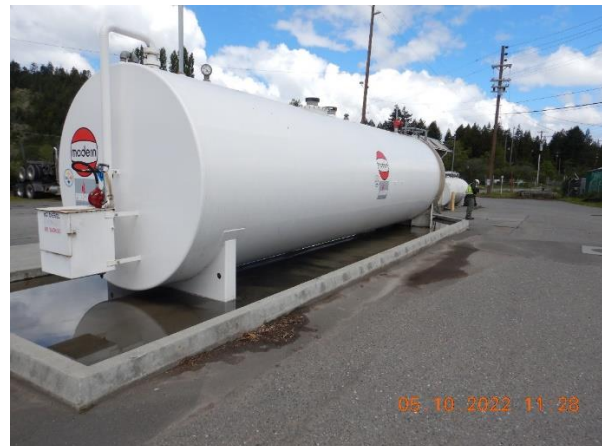
Pictures 10a and 10b: Onsite fueling station. Facility staff were unsure if the adjacent inlets were storm drain or sewer. Secondary containment not provided on all tanks/fuel. Accumulated water in concrete containment area diminished by accumulated stormwater. Picture taken by Farzad Kasmaei.

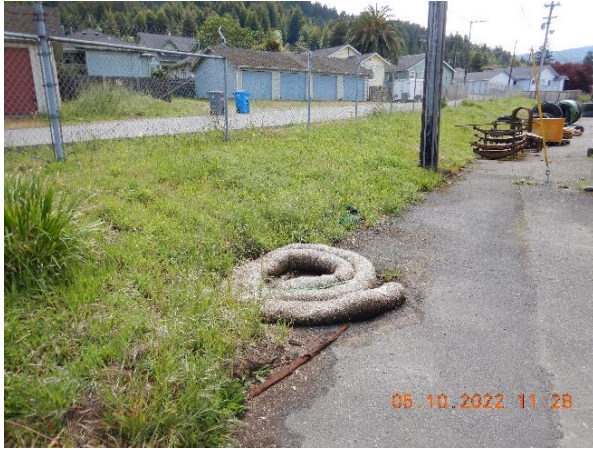
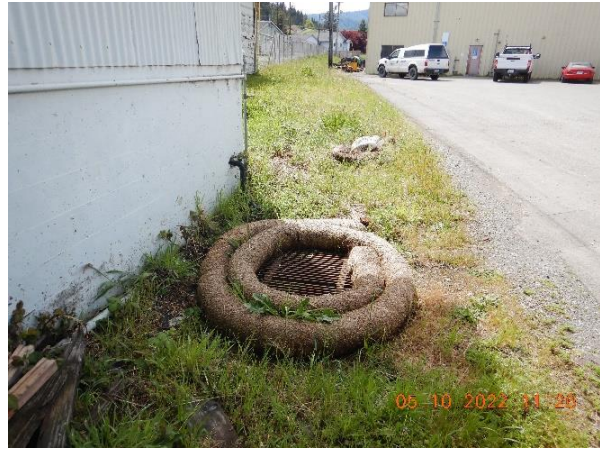
Pictures 12a, 12b: Looking southeast at storm drain inlets on north side of the facility in drainage area 3. Some of the fiber rolls installed around the inlets are old and in need of maintenance. Picture taken by Farzad Kasmaei.

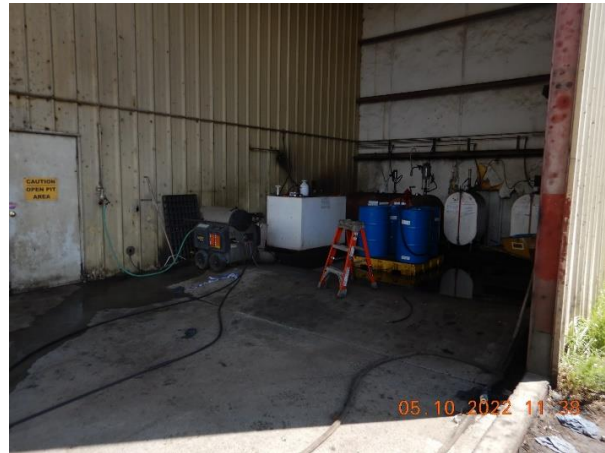
Pictures 13a and 13b: View of covered vehicle maintenance area. Picture taken by Farzad Kasmaei.

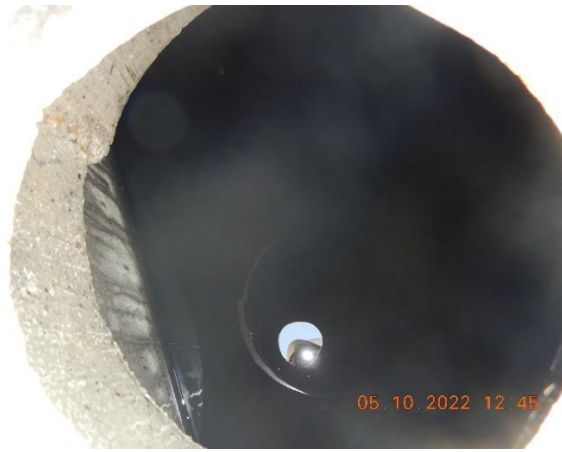
physically separate solids and floatable material. No chemical process or flocculants are used. Grab samples are collected from the last chamber, which was mostly full from the rain event the previous day (Picture 21c). No continuous process monitoring is utilized. Facility staff were unsure when the feature had last been maintained and could not provide a maintenance plan or schedule.

Pictures 21b, 21c: Newly installed clarifier on the south side of the Machine Shop building where the samples are collected (SWDB 3B). Picture taken by Farzad Kasmaei.

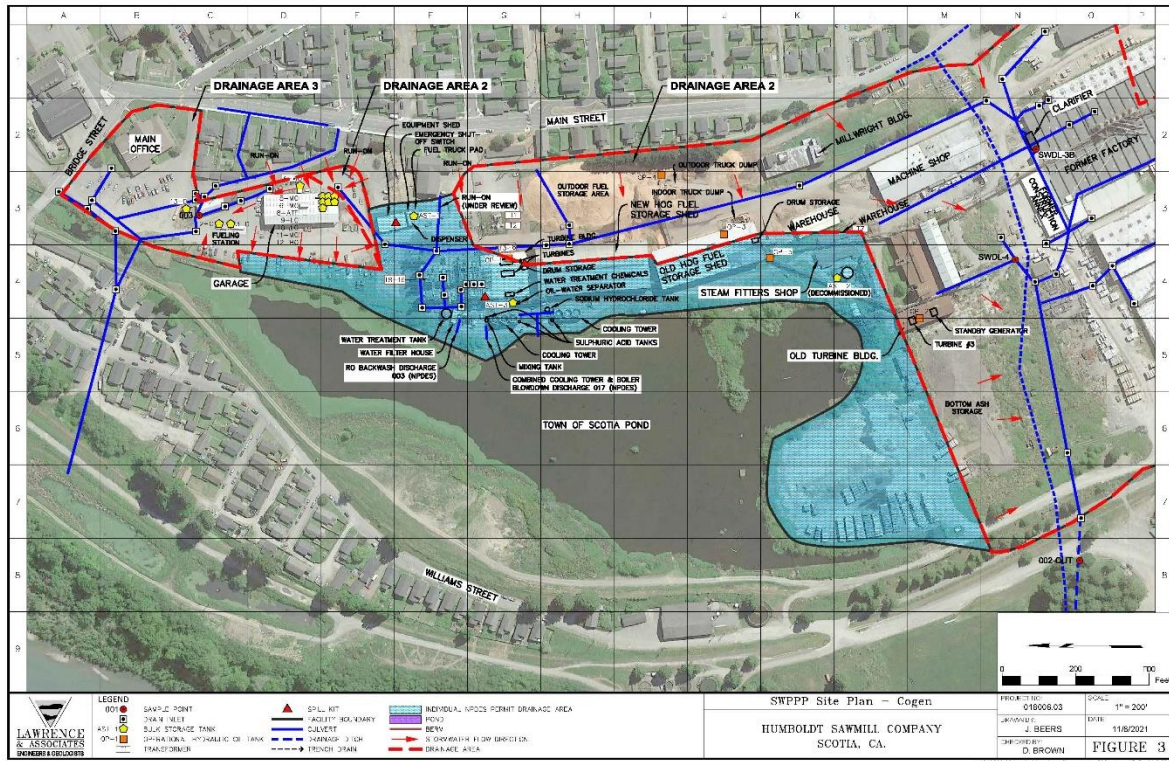
Site Map 1: This site map has been prepared by the Discharger and uploaded to SMARTS. The site map indicates the water flow directions, location of the Log Pond, Cogen area, and drainage areas 2 and 3 within the north side of the facility.

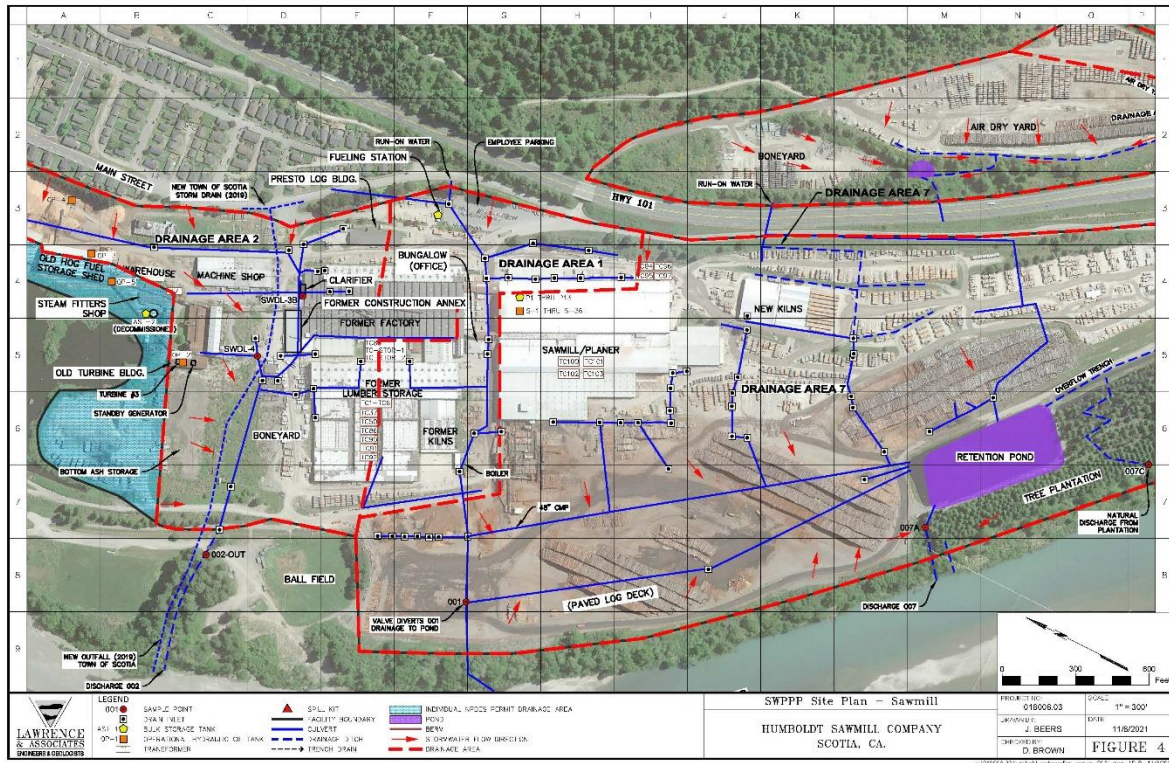
Site Map 2: This site map has been prepared by the Discharger and uploaded to SMARTS. The site map indicates the water flow directions, discharge points, drainage areas, and the location of the main retention pond, paved log deck, upper yard and drainage areas 1, 2 and 7 within the south side of the facility.
