North Coast Regional Water Quality Control Board

Og Kush Diet LLC, WDID 1_53CC411330

Inspection Date and Time			
Inspection Date	April 13, 2023		
Inspection Start Time:	10:30	Inspection End Time:	13:30
Site Location			
Address/Location	181 Oregon Mountain Road, Junction City CA 96048		
County	Trinity		
Assessor's Parcel Number (APN)	024-010-044-000		
Watershed	Lower Trinity River		
Property Owner and Cultivator Contact Information			
Property Owner's Legal Name and Company	Ivan Vlahov		
Mailing Address	181 Oregon Mountain Road, Junction City CA 96048		
Phone Number/E-mail Address	847-627-9909, ivlahov66@gmail.com		
Property Cultivator's Legal Name or Company	Og Kush Diet LLC, Ivan Vlahov		
Mailing Address	181 Oregon Mountain Road, Junction City CA 96048		
Phone Number/E-mail Address	847-627-9909, ivlahov66@gmail.com		
Consent to Inspect			
Full Name of Person Giving Consent	Ivan Vlahov		
Title of Person Giving Consent (e.g., owner, attorney)	Landowner		
Means of Giving Consent	Verbal

North Coast Regional Water Quality Control Board
 Cannabis Water Quality Inspection Report - Og Kush Diet LLC, WDID 1_53CC411330

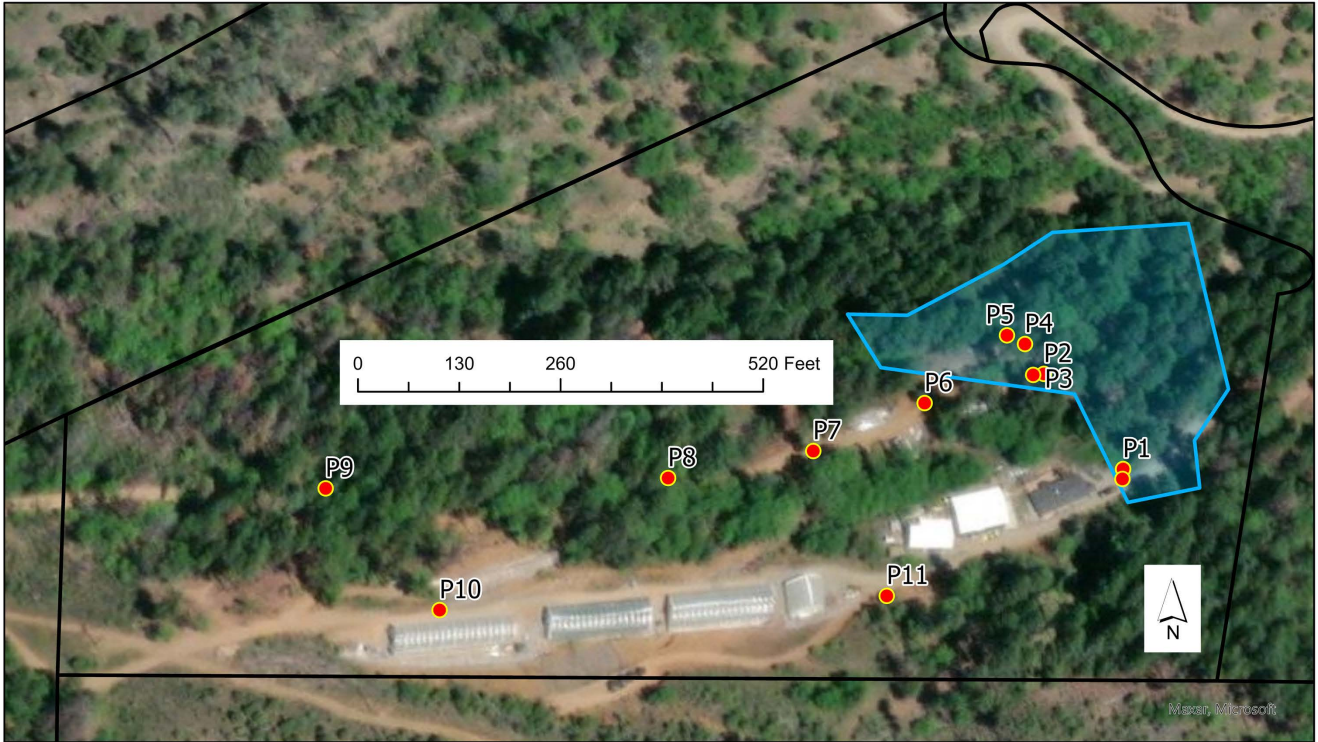
Figure 1: Site Map with parcel boundaries, points of interest P1-P11, and polygon area A1

Point features P1-P11 and polygon feature A1 are mapped in Figure 1 and described in Table 1.

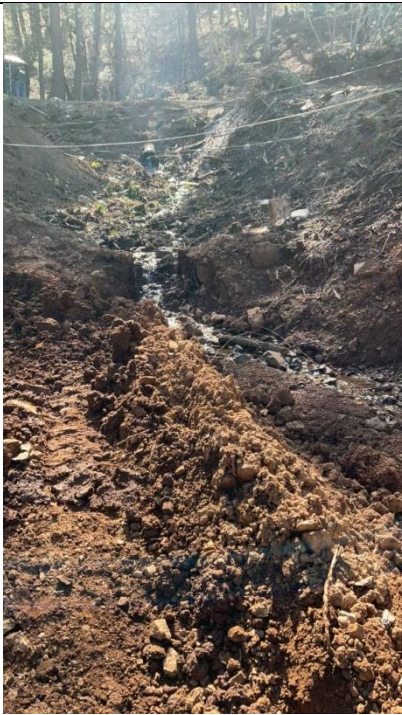
Photo Number: 2
	Photo Description: Excavator tracks on watercourse bank.
	Facing East
	Photo Number: 3
	Photo Description: Looking uphill at watercourse coming out of culvert stream crossing under access road. The channel was full of debris and lacked vegetation.

<p>Facing Southeast</p>

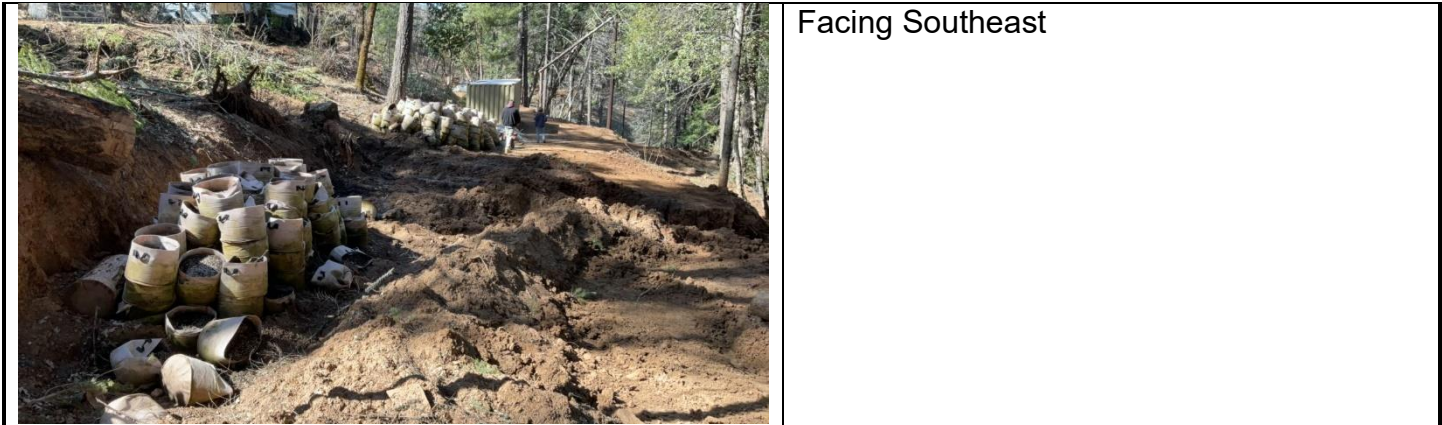
P3	
Category: Soil and Growing Medium (S)	Violation Present? Yes
Description: Approximately 300 grow bags with spent soil stockpiled on watercourse banks.

Photo Number: 3
	Photo Description: Bags stockpiled on watercourse bank.
	Facing Southeast
	Photo Number: 4
	Photo Description: View of bags on both sides of watercourse.

Facing Southeast

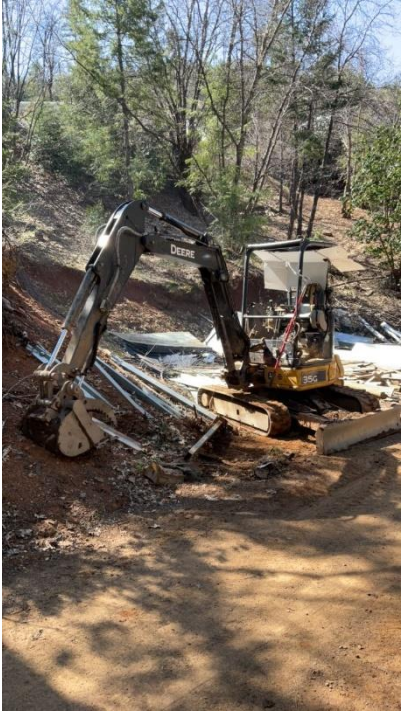
Photo Number: 1
	Photo Description: Excavator on site.
	Facing South
P7	
Category: Watercourse Crossings (WC)	Violation Present? Yes
Description: Two dirt fords. Stream diverted down road.	
	Photo Number: 1
	Photo Description: First dirt ford crossing.

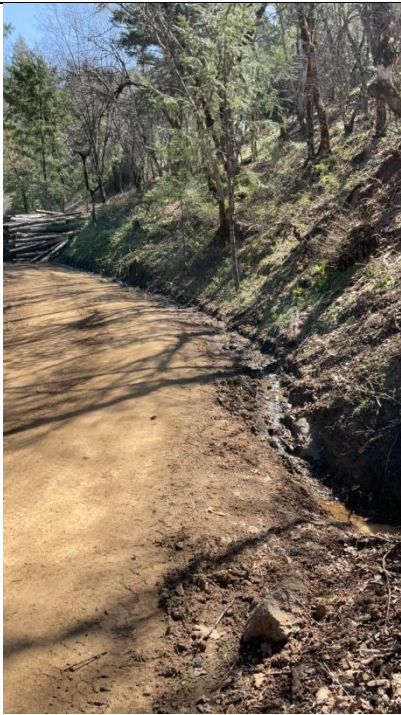
Photo Number: 4
	Photo Description: Ford crossing eroding dirt road.
	Facing South
P8	
Category: Watercourse Crossings (WC)	Violation Present? Yes
Description: Culvert stream crossing with perched outlet.

Photo Number: 1
	Photo Description: Perched culvert outlet.
	Facing Northwest
	Photo Number: 2
	Photo Description: Looking uphill at stream diverted into ditch. Culvert inlet on right side.

Facing East
P9		
Category: Watercourse Crossings (WC)		Violation Present? Yes
Description: Dirt ford stream crossing.

P8 and P11: Apply for a 401 Water Quality Certification to replace the misaligned and undersized culvert stream crossings.

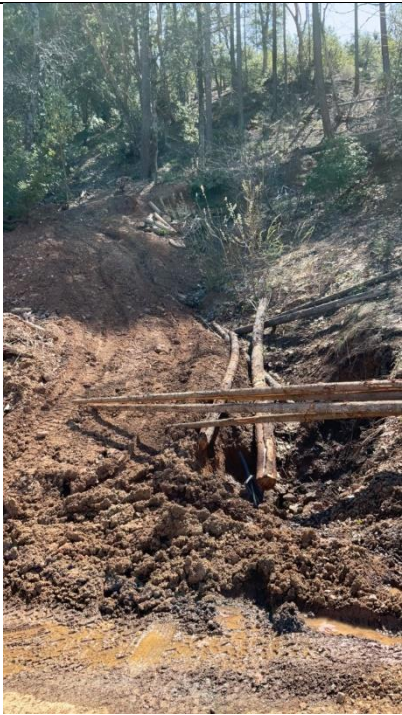
Photo Number: 1
 Photo Description: Upstream of culvert.

Facing East
