North Coast Regional Water Quality Control Board

Subject: **Notice of Violation** of State Water Resources Control Board Order No. 2014-0057 DWQ General Permit for Storm Water Discharges Associated with Industrial Activities (Industrial General Permit/IGP) for the West Coast Metals

File: West Coast Metals, 470 Caletti Avenue, Windsor, Sonoma County, WDID No. 1 49I018939

Attachment B: November 1, 2022, Facility Stormwater Inspection Report

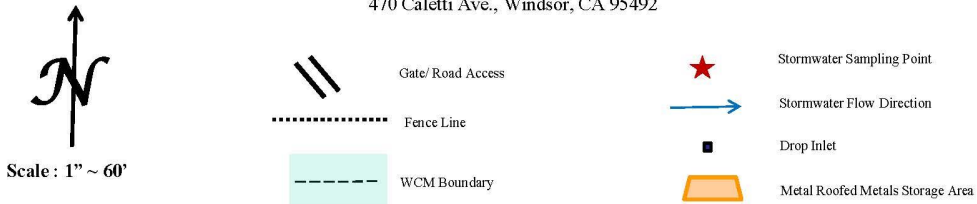
West Coast Metals Site Map

Site Map: The old Site map has been prepared by the Discharger's consultant that indicates the water flow directions and the storm drain inlets. However, the site map must be revised to include the drop inlets that are not shown and make corrections on the roofed metal storage locations.
