**CALIFORNIA REGIONAL WATER QUALITY CONTROL BOARD
NORTH COAST REGION**

Order No. R1-2023-0042

Amending Cleanup and Abatement and 13267 Order No. R1-2021-0056

**Justin Baldwin and Mia Baldwin as Trustees of the Baldwin J and M Trust,
Humboldt Spirit Inc. and Sprowl Creek LLC**

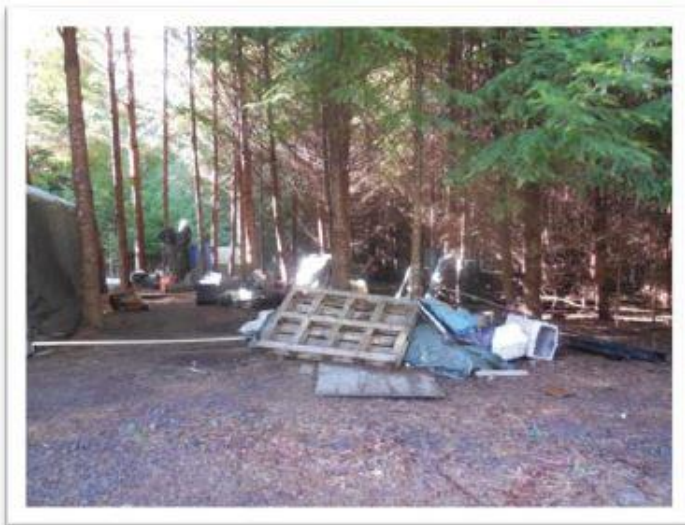
Miscellaneous storage west of pond R1

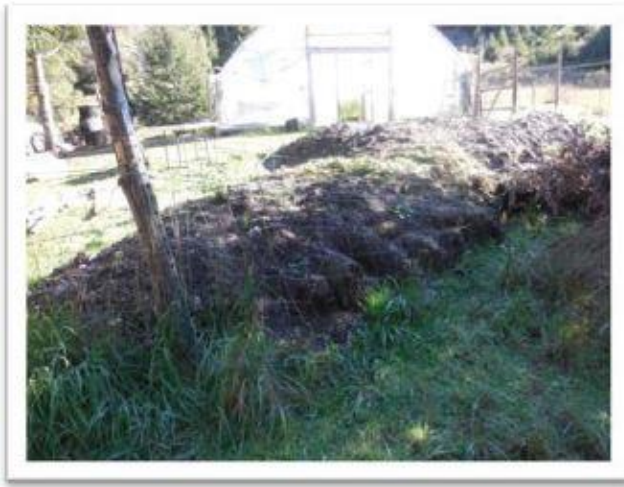
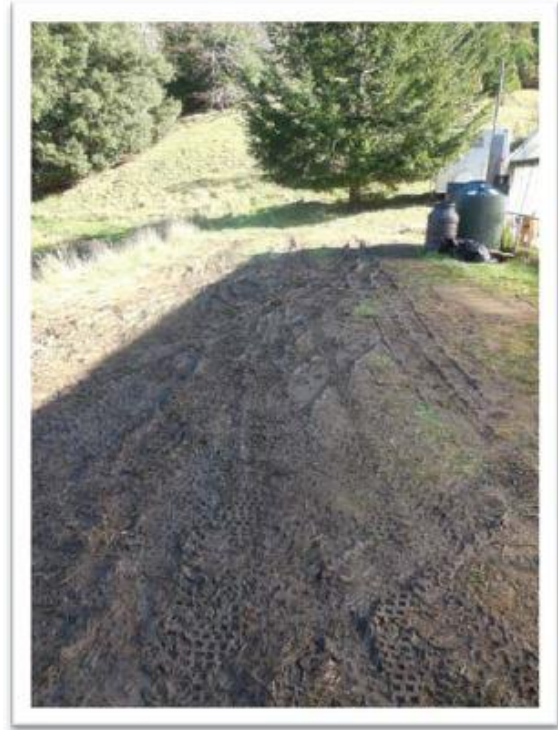
- Greenhouse G8: The greenhouse is sited on a flat area with a fenced grassy area just to the south. There were several small piles of potting soil to the west of greenhouse. The roadway between the greenhouse and the pond was very soft and muddy, and with many tire tracks. Housekeeping and drainage improvements may be warranted in this area.

Greenhouse G8, stockpiled potting soil to the south, muddy road to the west

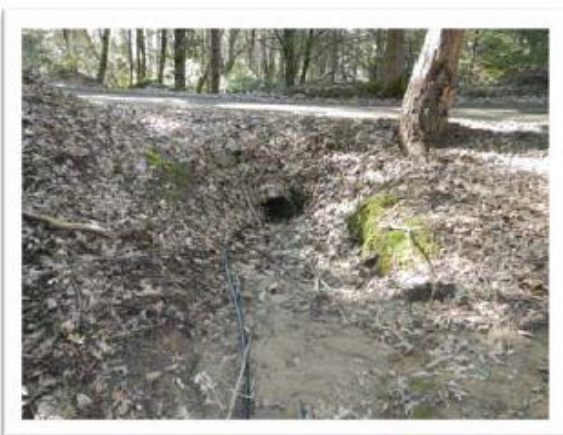
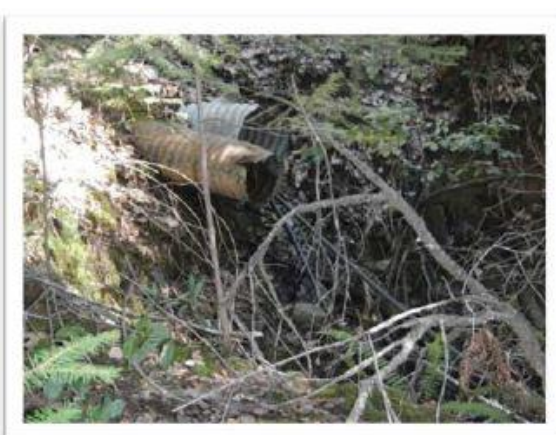
We observed water tanks in this stream channel, and conditions in the channel appeared poor, and susceptible to eroding and delivering sediment. We observed erosion and deposited sediment in the channel upstream of the road. The stream crossing culvert at this location (Crossing C2) appeared to be undersized, and we observed erosion along the road and around the culvert outlet.

Culvert C2, inlet and outlet (outlet photo taken by DFW staff)

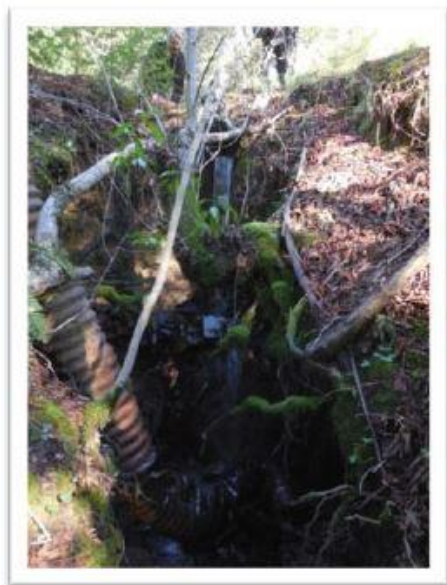
The culvert crossing the road at this location was shotgunned and showed signs of significant erosion and downcutting.

Culvert crossing located on Oak Rock Road, approximately due south of OG3, at or near the property line.

GPS coordinates indicate this roadway is located off the property; it may be appropriate to identify and contact the property owner association to review roads and culverts throughout the watershed.

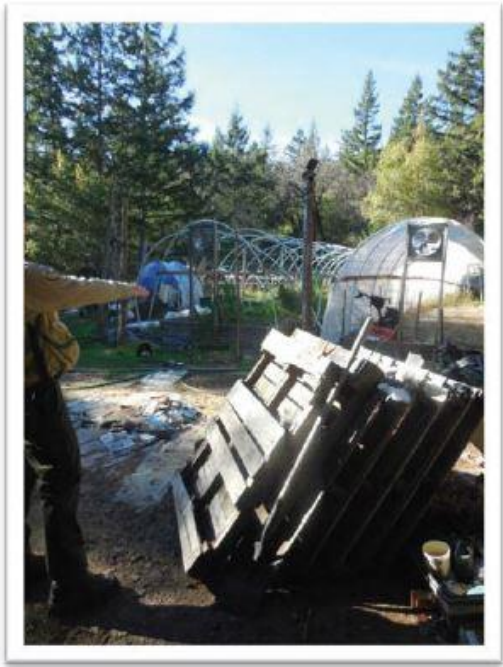
The development at G5 and just to the north includes a large cleared pad with several greenhouses or greenhouse hoop sets sitting on or over raised beds, access road, and encampment area with trailers, tents, pole and tarp structures, a screened open-air pit toilet, vehicles, and miscellaneous evidence of habitation and activity, although we did not encounter any occupants or onsite personnel. The greenhouse/cultivation footprint is well-mulched, and shows evidence of a fair amount of effort and care directly associated with cultivation in that area. However, this footprint is surrounded by materials, supplies, and waste materials associated with site development and operation, including piled vegetation and brush, loose soil, spent potting soil and plants, containers, bags, piping, tarps, pallets, garbage, etc.

Looking west at G5 greenhouses

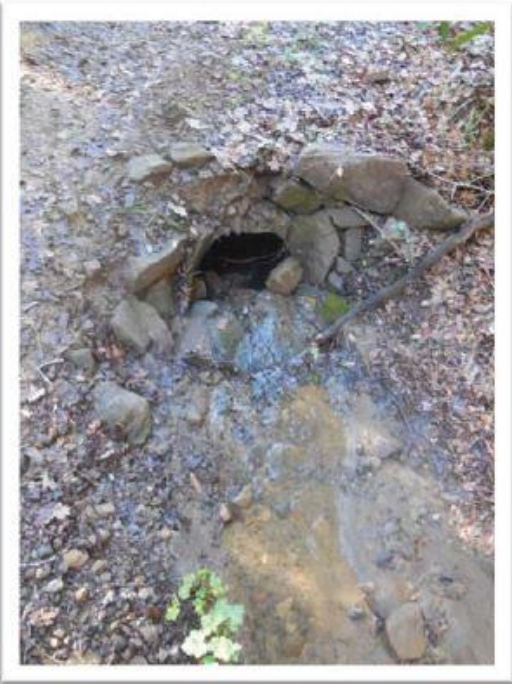
Culvert C3.1

The watercourse passes along a corner of this area, through (and likely over) a silted-in and apparently undersized culvert, C3 (shows as C13.1 on map).

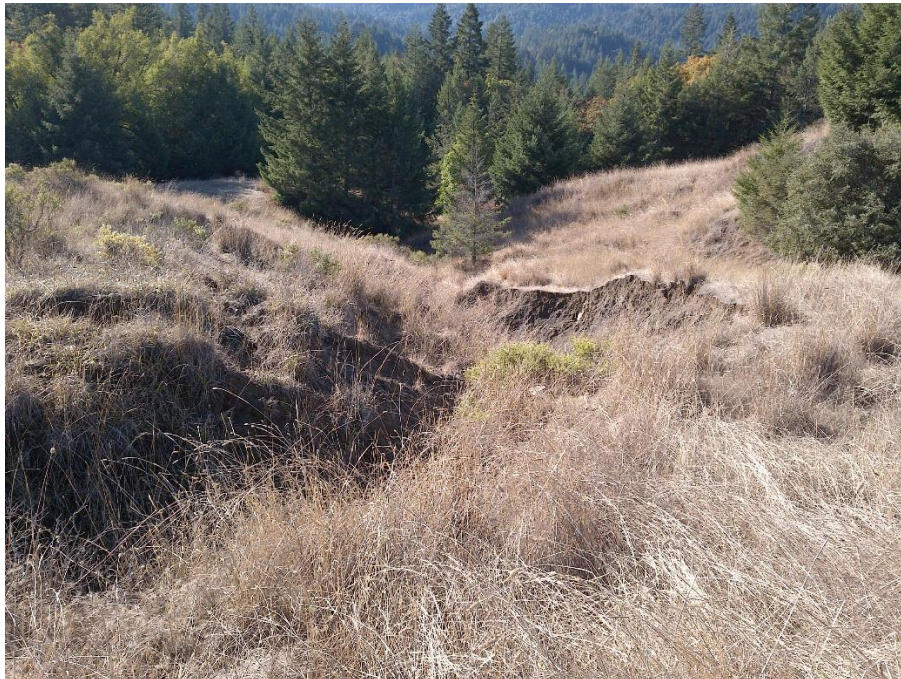
The above site map shows inspection points identified and discussed in this report. Inspection participants accessed the property from the north and stopped first in the vicinity of WQ 1, where I observed an approximate 200-foot length of road sloped into an inboard ditch that discharges to a deeply incising channel at WQ 2 (Photo 1 and Photo 2). We then walked west along Pepperwood Springs Road where I observed six watercourse crossings that appeared too narrow relative to the channel size, installed at too shallow of a grade and/or failing at WQ 3 thru WQ 8 (Photo 3 thru Photo 10).

Photo 2—Looking south and downstream at incised upstream stretch of watercourse at WQ 2.

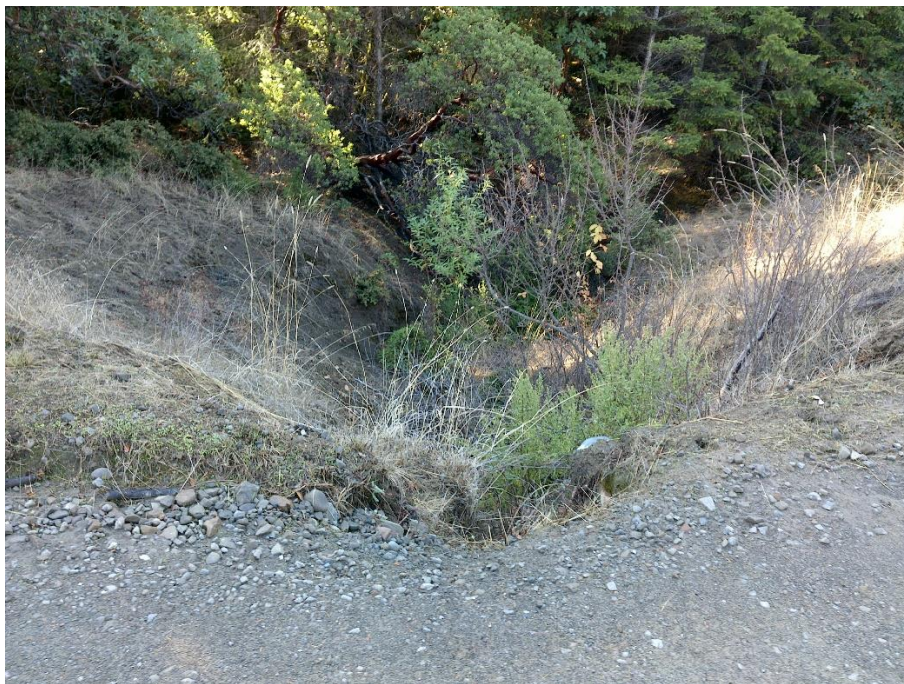
Photo 4—Looking south and downhill at culvert outlet located at WQ 3.

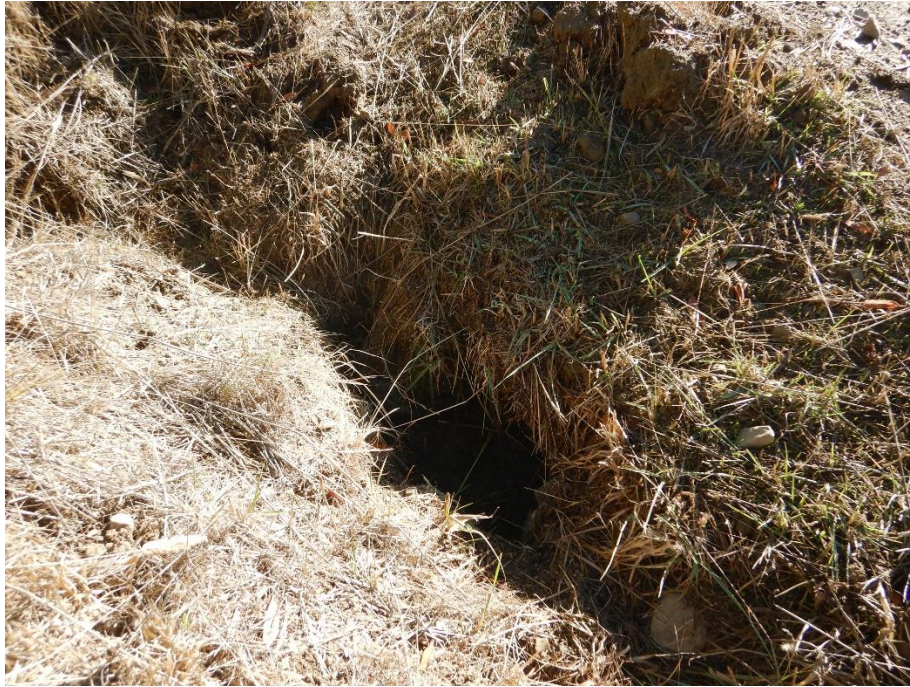
Photo 5—Stream channel in the vicinity of WQ 4.

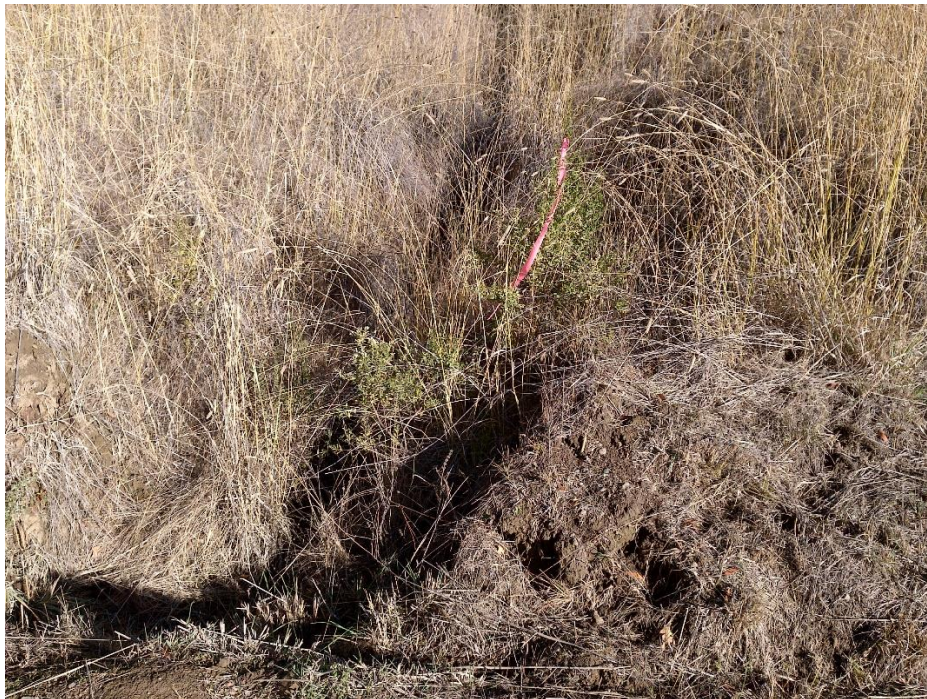
Photo 6—Looking north at watercourse upstream from road at WQ 5.

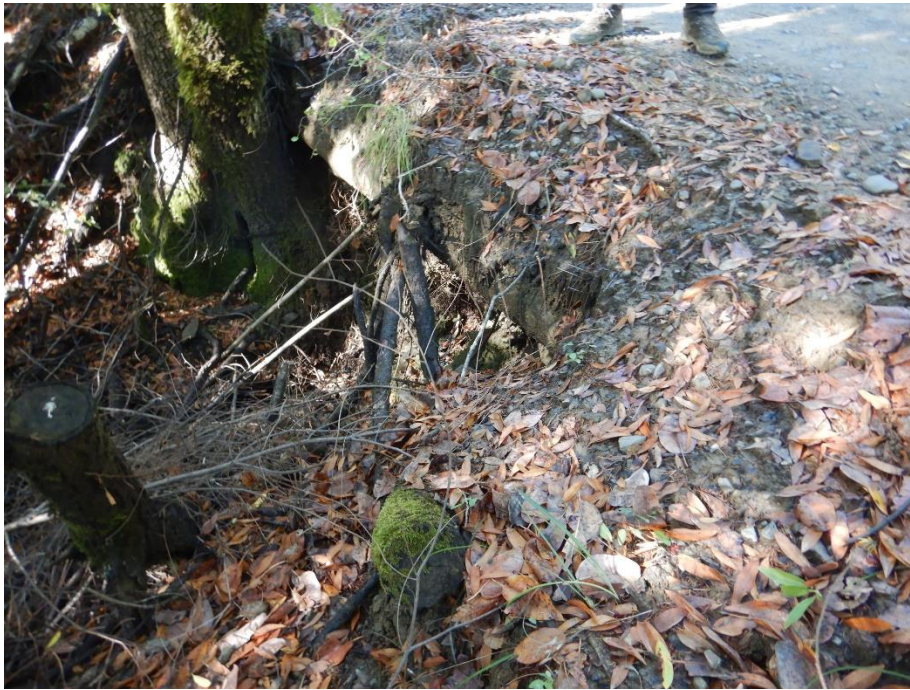
Photo 9—Looking west in the vicinity of the expected culvert outlet located at WQ 7.

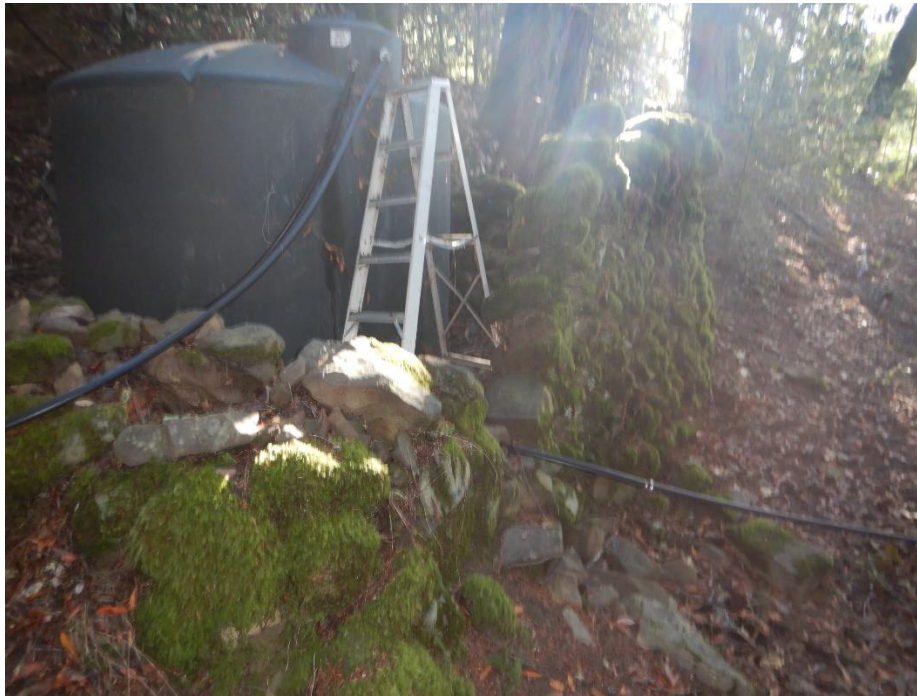
Photo 19—Tank collecting spring water at WQ 12.

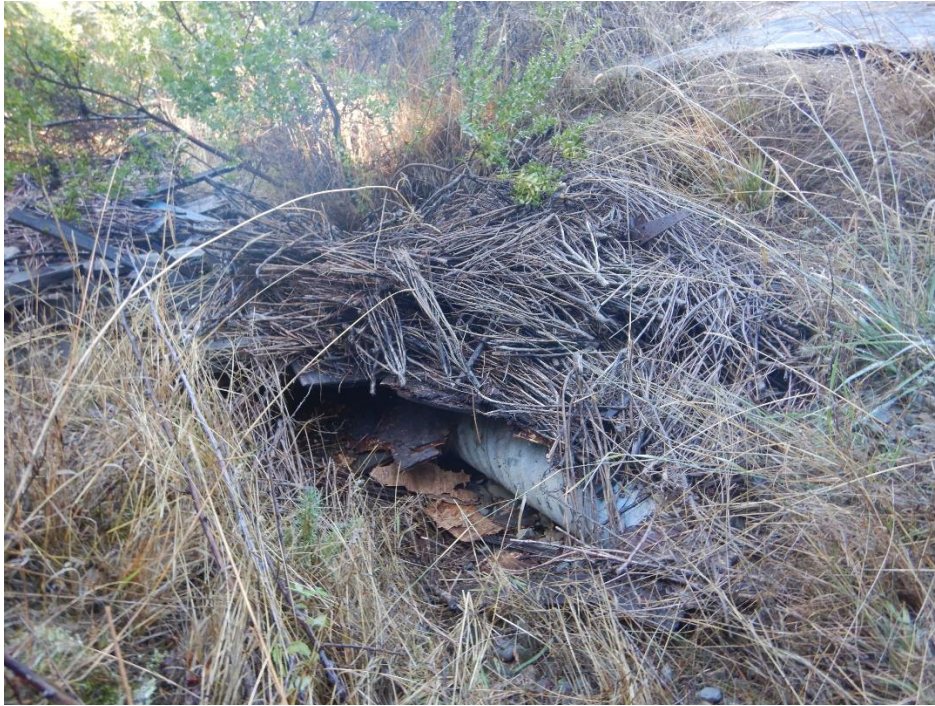
Photo 21—A buried culvert where a legacy road crosses the watercourse at WQ 13.

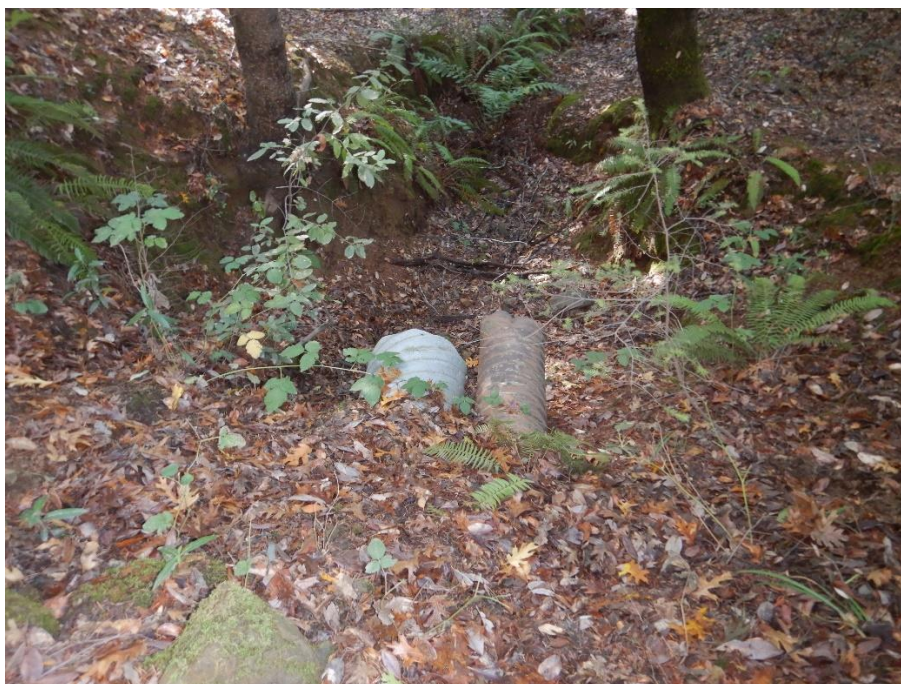
Photo 26—Looking downstream at two culverts, 12 inch and 18 inches in diameter, directed to an approximately five-foot-wide watercourse at WQ 16.

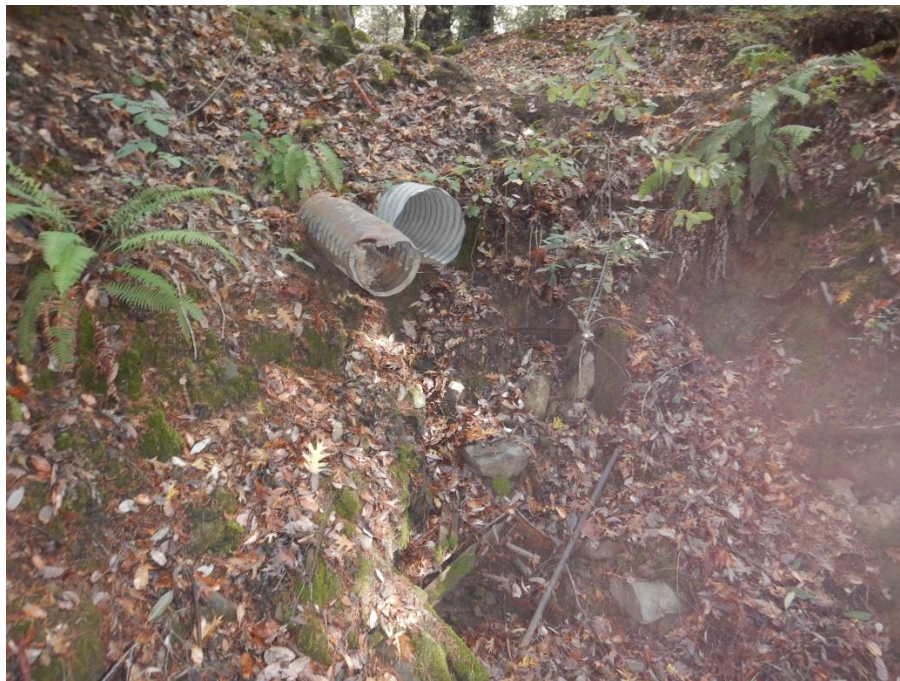
From WQ 14, we walked to the greenhouse located at WQ 15 (Photo 24) and I observed the large pile of potting soils, that is identified in the 2015 Inspection Report, remained behind the greenhouse (Photo 25). We then walked north to the reservoir outlet at WQ 11 and followed the receiving waters west where I observed a perched and undersized culvert conveying the watercourse across Oak Rock Road at WQ 16 (Photo 26 and Photo 27). This culvert, which was identified as C2 in the 2015 Inspection Report, is too small relative to the size of the receiving watercourse and installed shallow in the road fill resulting in a steep drop at the outlet that was scouring the downstream watercourse.

Photo 27—Looking upstream at the two culverts pictured in the previous image perched five feet above the receiving watercourse at WQ 16.

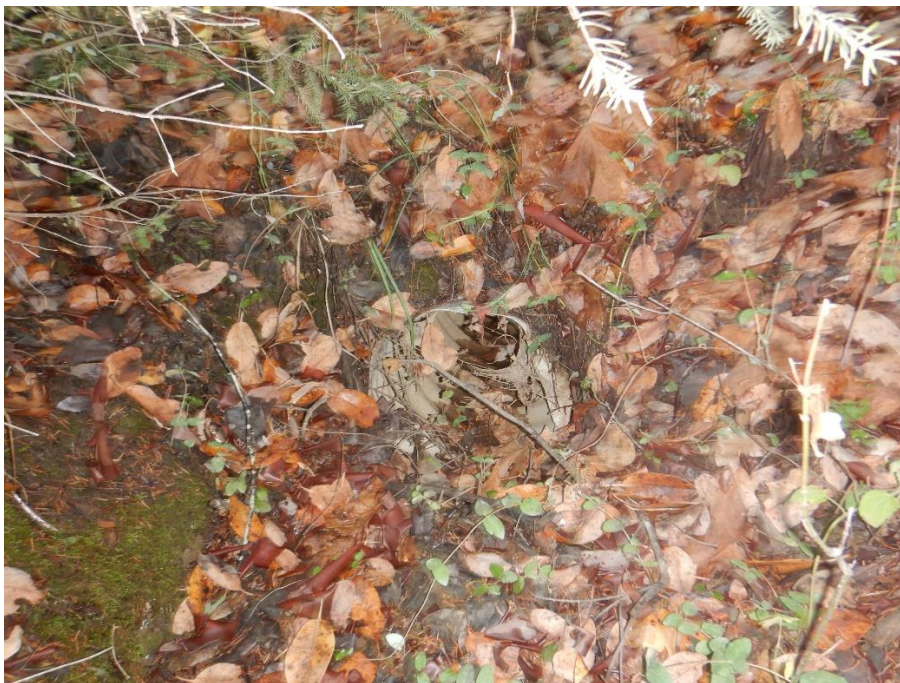
We continued south and I observed two more culverts that appeared undersized at WQ 17 and WQ 18 (Photo 28 thru Photo 31). Further south, Oak Rock Road passes the property boundary and loops back north onto the property. I observed a long section of road from WQ 19, to the north, without drainage before an inboard ditch directs surface water over the road and towards a tributary to Sproul Creek in the vicinity of WQ 20 (Photo 32 and Photo 33).

Photo 28—Looking west and downstream at inlet of a 15-inch diameter metal pipe located at WQ 17.

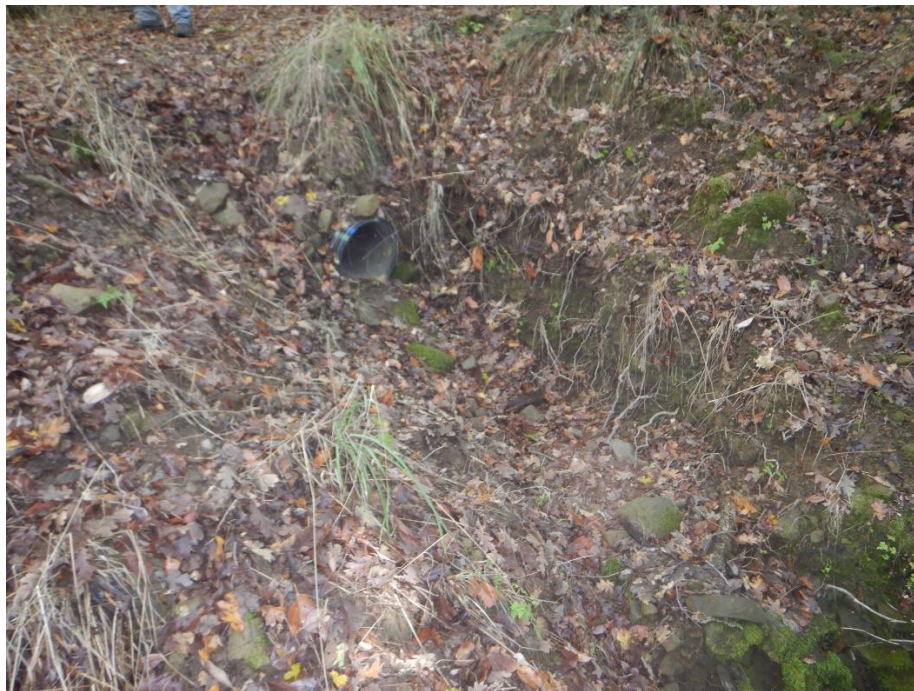
We walked back along Oak Rock Road to a point north of WQ 10 and headed west down a smaller and less used road. I observed a relatively new stream crossing at WQ 21 that appeared to be installed at channel grade (Photo 34 and Photo 35). Farther west, in the vicinity of WQ 22, I observed a watercourse approaching the road from the northeast, which is then directed along the northern boundary of the road before turning at a right angle and crossing the road through a culvert perpendicular to the road axis. The road approaching from the east is steep and likely contributes significant stormwater to the area. The hillslope to the south of the road segment that interrupts and parallels the watercourse is marked by a broad braided stream network. I observed an incised drainage immediately west from where the watercourse is culverted below the road (Photo 36).

Photo 35—Looking north at culvert outlet in the vicinity of WQ 21. The culvert is aligned with the stream bottom.

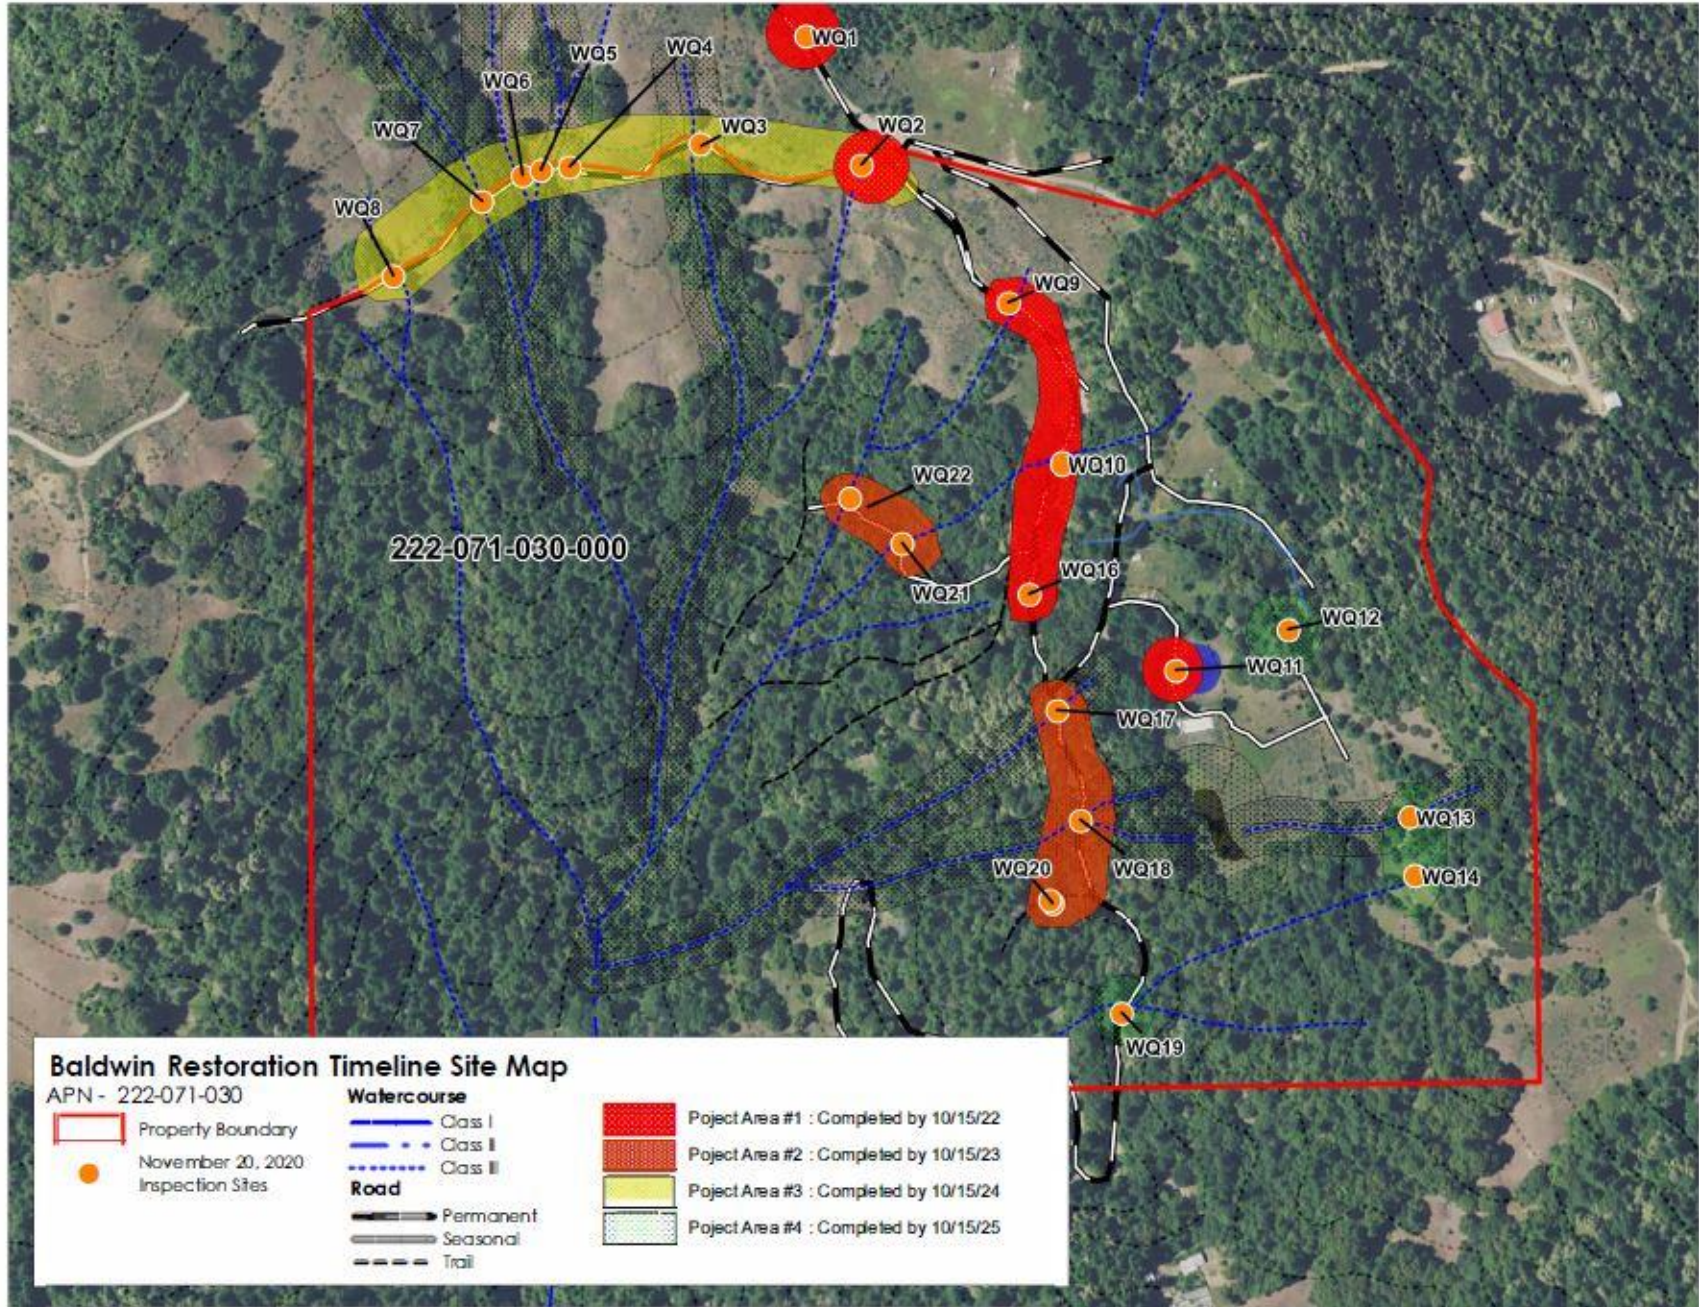
WQ 15	greenhouse bordering wetlands.	Greenhouse is close to wetlands.	threatened discharge of waste to receiving waters	Photo 24
WQ 22	road redirecting watercourse	Road leading to historical cultivation area redirects drainage and concentrates stormwater.	threatened discharge of waste to receiving waters	Photo 36

Photo 36—Looking at incised watercourse west of receiving drainage of watercourse that has been redirected by road in the vicinity of WQ 22.
