North Coast Regional Water Quality Control Board

INSPECTION MEMO

Eagle Rock, Inc. - La Grange Pit
40029 La Grange Road
Junction City, Trinity County

August 25, 2022

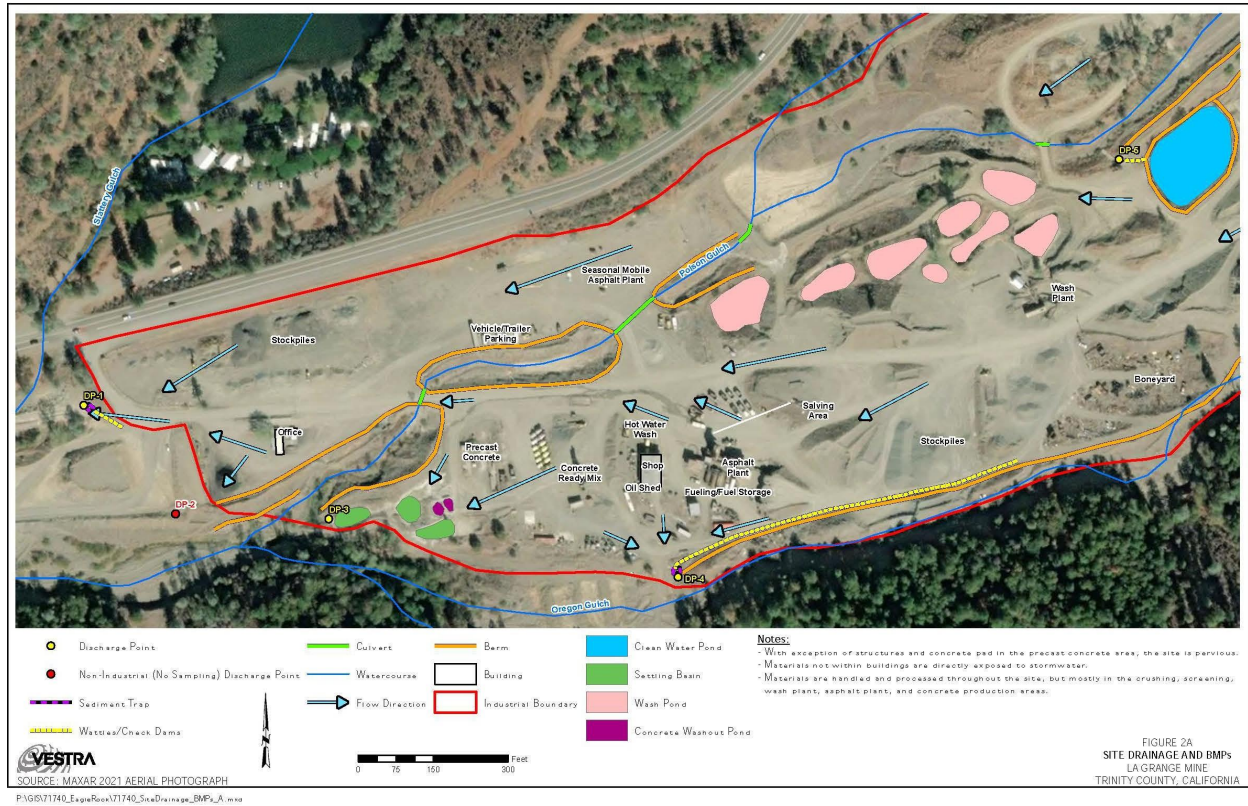
Site map 2: The site map has been prepared by Discharger’s consultant, indicating the central and western portions of the Facility. Stormwater flow directions, sampling locations, clean water and settling pond locations and the location of the earthen berms are shown on the site map.

Site map must be revised to reflect the current condition of the site. All discrepancies must be addressed. The drainage areas, potential monitoring/sampling points and any stormwater features such as missing wash pond must be included on the site map. The SWPPP may need to be revised accordingly.
