C3. Sample Inspection Report and Erosion Control Plan

Date: January 20, 2012

From: Colin Hughes, PG #8549
Pacific Watershed Associates Inc.
PO Box 4433
Arcata CA, 95518
colinh@pacificwatershed.com / 707-839-5130

Subject: Inspection report and erosion control plan for APN 123-456-789, Brown Cow, Valley County, California.

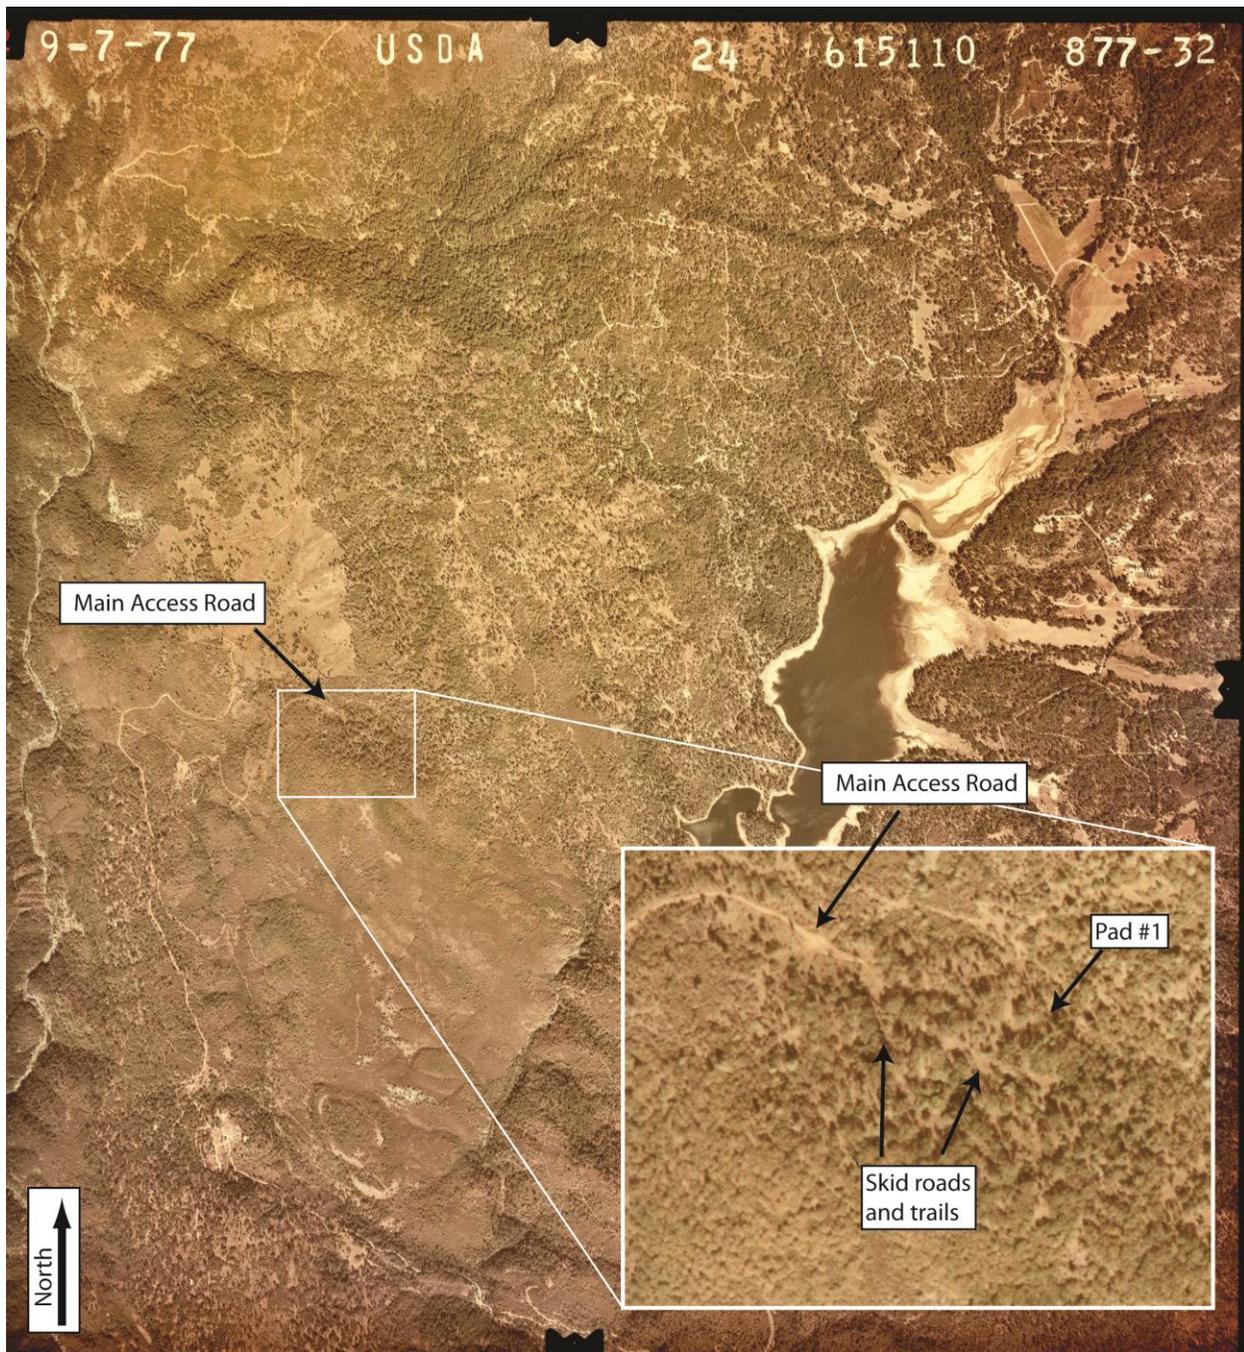
This aerial photograph was taken by the USDA in 1977. A larger scale inset has been added to the photo to provide greater detail at the XYZ Ranch property. The Main Access Road leading into the XYZ Ranch property can clearly be discerned. Numerous skid trails and skid roads can be seen, as well as canopy reduction from timber harvest and/or mining activities. Pad #1 can be seen in the photo to have been cleared of trees and vegetation and utilized by timber harvest activities.

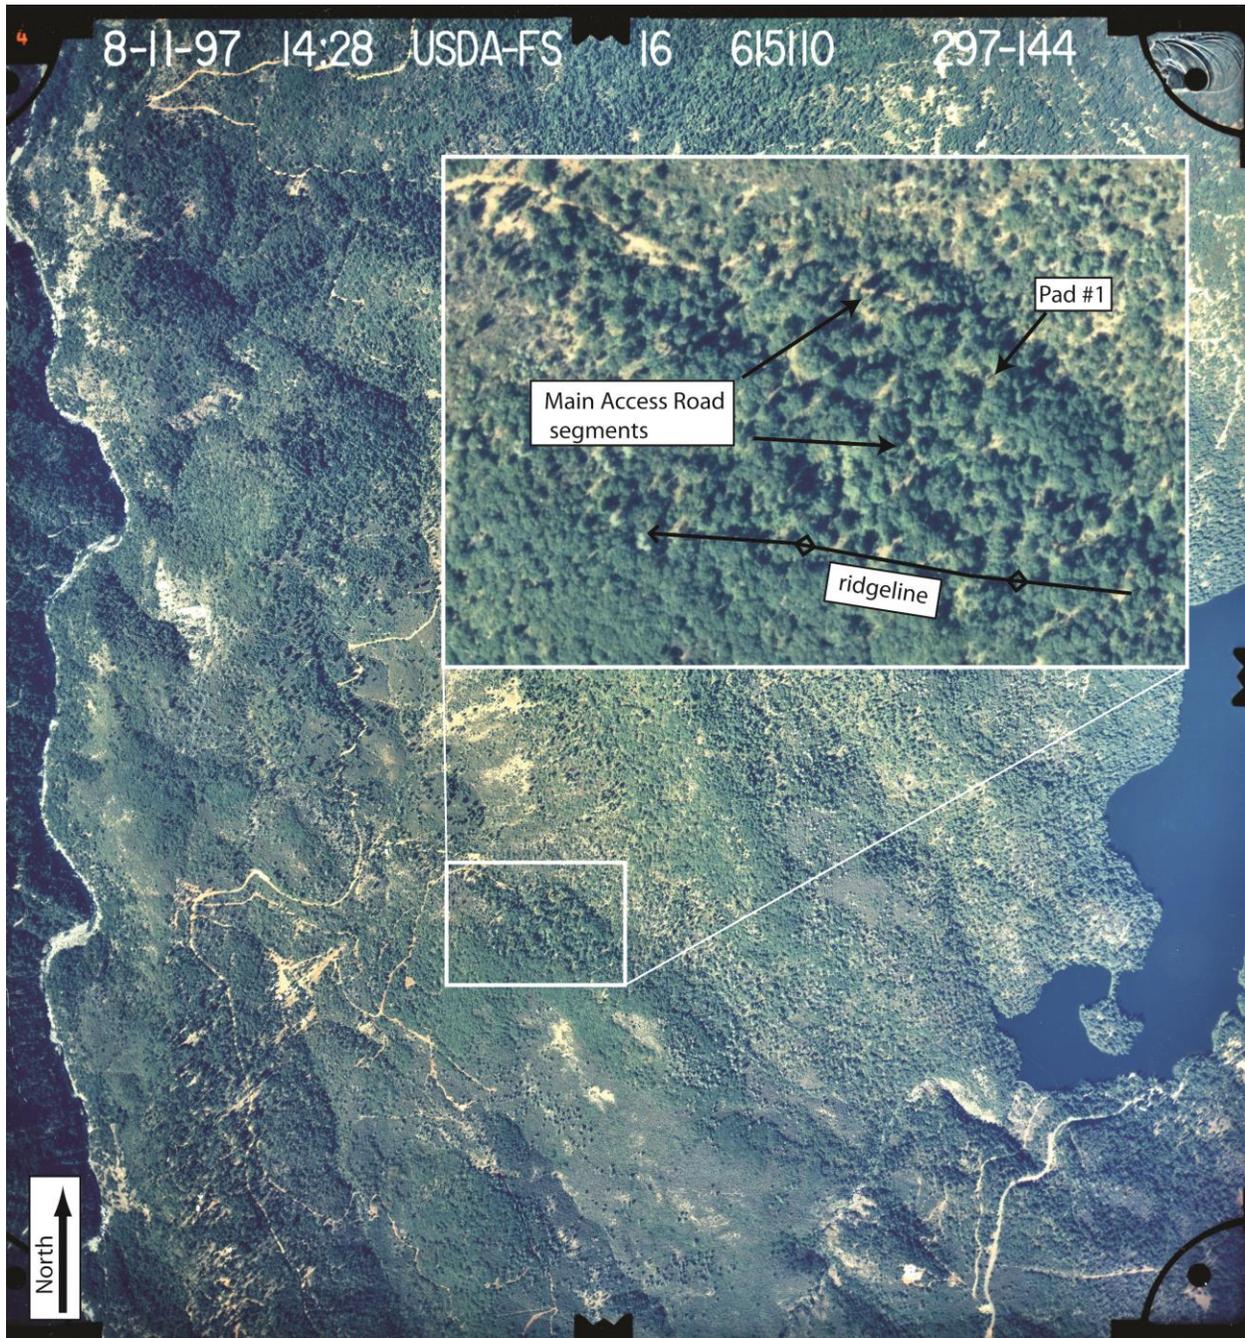
This aerial photograph was taken by the USDA in 1997. A larger scale inset has been added to the photo to provide greater detail at the XYZ Ranch property. By 1997, the Main Access Road had been constructed beyond Pad #1 and provided access towards the east-west trending ridge shown at the southern extent of the photograph inset.

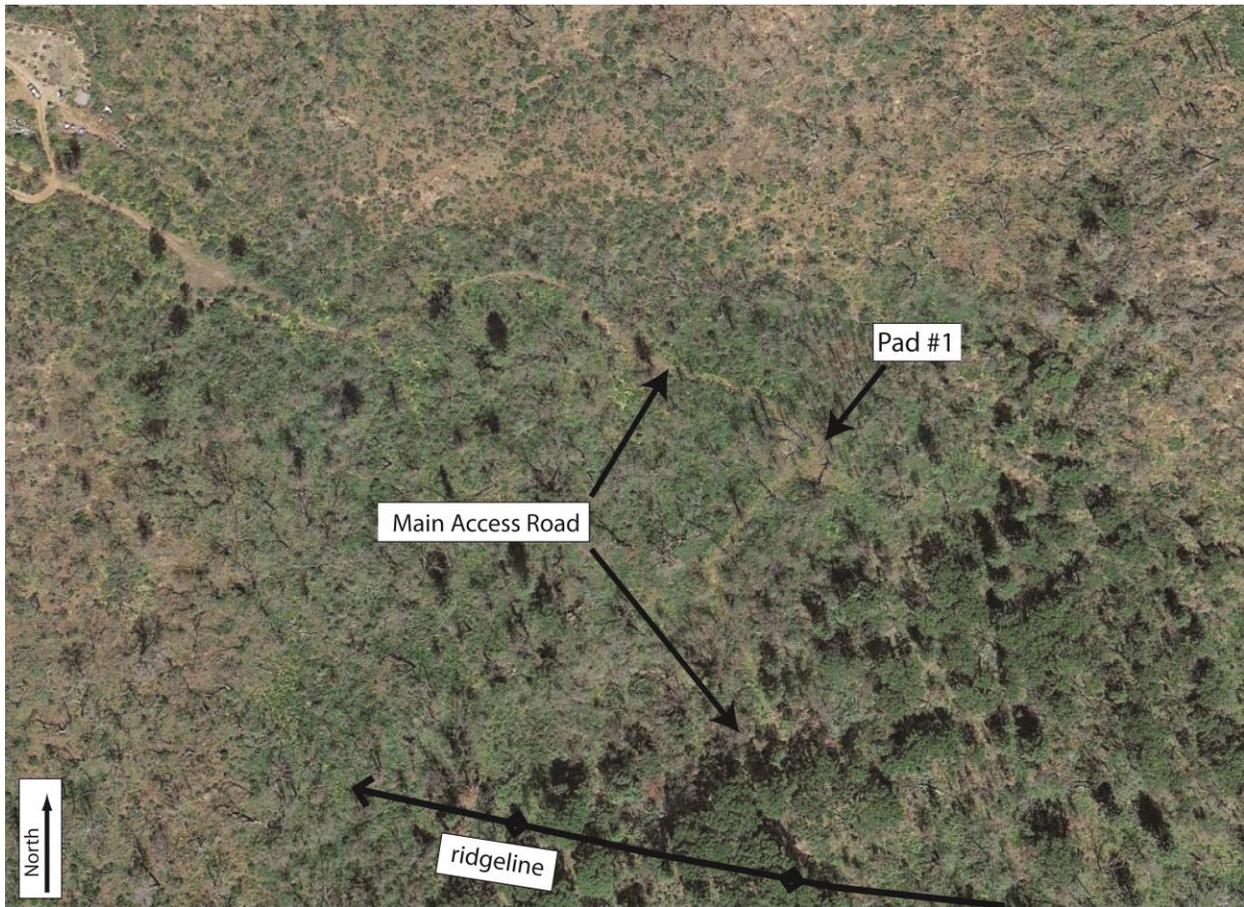
Google Earth imagery dated May 12, 2008. This photo was taken approximately two years after large-scale fires swept through this area of Valley County. Loss of tree canopy improves the visibility of existing property roads and cut and fill pads.

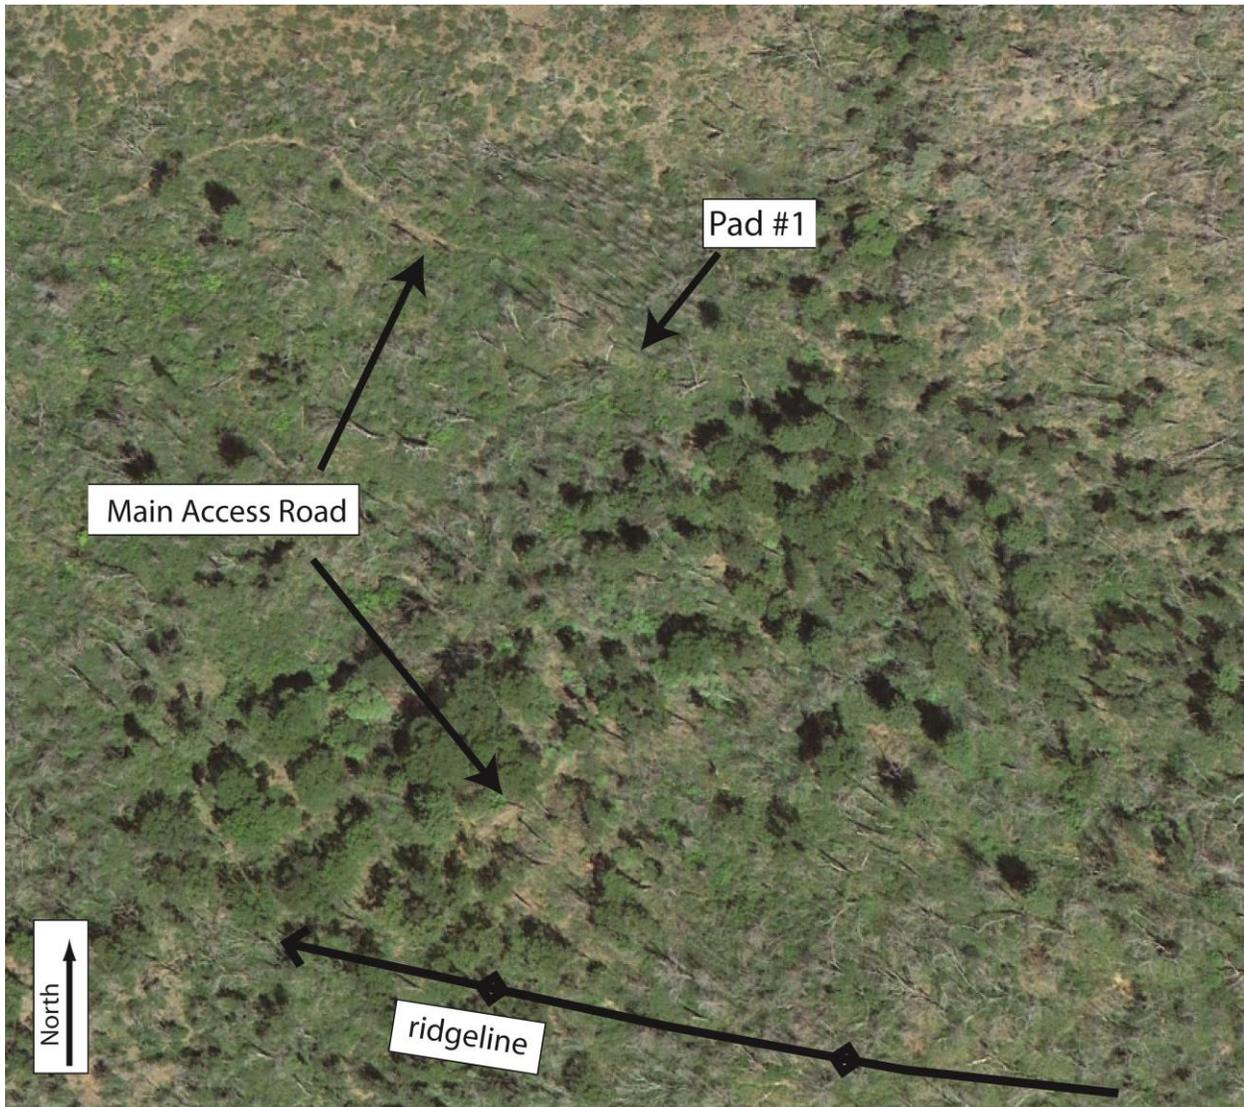
Imagery dated June 5, 2010, available on Google Earth, shows the property after the fire of 2008. Existing property roads and Pad #1 are much more visible on the 2010 imagery due to the loss of canopy in the 2008 fire. Pad #1 can be observed to be similar in shape and footprint area to the main/large terrace portion of Pad #1 in its current condition (Map 1 and Attachment A). Main Access Road can be discerned on the 2010 imagery in its current alignment and extending to the ridgeline in the central portion of the property.

Google Earth imagery dated June 5, 2010. This photo was taken approximately four years after large-scale fires swept through this area of Valley County. Substantial regrowth of vegetation is visible. No recent grading of property roads or cut and fill pads can be discerned from this imagery.
