Subject: Enrollment of THP 1-05-123 HUM (Unit 1) in the Freshwater Creek WWDR, "Tier II"

**THP: Mid Incline      THP 05-123      Unit # 1      3-9-09**

## **Erosion Control Plan (ECP) for the “Mid Incline” THP 1-05-123HUM**

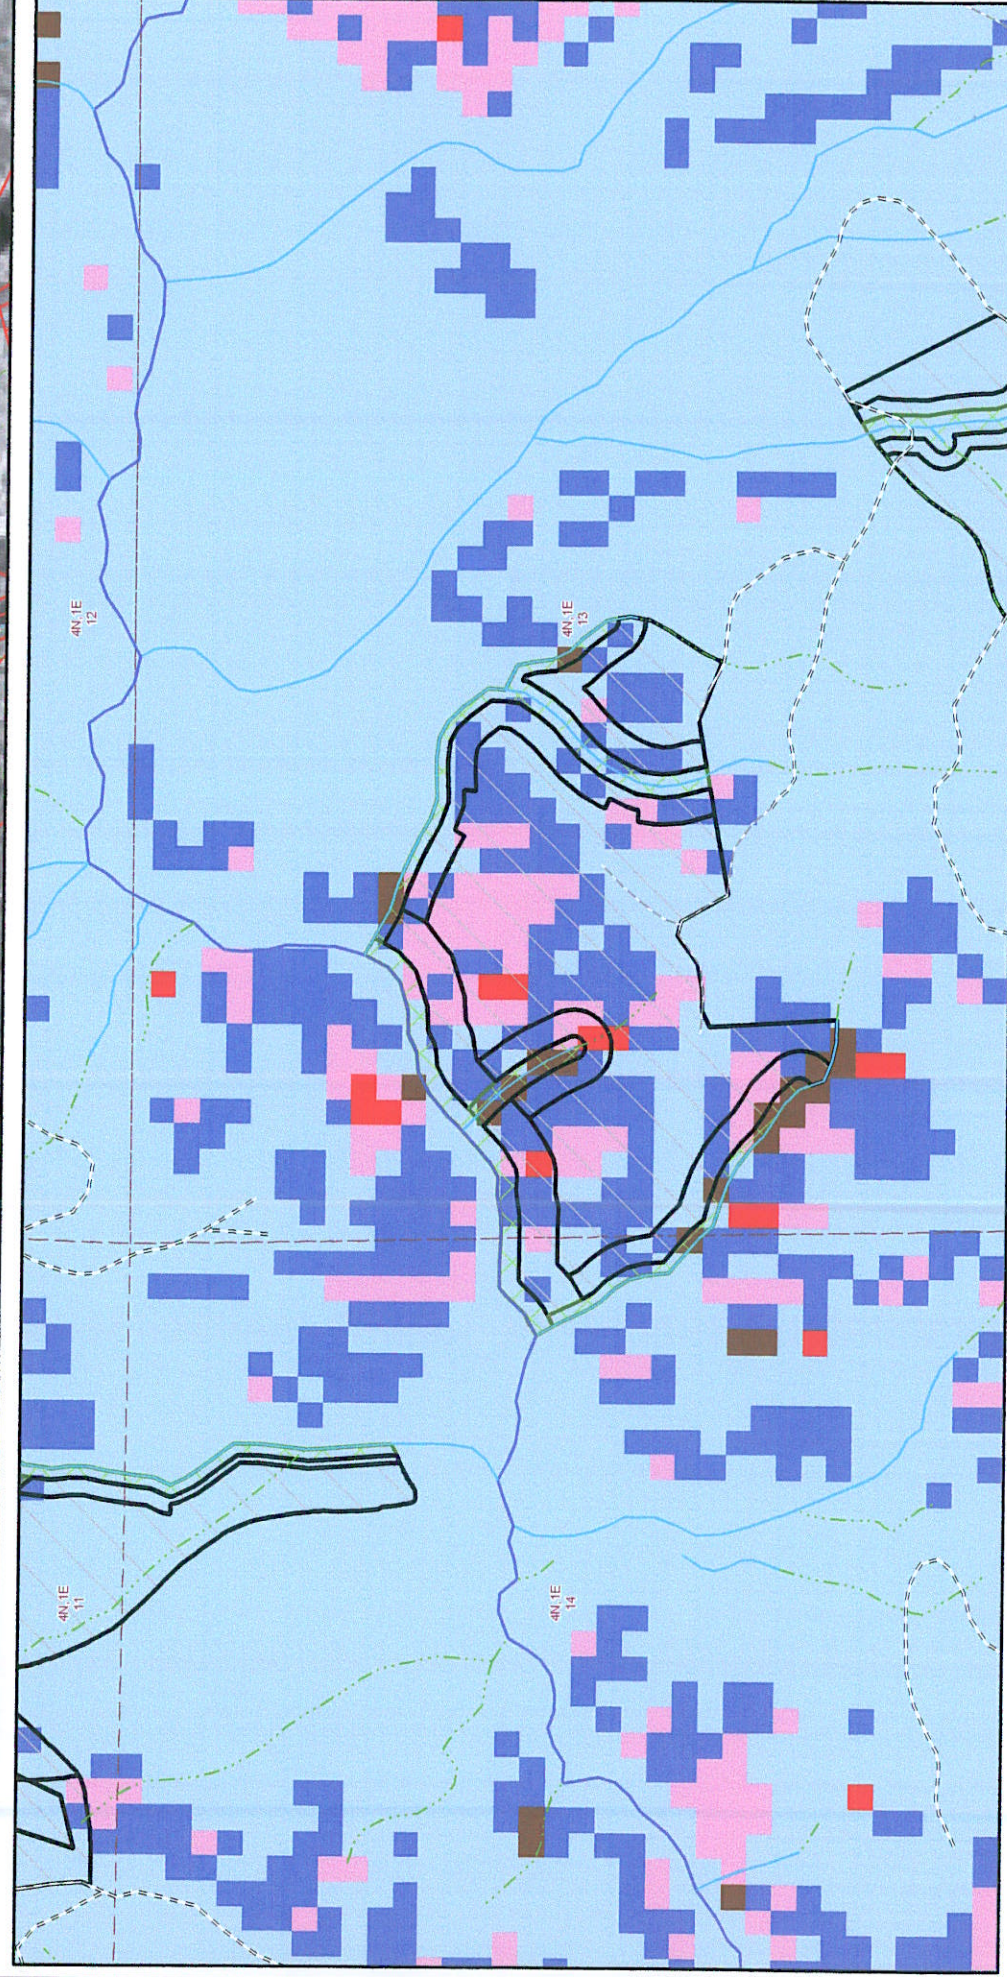
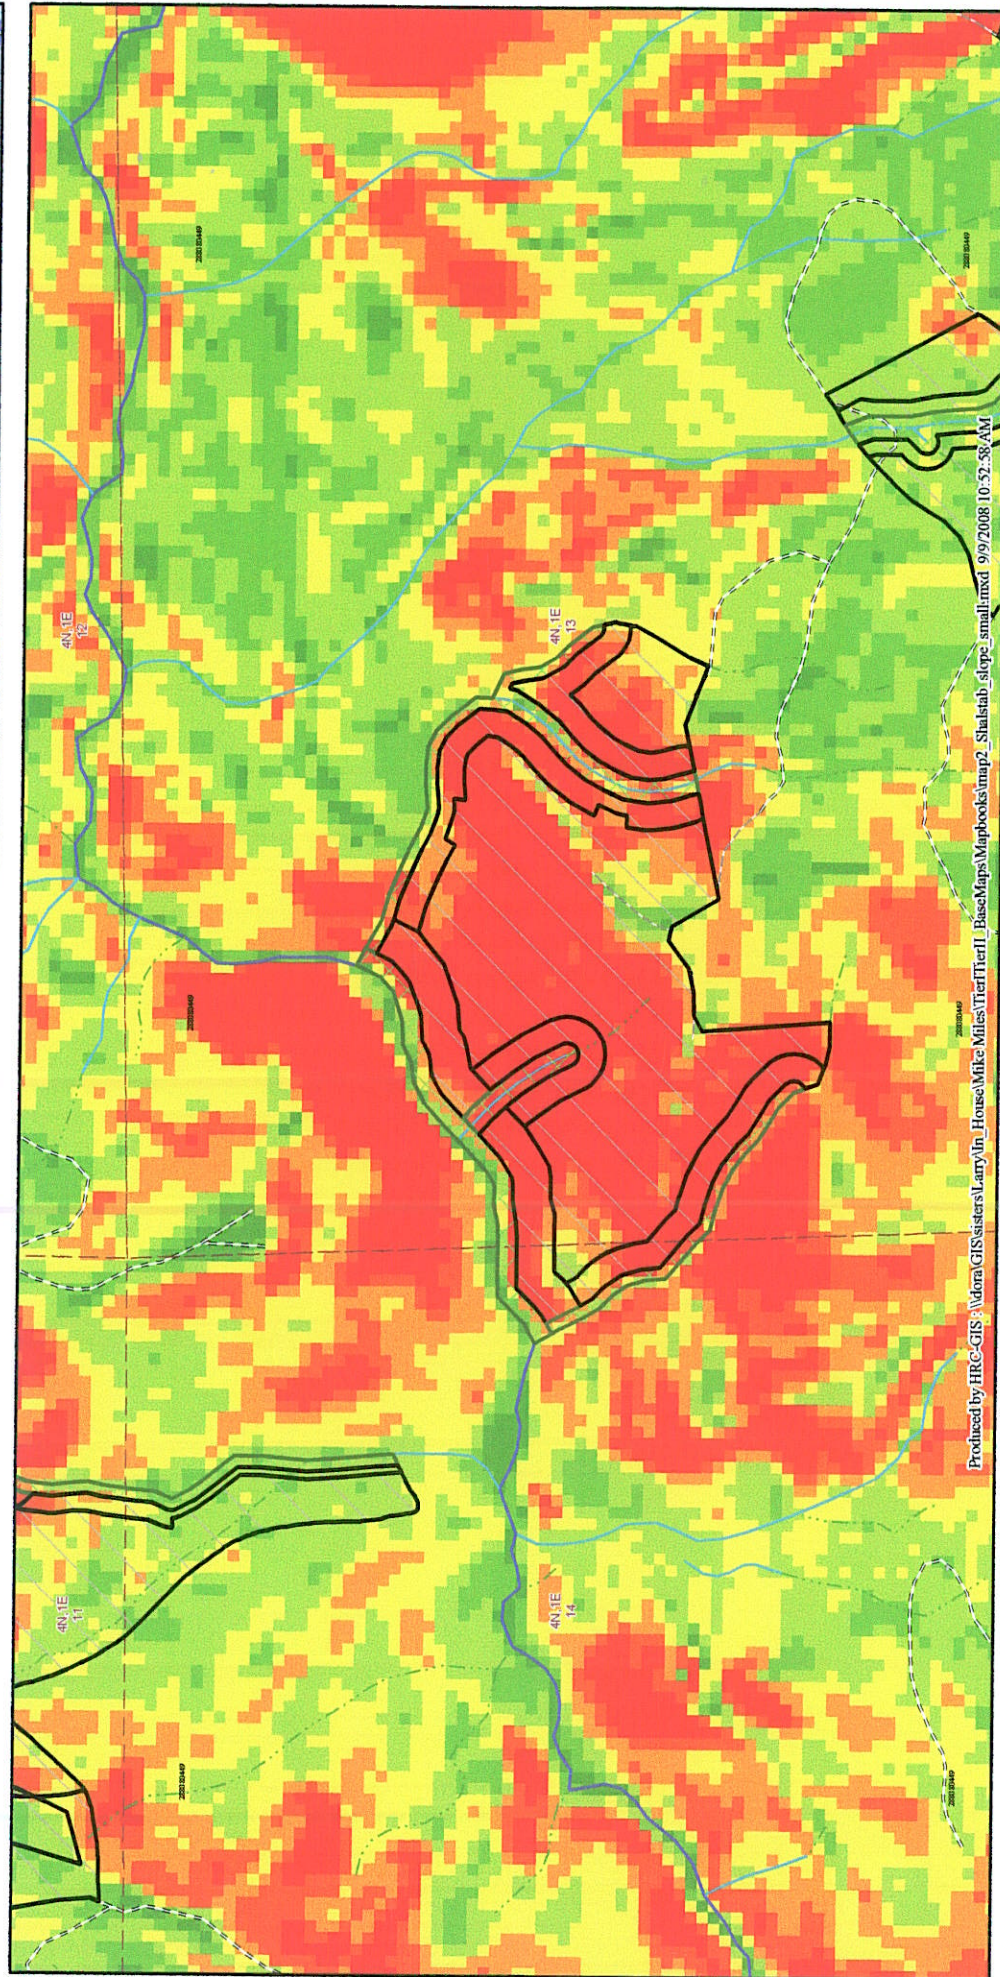
Figure 3

The harvest unit occupies north facing, steeply inclined slopes. CGS (1999) maps the unit as underlain by the lower facies of the Wildcat Group in contact with the Franciscan Mélange (Figure 3). The contact is mapped as a thrust fault dipping to the east. A dormant deep-seated translational landslide is mapped by CGS (1999) extending slightly into the eastern portion of the unit (figure 3). Additional mapping by CGS (1999) includes debris slide slopes that encompass the unit.
