**Final Report:
2004 - 2005 South Humboldt Bay Coastal Resources Protection
Project, Salmon Creek and South Fork Elk River Watersheds,
Humboldt County, CA**

**California State Water Resources Control Board
Agreement #03-211-551**

**Pacific Watershed Associates
Arcata, California
(707) 839-5130
December 2005**

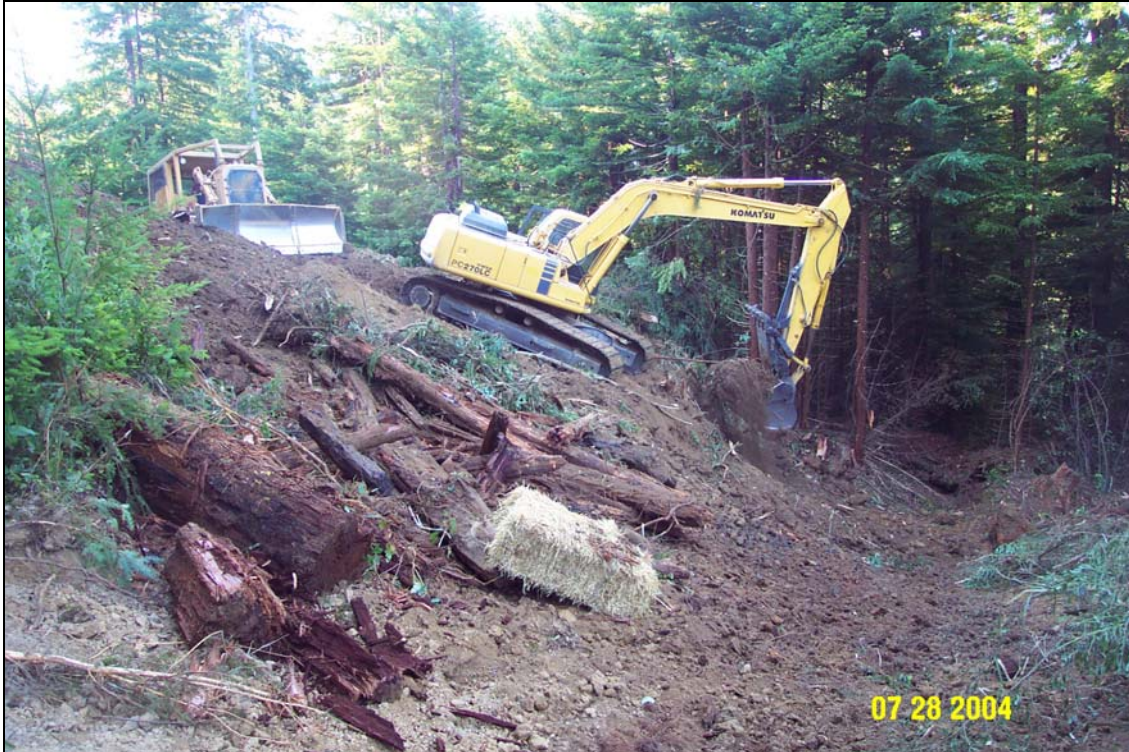
Photo #2. Site #1, U06.6966 Road, post-treatment. Spoils were stockpiled on the left side of the crossing and covered with slash to protect the surface from rain-splash. Straw mulch was placed along the sides of the excavated channel to help catch fines generated from the fresh surface. The excavator and dozer are working on site #2, in the upper left of the photo.

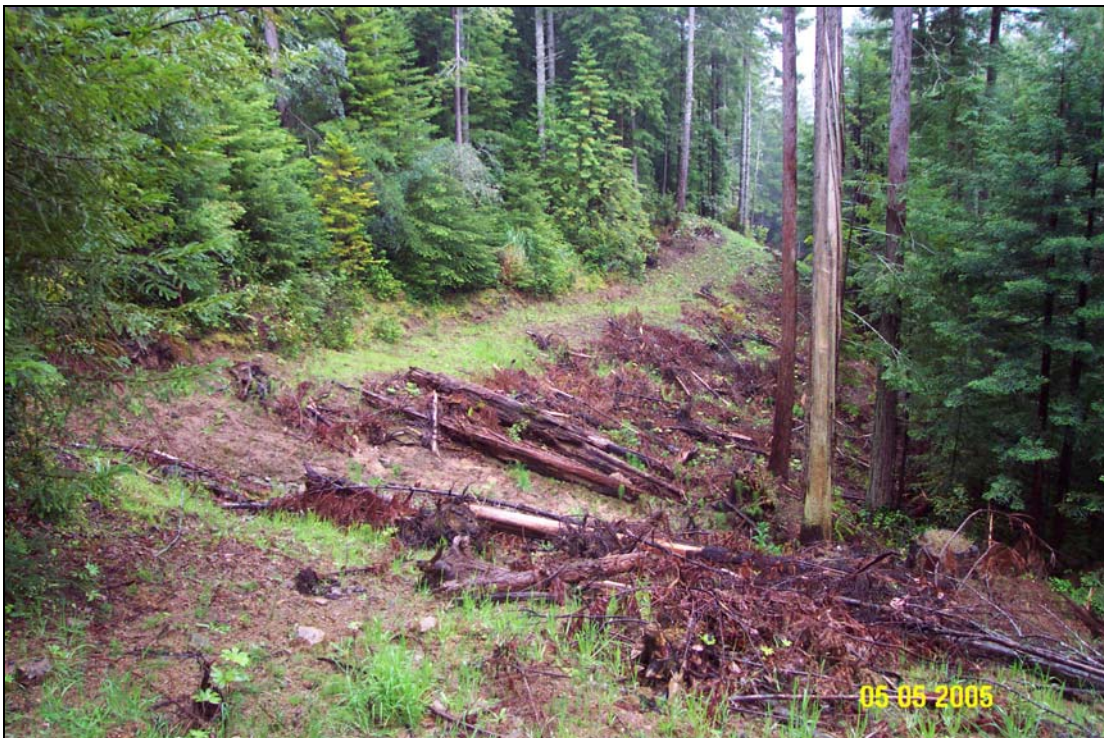
Photo #5A. Site #3, stream crossing on the U06.6966 Road, pre-treatment. View is from the right side of the crossing looking toward the left road approach. Prior to treatment, the stream had been diverting down the left road, causing a long gully down the hillslope below. Note the tree trunk in the upper right corner of the picture for comparison with the photo below.

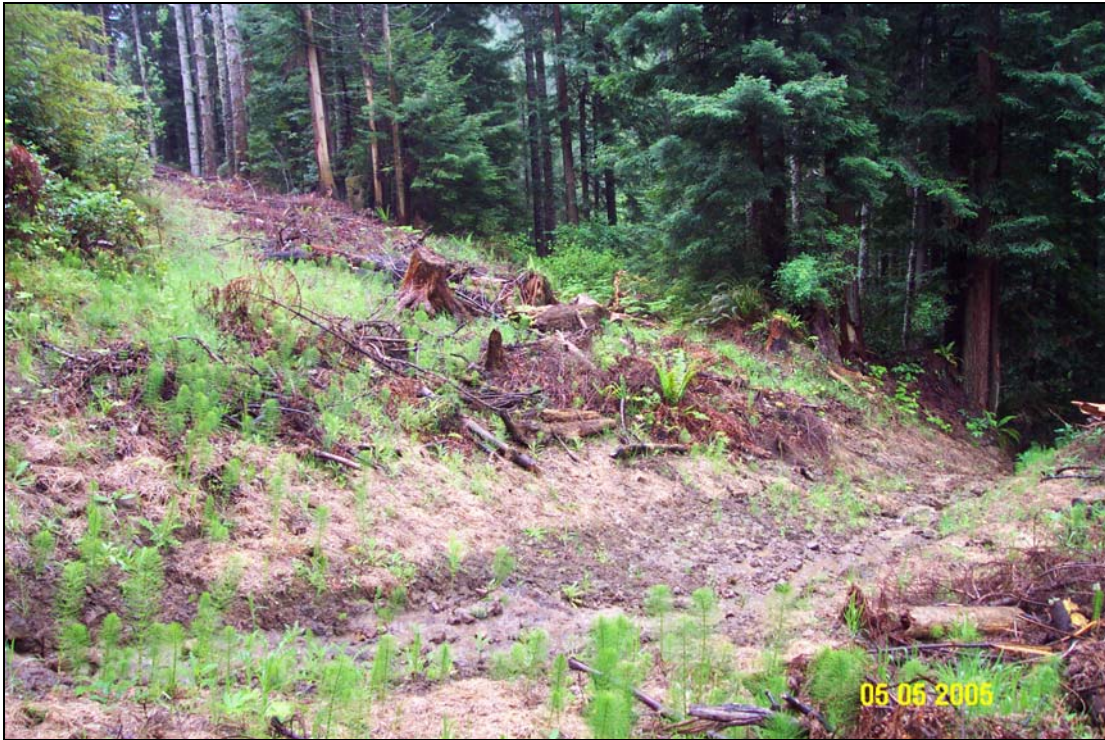
Photo #15. Site #6, post treatment, almost one year later. The view is similar to that in the photo above, only closer to the crossing. Note stump in the upper right of the photo.

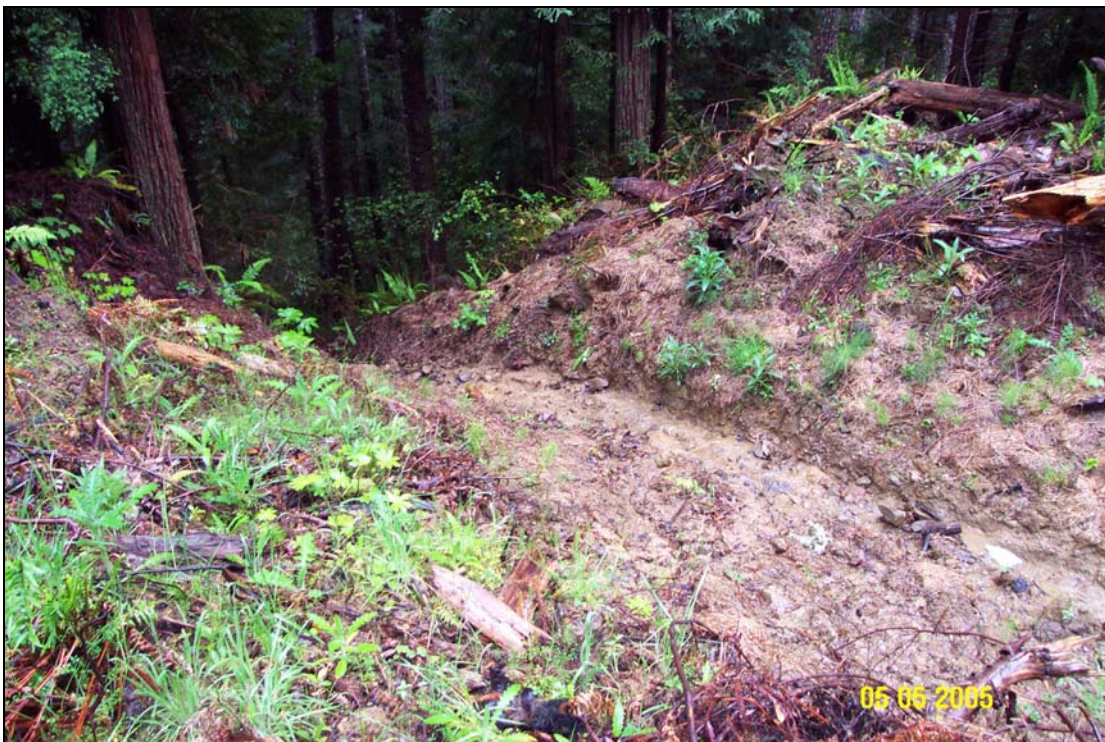
Photo #16. Another shot of Site #6, U06.6966 Road, post-treatment after one winter. View is from the right side slope near the top, looking downstream toward the bot.

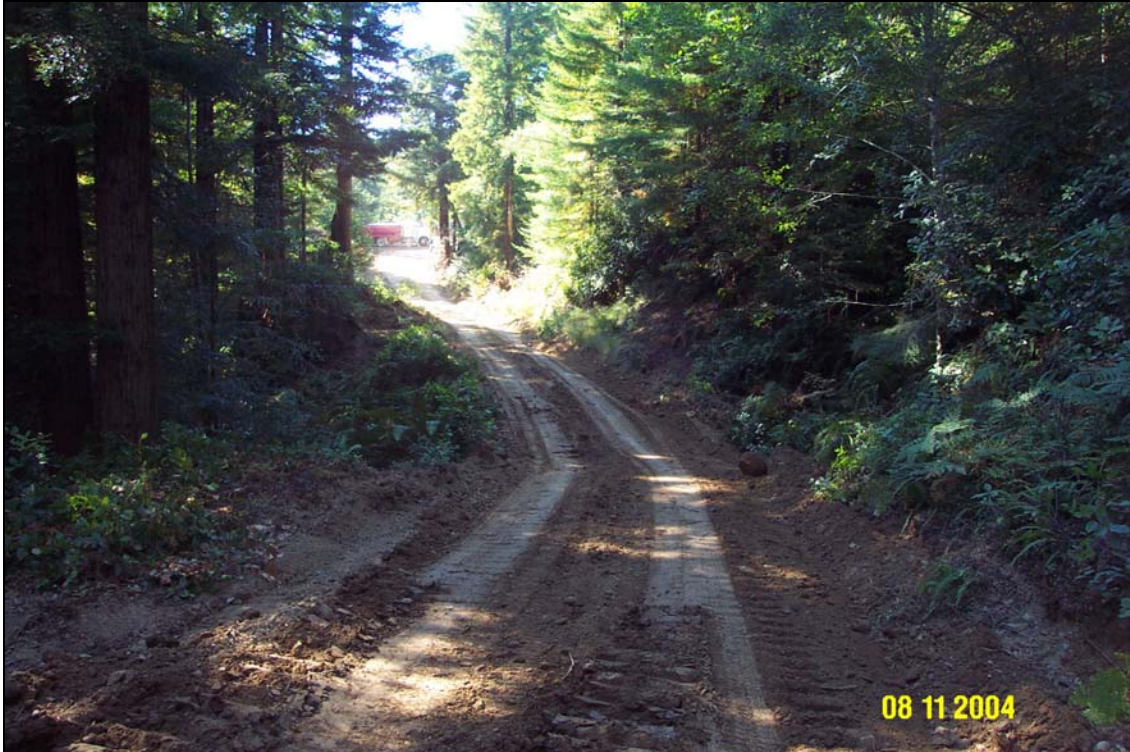
Photo #18B. Site #7, almost one year after treatment. View is similar to the above photo. The edge of the road was pulled back and some of the material was stockpiled upon the cutbank to create a complete outslope.

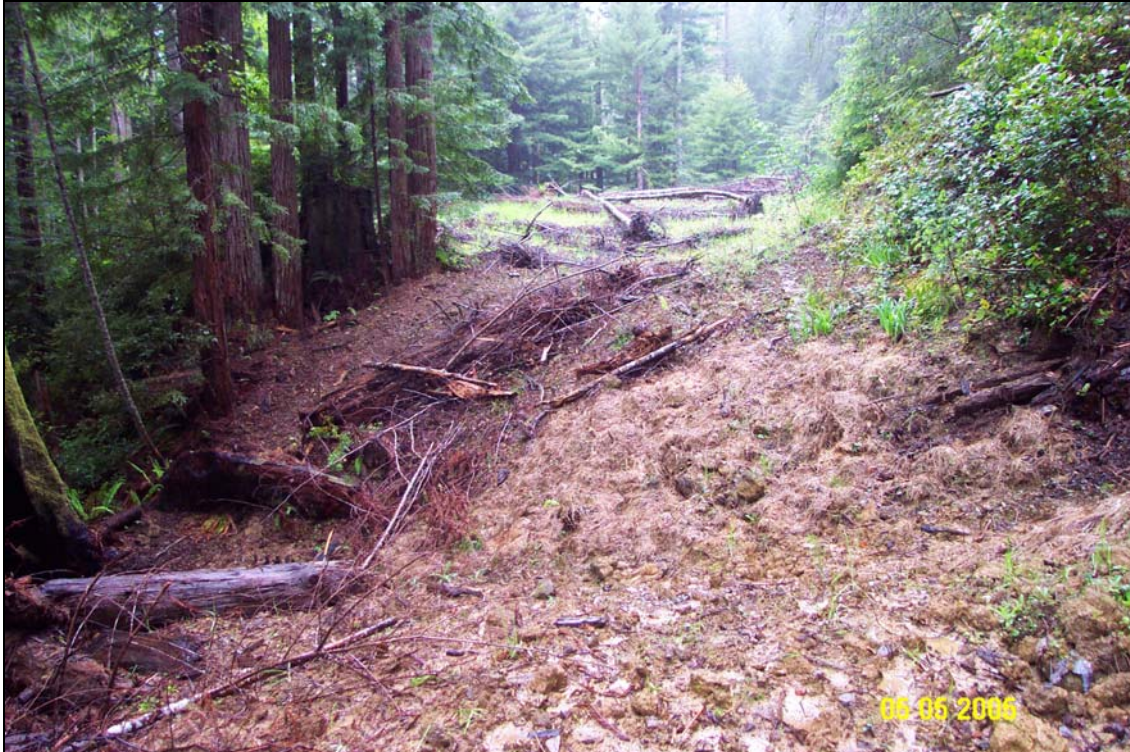
Photo #19. Site #8, stream crossing on the U06.6966 Road, pre-treatment.

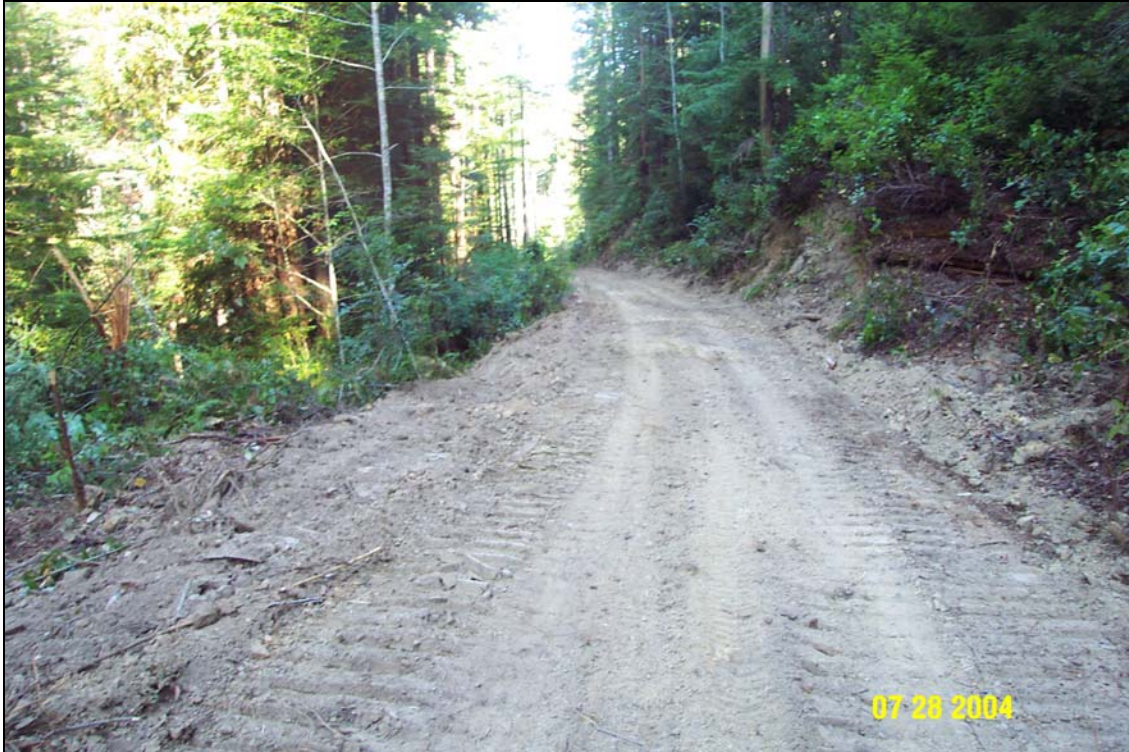
Photo 1. U06.6966 Spur 1 Road, Site #19, stream crossing, pre-treatment. The picture was taken from the left road approach looking across the crossing down the right road approach.

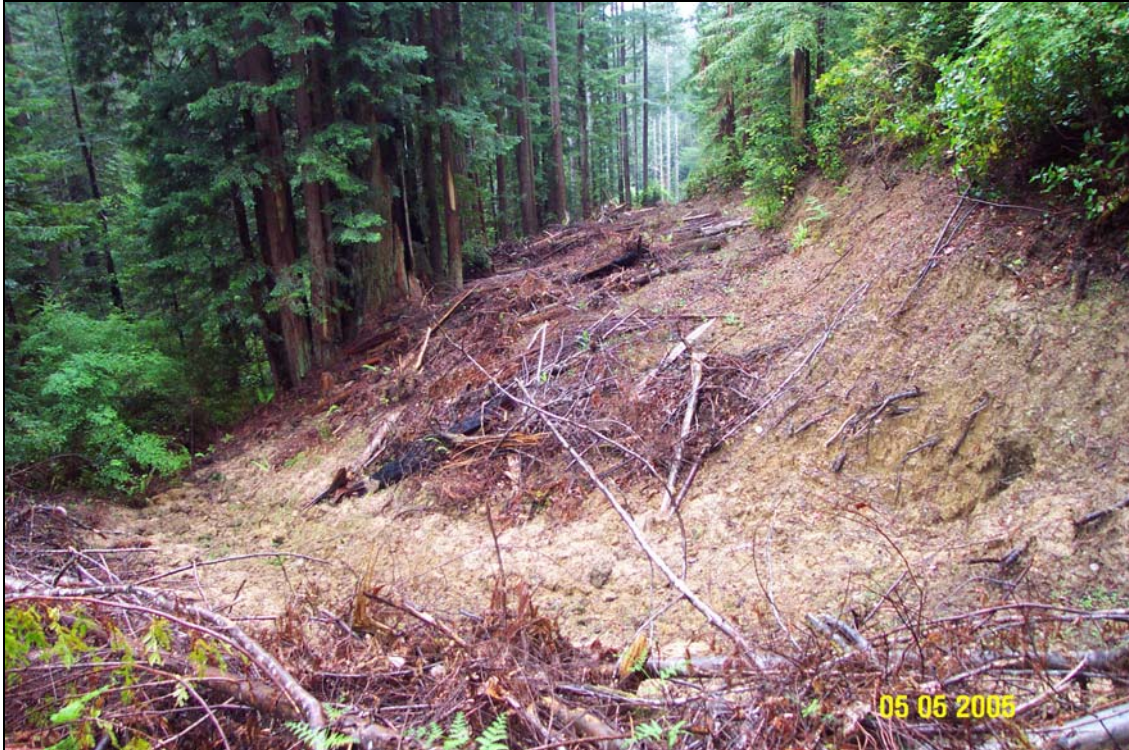
Photo 2. U06.6966 Spur 1 Road, Site #19, stream crossing, post-treatment almost one year later. The view is similar to the above photo, except taken from closer to what used to be the inboard edge of the road. Straw mulch was placed on the excavated side slopes near the channel bottom and slash placed on disturbed road surfaces to protect them from rainsplash.

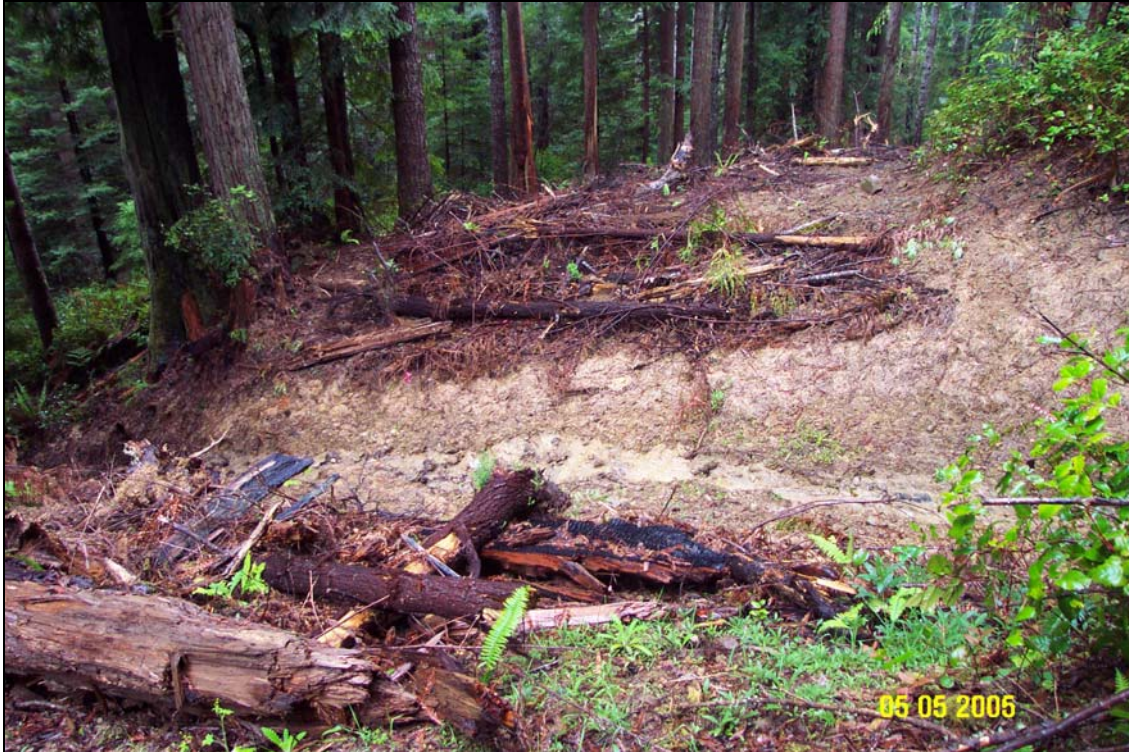
Photo 3. Stream crossing Site #18 approximately one year after decommissioning. Picture was taken from above the left side slope near the upper end of the excavation with the downstream end of the excavation (the bot) on the left side of the photo.

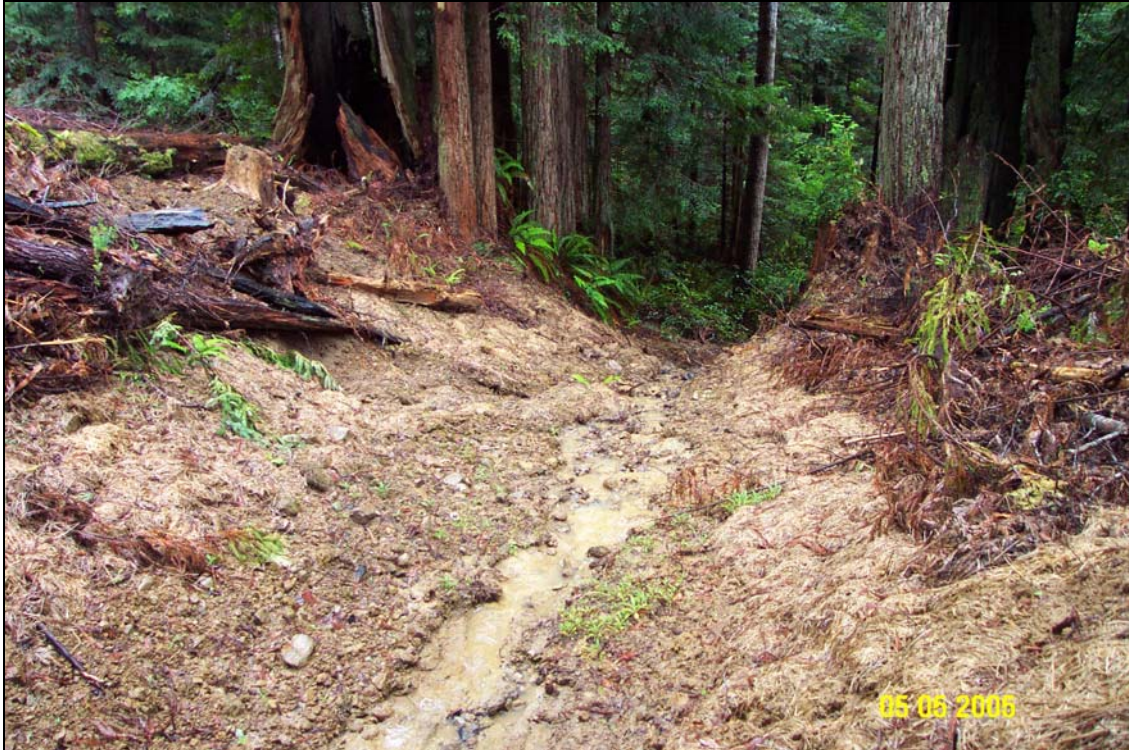
Photo 4. Stream crossing Site #18 approximately one year after decommissioning. Picture was taken from above the right side slope near the upper end of the excavation looking toward the bot.

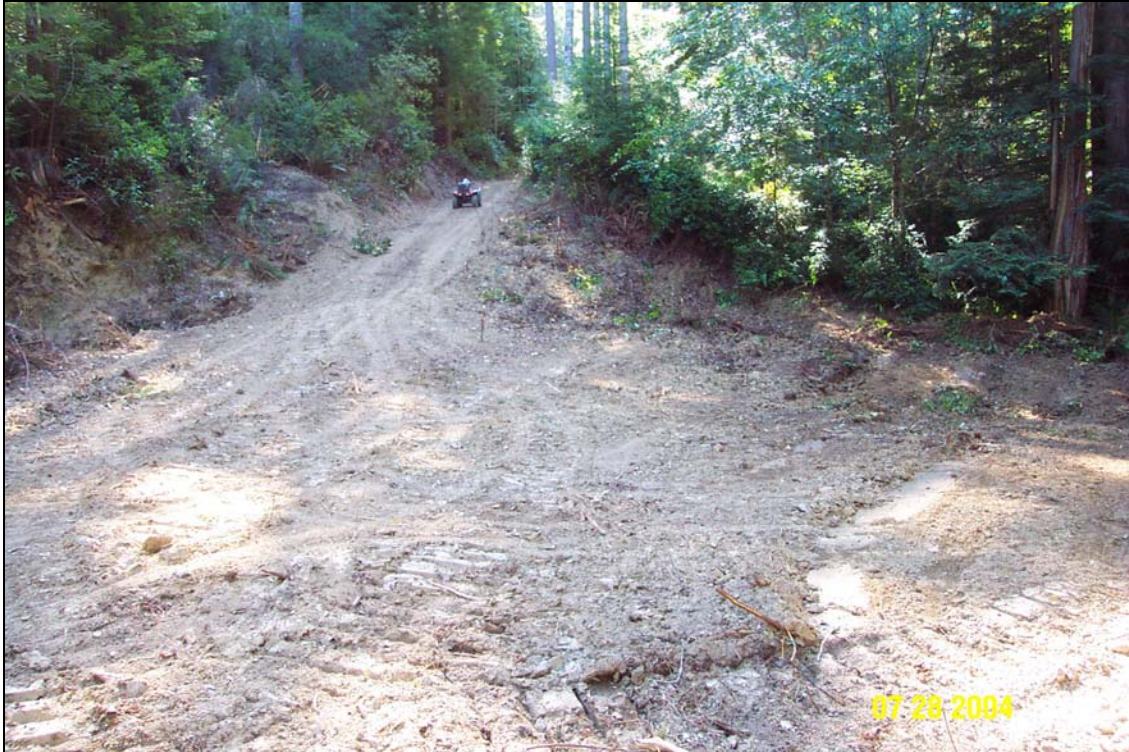
Photo 5. U06.6966 Spur 1 Road, Site #17, stream crossing, pre-treatment. The picture was taken from the right side of the terminal landing on this road that buried the original stream valley. The downstream end of the crossing is on the right side of the photo. Note the quad in the top center-left of the photo on the left road approach.

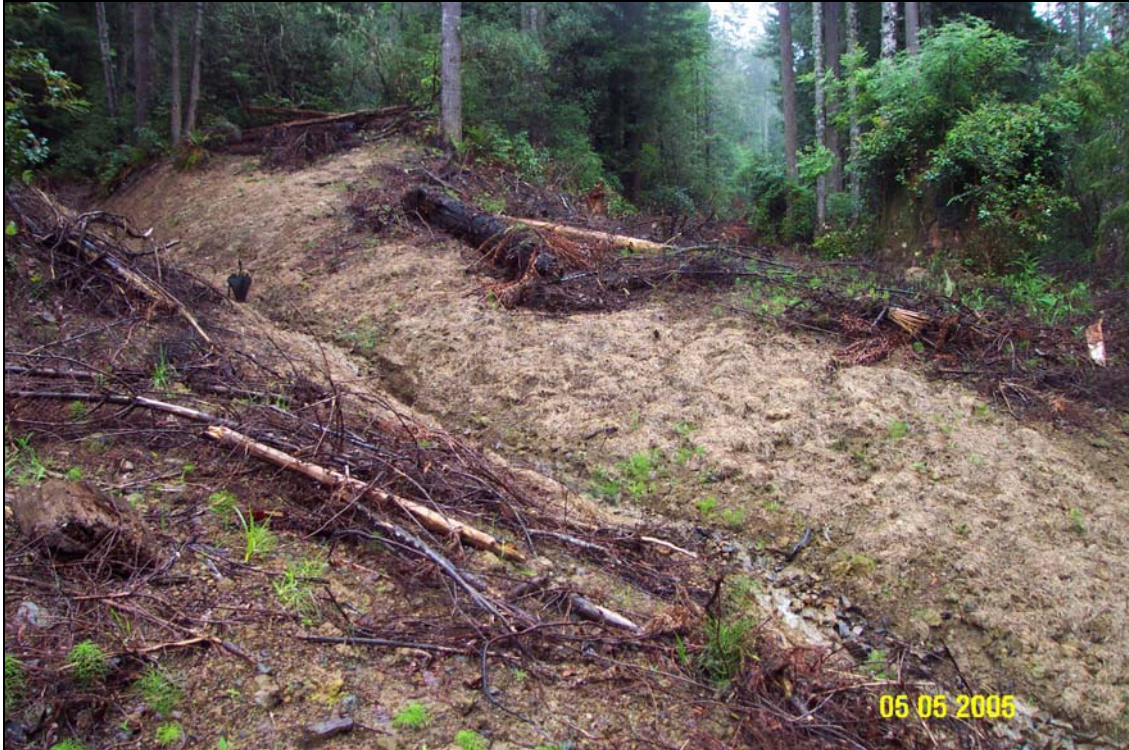
Photo 6. Stream crossing Site #17 approximately one year after decommissioning. View is similar to the photo above and was taken from above the right side slope near the middle of the excavation looking toward the slash covered left road approach. The upstream end of the excavation is in the upper left corner of the photo.

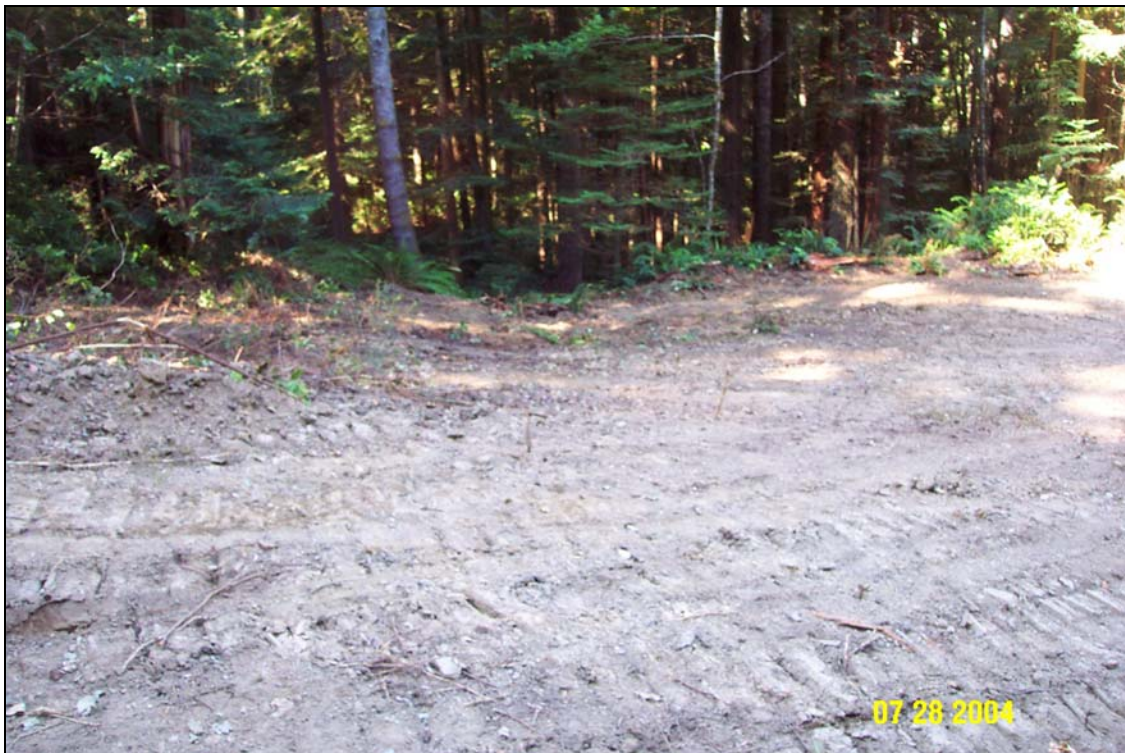
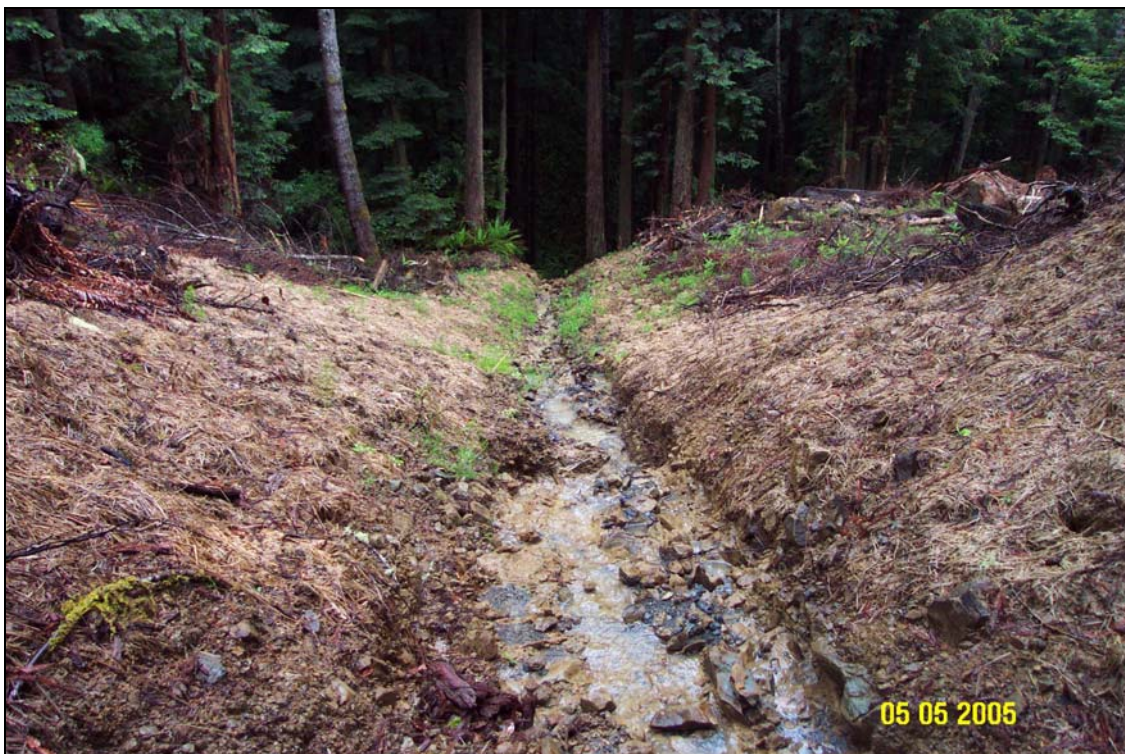
Photos 7A and 7B. U06.6966 Spur 1 Road, Site #17, stream crossing, pre- and post-treatment. The picture was taken from approximately the middle of the original landing surface, looking downstream. The bottom photo was taken after the site had gone through its first winter post-excavation.

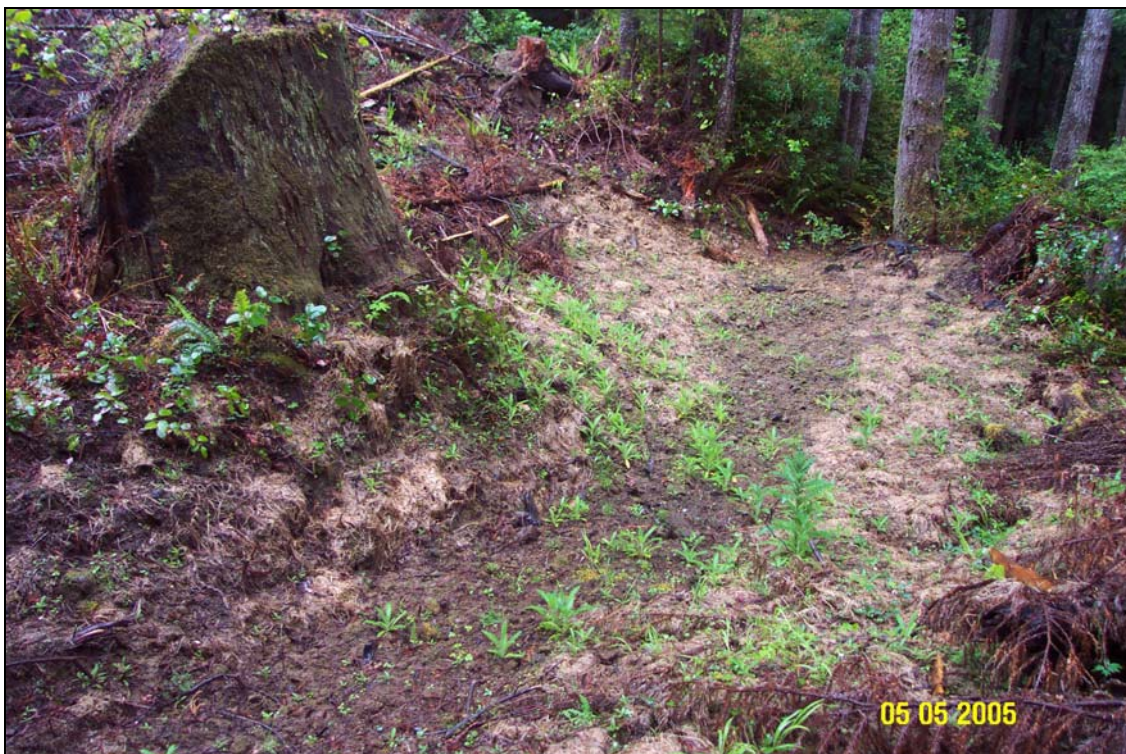
Photos 8A and 8B. U06.6966 Spur 1 Road, Site #16, stream crossing, pre- and post-treatment. The picture was taken from approximately the top, looking downstream. The bottom photo was taken after the site had gone through its first winter post-excavation.

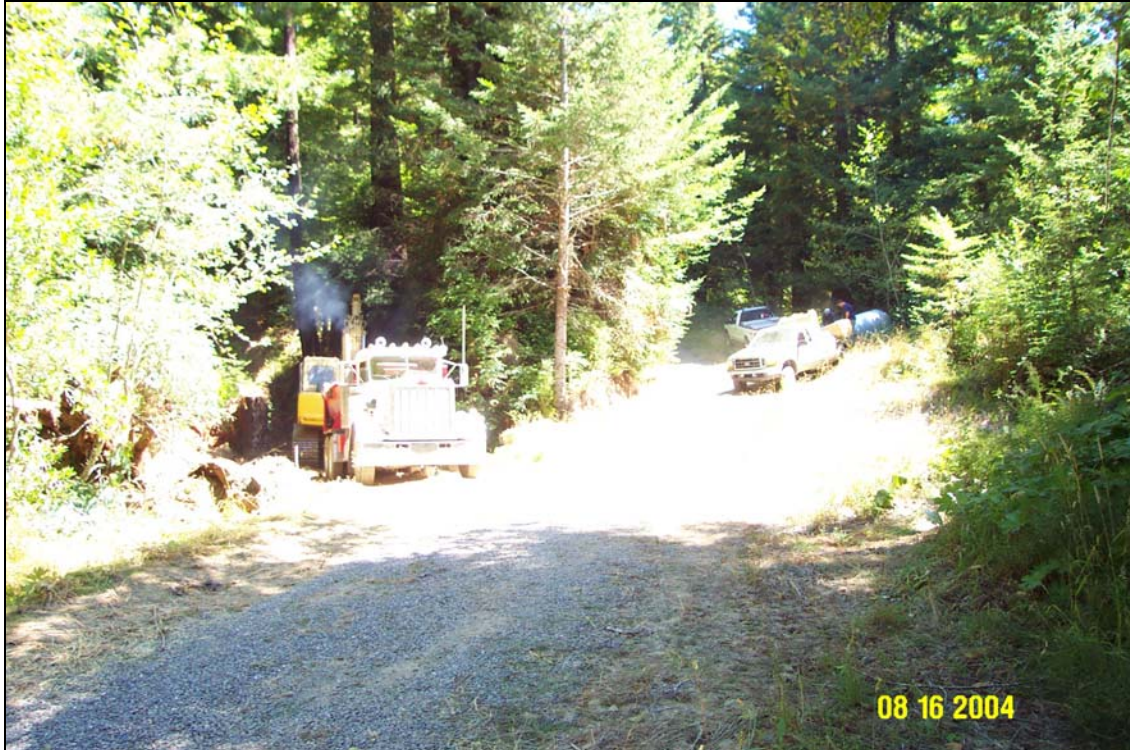
Photo 1. U06 Road, Site #1129, stream crossing, during its upgrade. The picture was taken from the left road approach looking across the crossing toward the right road approach. The excavator is removing fill from the stream valley upstream of the inlet and loading the spoils into dump trucks to be endhauled to a stable spoil disposal area nearby.

Before moving to the Salmon Creek watershed portion of the Headwaters Forest Reserve, the equipment crew was directed to treat a high priority stream crossing site (#1129) on the U06 Road along the riparian corridor of the mainstem South Fork Elk River (Map 3). This actively failing stream crossing was upgraded by rebuilding the stream crossing, removing over 1,190 yd³ of material from the crossing as well as stored sediment from the stream channel above the crossing. The culvert inlet was wrapped with an expanding clay collar and both the inboard and outboard fillslopes armored with rip rap.

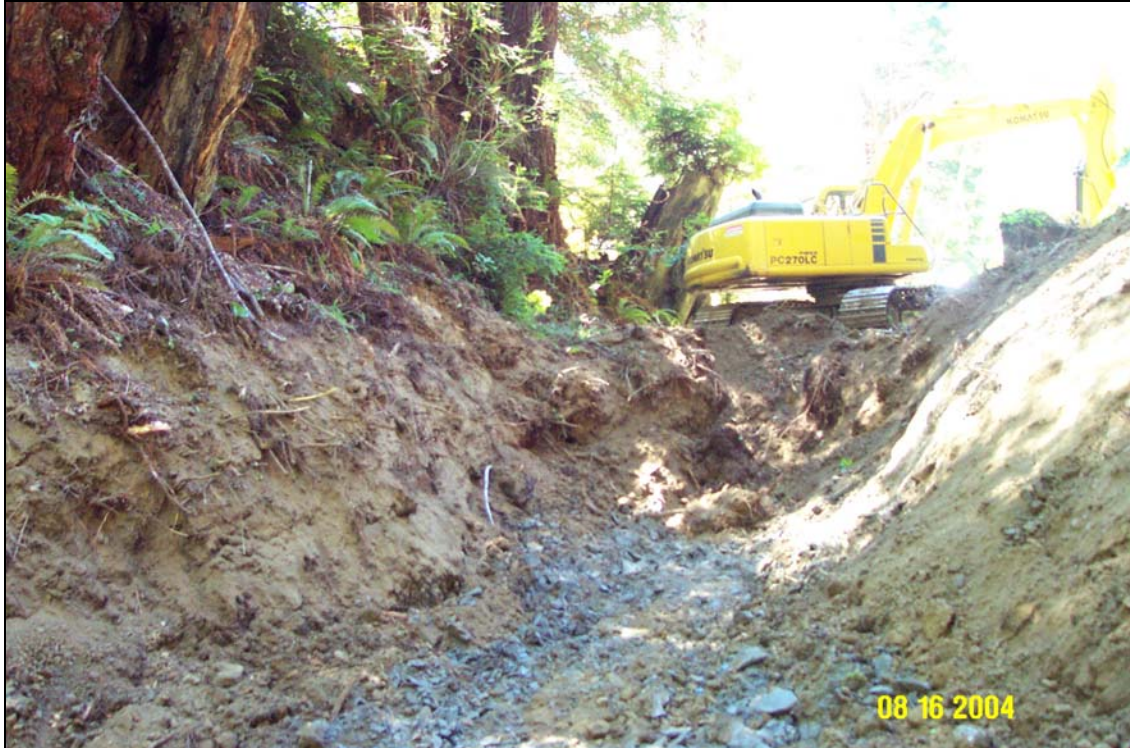
Photo 2. The same stream crossing during treatment. The photo was taken from just downstream of the top, looking downstream. The excavator is sitting just upstream of the inboard side of the crossing, cleaning out stored sediment from the stream valley. The gray material in the new channel bottom is siltstone bedrock of the Wildcat Formation, a rather soft but indurated material.

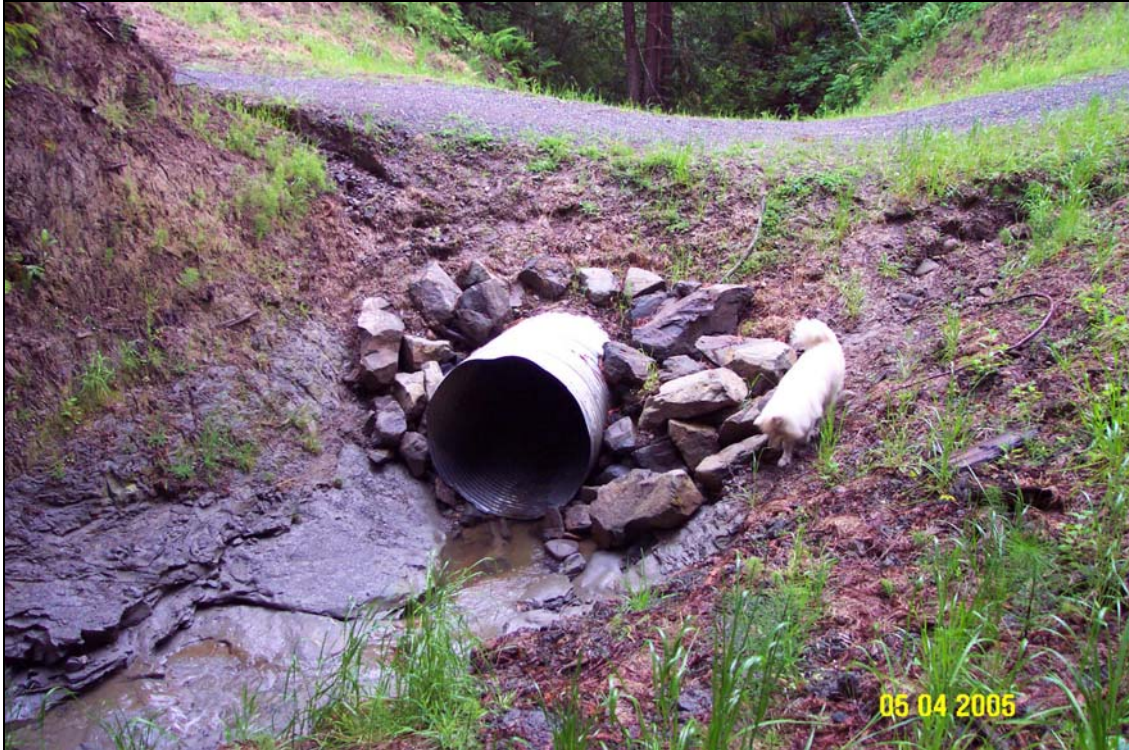
Photo 6. U06 Road, Site #1129, stream crossing, post-treatment. The picture was taken from the right side-slope above the culvert inlet looking downstream toward the inlet in the foreground and the lowered stream crossing. Note the siltstone bedrock surfaces in the channel banks and bottom just upstream of the inlet.

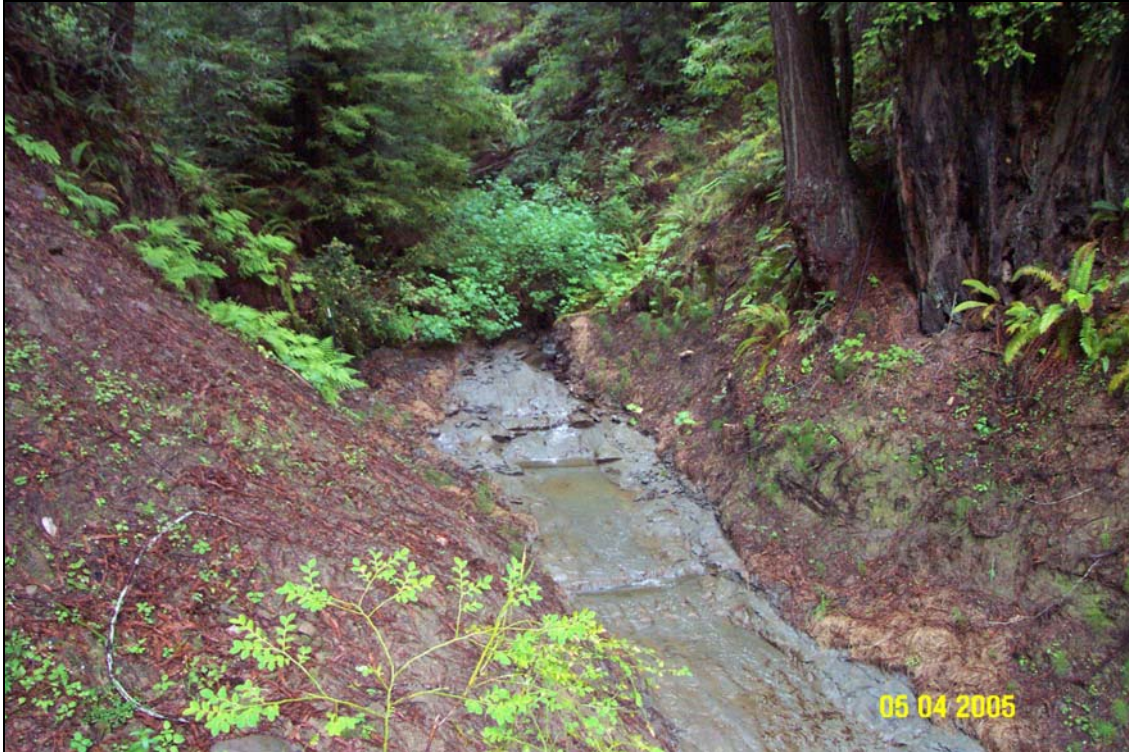
Photos 8 and 9. U06 Road, site #1129, post-treatment. Top photo show picture of the upstream extent of the channel excavation upstream from the crossing. The bottom photo shows part of the excavated channel as well as the new culvert inlet in the upper right of the photo. Both photos show the gray, slick surface of the Wildcat siltstone bedrock which controlled the depth of the channel excavation.

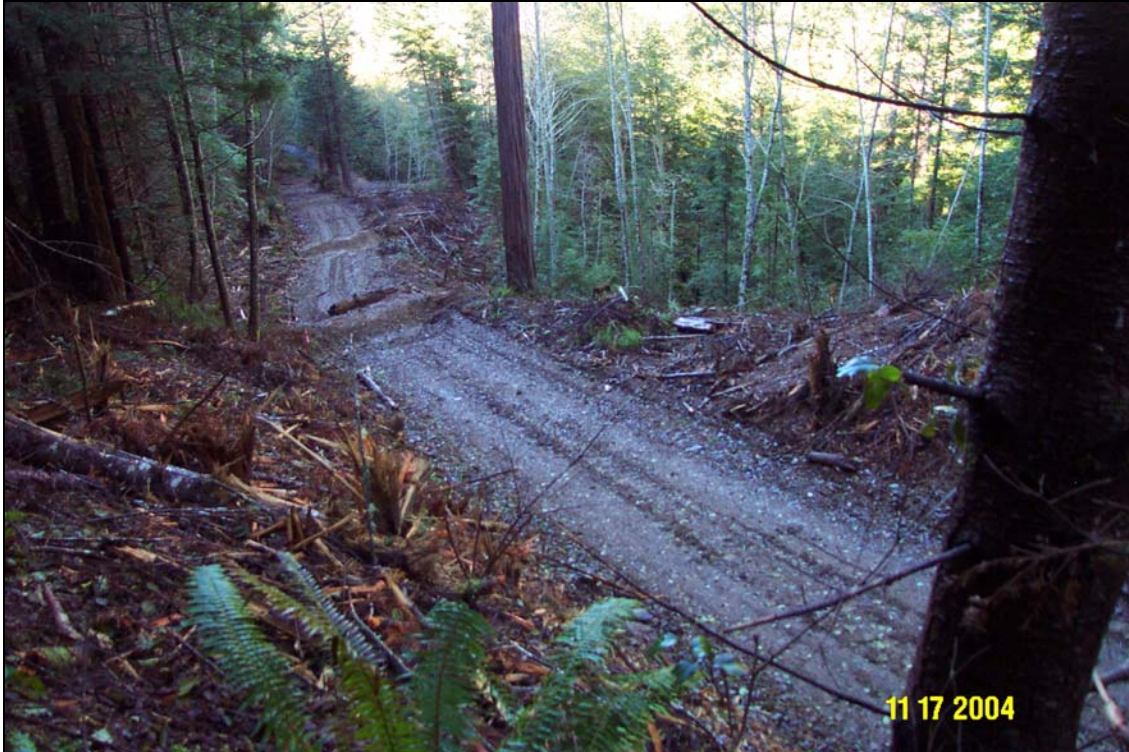
Photos 2A and 2B. R14 Road, site # 143 stream crossing, pre- and post-treatment. The picture was taken from above cutbank immediately to the right of the crossing. Note the lower and upper portions of the stream crossing have been excavated in the lower photo. A small road prism remains to allow future equipment access beyond this site. The remainder of this road is slated for decommissioning in summer 2006. Road fill, sidecast during road construction activities, was slumping and threatening to deliver to a large Class 2 stream directly down-slope. Site #142.9 is visible to the left of the Redwood tree in the top-center of the photo.

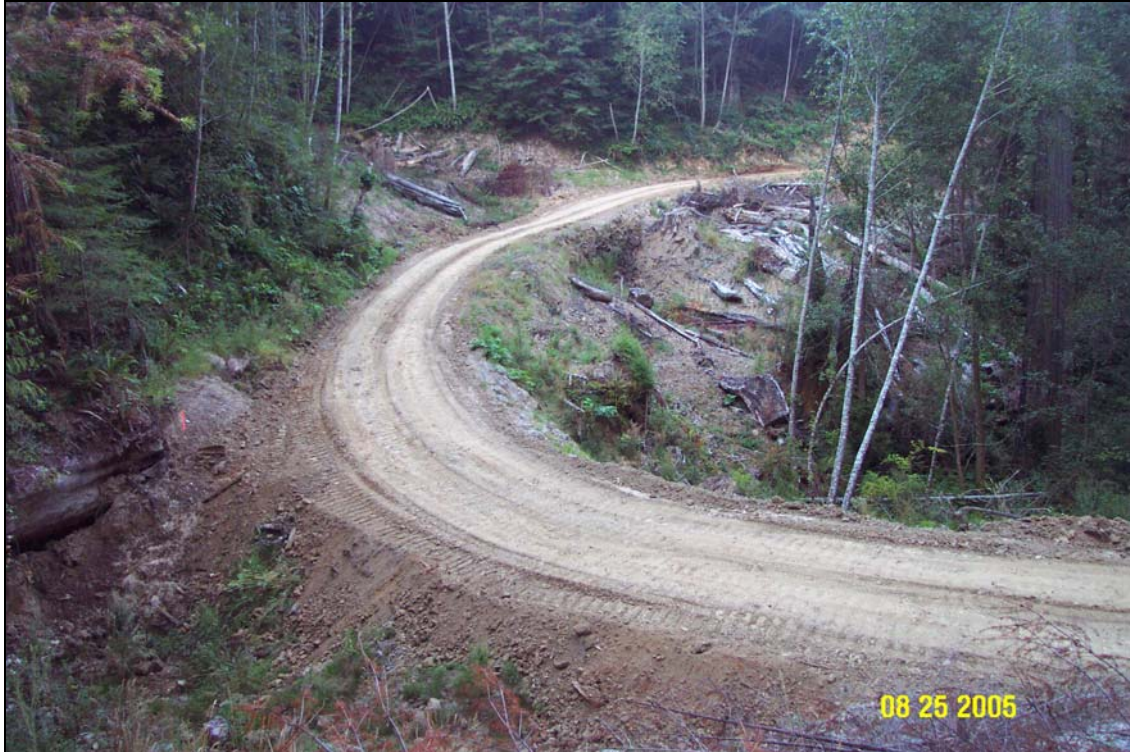
Photos 3 and 4. R14 Road, site #143.2, pre and post treatment. The lower portion of this site had been excavated treated as part of an earlier decommissioning project the previous year. The upper portion of this site had a large break-in-slope with fill over-steepened and saturated above the road. The upstream portion of this site was excavated to the natural channel grade.

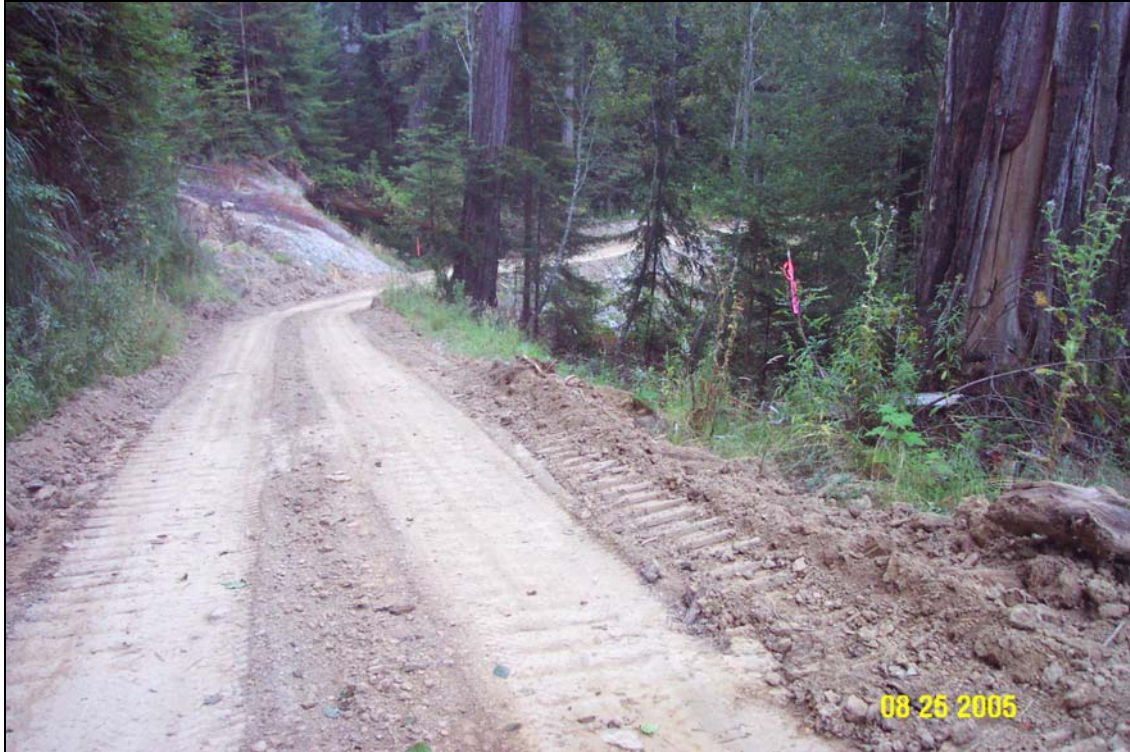
Photos 6A and 6B. R14 Road, site #144, pre and post treatment. View is approximately from the top of the excavation. Note the right road approach has been completely re-contoured in the lower photo. The entire road prism beyond this site was completely re-contoured between sediment delivery sites, funded by the BLM. All sites and road reaches from this site to the beginning of the road, is slated for completion in summer 2006.

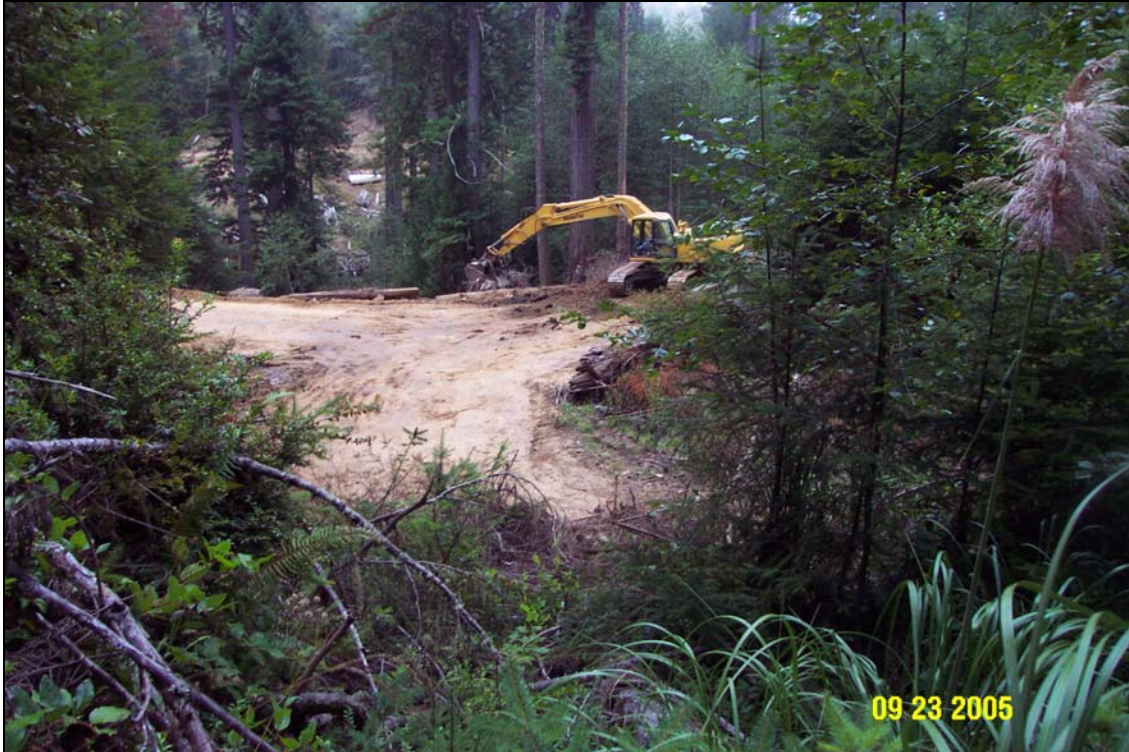
Photos 7A and 7B. R14 Road, site #144.1, landslide, pre- and post-treatment. View is from the right end of the site, looking back towards site #144 stream crossing in the distance. Note the site has been completely outsloped, by placing some of the spoils against the cutbank.

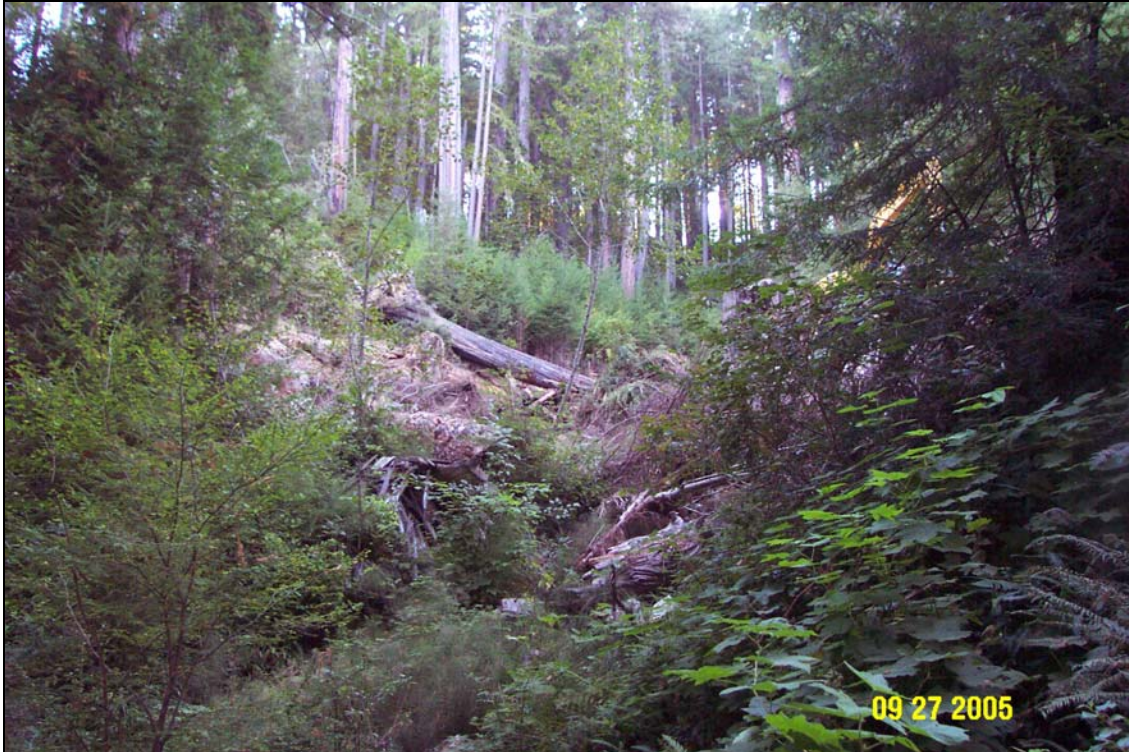
Photos 8A and 8B. R14 Road, site #145, pre and post treatment. View is approximately from the top of the excavation. Note the large woody debris, unearthed during the excavation, was placed upon the side slopes both as a protective layer as well as to catch any material that might slough off. Note the old growth stumps in the lower photo. The previously buried stumps provide guidance to the excavator operator to help locate the original ground surface.
