**Final Report:
2004 - 2005 South Humboldt Bay Coastal Resources Protection
Project, Salmon Creek and South Fork Elk River Watersheds,
Humboldt County, CA**

**California State Water Resources Control Board
Agreement #03-211-551**

**Pacific Watershed Associates
Arcata, California
(707) 839-5130
December 2005**

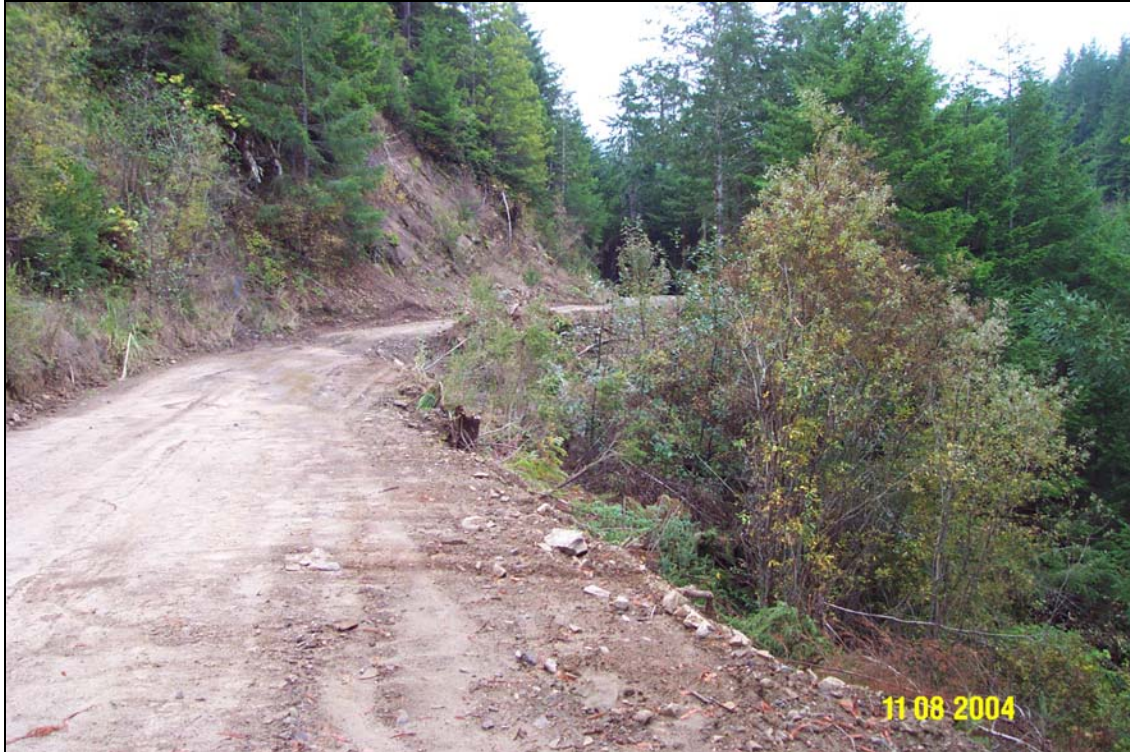
Photos 1A and 1B. R8 Road in the Salmon Creek watershed. Site #121, a stream crossing, pre- and post-treatment. The picture was taken from the right road approach looking across the crossing. Note the new plastic culvert and downspout installed as a temporary crossing until the road can be completed, slated for decommissioning in summer, 2006. This site is located on steep inner-gorge slopes directly above Salmon Creek.

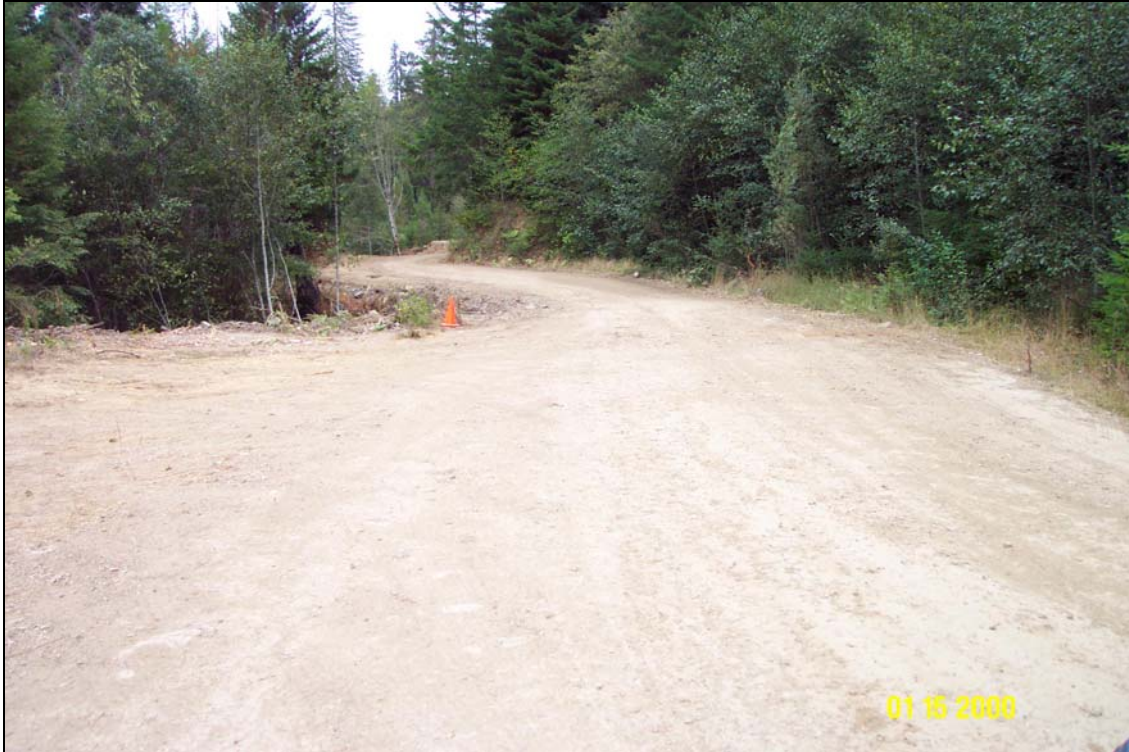
Photo 6A and 6B. R8 Road, site #121.5, a stream crossing, pre- and post-treatment. The picture was taken from the left road approach looking across the crossing. Note the abundance of large woody debris unearthed during the excavation, placed on the newly excavated side slopes.

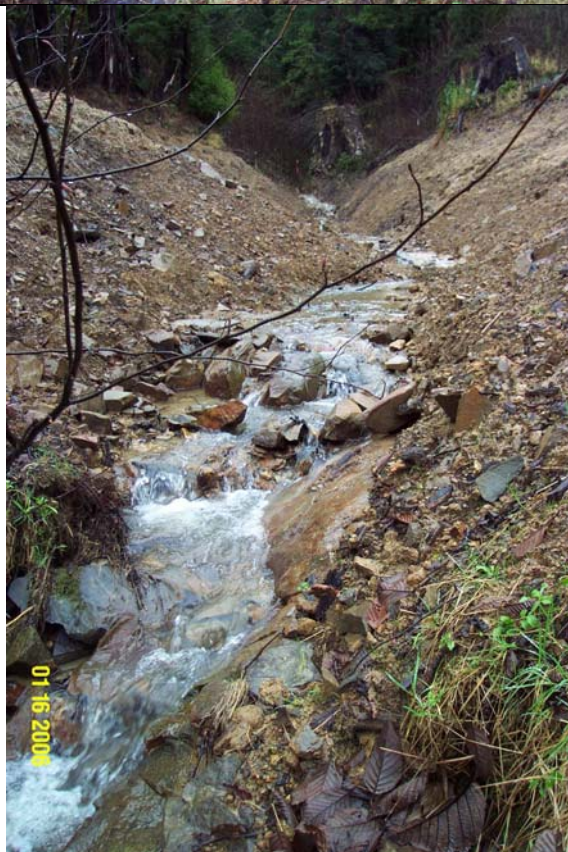
Photos 12 and 13. R8 Road, site #122, post-treatment. The photos were taken from near the bottom of the excavation looking upstream to the top of the excavation. A large hard-rock “knocker” controlled the depth of the excavation near the lower end of the site, creating a

convex shaped channel bottom profile. Usually, excavated stream channel profiles should be straight-line or concave-up, except in situations like this where natural hard points control the resulting shape.
