**CALIFORNIA REGIONAL WATER QUALITY CONTROL BOARD
SAN DIEGO REGION**

STAFF REPORT

**Proposed Administrative Civil Liability
Contained in Complaint No. R9-2009-0040
City of Laguna Beach
Sewage Collection System**

August 18, 2009

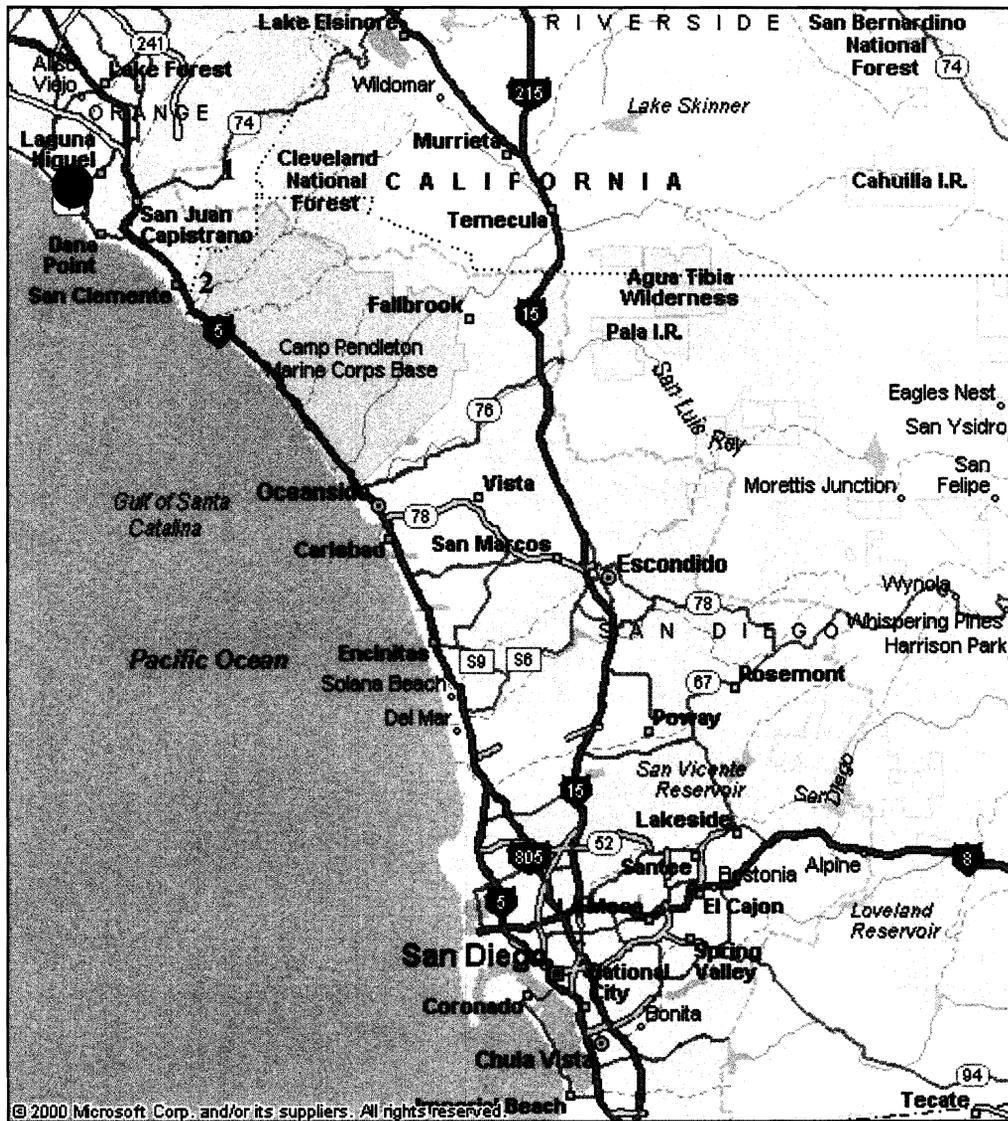
Location of SSO at Bluebird SOCWA Lift Station,
Laguna Beach, California

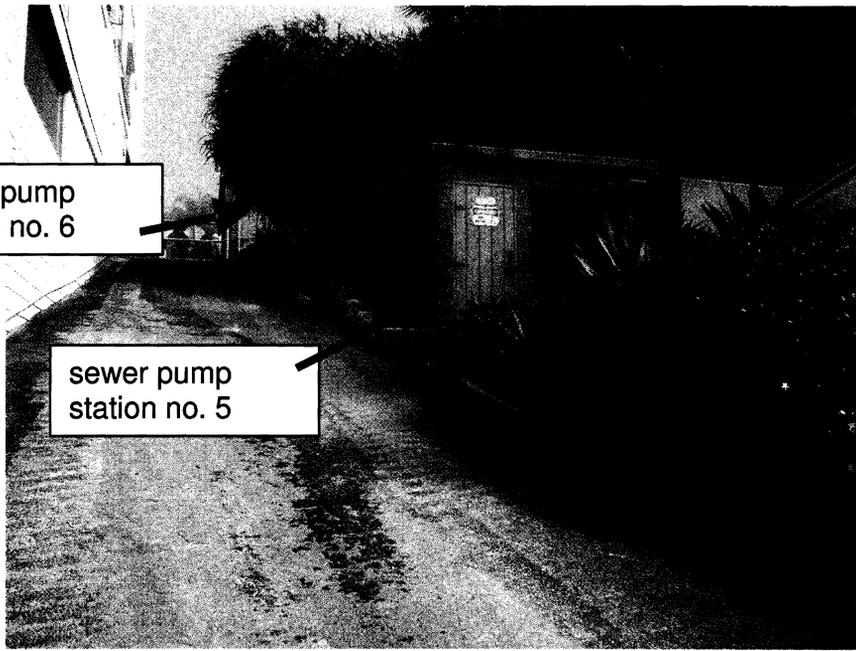
Figure 11 - Diversion pump station for the storm drain.

- The end of the storm drain is partially blocked by wood (figure 9 and 10), holding some of the sewage back. At approximately 11:30am, the diversion in this storm drain was used to pump the sewage back to the Bluebird Lift Station (figure 11).

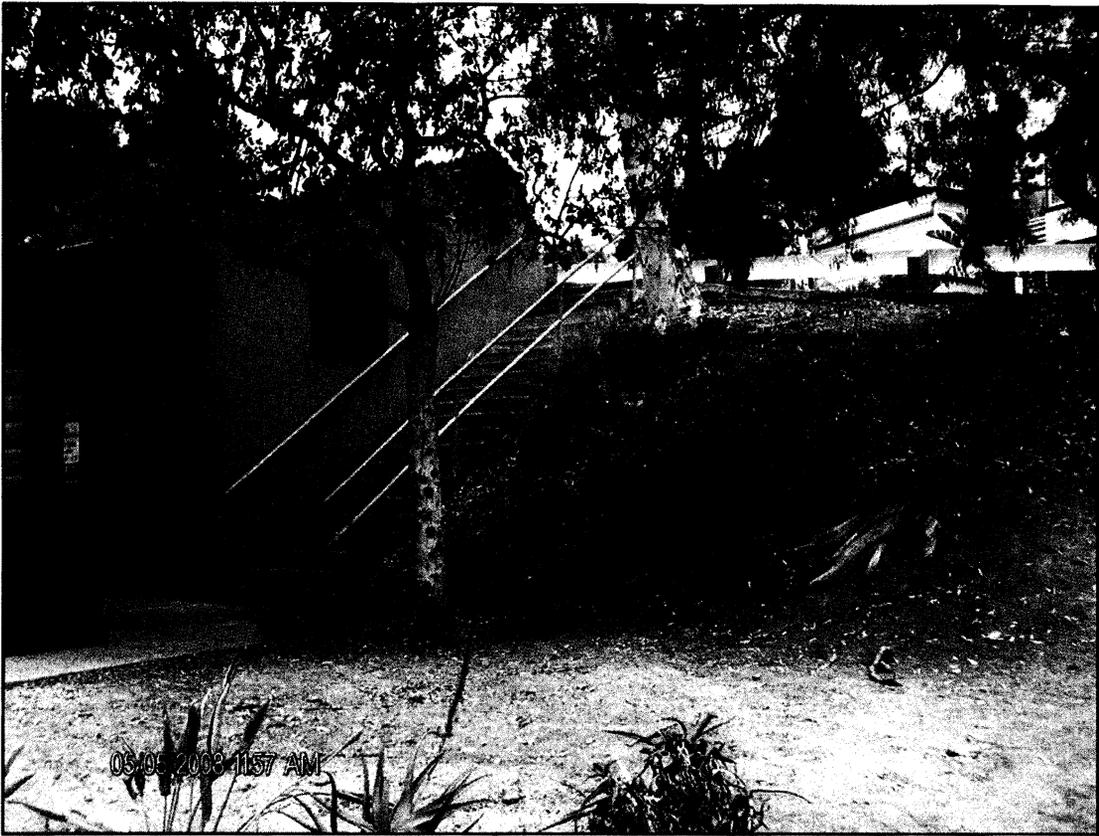
Photo #1: Pump Station Exterior

Photos #1, #2 and #3 show the Pump Station exterior prior to the October 29 event.

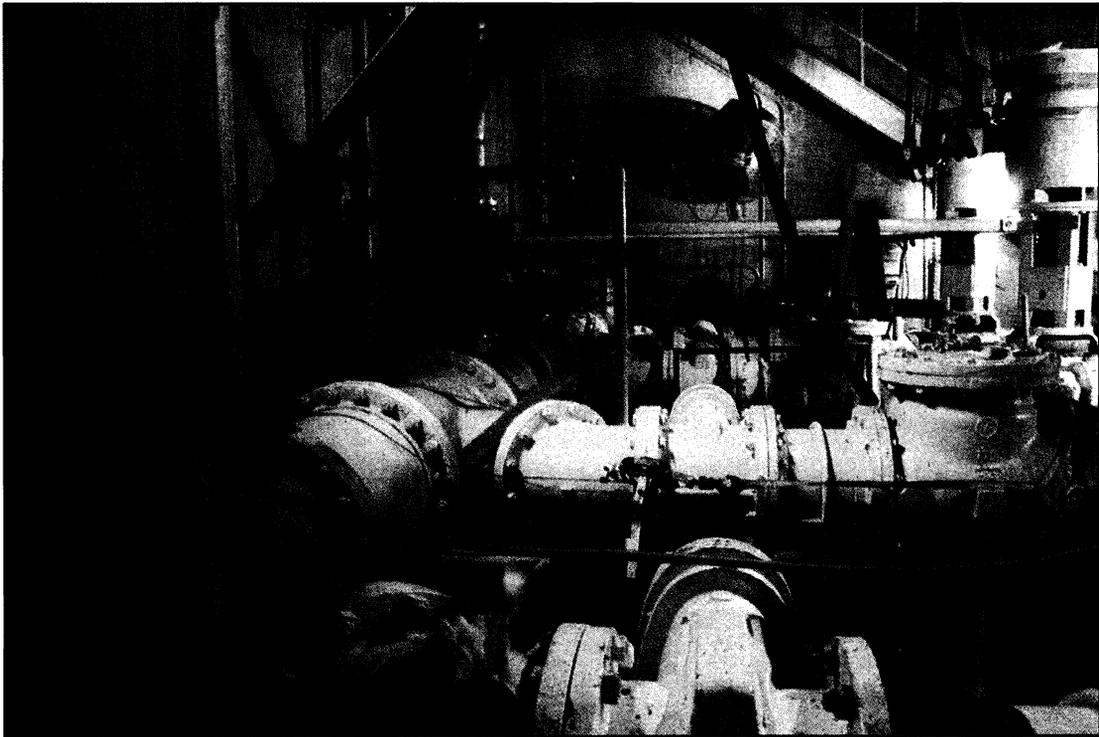
Photo #4: Dry Well Interior

The pump station has four pumps in the Dry Well. Each pump has a rated capacity that exceeds the peak inflow rate from the gravity sewer system. Thus, the pumps operate as Operating, Standby #1, Standby #2, and Standby #3. The pump station also has standby power that can maintain the pumps in operation should there be a loss of utility power. Having three permanently-installed standby pumps and a permanently-installed onsite standby power generator are key features for this facility because it lacks onsite emergency storage (to provide short term storage of inflow should the station lose pumping capacity due to mechanical or electrical failure). **Photo #4** shows the constrained layout of pumps and piping inside the Dry Well.

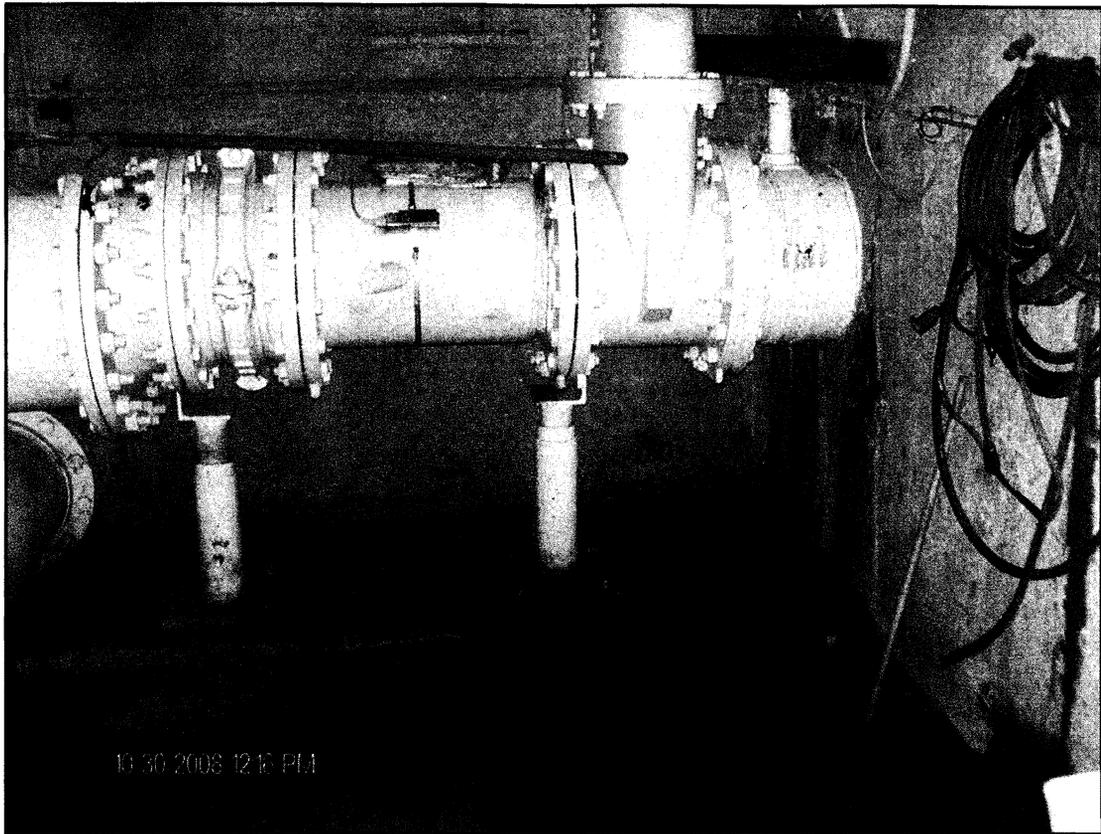
Photo #5: Discharge Header: Strap-on Flow Meter and 16" Shutoff Valve

A strap-on ultra-sonic flow meter, manufactured by Greyline Instruments, Inc., is installed at the eastern end of the header, just prior to this piping exiting the Dry Well. This flow meter provides an analog signal (4 to 20 mA) that is sent to a circular chart recorder located in the MCC Room on the upper level. This flow meter also provides a control signal to the ECO2 odor control system that regulates the production and injection of oxygen into the buried force main immediately downstream of the pump station. **Photo #5** shows this flow meter and the 16-inch shutoff valve on the discharge header.

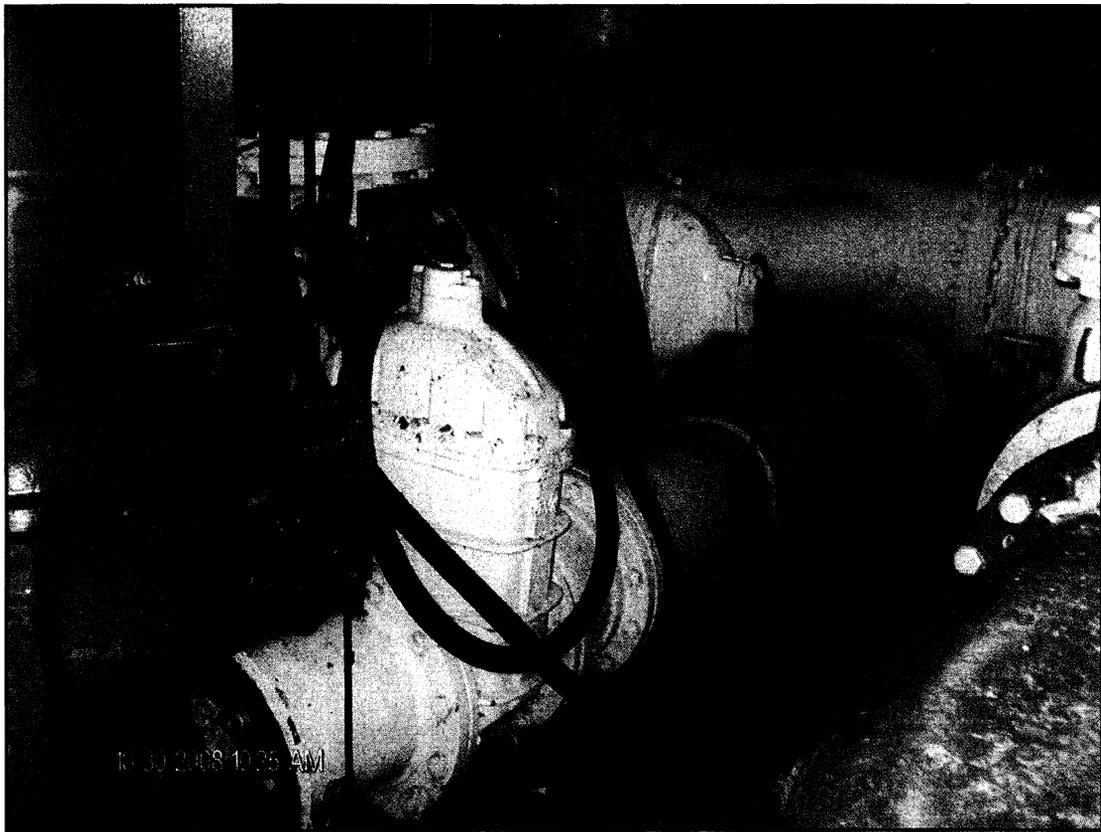
Photo #6: Pump #2 Suction Piping

Photo #6 shows the suction piping for Pump #2, which is a typical layout for all four of the pumps.

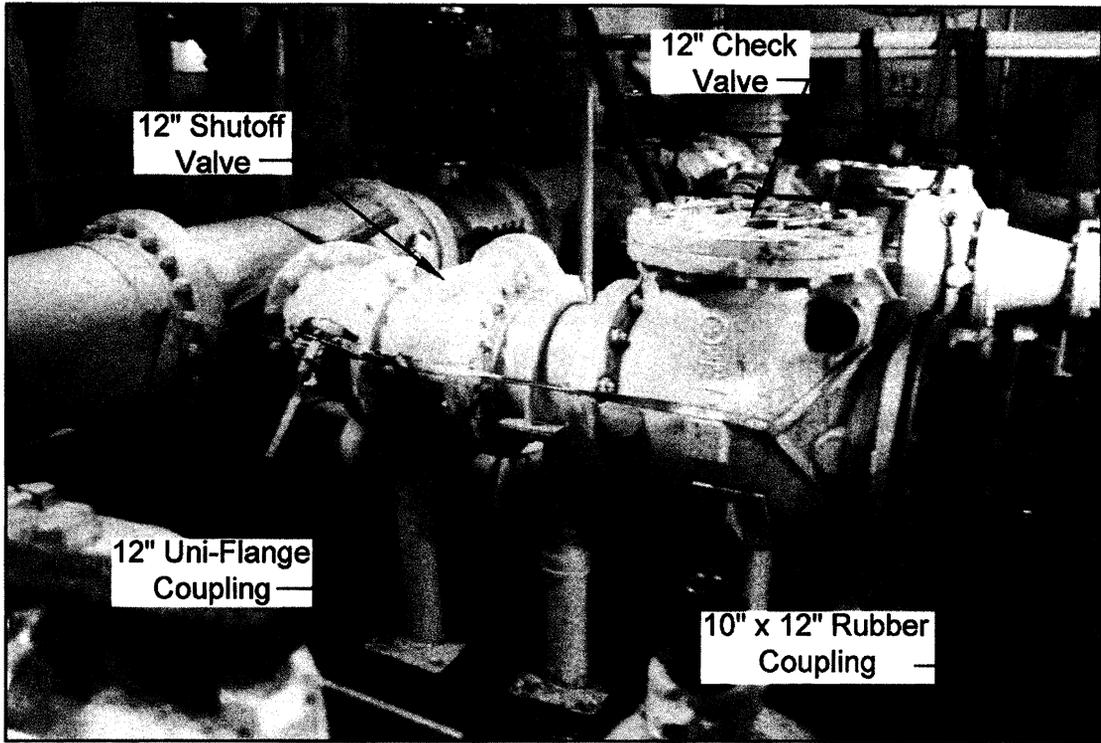
Photo #7: Pump #2 Discharge Piping

Photo #7 shows the discharge piping for Pump #2. That piping layout is typical only for Pumps #1 and #2 (the two new pumps).

Photo #7 shows how the valving is supported for each pump's discharge piping. A separate pipe support is furnished beneath the shutoff valve, spool with Uni-Flange coupling, and check valve. Each of these pipe supports are bolted to the floor. There are differences, however, in how each support is connected to the piping element it is supporting:

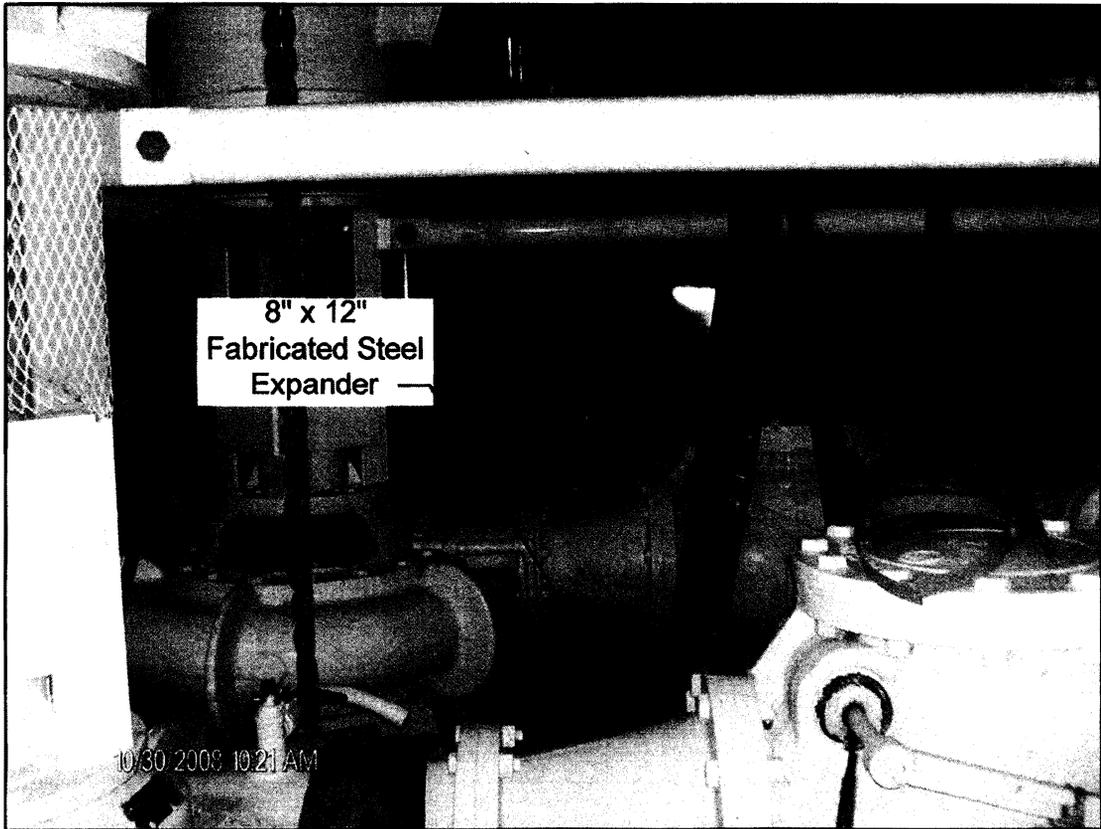
Photo #8: Pump #3 & Pump #4 8"X 12" Expander on Discharge Piping

Photo #8 shows the fabricated steel expander that connects the 8” pump discharge to the 12” check valve, for Pump #3 and #4, only.

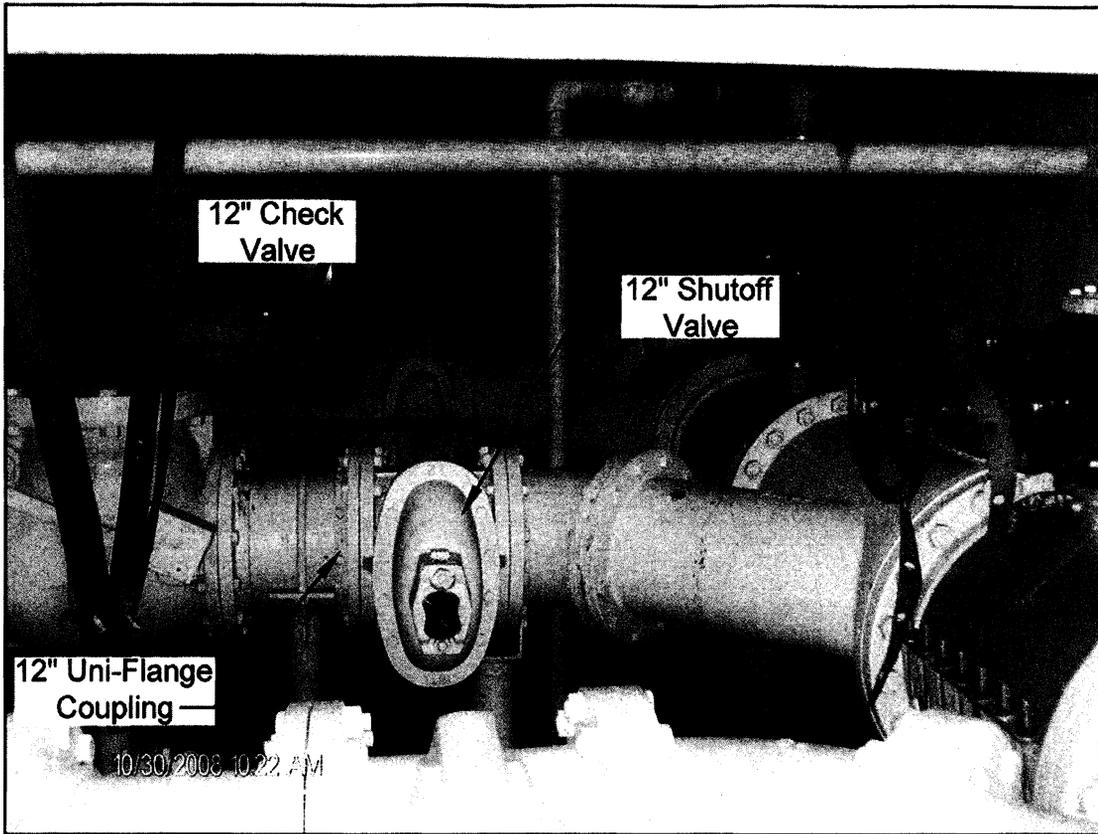
Photo #9: Pump #3 Uni-Flange Coupling on Discharge Piping

Photo #9 shows the Uni-Flange coupling on the discharge piping for Pump #3.

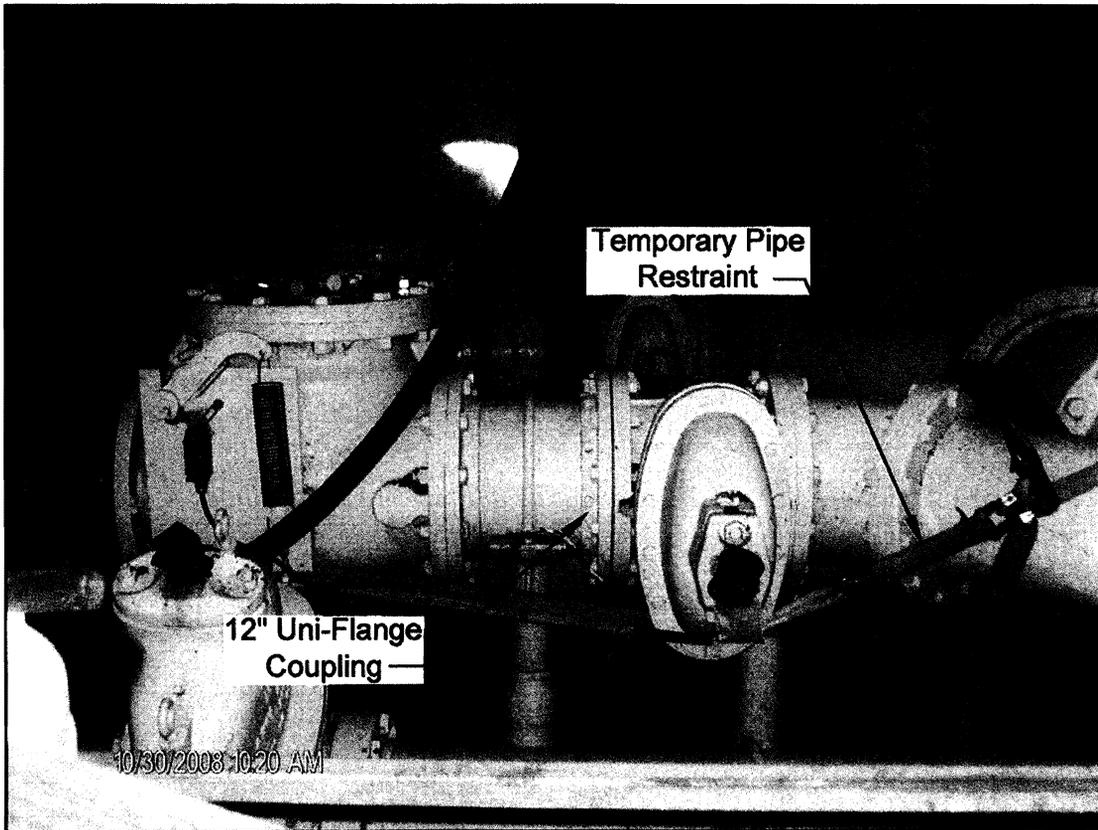
Photo #10: Pump #2 Uni-Flange Coupling on Pump #2

Photo #10 shows the Uni-Flange coupling on the discharge piping for Pump #2.

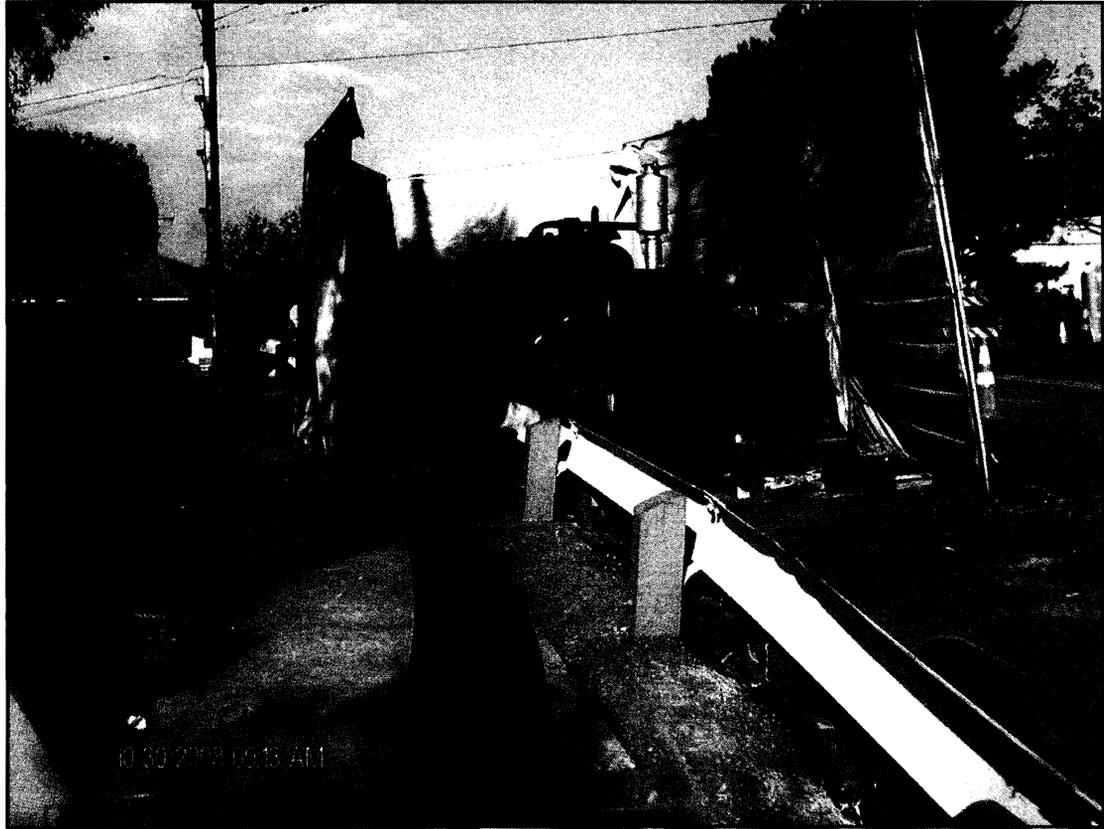
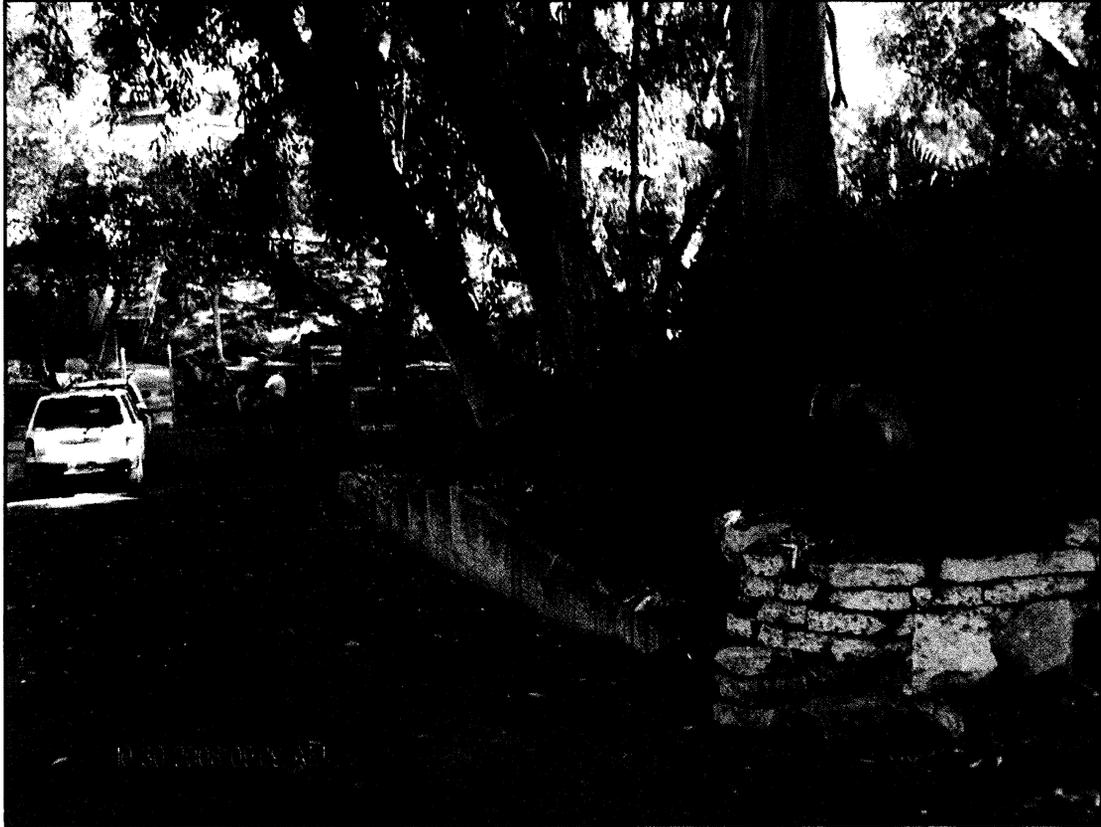
Photos #18 through #22 show the bypass pumping system as installed on October 29.

Photo #18: Bypass Pumps on Glenneyre Street (October 30th)

Photo #19: Bypass Pump Discharge Piping (October 30th)

Photo #20: Bypass Pump Discharge Piping (October 30th)

Photo #21: Bypass Pump Discharge Piping (October 30th)

Photo #22: Bypass Pump Discharge Connection (October 30th)

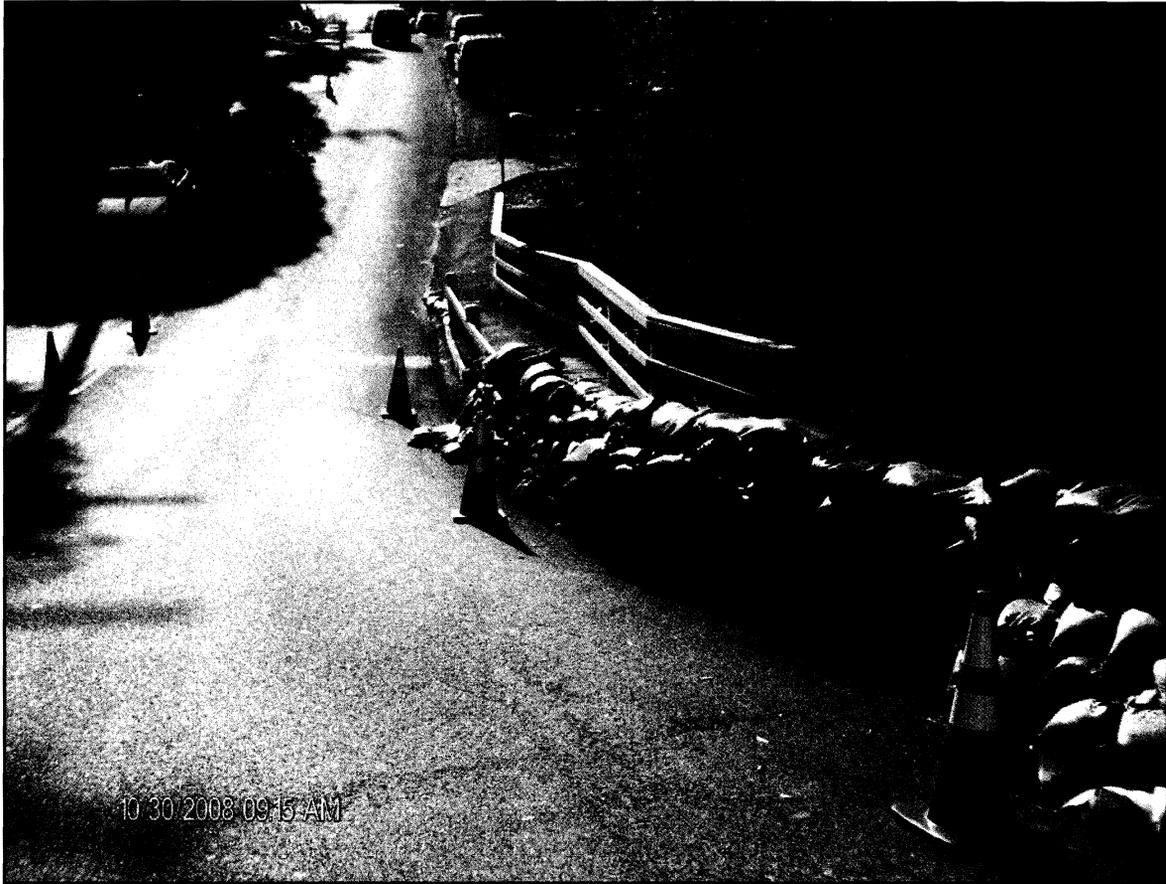
Photo #23: Traffic Control on Glenneyre Street (October 30th)

Traffic cones had been setup to block off the southerly lane of Glenneyre Street from its intersection with Calliope Street, for several hundred feet south along Glenneyre Street. Sand bags had also been placed to preclude sewage flow from flowing down unprotected side slopes of the street embankment. **Photo #23** shows traffic control features and surface drainage features that were installed by Griffin Dewatering and City Staff on October 29, along a portion of Glenneyre Street.
