**Subject: Notice of Violation and Investigative Order No. R9-2016-0067, Otay Landfill, San Diego County**

**NOTICE OF VIOLATION AND  
INVESTIGATION ORDER  
No. R9-2016-0067**

**FACILITIES INSPECTION REPORT**

# Otay Landfill

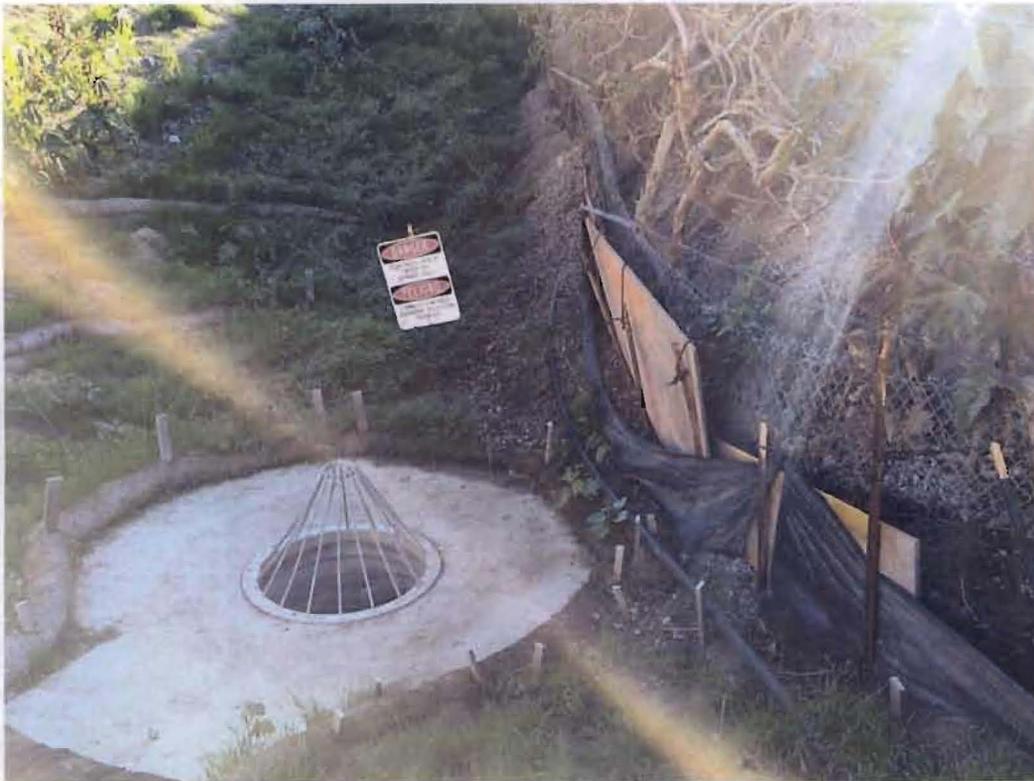
Figure 6- South Perimeter Drain Outlet

All no longer functioning BMPs need to be replaced.

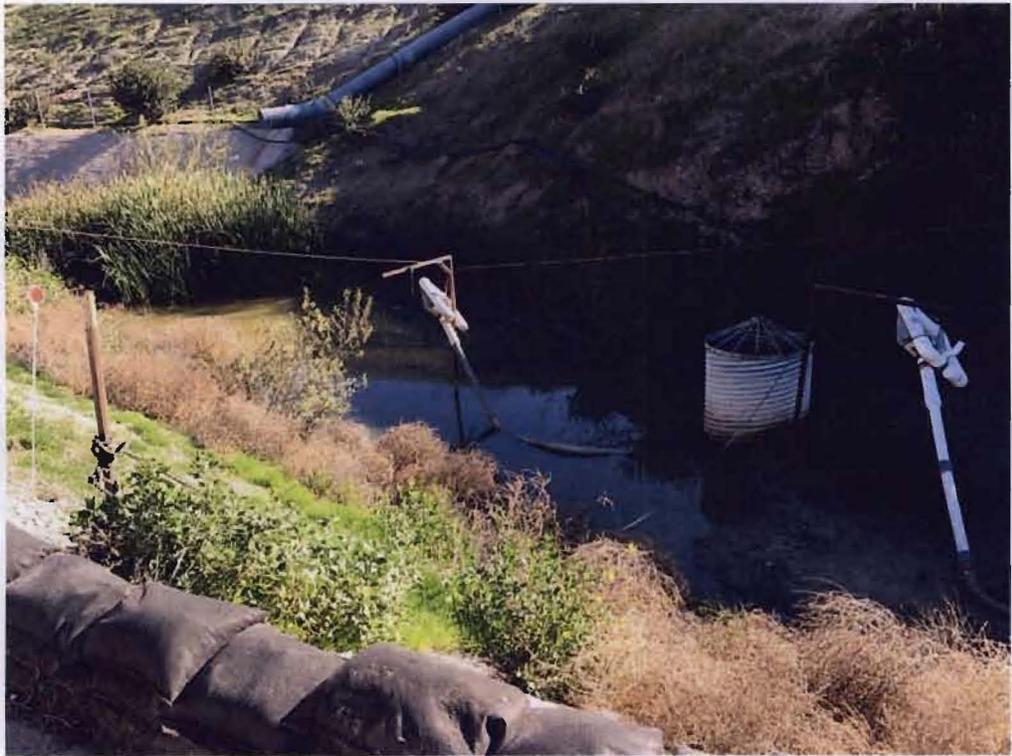
Figure 10- South Storm Water Basin

New straw wattles implemented in a lower risk area. While high risk erosion areas have failed or poorly implemented BMPs.

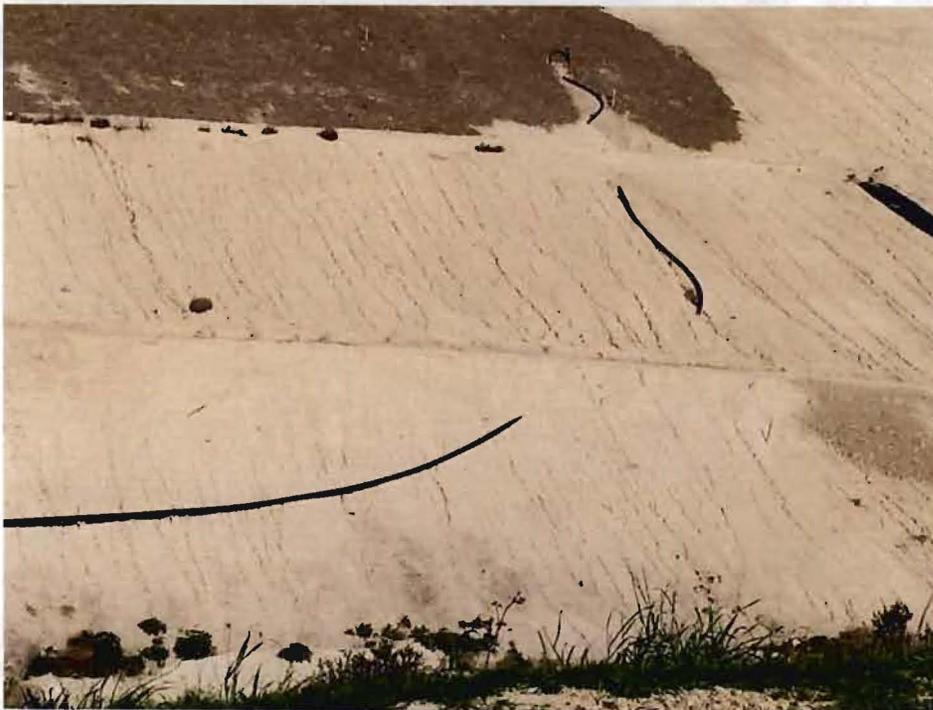
Figure 19- Zoomed Image of Contaminants Observed in Mulch

Contaminants observed in mulch applied for erosion control on side slopes. Water Board staff access card show for size comparison.

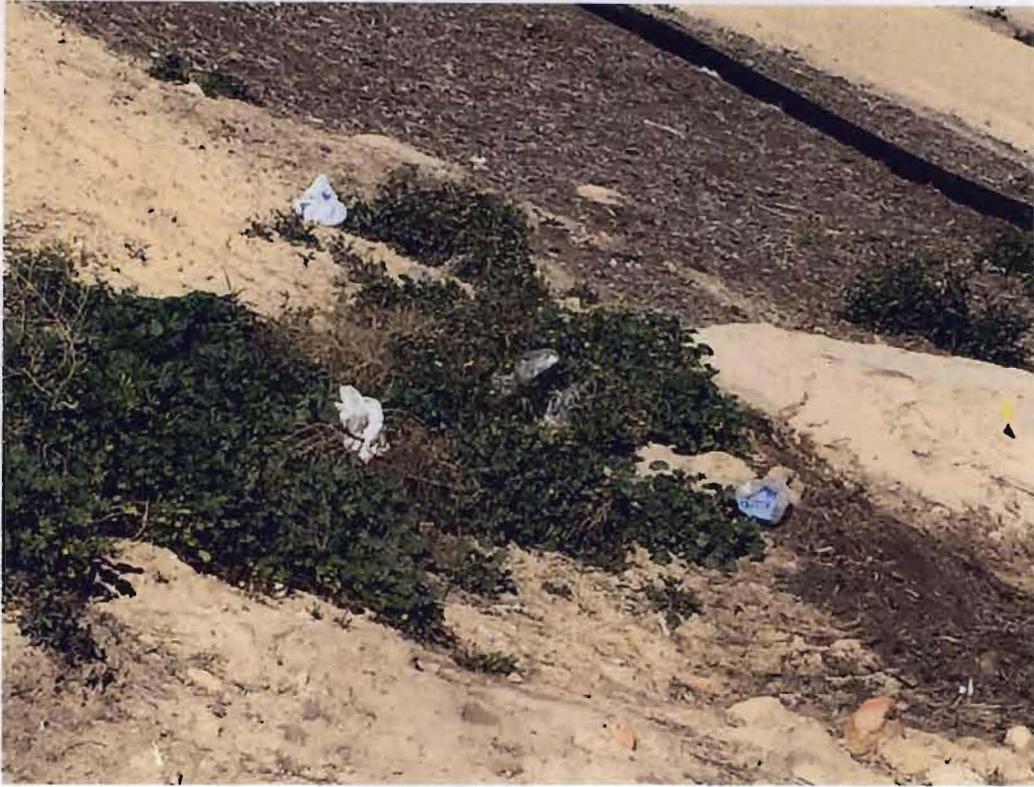
Figure 24- East Side Slope

Unopened bottled water left on gas probe. Trash observed.
