Report of Transboundary Bypass Flows into the Tijuana
River

Minute 320 Binational Technical Team

Final Report

April 2017

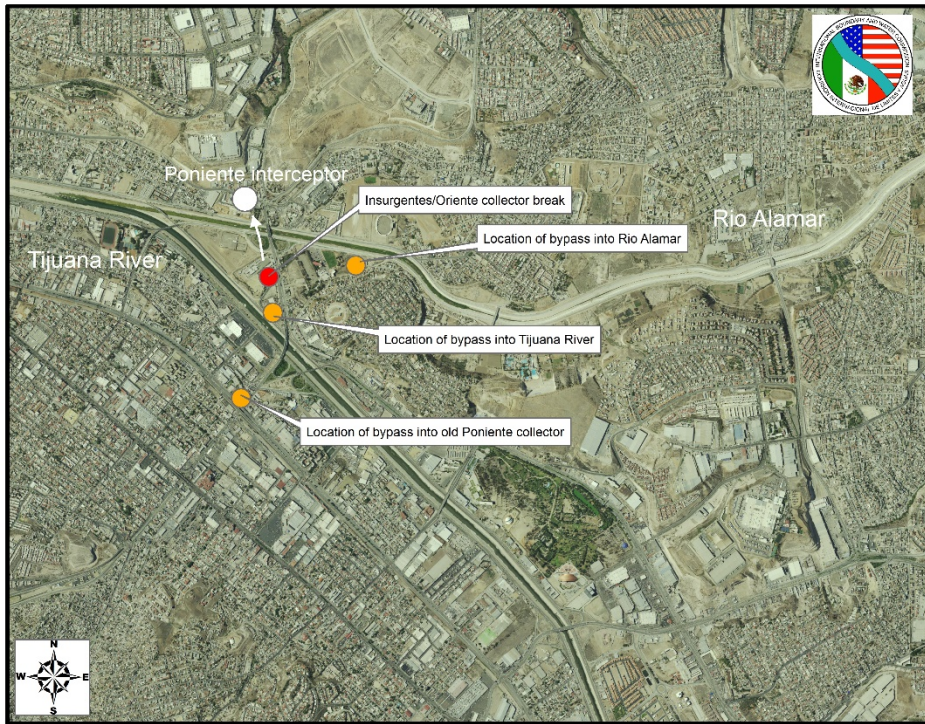
Figure 2 Location of 2017 collector break

On March 1, Roberto Espinosa reported to USIBWC additional details made known at the meeting. On February 1, 2017, there was a collapse of the 48-inch diameter *Insurgentes/Oriente* Collector in the vicinity of the confluence of the Alamar River and Tijuana River. Emergency repairs were undertaken but they were compounded by rain, abandoned underground structures, the failure of a new bus shelter, and overhead and buried power lines. Base flow in the collector was diverted to other pipes, however peak flows were diverted to the river. The nature of the repairs and the expansion of the civil footprint led to a protracted period of repair. The repair work was completed on February 23, 2017. CESPT confirmed their failure to notify the MXIBWC of the emergency work and bypassing of wastewater flows to the river, for that reason, MXIBWC could not provide an estimate for the volume of bypassed wastewater. CESPT also noted that the failure points to the problem of aging infrastructure. CESPT spent \$5 million pesos (MXN), approximately \$260,000 (USD) on repairs, and estimates a need for replacement of approximately two km of 42-inch diameter collectors in the vicinity which will cost around \$28 million MXN, approximately \$1.5 million USD. An additional seven km of pipeline installed in the 1980s are in critical condition and in need of replacement. The Mexican Section stated that they will be coordinating with the State of Baja California to improve CESPT's notification and coordination process.

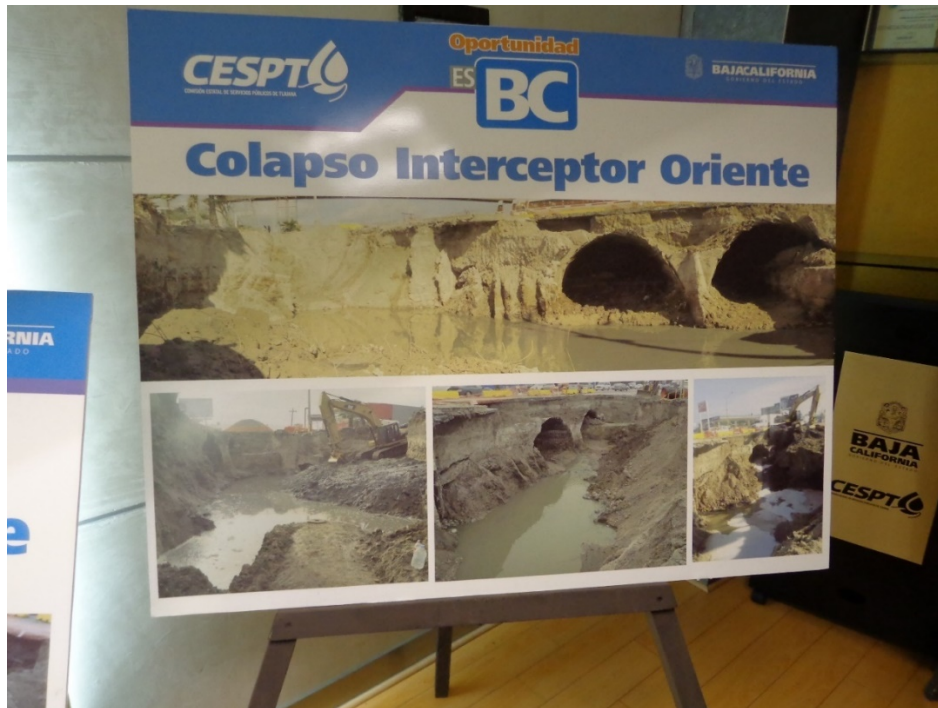
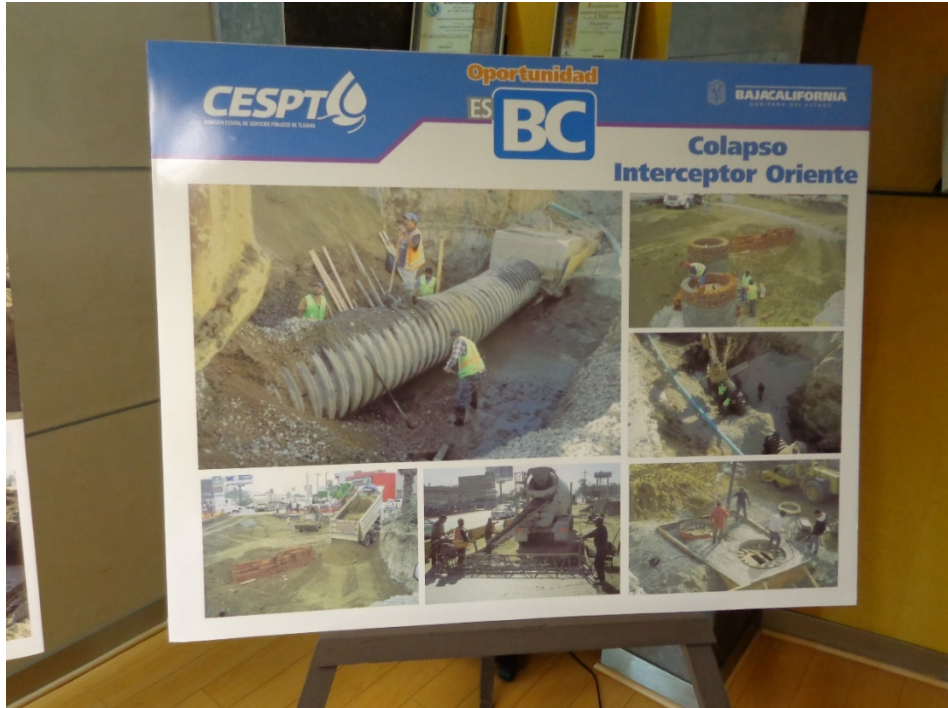
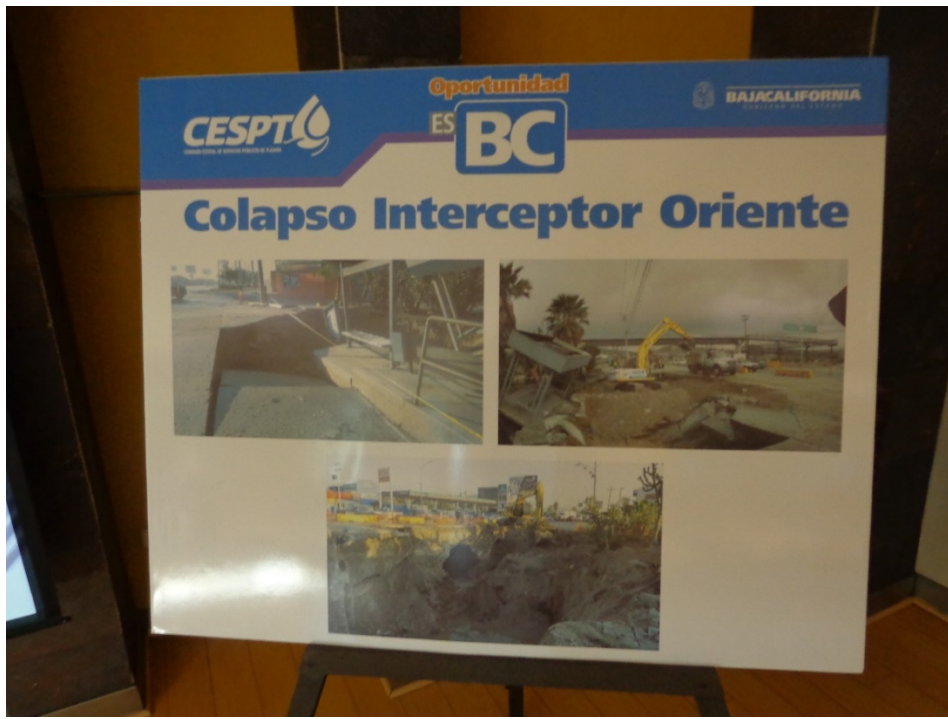
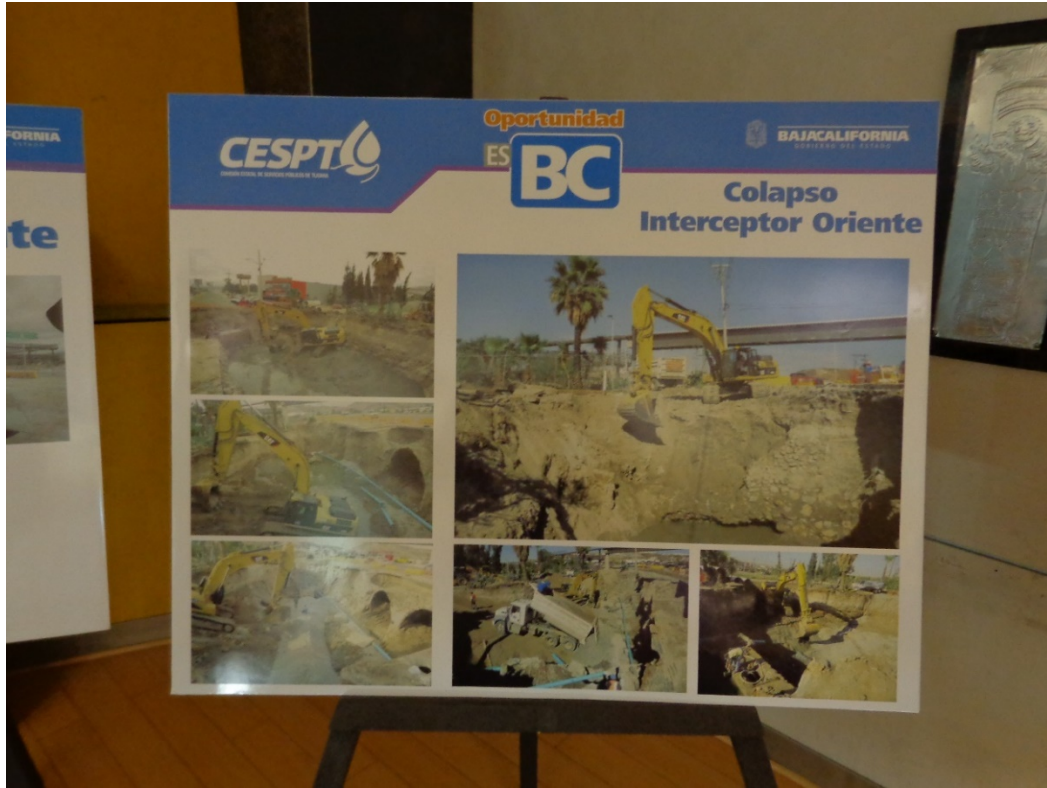
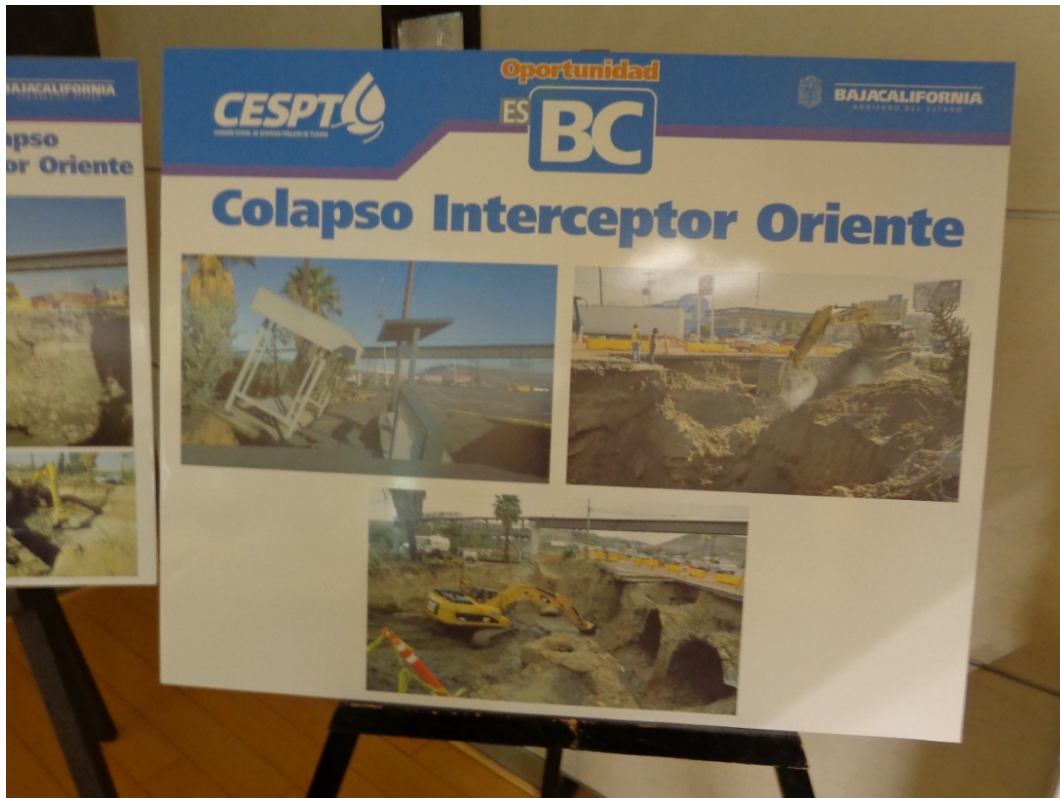
Photographs displayed during the March 9, 2017 meeting at CESPT offices are shown below:

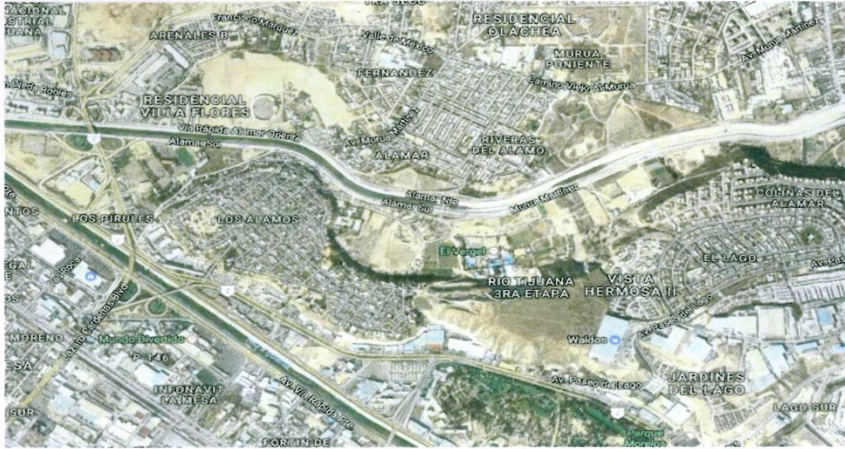
DISTRITO JUAN OJEDA	17 DE ENERO DEL 2017	COLALAMAR BLVD. LAZARO CARDENAS
DESVIOS DE FLUJO BY-PASS PVC 6"		
    <p data-bbox="347 890 867 953">EL 17 DE ENERO, COMO PARTE DE LOS TRABAJOS PRELIMINARES A LA REPOSICION DE LA TUBERIA COLAPSADA DEL COLECTOR INSURGENTES, SE INSTALO BY-PASS DE PCV DE 6" PARA ENCAUZAR EL FLUJO REMANENTE HACIA EL INTERCEPTOR ORIENTE</p>

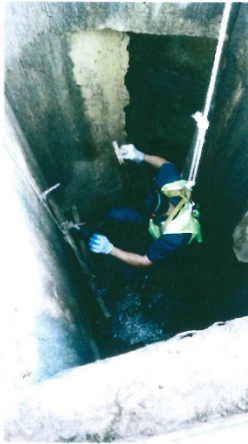
DESVIOS AL COLECTOR PONIENTE

EL DIA 02 DE ENERO DEL 2017, SE TRABAJO EN LA INSTALACION DE UN TAPON INFLABLE DE 24"-48" DE DIAMETRO EN LA CAJA DERIVADORA DEL COLECTOR PONIENTE UBICADA SOBRE EL BOULEVARD FEDERICO BENITEZ ESQUINA CON EL BOULEVARD LAZARO CARDENAS, DE LA COL. LA MESA, EL CUAL SE REALIZO CON EL OBJETO DE ELIMINAR EL 100% DE LAS APORTACIONES CONDUCCIDAS A TRAVES DEL COLECTOR PONIENTE HACIA EL COLECTOR ORIENTE. LO ANTERIOR COMO MEDIDA PREVENTIVA Y PARA EVITAR DERRAMES DE AGUAS NEGRAS HACIA LA CANALIZACION DEL RIO TIJUANA, ORIGINADAS POR EL APARENTE COLAPSO DE UN TRAMO DEL COLECTOR ORIENTE DE 60 PULGADAS DE DIAMETRO.
