San Diego Regional Water Quality Control Board

SUBJECT: OFFER TO SETTLE ADMINISTRATIVE CIVIL LIABILITY FOR ALLEGED VIOLATIONS OF THE CONSTRUCTION GENERAL STORM WATER PERMIT, ORDER R9-2018-0072, CASTLEROCK WESTON CONSTRUCTION SITE, WDID 9 37C374922

Attachment 2 – Castlerock Inspection Report Photo Log
Photos from January 19, 2017

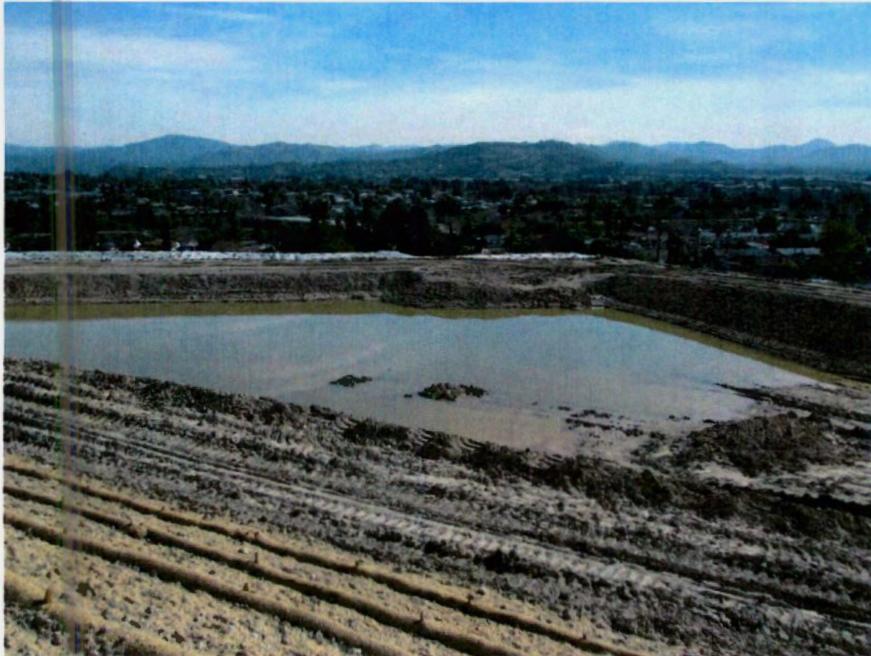
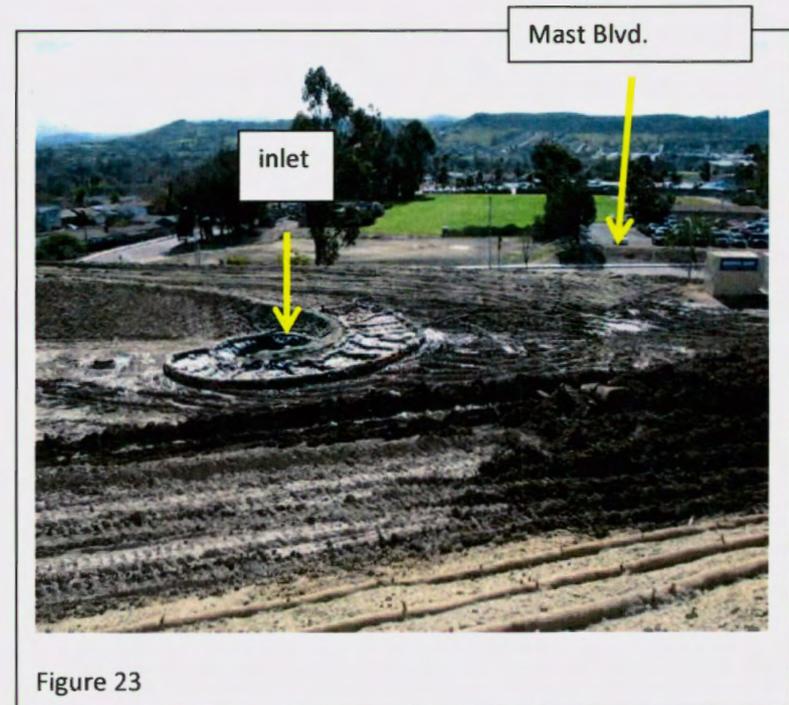
Figures 22 and 23.

8. The inspection concluded with observations of capture hole #4 (see Attachment 2, Figure 39). This capture hole is situated on a fill slope erected above several houses on Medina Dr. Mr. Nichols stated that he had previously used a pump to dewater the capture hole into the MS4 inlet, and that the water was visibly clear. This was done out of concern for possible slope failure due to the volume of water being stored on the fill slope. We discussed that the CGP

Capture hole # 4 on the southeast area of the construction site, photo taken facing southeast. Figure 23 shows an inlet that is connected to the City of Santee MS4.
