**CALIFORNIA REGIONAL WATER QUALITY CONTROL BOARD
SAN DIEGO REGION**

In the matter of:)	
)	
San Diego County)	Order No. R9-2019-0020
Sanitation District)	
)	
February 2017 Sanitary Sewer)	
Overflow, Los Coches Creek,)	Settlement Agreement and
San Diego River)	Stipulation for Entry of
)	Administrative Civil Liability
)	Order
Place ID: 631623)

**CONCEPTUAL MITIGATION PLAN
SIERRA ALTA WAY WASTEWATER EMERGENCY PIPE REPLACEMENT PROJECT
LAKESIDE, SAN DIEGO COUNTY, CALIFORNIA**

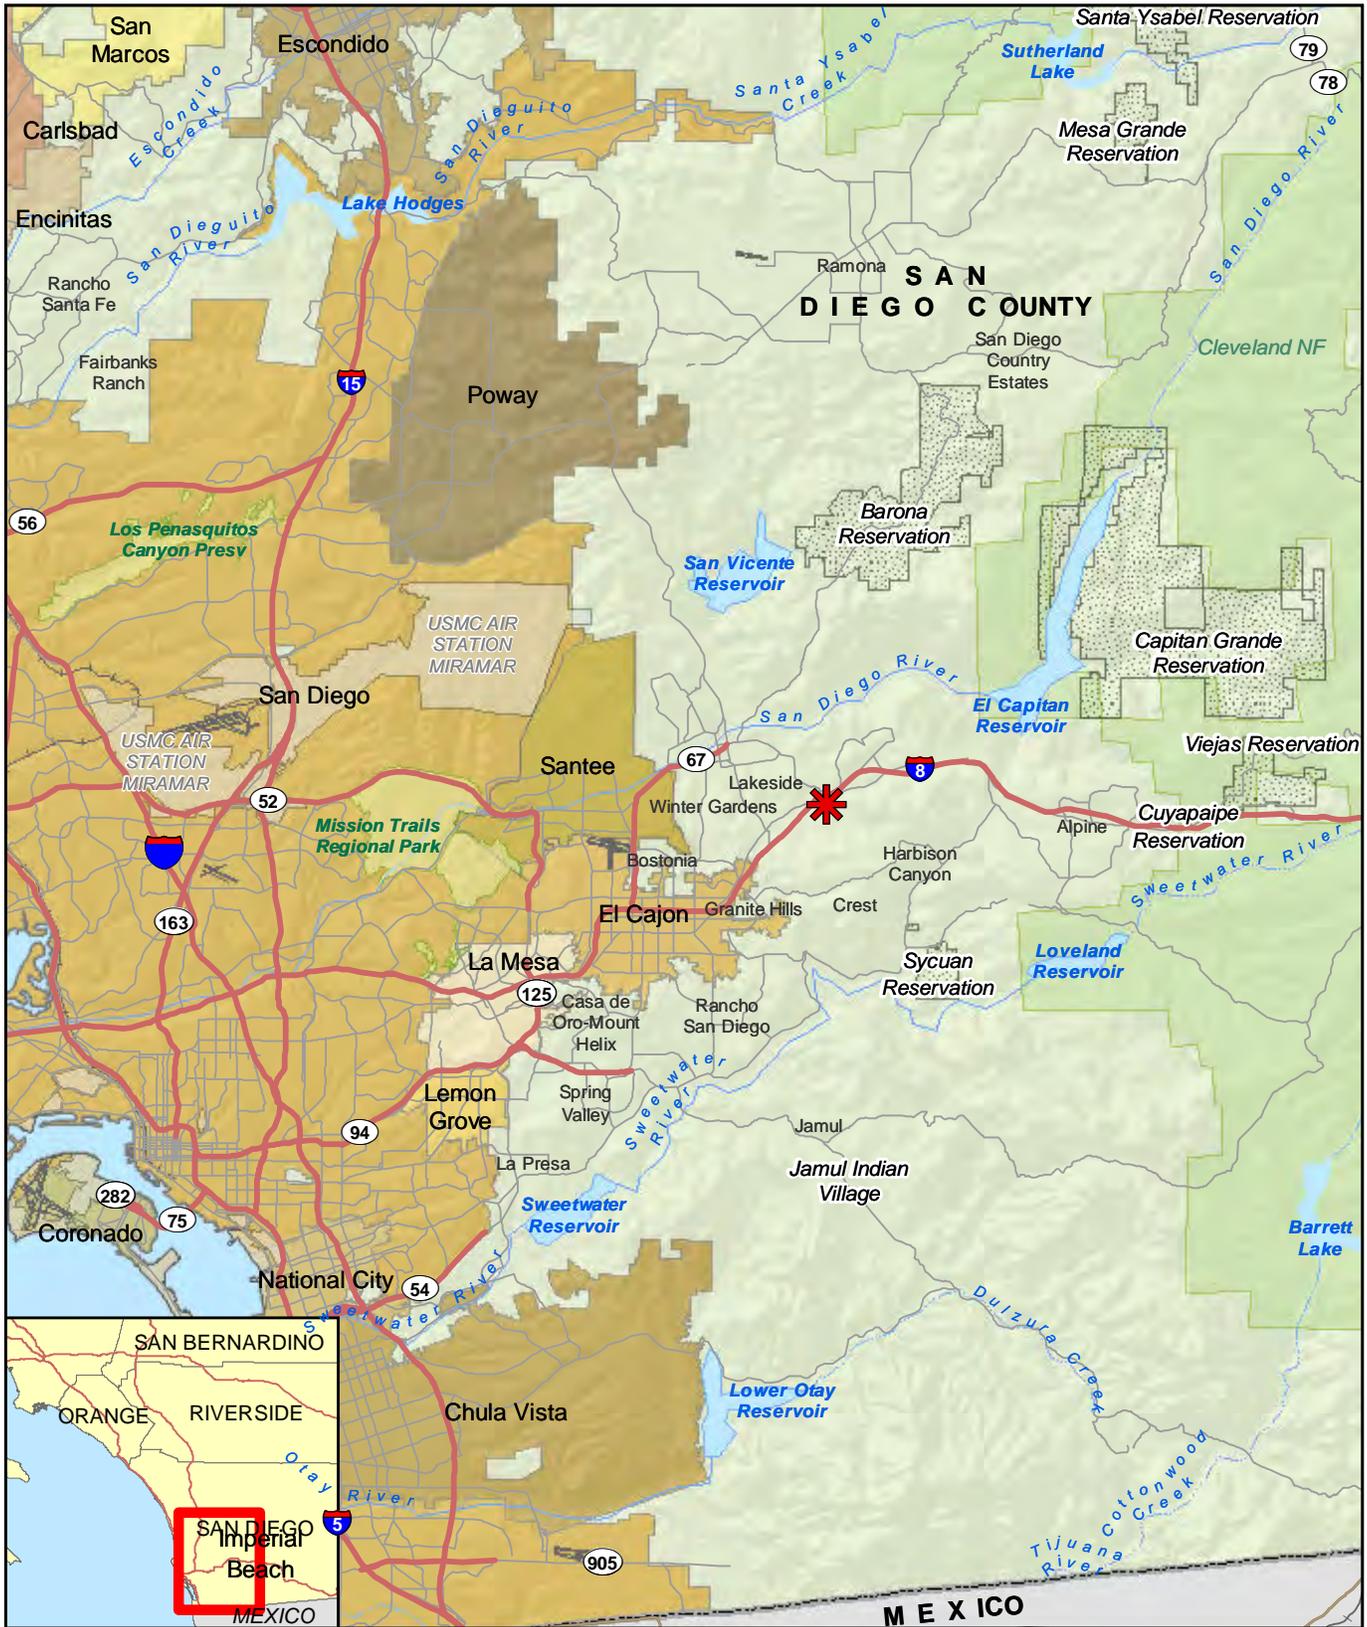
FIGURE 1
Regional Location

The project site is located south and west of East Sierra Alta Way in the unincorporated community of Lakeside, CA (Figure 1). From the site, Los Coches Creek flows west and northwest through Lakeside until it empties into the San Diego River.

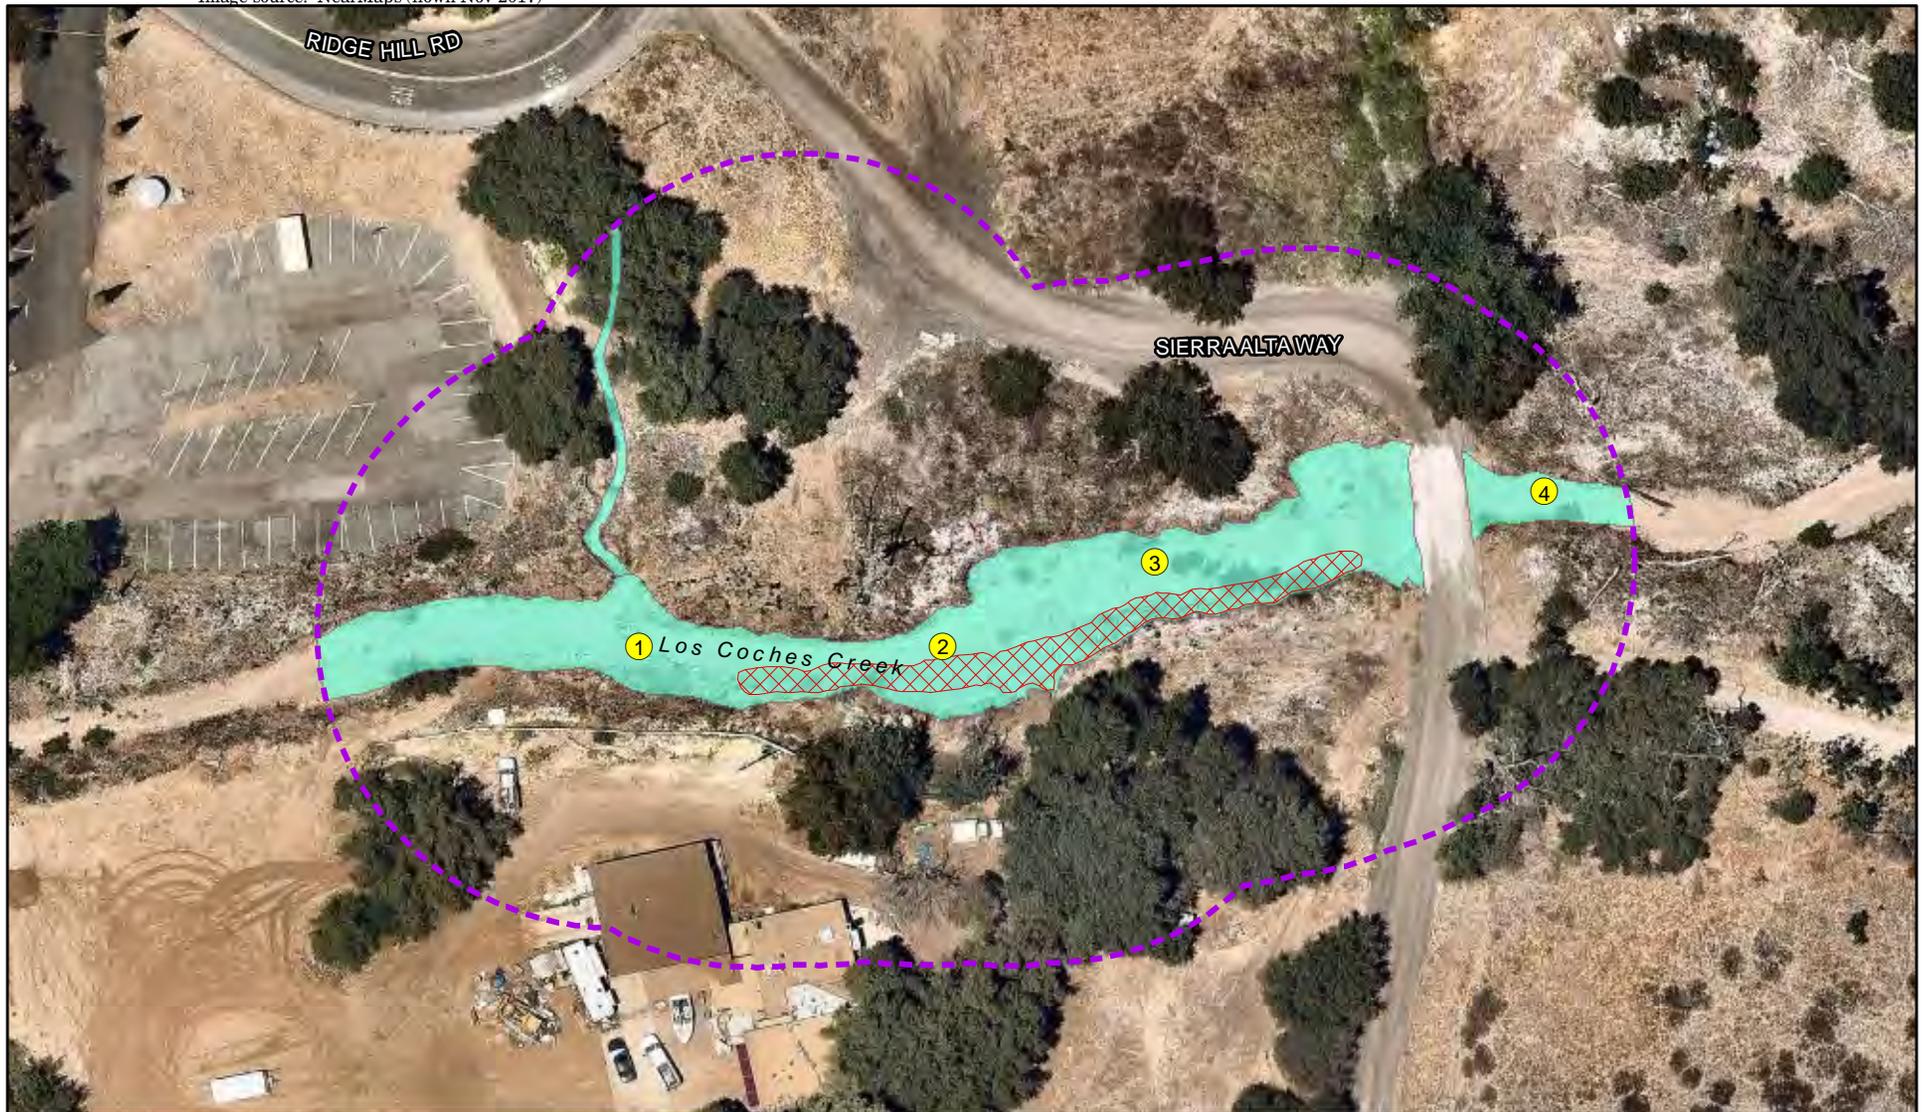
FIGURE 2

A wetland delineation was conducted for the Sierra Alta Way Wastewater Emergency Pipe Replacement Project (RECON 2018; Attachment 1). Permanent impacts occurred as a result of sewer pipe replacement and riprap installation (Photograph 1). Permanent impacts to USACE/RWQCB non-wetland waters of the U.S./CDFW streambed total 0.05 acre and 234 linear feet (Table 1; Figure 2). These permanent impacts only occurred to the unvegetated channel; no natural vegetation communities were impacted.
