**WRITTEN MATERIAL SUBMISSION FOR  
DECEMBER 12, 2007 AGENDA ITEM NO. 16  
COMPLAINT NO. R9-2007-0099  
(TENTATIVE ORDER NO. R9-2007-0215)  
FOR ADMINISTRATIVE CIVIL LIABILITY AGAINST THE CITIES OF  
VISTA AND CARLSBAD FOR VIOLATION OF NO. R9-2006-0003-DWQ,  
STATEWIDE GENERAL WASTE DISCHARGE REQUIREMENTS FOR  
SANITARY SEWER SYSTEMS  
(Reference: NCRU:01-0743.02 & 01-0764.02:ebecker)**

## **INVESTIGATIVE ORDER NO. R9-2007-0060, DISCHARGE OF UNTREATED SEWAGE INTO BUENA VISTA LAGOON, WITHIN THE CITY OF CARLSBAD, SAN DIEGO COUNTY**

**INVESTIGATIVE ORDER NO. R9-2007-0060  
FOR  
CITY OF VISTA  
CARLSBAD MUNICIPAL WATER DISTRICT  
VIOLATION OF WASTE DISCHARGE REQUIREMENTS NO. R9-2007-0005  
FOR THE  
DISCHARGE OF UNTREATED SEWAGE INTO THE BUENA VISTA LAGOON  
WITHIN THE CITY OF CARLSBAD  
SAN DIEGO COUNTY**

**CITY OF CARLSBAD  
24-INCH FORCE MAIN FAILURE  
BUENA VISTA LAGOON  
Carlsbad, California  
NCRU: 01-0743.02 & 01-764.02:ebecker**

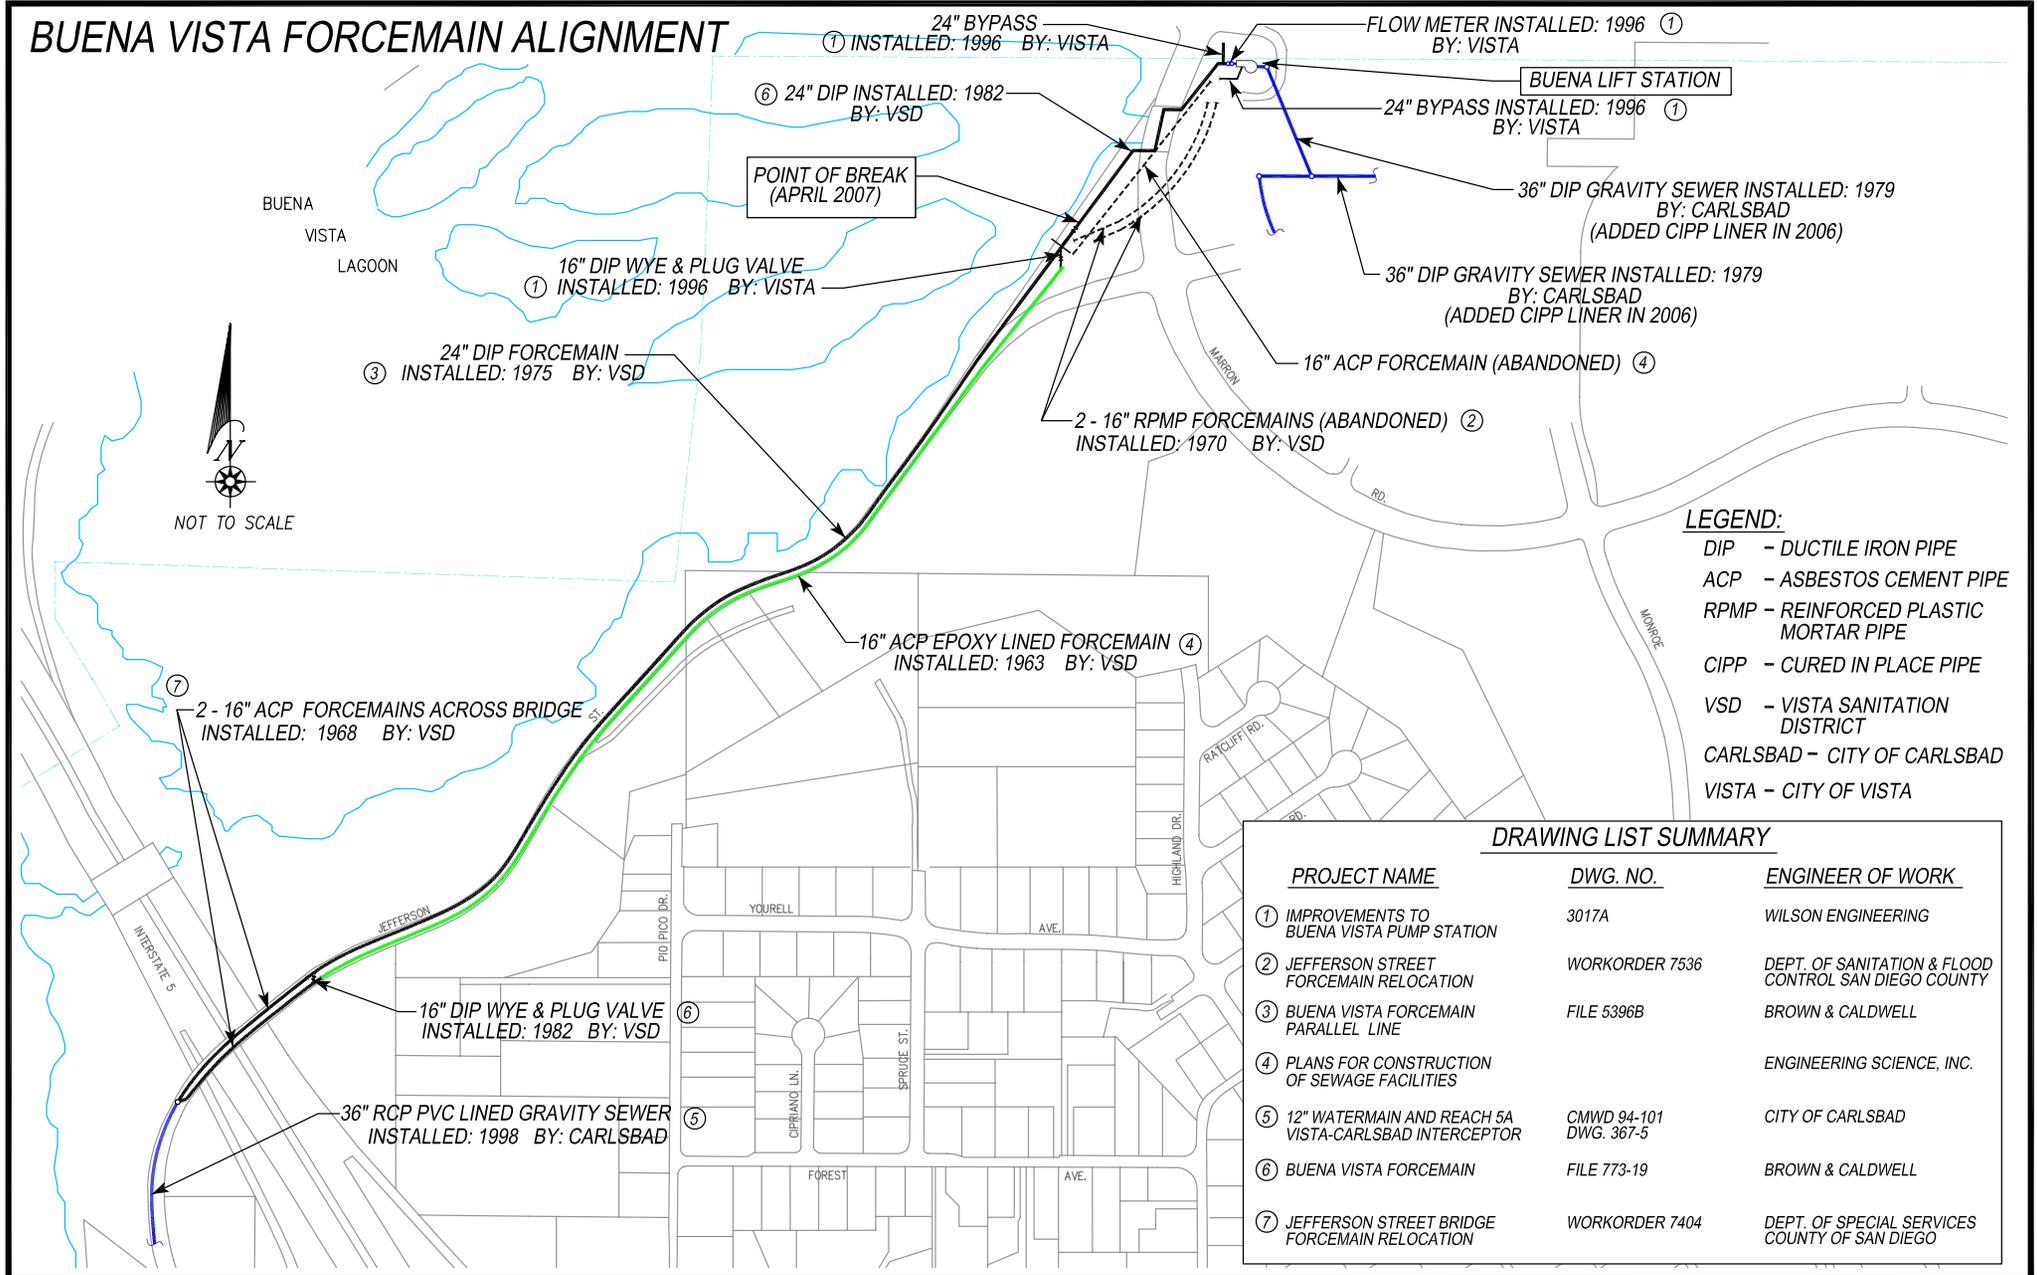
# BUENA VISTA FORCEMAIN ALIGNMENT

The 1982 24-inch DIP force main was designed by the firm of Brown and Caldwell Consulting Engineers through an agreement with Vista Sanitation District (Appendix 2c). The location of the pipe was not constructed in the lagoon, but followed and was within the Jefferson Street alignment where it replaced a 16-inch diameter force main.

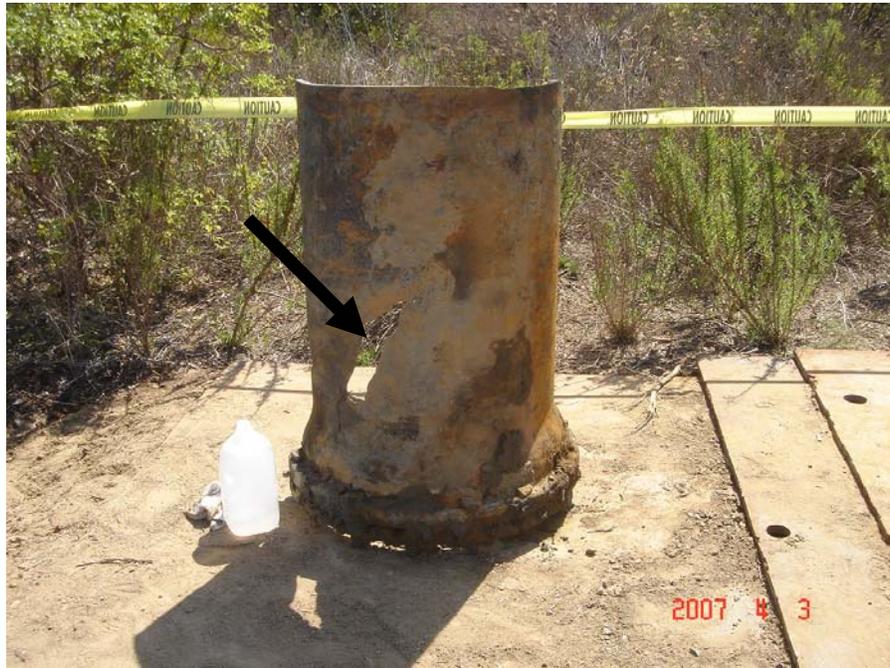
**Figure 2: Overall View of Pipe Specimen from Discharge Site Excavation from Exterior. Arrow indicates hole in pipe.**

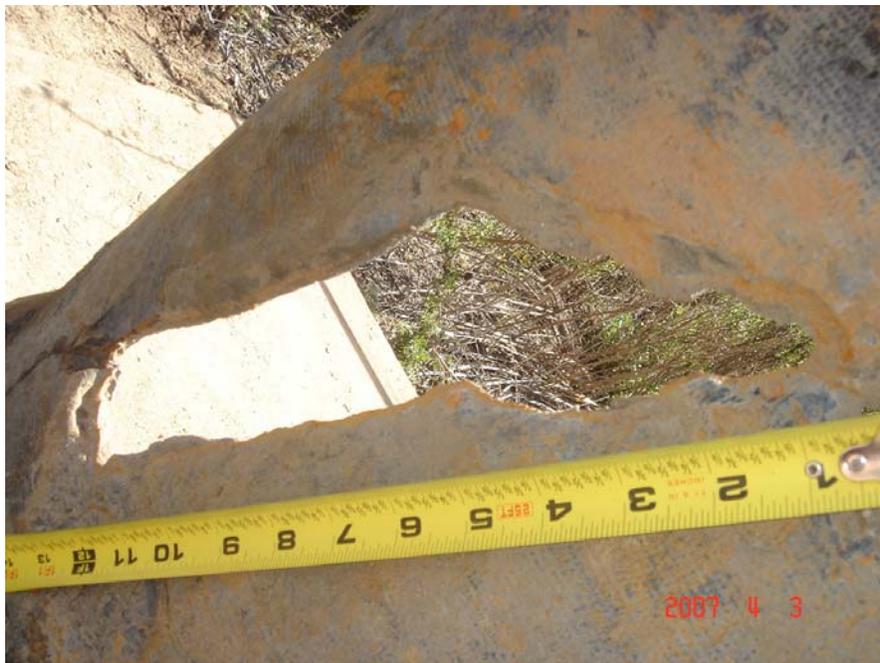
It does preliminarily appear that the cause of the failure was external corrosion. The early testing of soils from the site by Schiff Associates, Inc. indicates a highly corrosive

**Figure 3: Close up of Hole from Exterior**

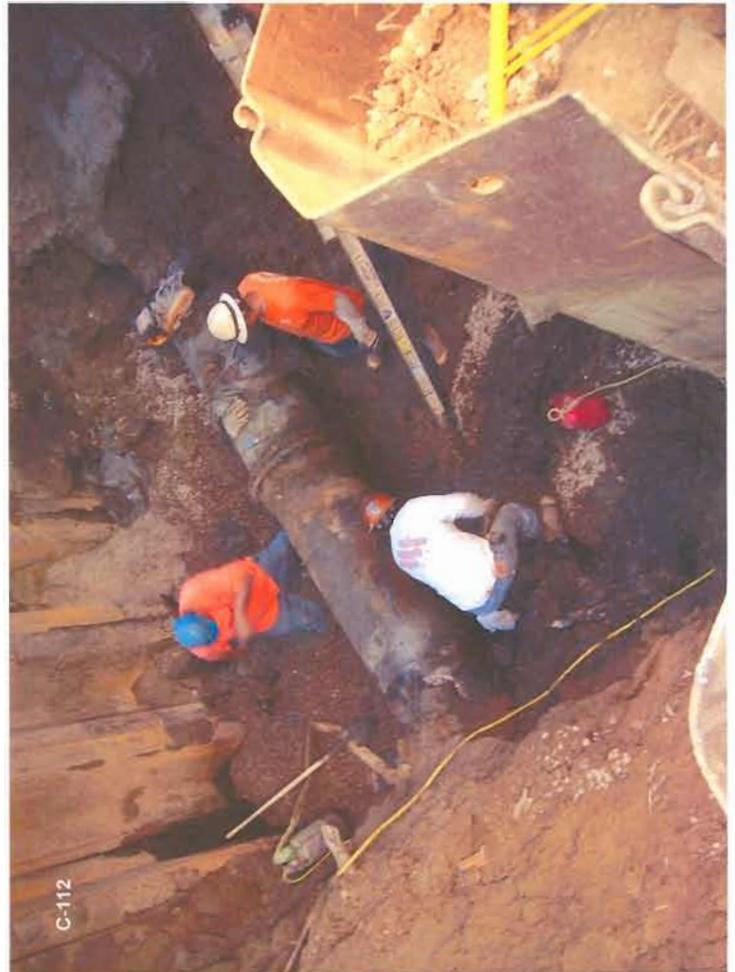
C-110	4/2/07	PM	Ronnie Kaufold - Vadnais Corp.	McMahon setting lagoon side of pilings	Materials used to shore trench
C-111	4/3/07	AM	Ronnie Kaufold - Vadnais Corp.	Shows hole in 24" ductile iron pipe	Pic Taken in trench, pipe in place
C-112	4/3/07	AM	Ronnie Kaufold - Vadnais Corp.	Contractors hand digging under force main	Documents leak repair
C-113	4/3/07	AM	Ronnie Kaufold - Vadnais Corp.	Cutting out section of force main	Documents leak repair
