Subject: Valencia Project Site – Meeting with CRWQCB, Follow up Requirements

INSPECTOR'S REPORT

Memo

Subject: May 15, 2015 Sampling at Valencia Construction Site

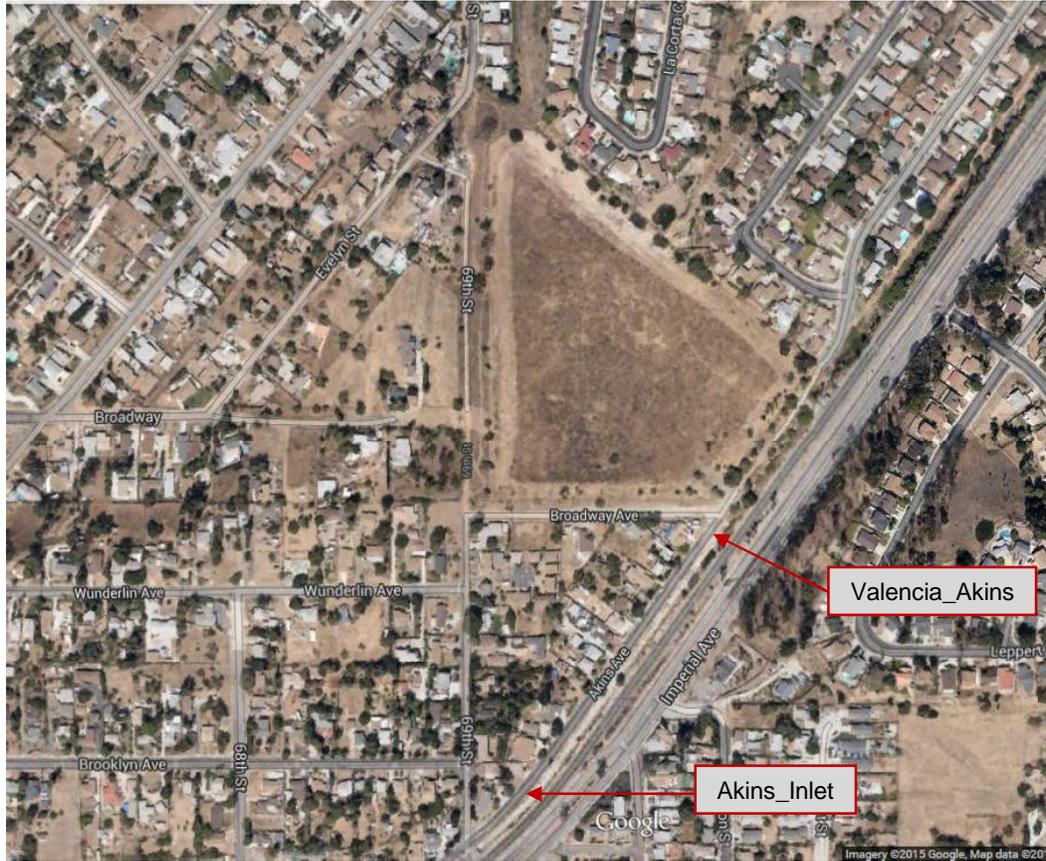
Figure 1. Sampling Locations

Per the City's request, D-MAX collected samples of runoff from the Valencia construction site. Runoff was observed discharging from the construction site only at the Akins Avenue entrance/exit sampling location (site Valencia_Akins, Figure 1 and Photo 1). Because gravel bag check dams were positioned along Akins Avenue from the site discharge point down to the nearest storm drain inlet, a sample was also taken downstream of the last set of gravel bags, just before the water entered the inlet (site Akins_Inlet, Figure 1 and Photo 2).
