10
11 IN THE MATTER OF:) **DECLARATION OF BEN ANDERSON**
12 ADMINISTRATIVE CIVIL LIABILITY COMPLAINT) **IN SUPPORT OF SAN ALTOS –**
13 No. R9-2015-0110) **LEMON GROVE, LLC’S LEGAL AND**
AGAINST SAN ALTOS – LEMON GROVE, LLC) **TECHNICAL ARGUMENTS AND**
14) **ANALYSIS IN OPPOSITION TO**
15) **ADMINISTRATIVE CIVIL LIABILITY**
16) **COMPLAINT NO. R9-2015-0110**
17)
18)
19)
20)
21)
22)
23)
24)
25)
26)
27)
28)

Subject: PIN: SM-828060:wchiu

This letter will serve as San Altos-Lemon Grove, LLC's ("LLC") response to the Notice of Violation No. R9-2014-0153 issued by the San Diego Water Board on December 19, 2014. The LLC takes its responsibilities under Order No. 2009-0009-DWR seriously and has made a determined effort to correct any deficiencies at the construction site and employ the most effective Best Management Practices available. We have employed three different contractors with over 1,400 man hours including Saturdays and Sundays, associated BMP equipment and material and management for the project. To date the costs exceed \$ 60,000 in an effort to remedy deficiencies on the site since the rain events in early December. While we understand that money spent is not a measure of eff

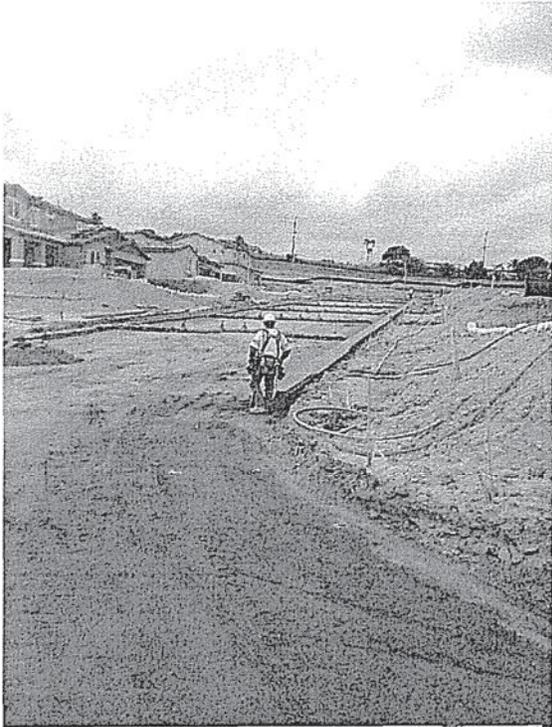
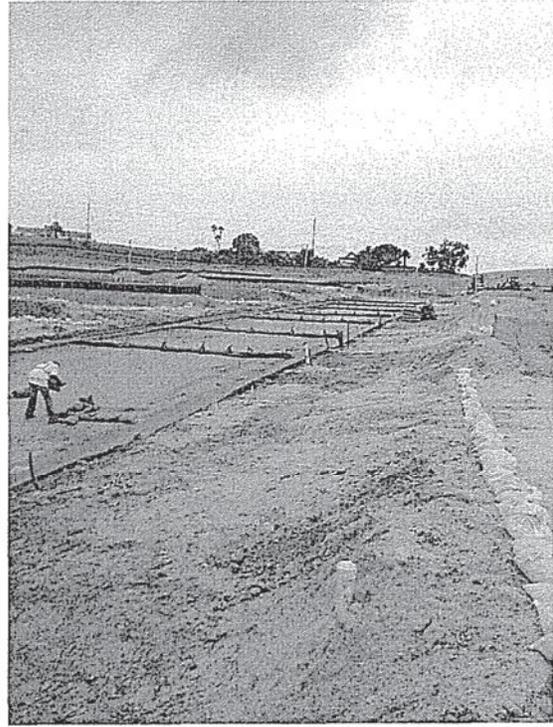
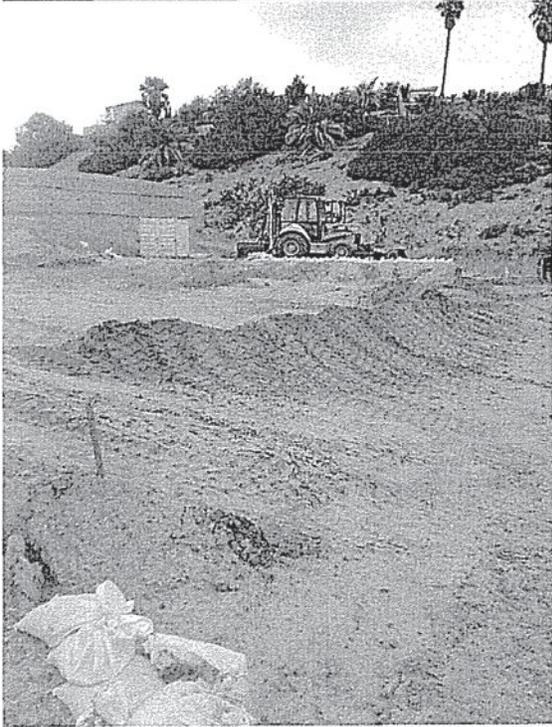
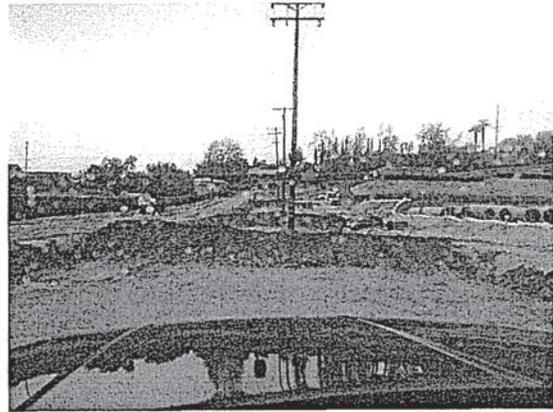
7: Failure to Implement Adequate Controls for Active Areas

b. **Observation:** During the December 15, 2014 inspection, the San Diego Water Board inspector observed several active areas of the site that did not have appropriate erosion control BMPs in place or ready to be deployed. See attached December 15, 2014 Facility Inspection Report Finding 4 and Photo 8.

Photos of active areas with appropriate erosion control BMP's in place or ready to be deployed
