Subject: Valencia Project Site – Meeting with CRWQCB, Follow up Requirements

INSPECTOR'S REPORT

Project: Valencia		Date: 12/24/14	Hours: 3
Developer: Anderson		Project No.: GR-1691	
Location: San Altos		Inspector: Harper	Contract Day:
Weather: Clear/warm			
MANPOWER AND EQUIPMENT			
Grading Contractor:	Underground Contractor:	Other Contractors:	
Koloa Pacific	Koloa Pacific	TVD, BCA Development, Surveyors, Cal West	
Equipment: various	Equipment: Various	Equipment: Various	
Remarks: Developer's Supervisor Onsite: <input checked="" type="checkbox"/> Y <input type="checkbox"/> N			
TVD placing silt fence on lots 1 through 5. William advised that by end of day, they should have silt fence at lots 67 through 73. Crew also filling rills at north area of site and performing housekeeping. Koloa continues to grade roads and Cal West cleaning bio basin #18 by dewatering to lot 56, which was fortified with extra gravel bags. Dwayne on site for BCA, William onsite for TVD with appx 10 workers from Labor Ready.

Subject: May 15, 2015 Sampling at Valencia Construction Site

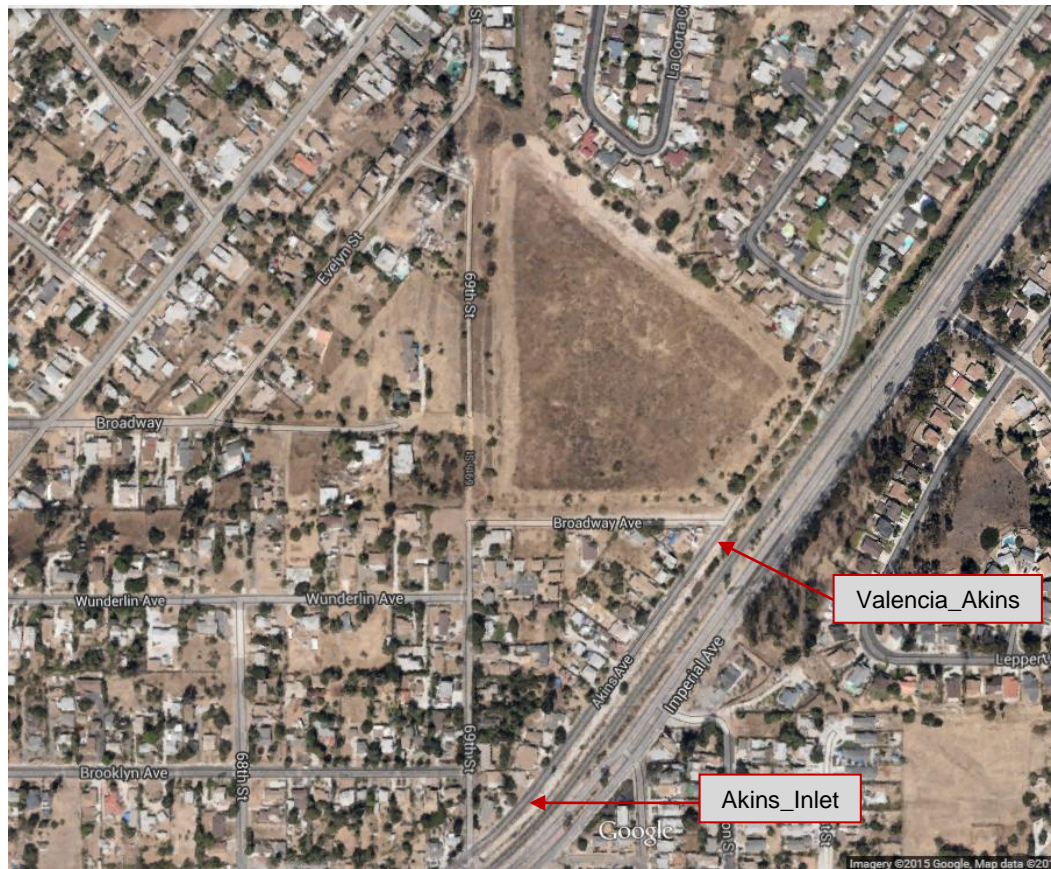
Figure 1. Sampling Locations

Per the City's request, D-MAX collected samples of runoff from the Valencia construction site. Runoff was observed discharging from the construction site only at the Akins Avenue entrance/exit sampling location (site Valencia_Akins, Figure 1 and Photo 1). Because gravel bag check dams were positioned along Akins Avenue from the site discharge point down to the nearest storm drain inlet, a sample was also taken downstream of the last set of gravel bags, just before the water entered the inlet (site Akins_Inlet, Figure 1 and Photo 2).

Each sample was collected and analyzed for turbidity and pH using a calibrated field meter. The Valencia_Akins site had a turbidity value that exceeded the numeric action level of 250 NTU. Unprotected loose sediment observed along the site perimeter near the Akins entrance likely contributed to the high turbidity levels. Photo 3a shows the project area near the Akins inlet during the rain event on 5/15/2015. Photo 3b is a close-up photo of the same area two days earlier. It appears that the loose sediment observed on 5/13/2015 was not sufficiently cleaned up or protected prior to the rain event.

The sample collected at the Akins_Inlet site downstream of the Akins entrance had a turbidity value below the numeric action level. This decrease in turbidity between the Valencia_Akins and Akins_Inlet locations may be due to a combination of sediment settling out at the gravel bag check dams and the runoff from Akins Avenue comingling with the site runoff. Results are summarized in the table below, and photos of the samples in clear containers are presented as photos 4 and 5.
