California Regional Water Quality Control Board, San Diego Region

**NOTICE OF VIOLATION**  
**No. R9-2015-0050**

El Camino Real Road Widening Project  
PIN No. SM-832587:lwalsh

**FACILITY INSPECTION REPORT**

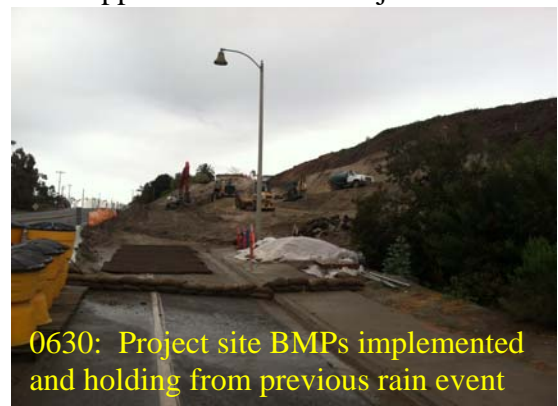
- 0649** Rainfall intensity increased significantly prompting LAE staff to return to the site to assess BMP effectiveness. Tim Loveridge observed that the existing drainage inlet located at the northeast corner of El Camino Real and Tamarack Avenue was overwhelmed by the increased flow. Sediment laden runoff was observed flowing over the top of the curb, up the adjacent pedestrian walkway, and out into the intersection.

- 0700** The Project Inspector and LAE staff found that the northernmost BMPs intended to prevent runoff from entering the project site had been breached. This flow combined with the slope runoff from behind the K-Rail resulted in a sediment and debris blockage that breached and gave way to the discharge. The sediment and storm water flowed unabated into the northbound number 2 lane of El Camino Real through the lifting holes of the K-Rail. There was no safe access for staff to block the lifting holes or remove the debris, so efforts focused on maintaining the downstream check dams which were also overrun by the volume of water and sediment.

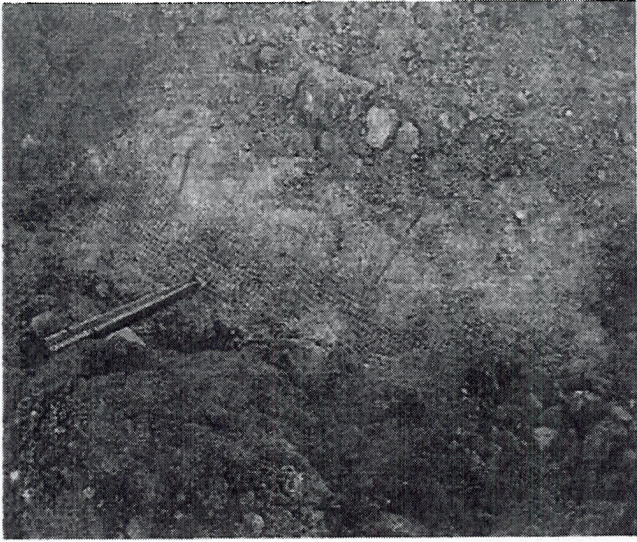
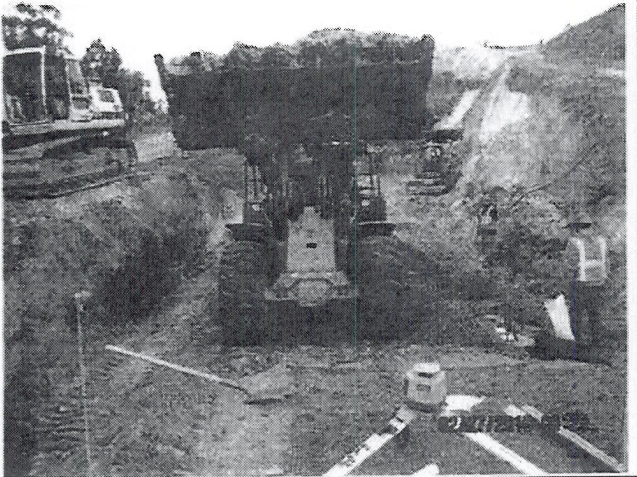
Date:		By:	<i>T. Loveridge</i>
2-27-15			
Exposed grid for tie-in.		Loader wheel rolling the backfill.

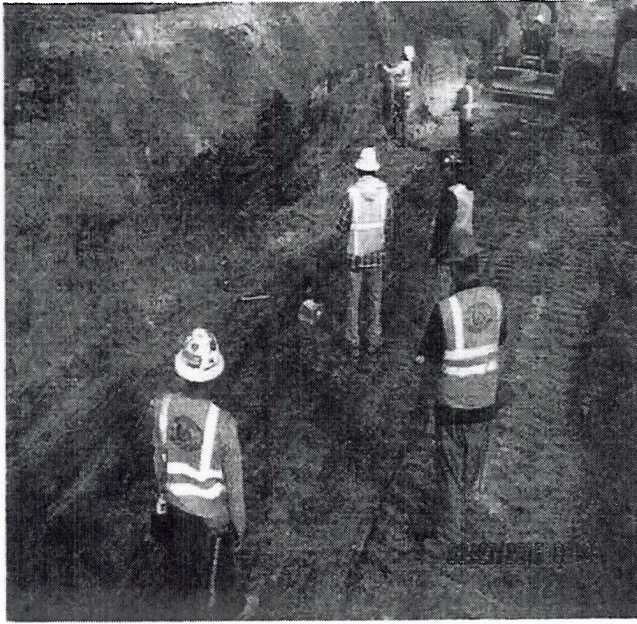
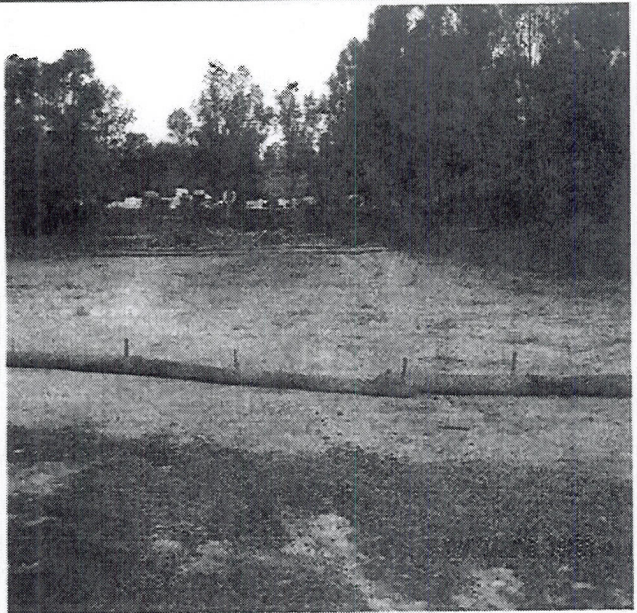
Date:		By:	<i>T. Loveridge</i>
2-27-15			
Steve with SCS taking compaction test over the grid.		Additional fiber rolls installed in the Tamarack yard.
