TECHNICAL MEMORANDUM

Re: Corrective Action Work Plan for Barge Dredged Material Spill
San Diego Shipyard Sediment Site, North Shipyard, San Diego, California

SUBJECT: **SUPPLEMENTAL INCIDENT REPORT**
SCOW SEDIMENT LEAKAGE

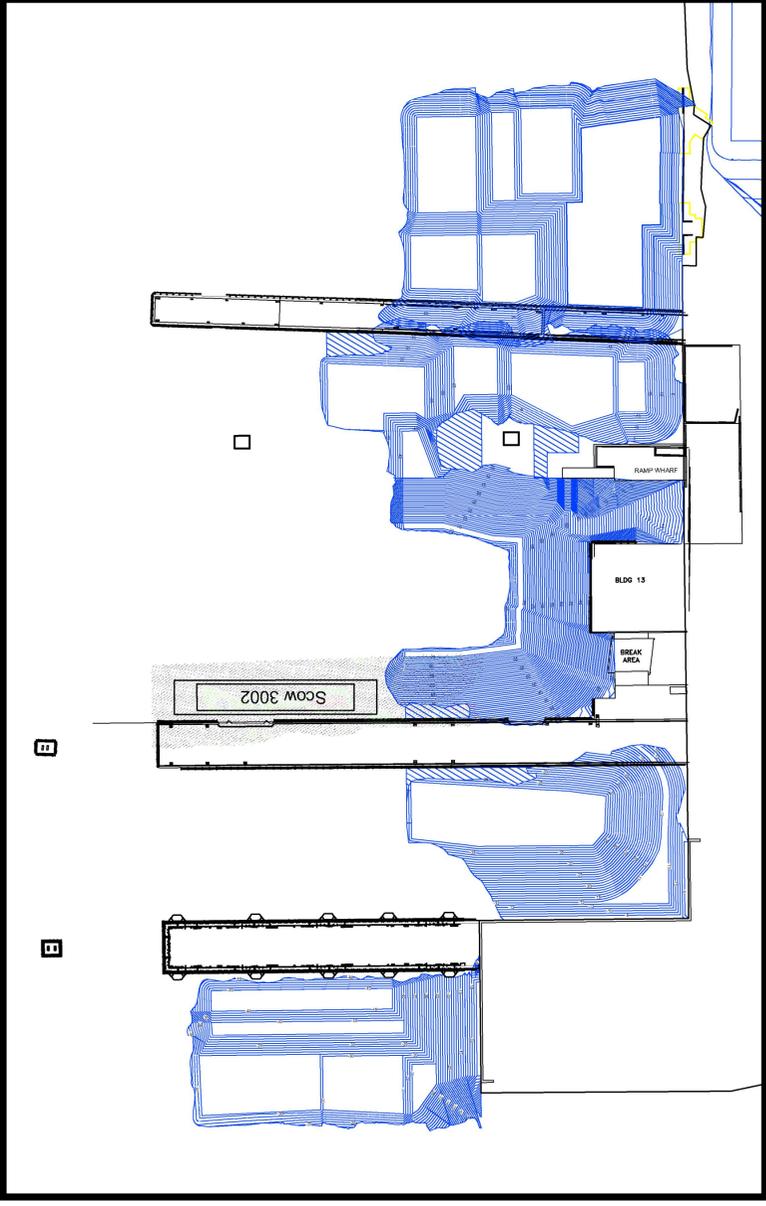
ATTACHMENT 2
BATHYMETRIC SURVEY INDICATING AREA
OF SPILL

A visual observation on Monday, 6/22/15, indicated that the scow might have lost material. At that time the scow was at the SMA. A third-party survey was ordered on 6/22/15 to determine if there was in-fact a sediment loss. Survey data analysis was performed on 6/24/15. These analytical calculations were performed and verified to determine the scope of leakage. On June 25, BAE

The leaked sediments will be recovered in the same manner as the means and methods used to meet the Cleanup and Abatement Order (CAO) protocols. The CAO requires the use of double silt curtains that surround the dredge footprint. The sediments will be dredged with an environmental bucket unless the sediment conditions require a heavier digging bucket. Sediments will be loaded into a scow and transported to the Sediment Management Area (SMA) where they will be processed and transported to the Otay landfill by trucks. No decanting will occur. The water from this small dredge area will be transferred from the scow to the SMA onshore storage tanks and discharged into the City's sewer system according to permit conditions. The estimated time to complete this recovery is one to two days. The contractor will be responsible for the direct dredging costs associated with recovering the leaked sediments. All other costs will be mutually agreed upon. Once dredged, the area will be re-surveyed to confirm removal of the leaked sediments.

R.E. Staite Engineering is preparing a dredge management plan for removal of the leaked sediments. It is necessary to remove these sediments prior to 9/28/15. The plan will follow and incorporate all protocols associated with the CAO including deployment of silt curtains, post dredge surveys, handling, storage and discharge of sea water and truck transportation to the Otay landfill.
