Draft Memorandum

To: Orange County Coastkeeper
From: Anchor Environmental, L.L.C.
Date: April 13, 2005
Re: Review of Structural Components and Existing Conditions
Rhine Channel, Newport Beach, California

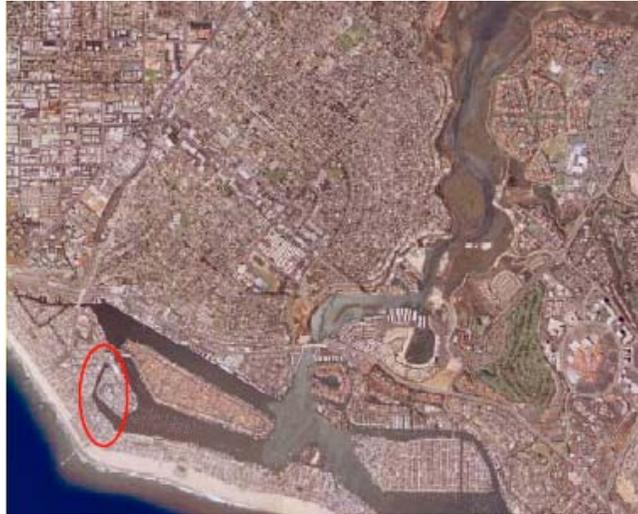
Photo 1. The Rhine Channel is located at the west end of Newport Harbor in the industrial sector.

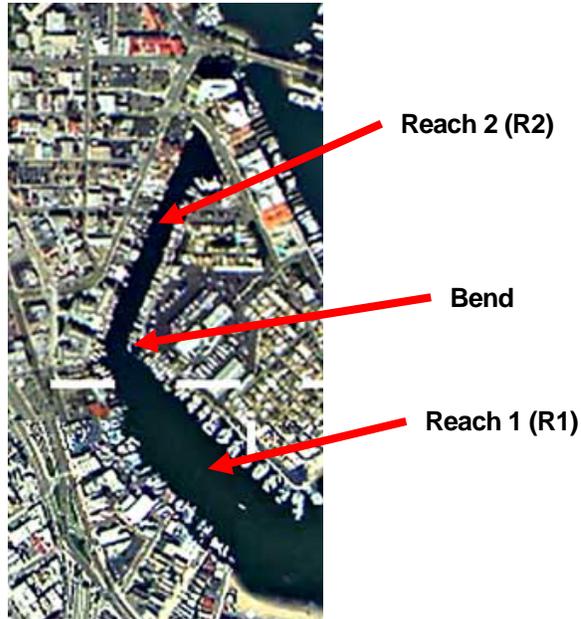
The Rhine Channel is approximately 2,300 feet long and consists of two reaches (photo 2). The outside reach (R1) extends from the mouth of the channel to the bend, and is oriented to the northwest. The inside reach extends from the bend in the channel to the end and is oriented to the north. Figures 2A and 2B in the main text of the accompanying report show a two-part plan view of the channel and includes station designations that will be used throughout this document. Table 1 displays the basic channel characteristics of both reaches.

Photo 2. Two reaches of the Rhine Channel

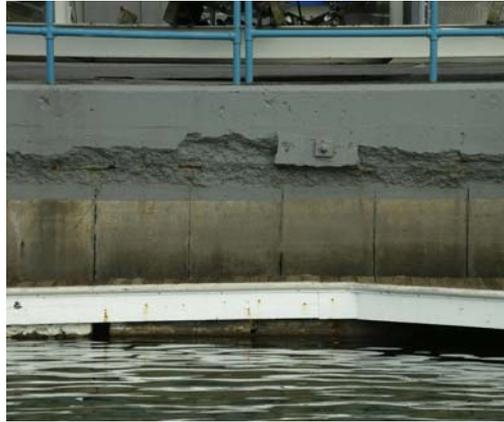
The entire bank of the Rhine Channel has been developed into housing, restaurants, small businesses, and marine support services. The channel's perimeter is approximately 5,000 feet long and mainly comprises a concrete slab bulkhead. Occasionally the bulkhead is supported by steel tiebacks as depicted in photo 3. Some of the tiebacks appear to have been installed post construction. The top of the bulkhead is at approximately 10 to 12 feet MLLW in elevation. A concrete cap rests on top of the bulkhead.

Photo 3. Steel tieback supporting concrete bulkhead

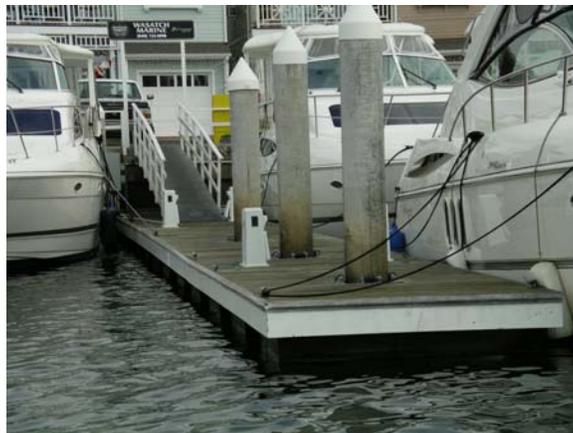
Most docks along the channel are floating systems tied to concrete guide piles (photo 6). The docks are free to move with the water height on a series of rollers. The docks are oriented in various alignments; they are parallel, perpendicular, or diagonal to the bank. Along the west side of R1, the docks surrounding the channel typically extend 60 feet out into the waterway and are 15 feet apart. On the east side of R1, the docks can be up to 35 feet apart and house up to eight boats in a herringbone pattern. In R2, the west side docks are typically 35 feet long and 15 feet apart.

Photo 6. Typical floating dock with concrete piles
