REDWOOD NATIONAL PARK REHABILITATION STUDY

(Test Area 1 and 2)

REHABILITATION METHODS AND COST ANALYSIS

November 1977

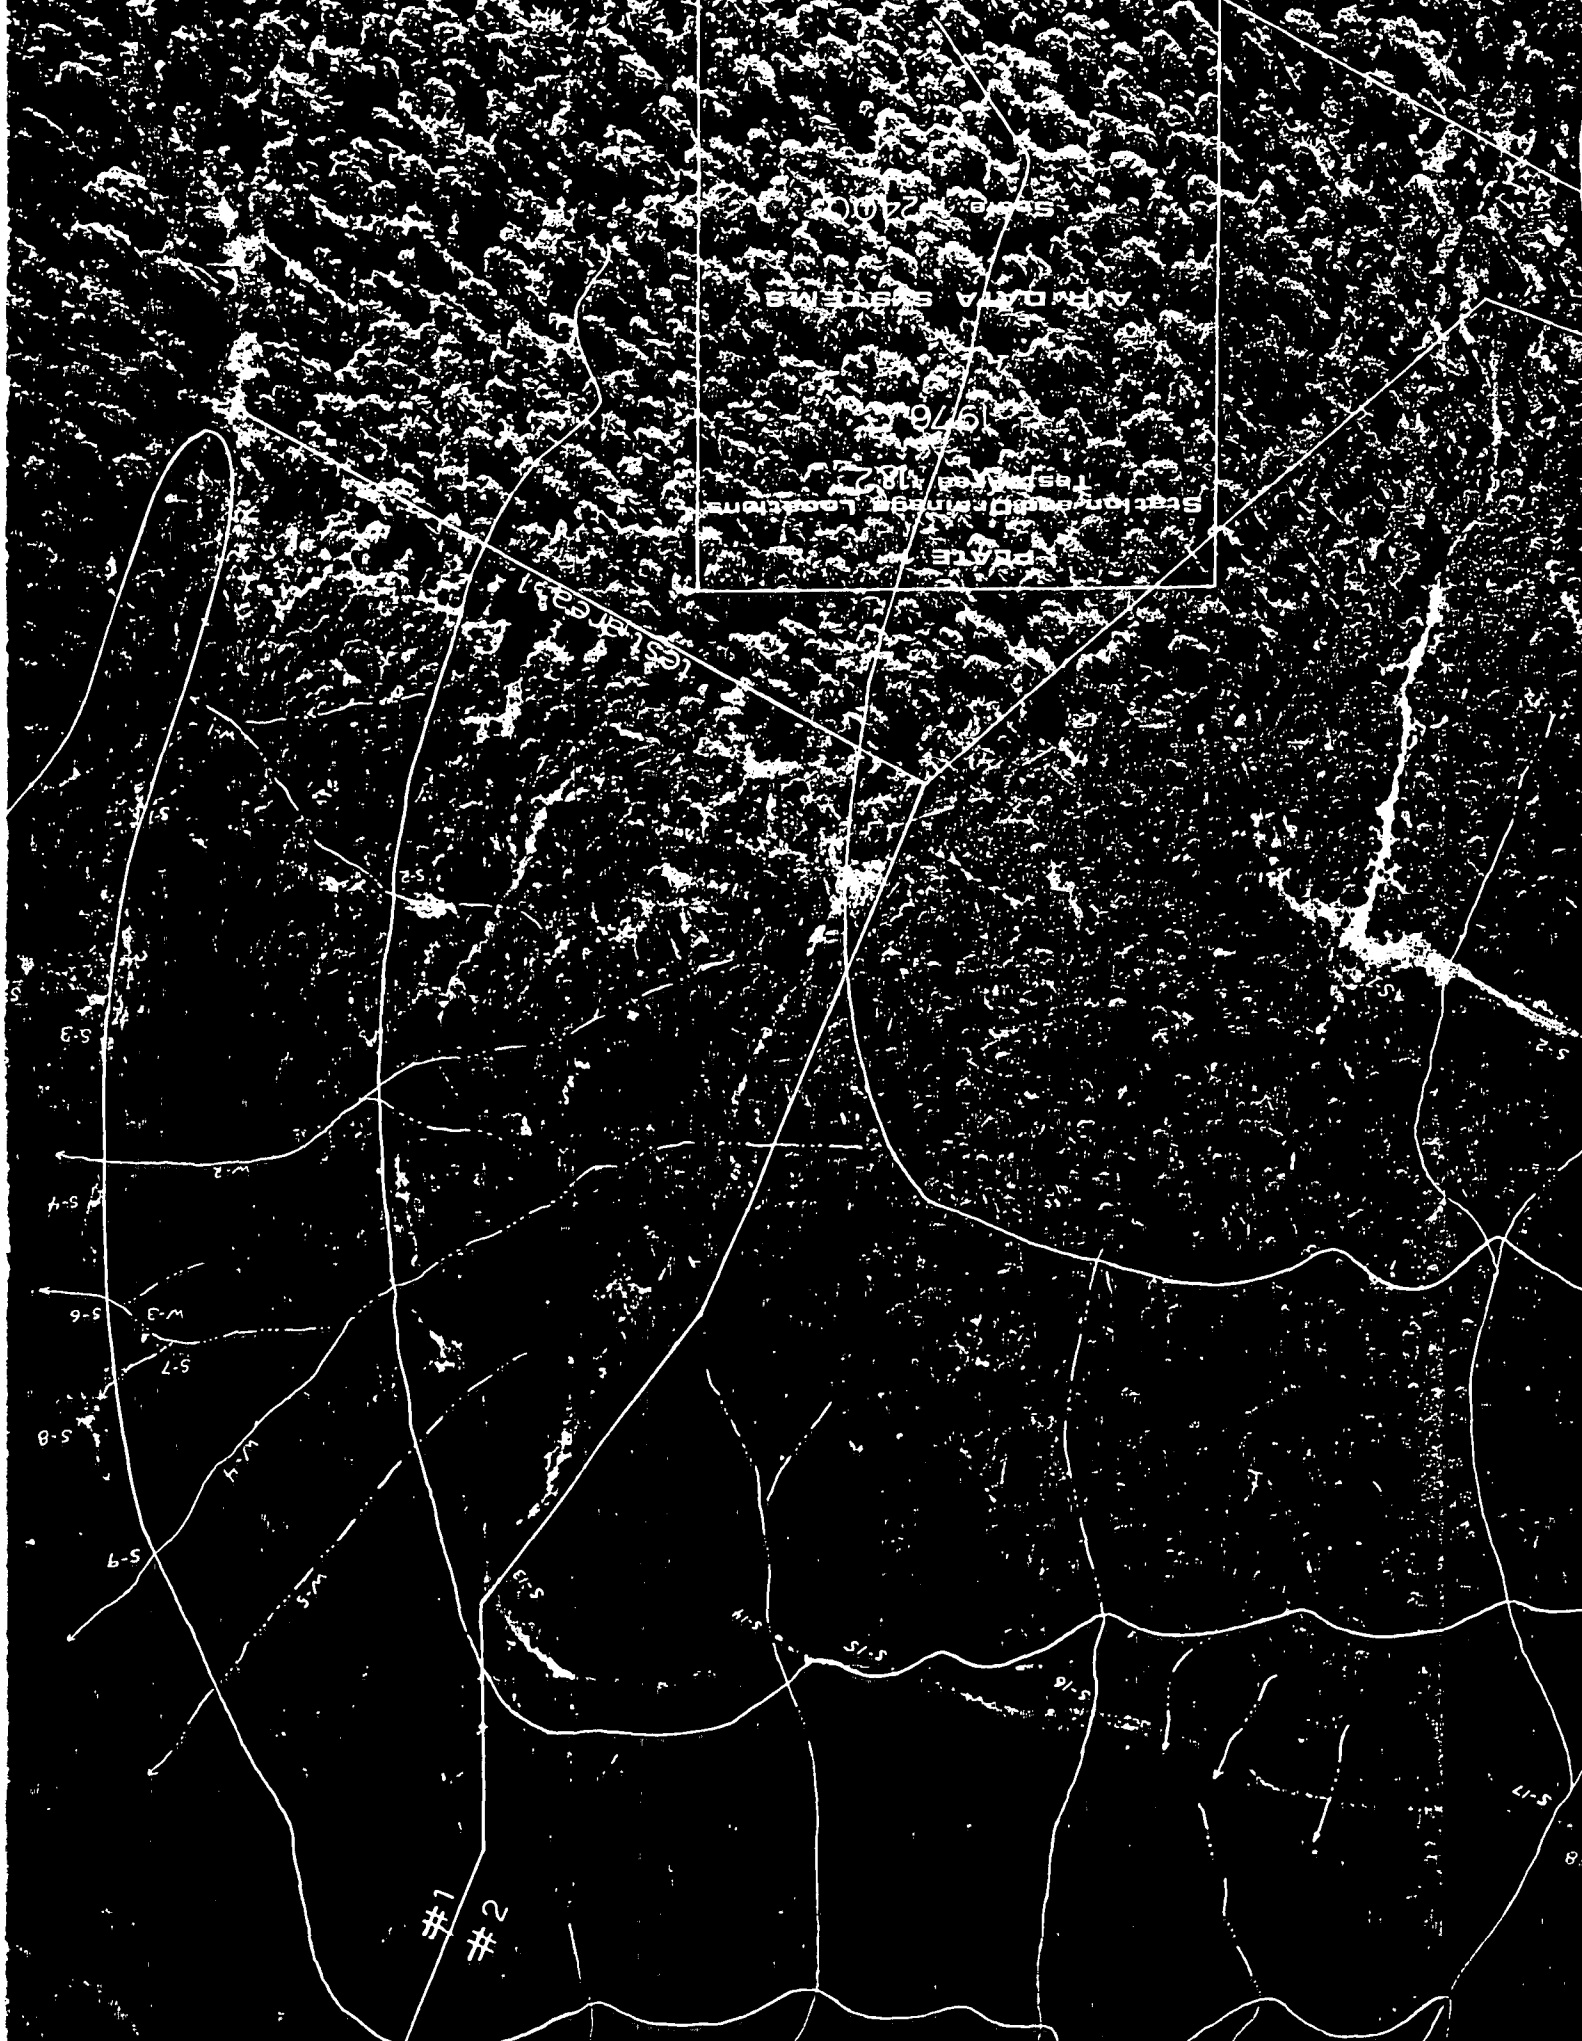
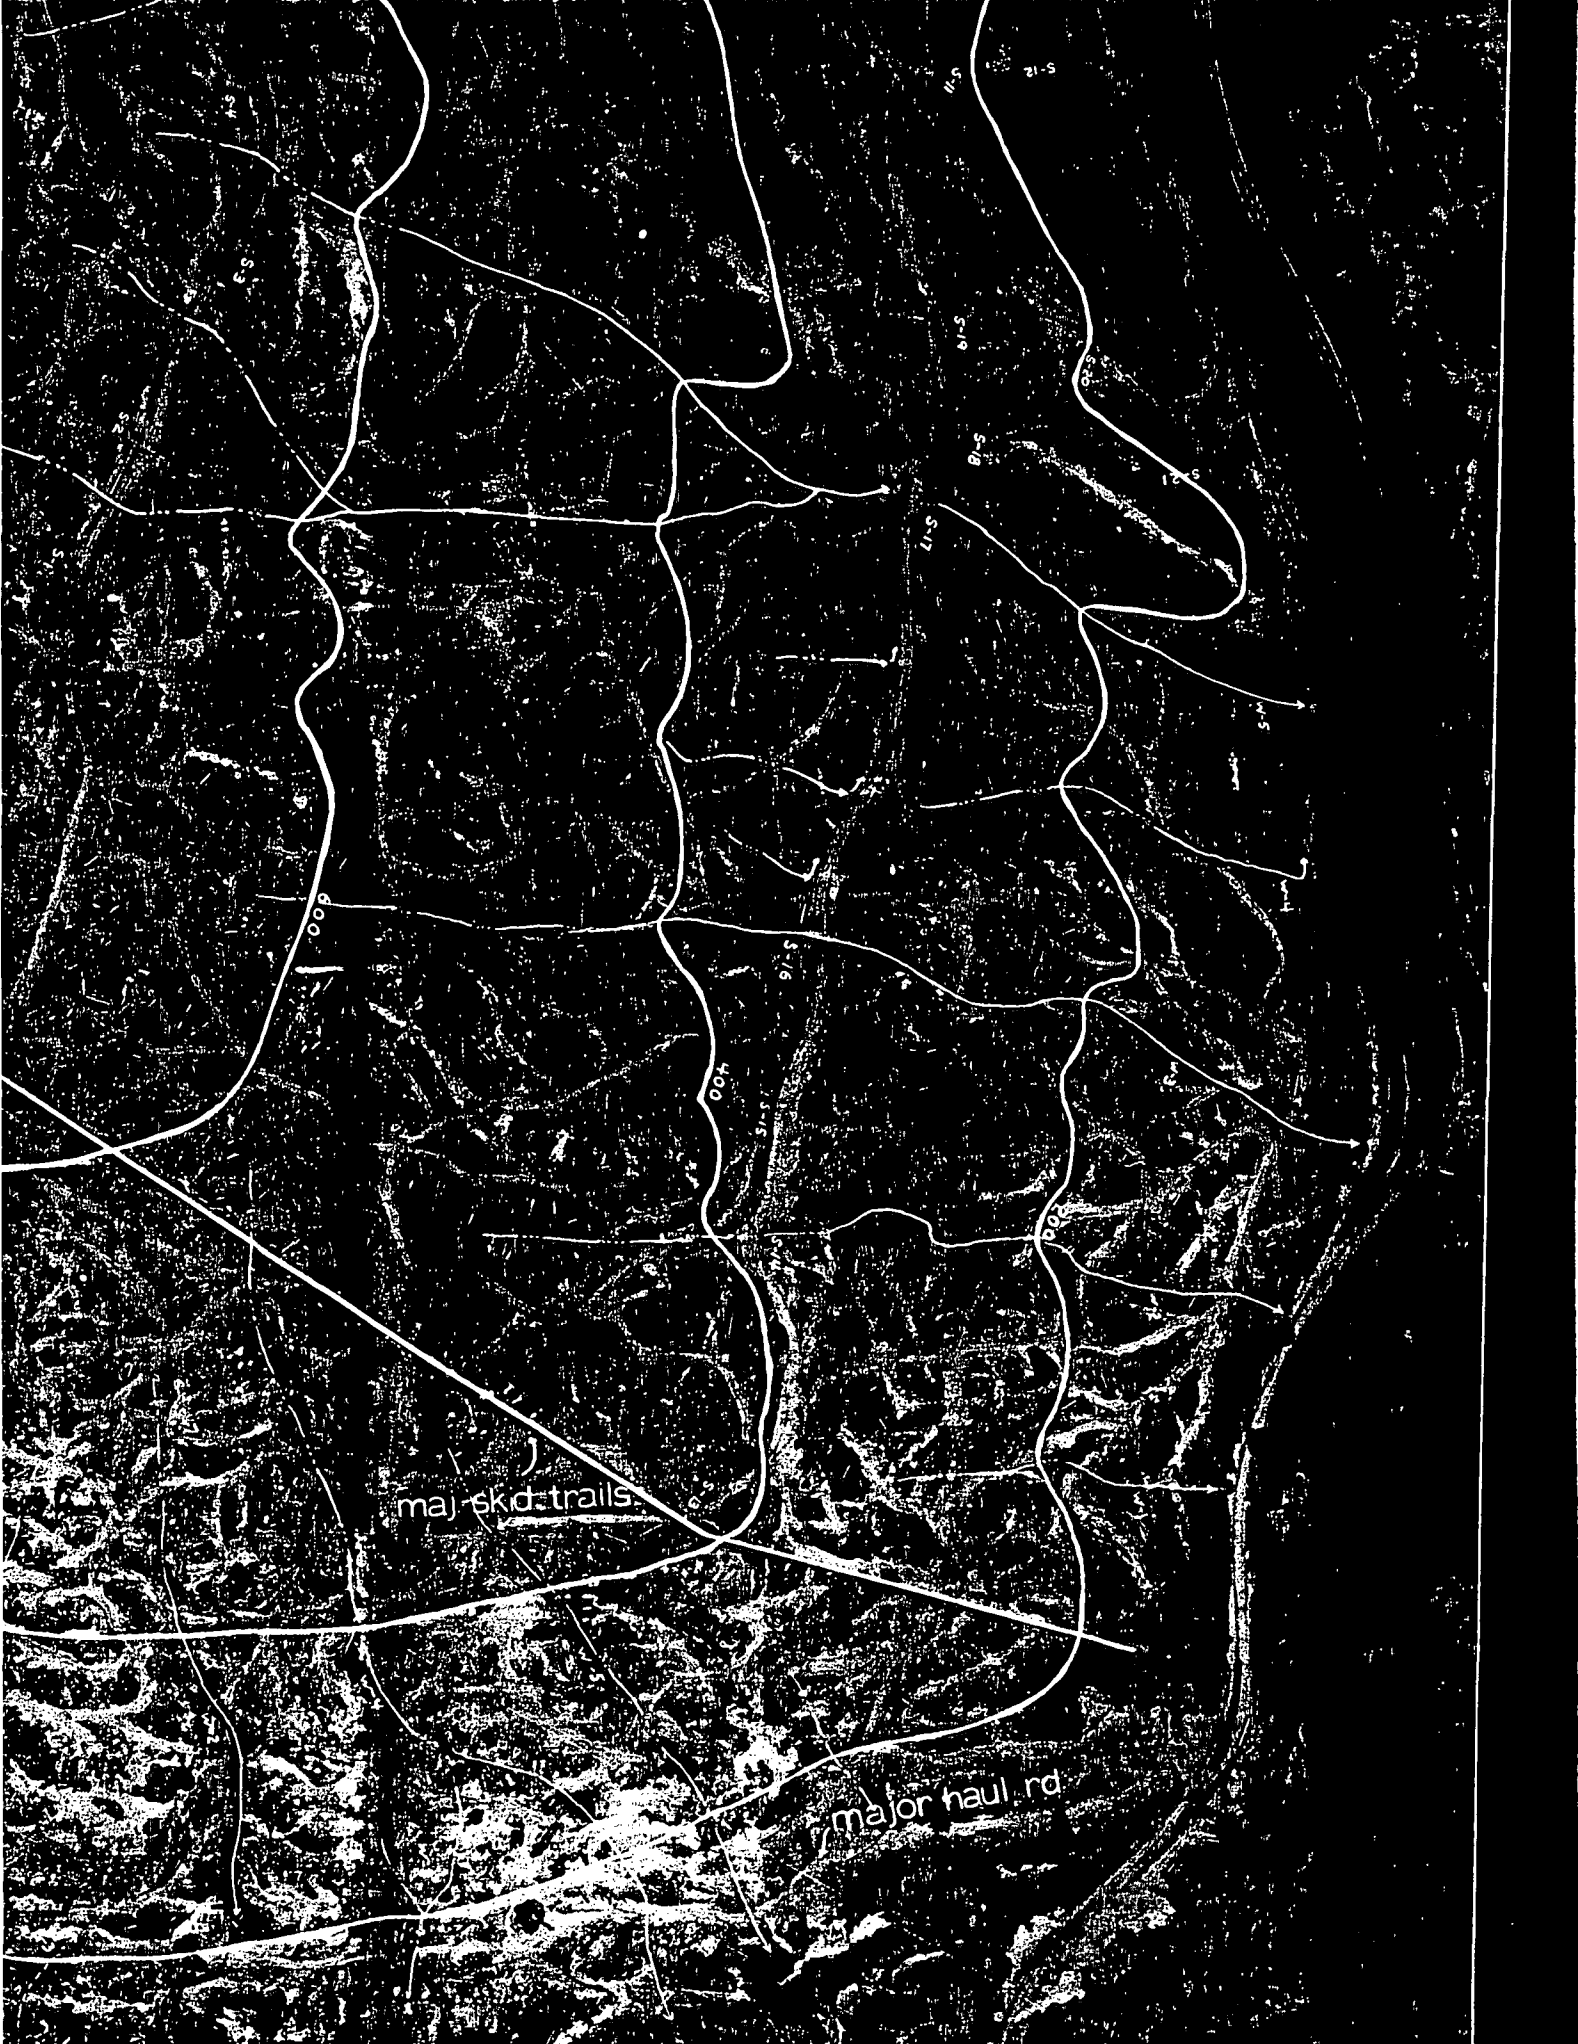
PLATE 1  
Station and Drainage  
Test Area 18  
1976  
AIP DATA SYS  
Scale 1:240,000

Erosion control on gullies and slope failures, areas (S-1, S-2, S-3, S-7) located on Plate 1 and Plate 2 was accomplished in two steps: 1) check dams of various sizes were installed in gullies (dissecting slide masses and skid trails); gullies were also filled with brush bundles and 2) 1-3 foot redwood stakes were driven into slump masses (with slopes greater than 20-25 degrees) to give support to alder and willow waddles.

erosion tending to bury them. Because of this, and the natural rotting of the wood, these crossings are susceptible to cave-ins, making them dangerous to work around (test area 1, where W-2, W-4 and W-5 cross the major haul road; Plates 1 and 2).

Reestablishment of a natural drainage net through the haul road was done at one location (S-6). At this location a plugged culvert had caused redirection of a drainage channel which resulted in water back-up behind the haul road. Water eventually drained in a dispersed manner across the road, depositing silt and sand as it flowed. The plugged culvert was removed, and a trench dug in its place which reestablished the natural drainage through the road. A temporary increase in sediment transport is expected until trench walls stabilize themselves. The detrimental effects of a temporary increase in sediment transport are considered minimal when compared with possible road failure caused by 1) increased water saturation of above road soil and 2) further overloading of the road by sedimentation. Originally a sediment trap was to be installed, but this was found to be impossible because of down slope slash accumulation which obscured the slope drainage course.

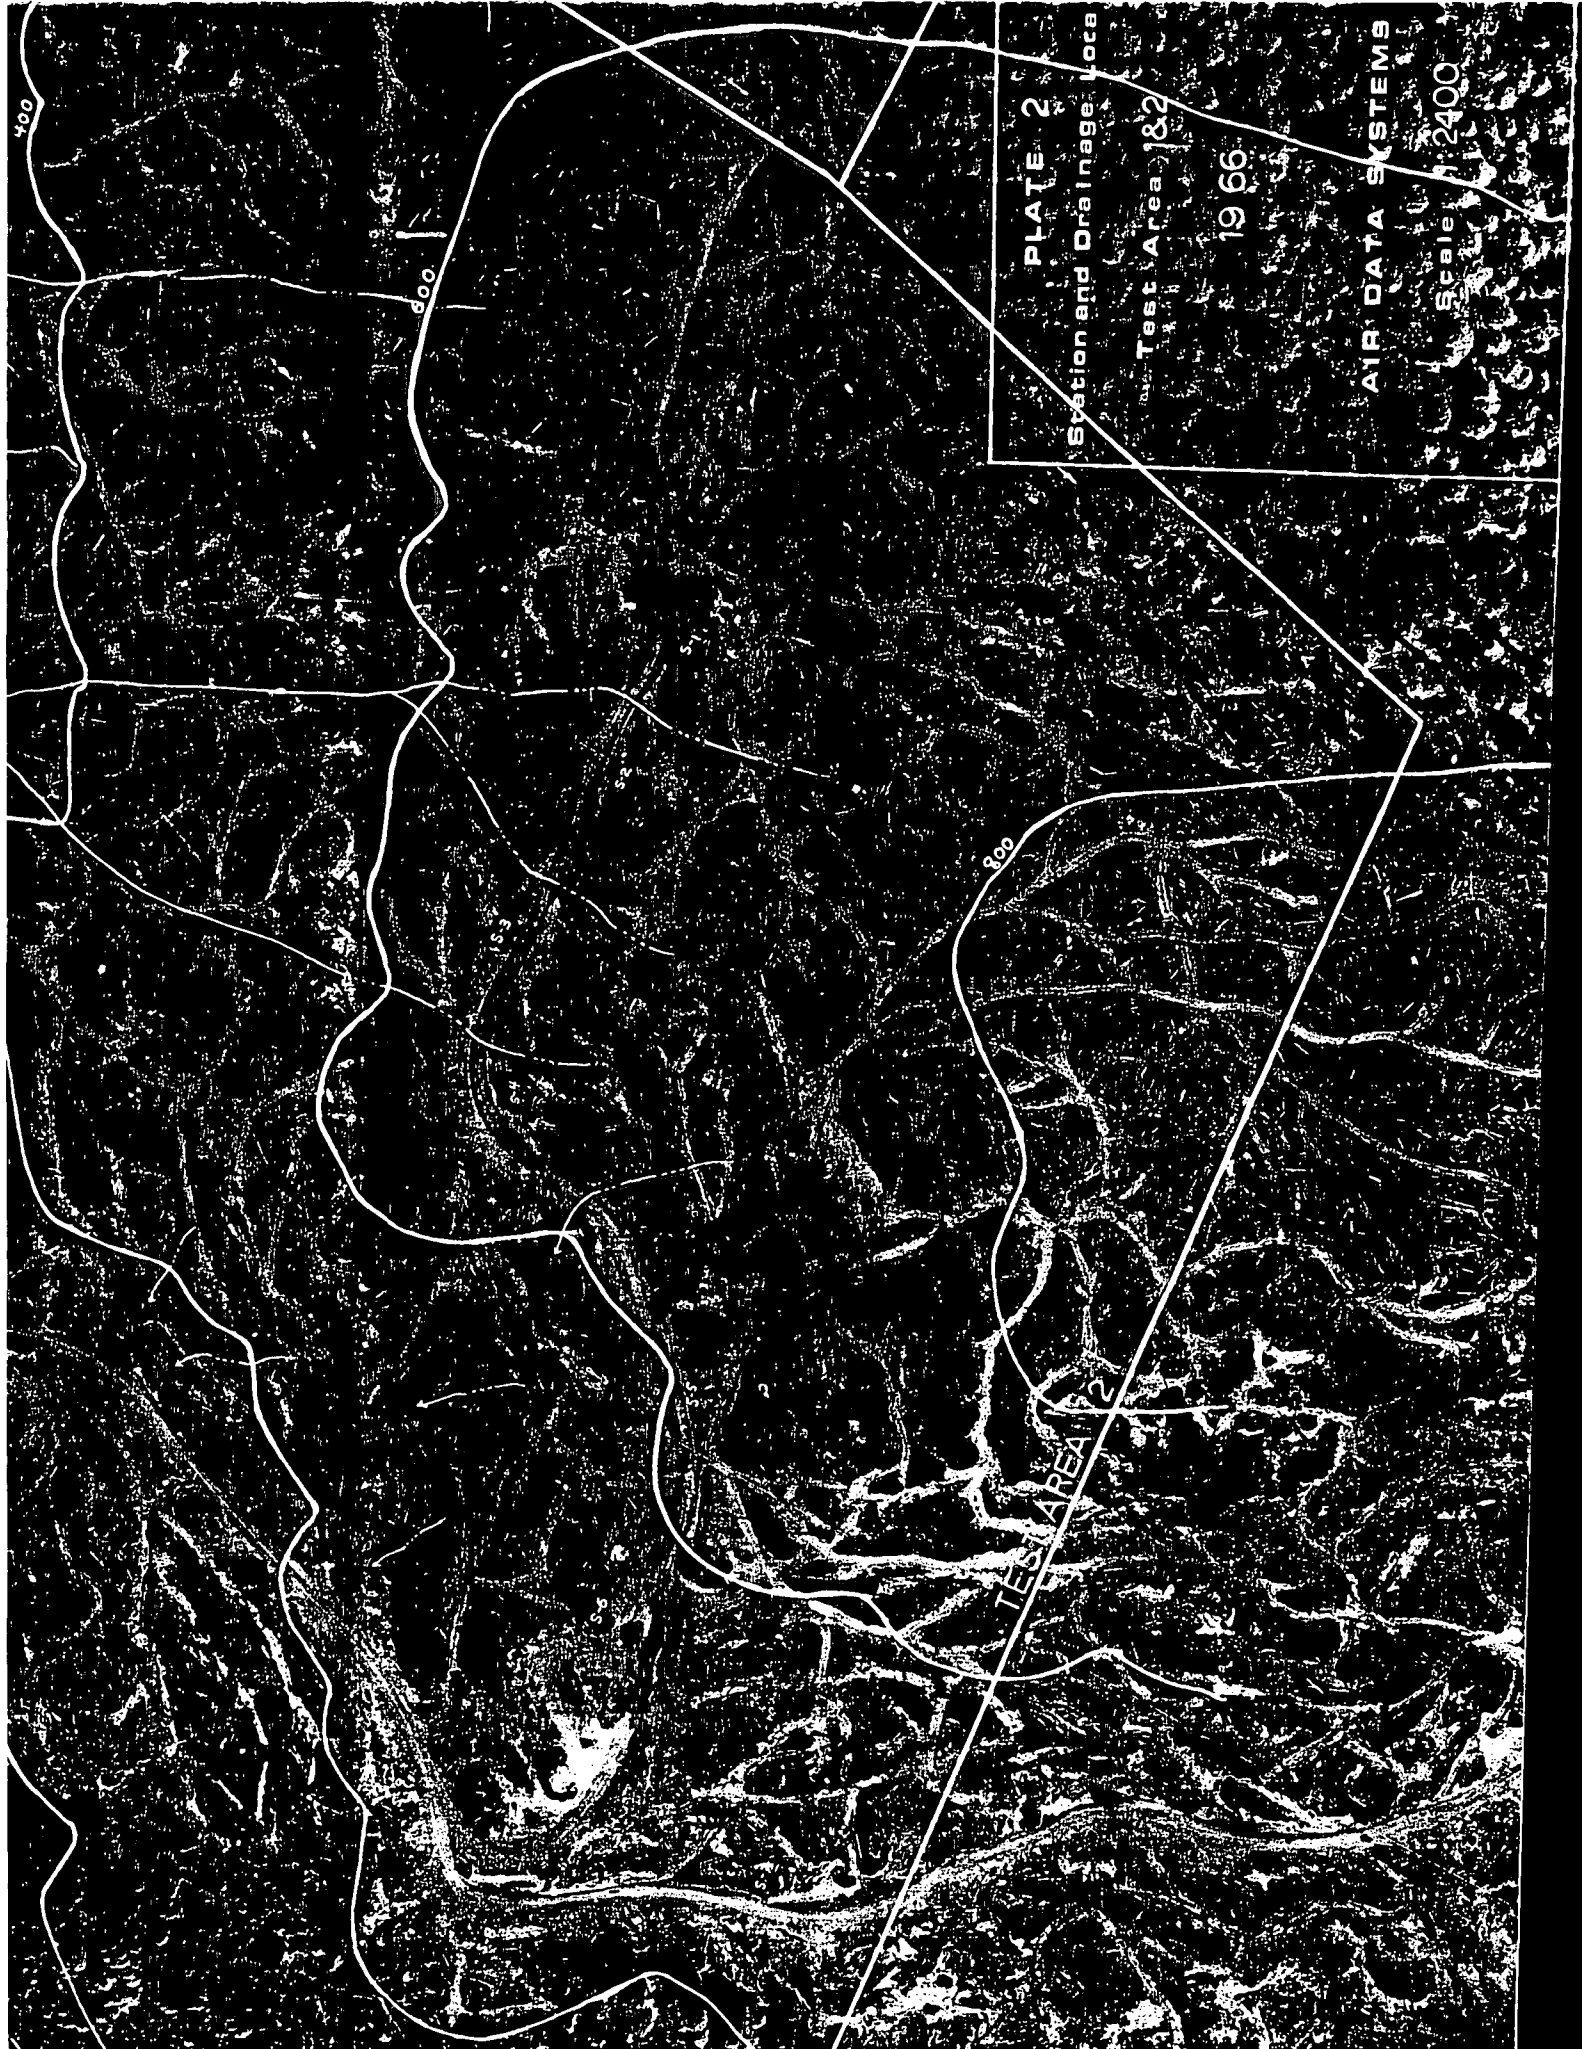
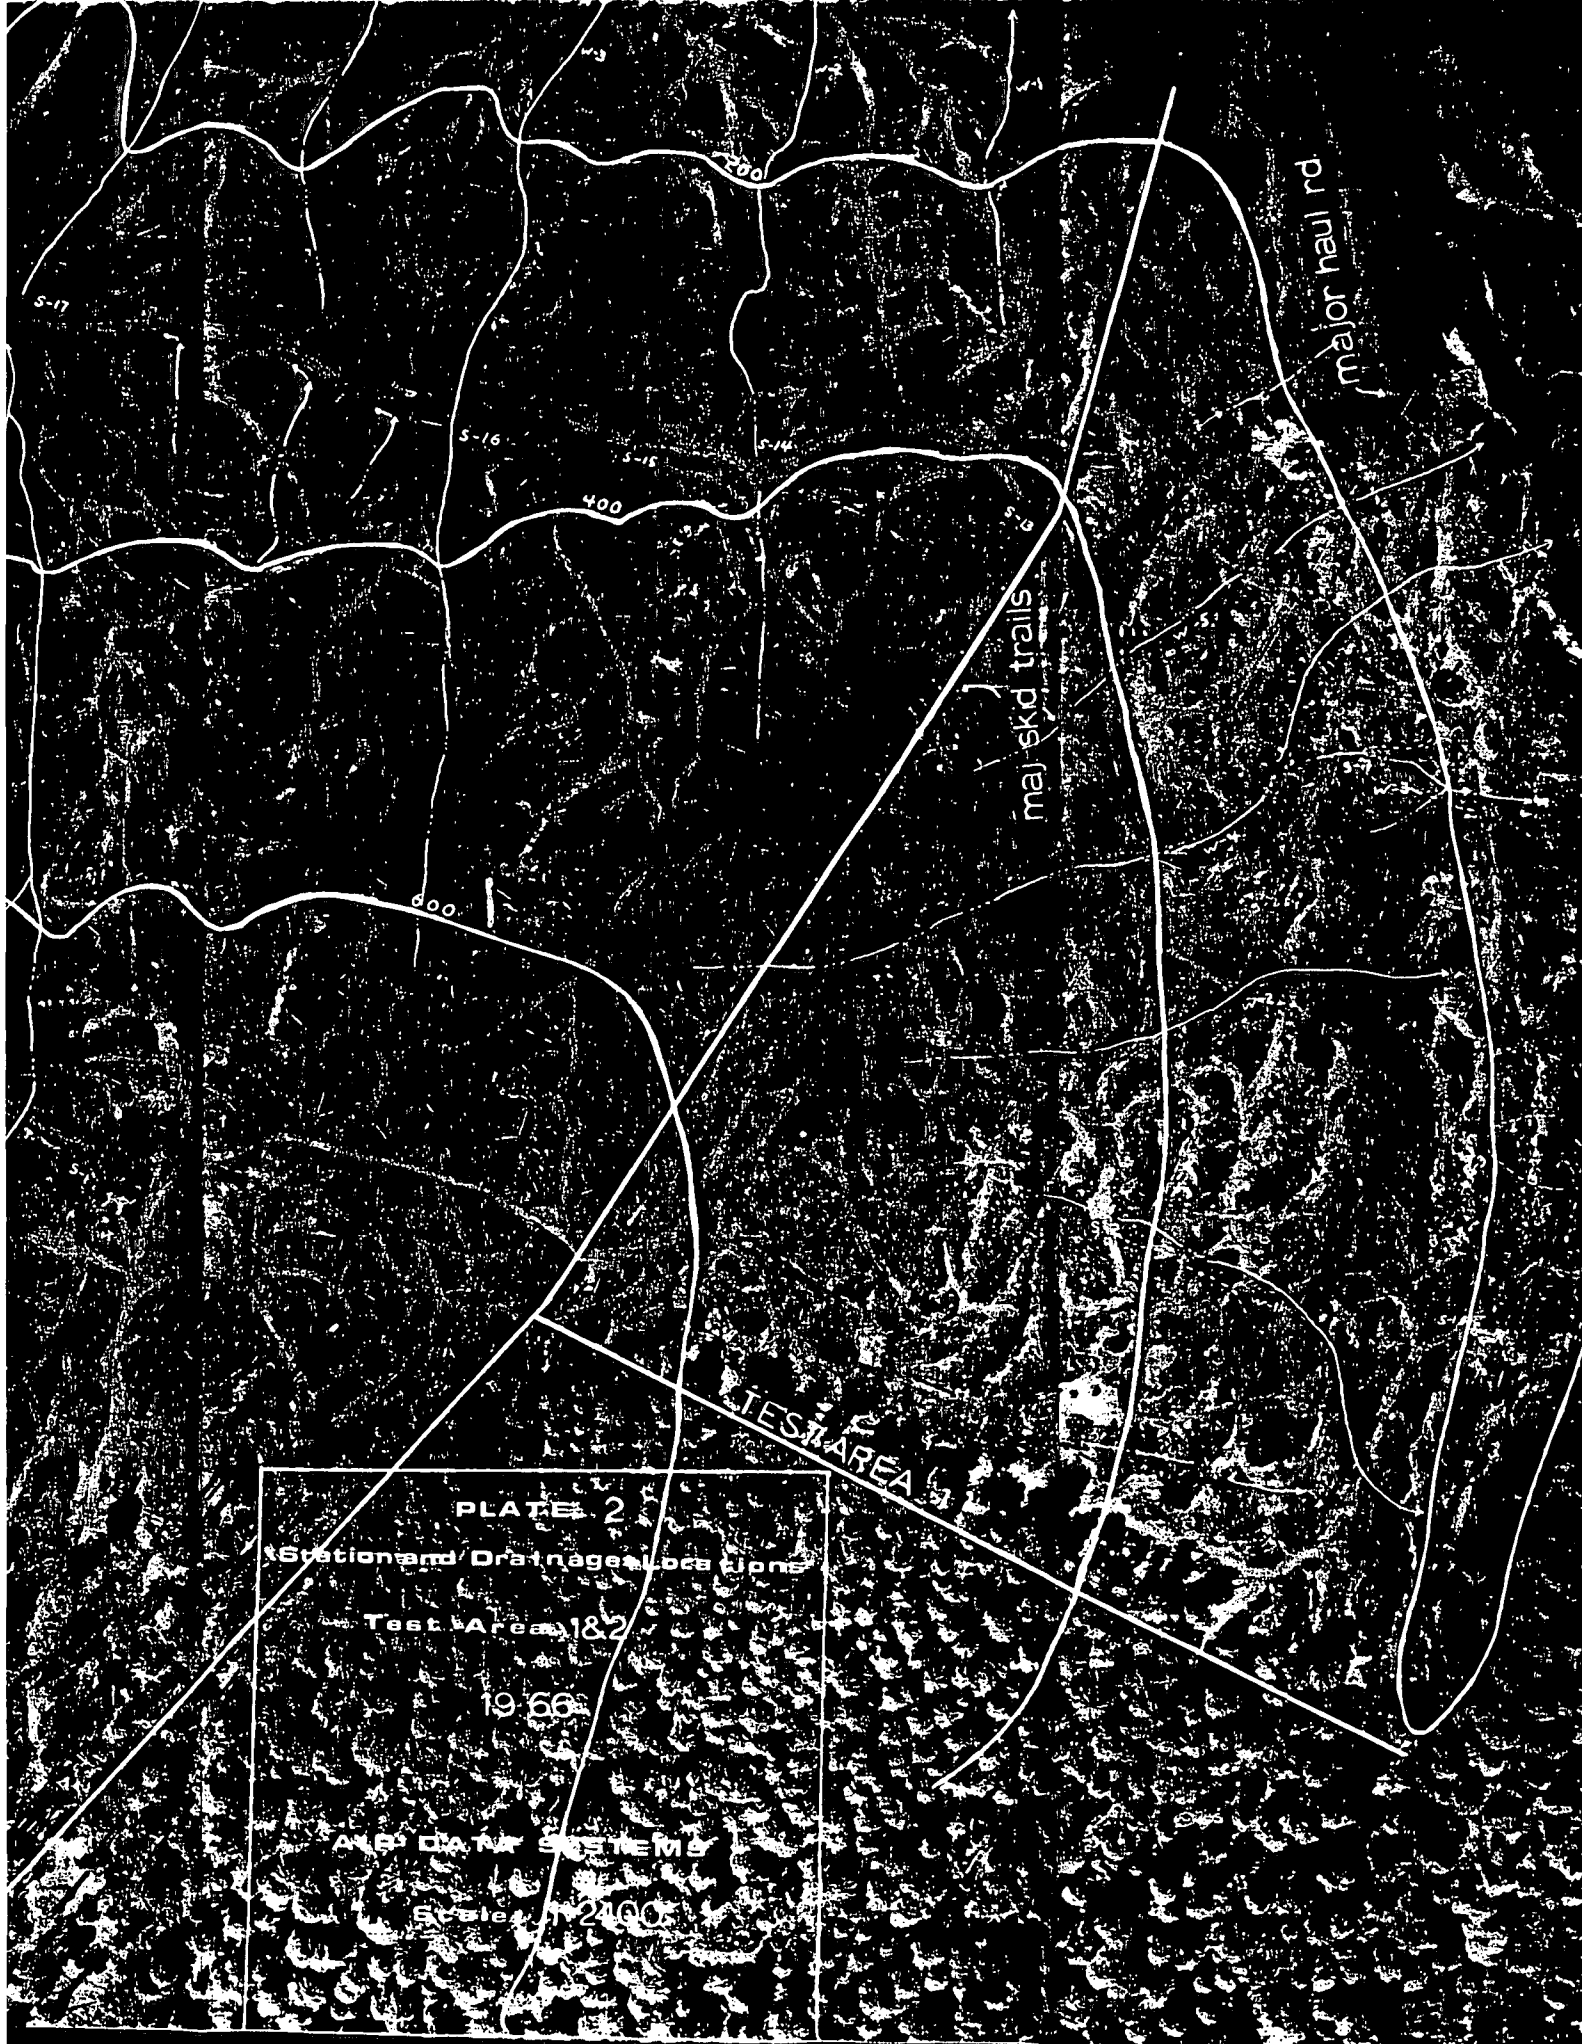
PLATE 2

Costs are based on data generated in the test area 2, 1977 cost analysis. Rehabilitation recommendations were made to correct ground conditions as they appeared to have existed in 1966 (Plate 2). Recommendations were made with the aid of Humboldt County (1966) photography.

The condition of the main haul road (Plate 2) was assumed similar to the present upper haul road in test area 2, 1977 (S-2 to S-4; see Appendix B for cost itemization). The two major skid trails on the upper slope (Plate 2) were assumed similar to the present lower haul road in test area 2, 1977 (S-13 to S-16; see Appendix B for cost itemization).

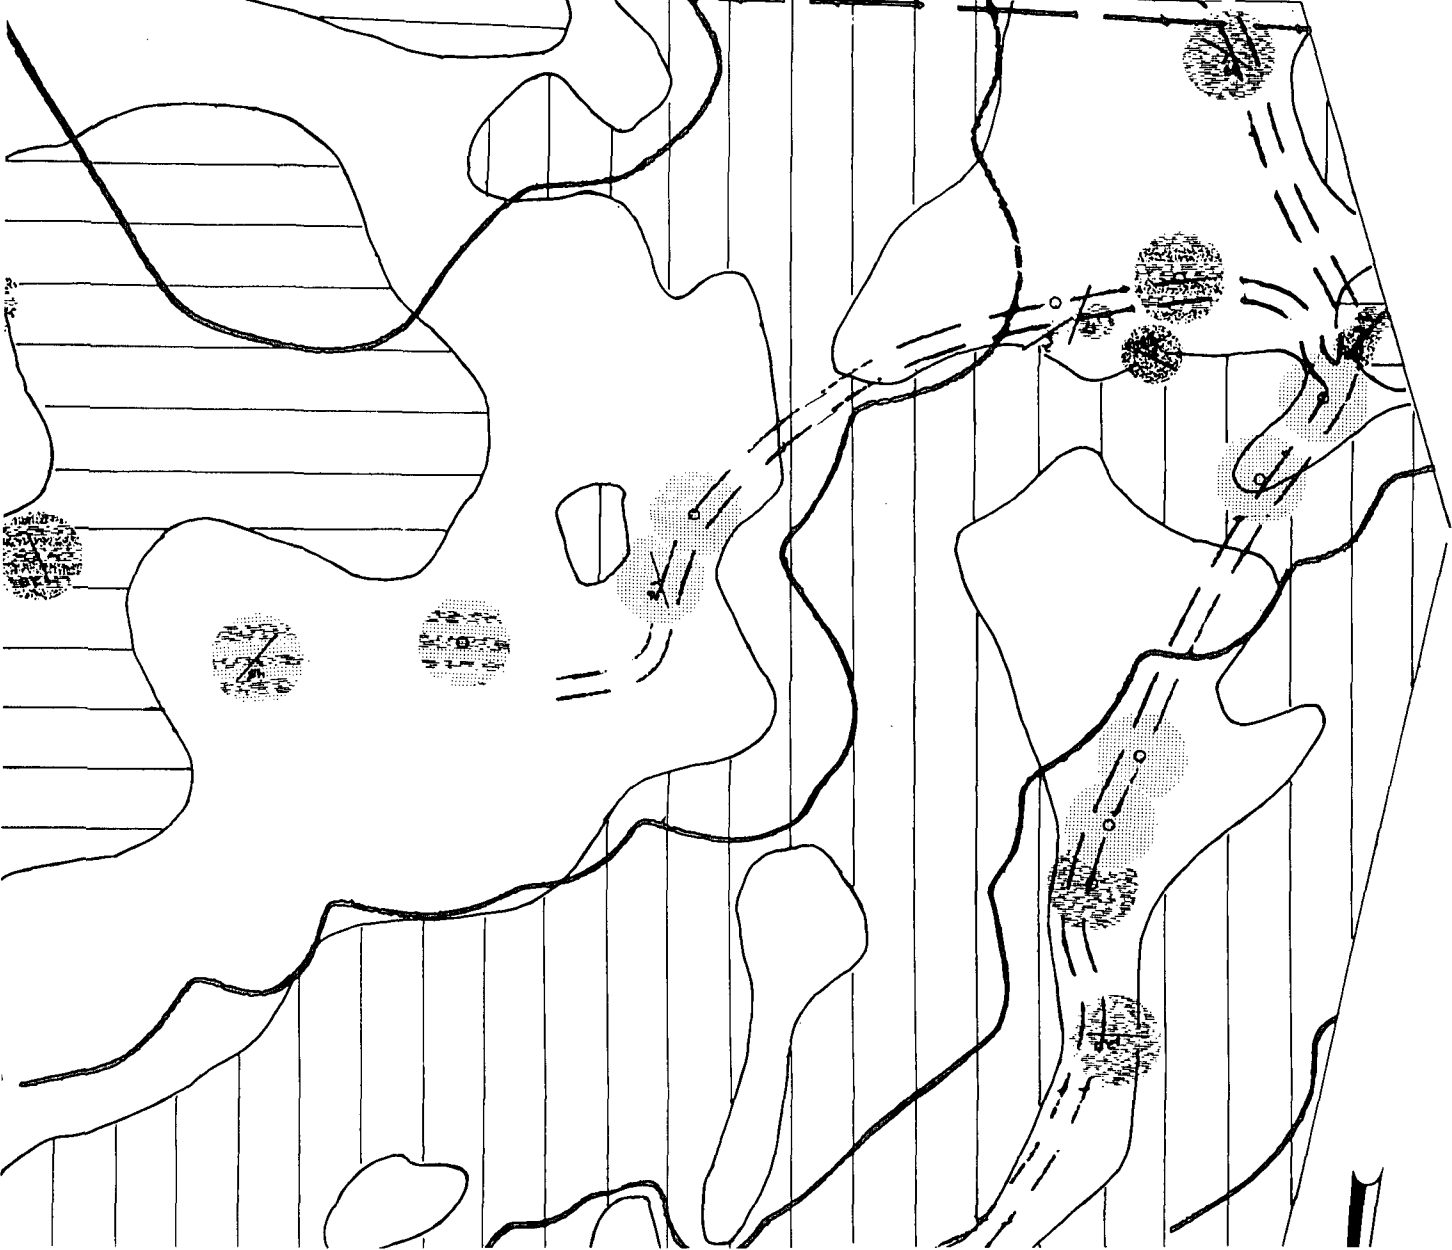
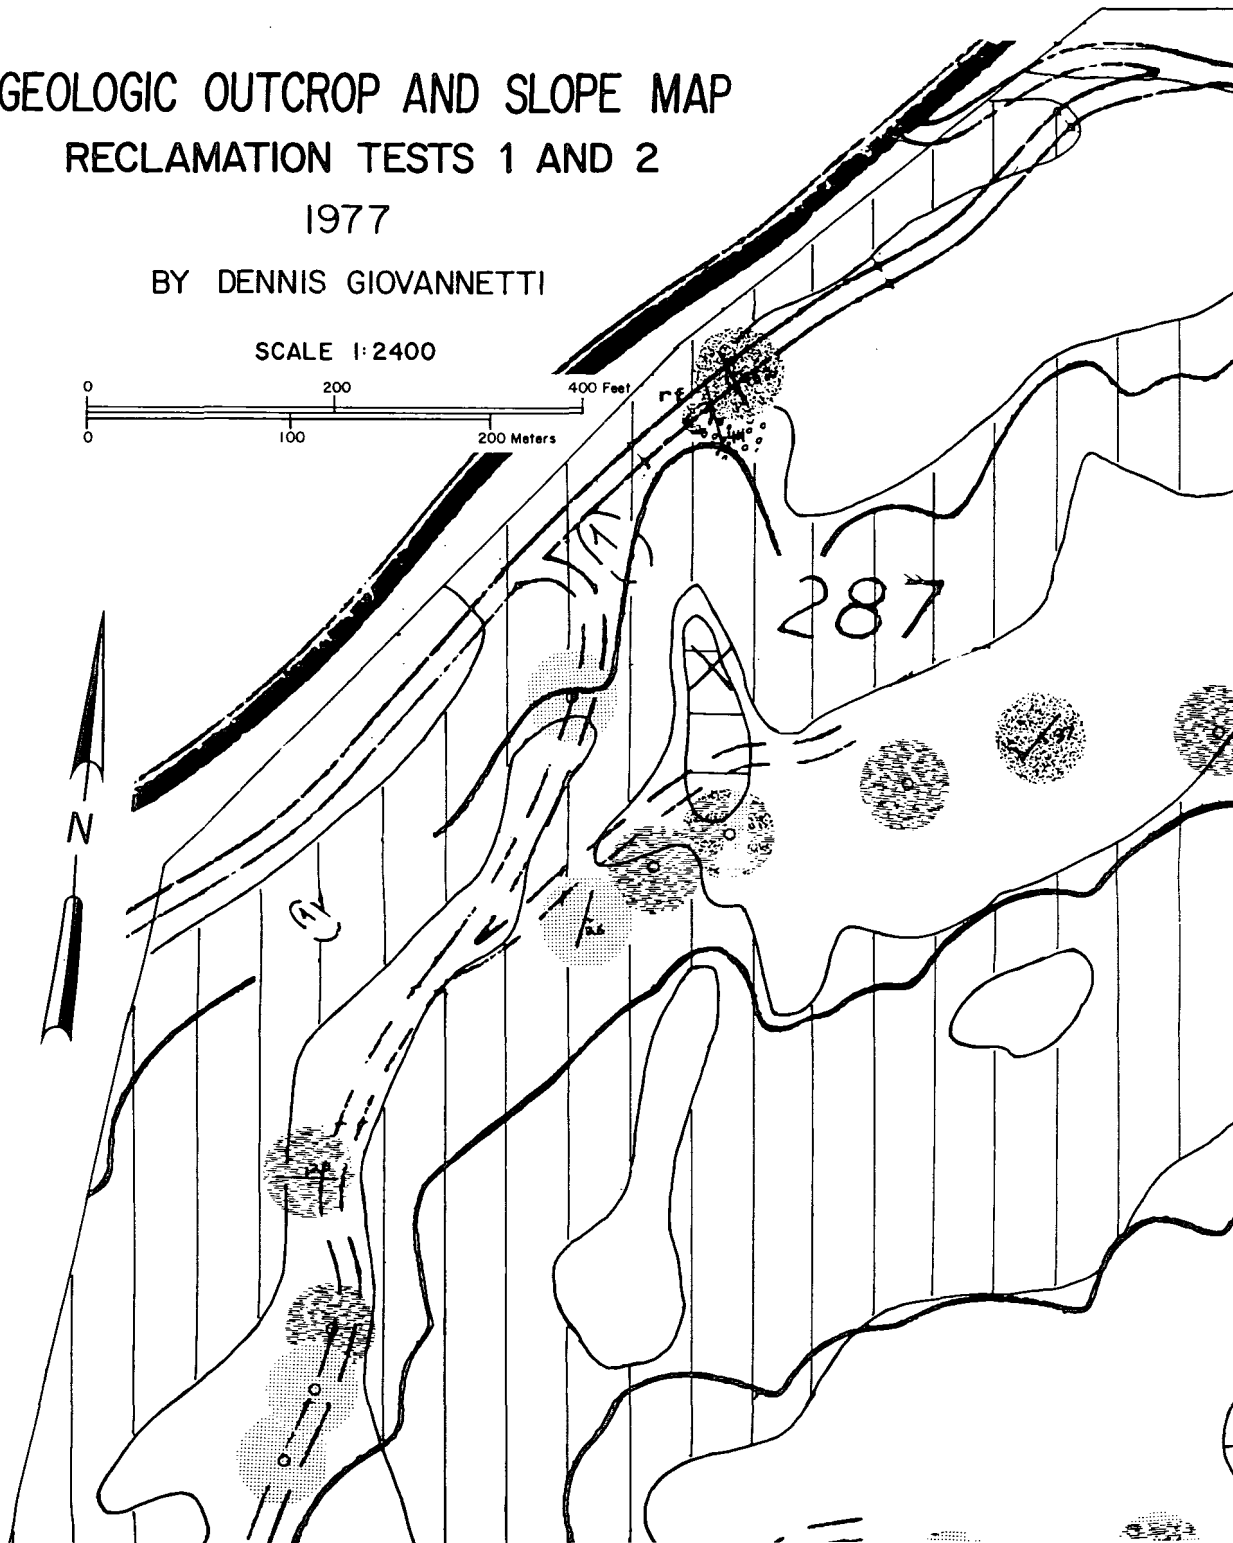
# GEOLOGIC OUTCROP AND SLOPE MAP RECLAMATION TESTS 1 AND 2

The outcrop and slope data in Plate 3 were used to make subjective judgments of the "hazard potential" of test area terrain. This topic is discussed in a later section of this report. These judgments are subjective because only three objective variables (rock type, rock attitude, and hillside slope) and one subjective variable (geologist's understanding

The stability analysis for test area 1 and 2 is based on knowledge of ground slope, bedrock type, attitude of bedding (strike and dip), and rock competency characteristics. As shown in Plate 3, the majority of this area has slopes of at least 10-20 degrees, with much of the area having greater than 20 degree slopes. These slopes would generally be considered failure prone in Franciscan Group terrain, and lead to giving an area a "high hazard potential" rating. Studies by Nilsen and Brabb (1975) done in the San Francisco Bay Area have determined that slopes greater than 9 degrees
