File: HUMBOLDT COUNTY 1973

BRIDGE REPORT

REDWOOD CREEK
Humboldt Co. Road 6L200
(Chezem Road)

Bridge No. 4C-121
Post Mile 1.49

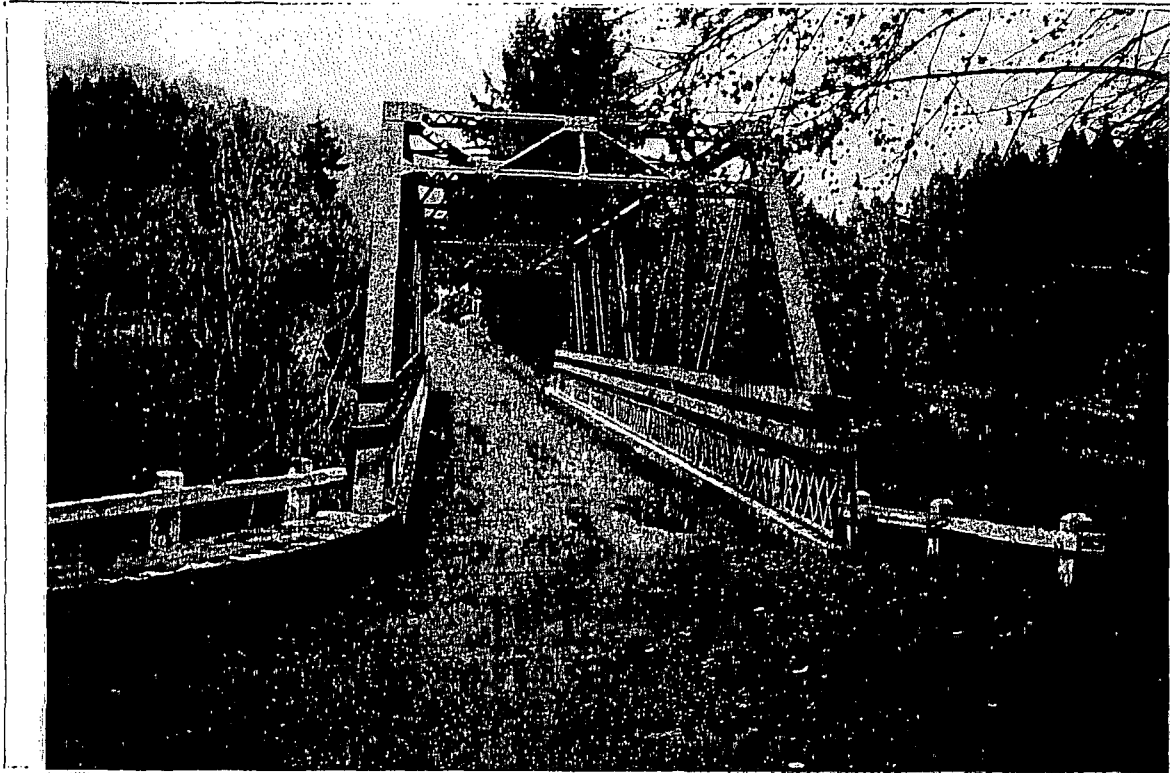
Approach Roadway Looking * West

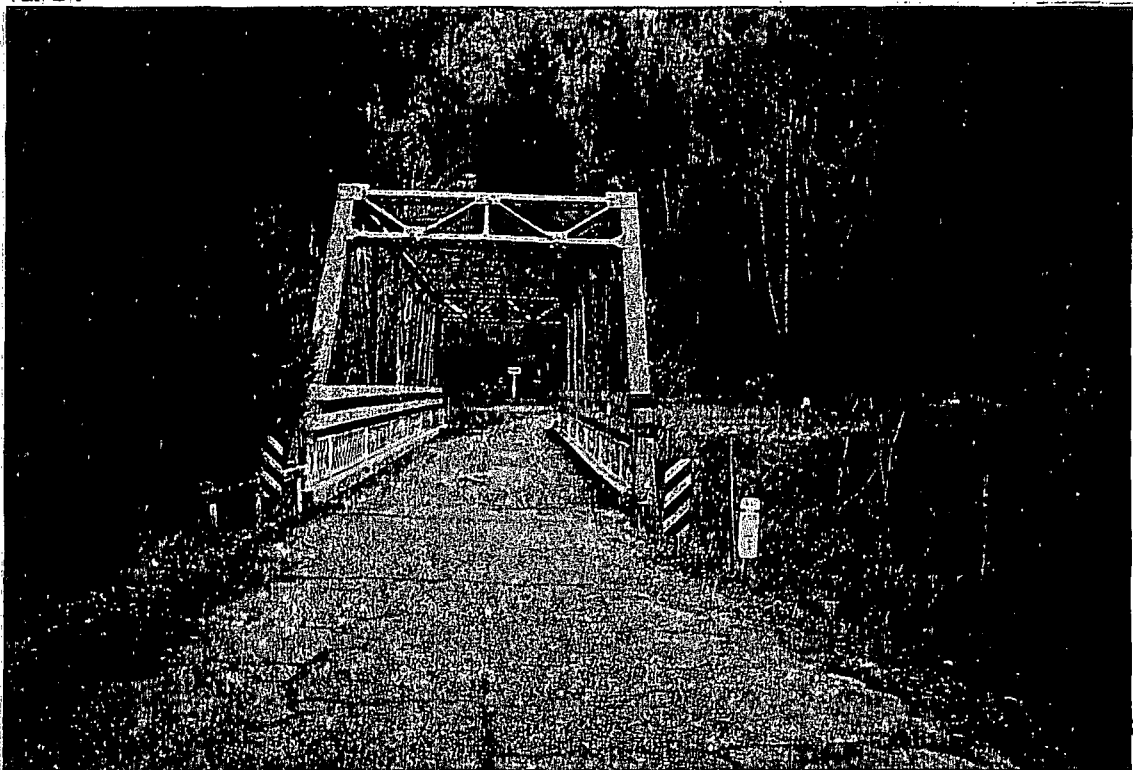
Approach Roadway Looking * East

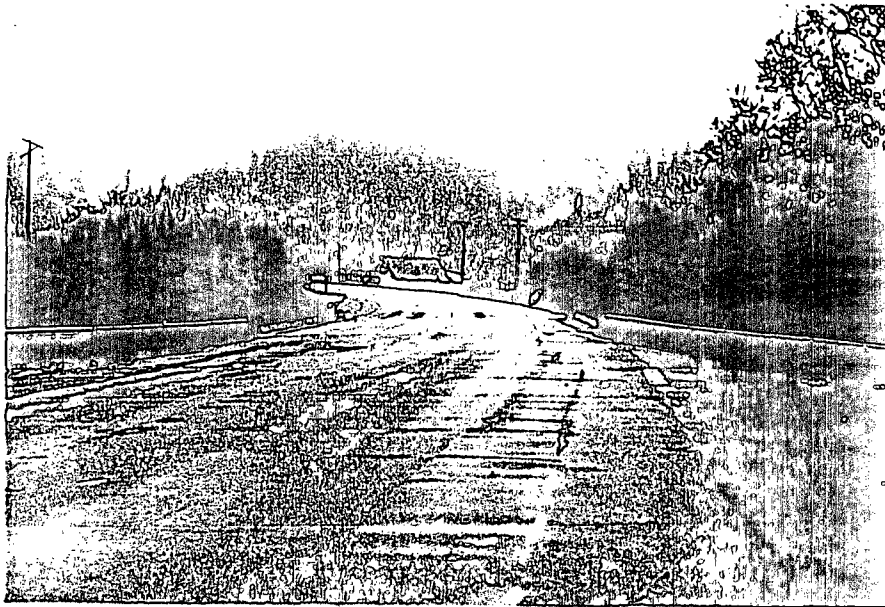
DECKVIEW LOOKING AHEAD
3-17-87.19
JPH-5

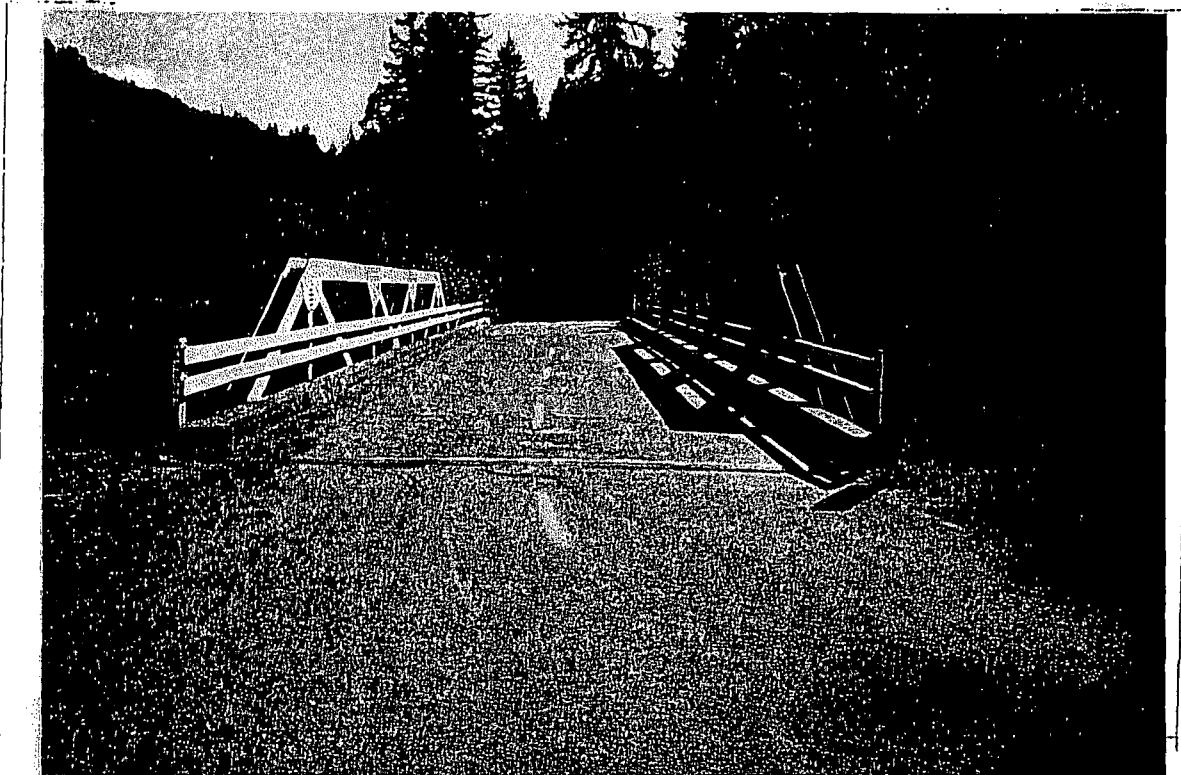
Approach Roadway Looking * South
