Greenwood Creek Stream Survey: Data Analysis and Recommendations

May 15, 1996

*Greenwood Creek Watershed Project
(GT-5-95-08-011)*

Prepared by Forest, Soil & Water, inc.

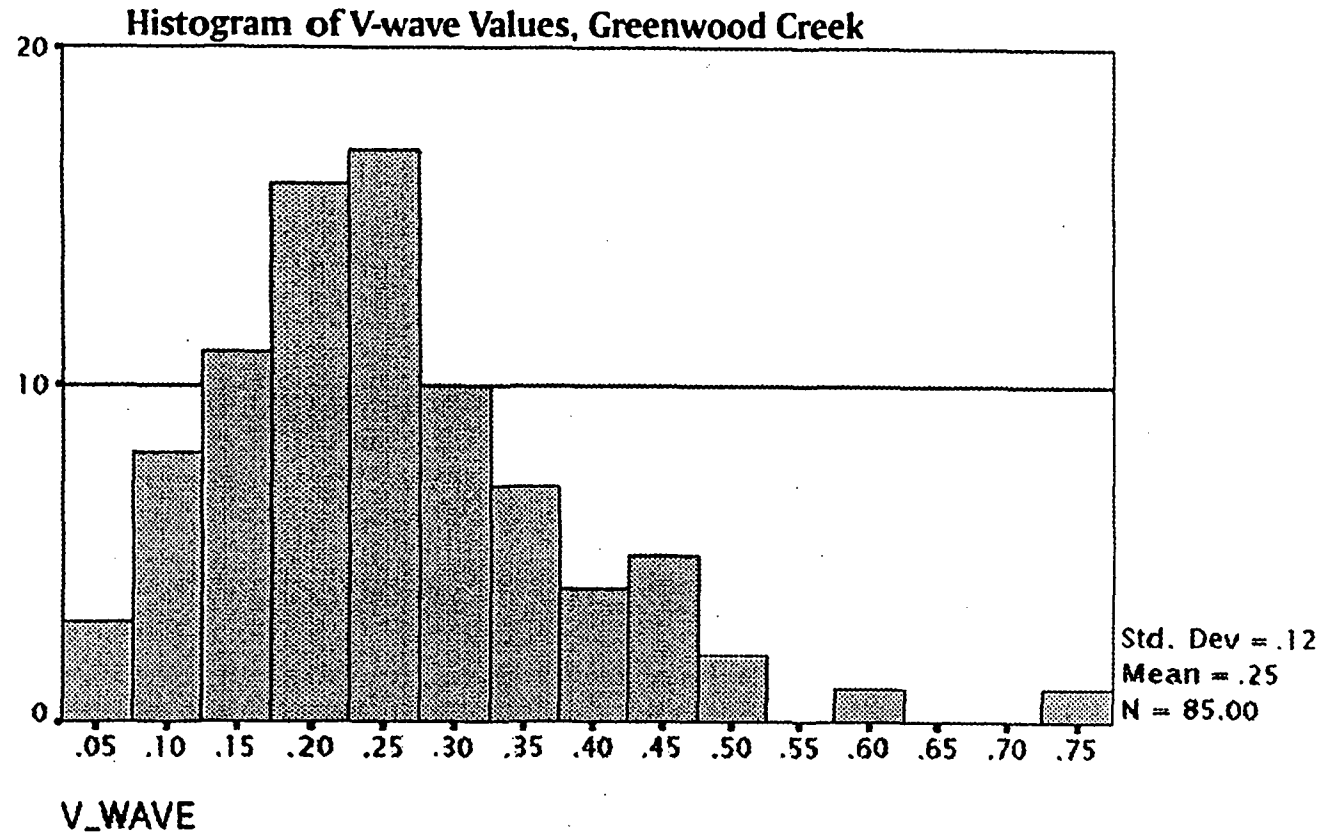
A histogram of the V-wave values is shown in Figure 9. Crews measured 85 pools. The mean pool filling (V_w in Hilton and Lisle) was 0.25, with a standard error of 0.01. The mode of the data, when grouped by five percent intervals, is also 0.25, or 25%.

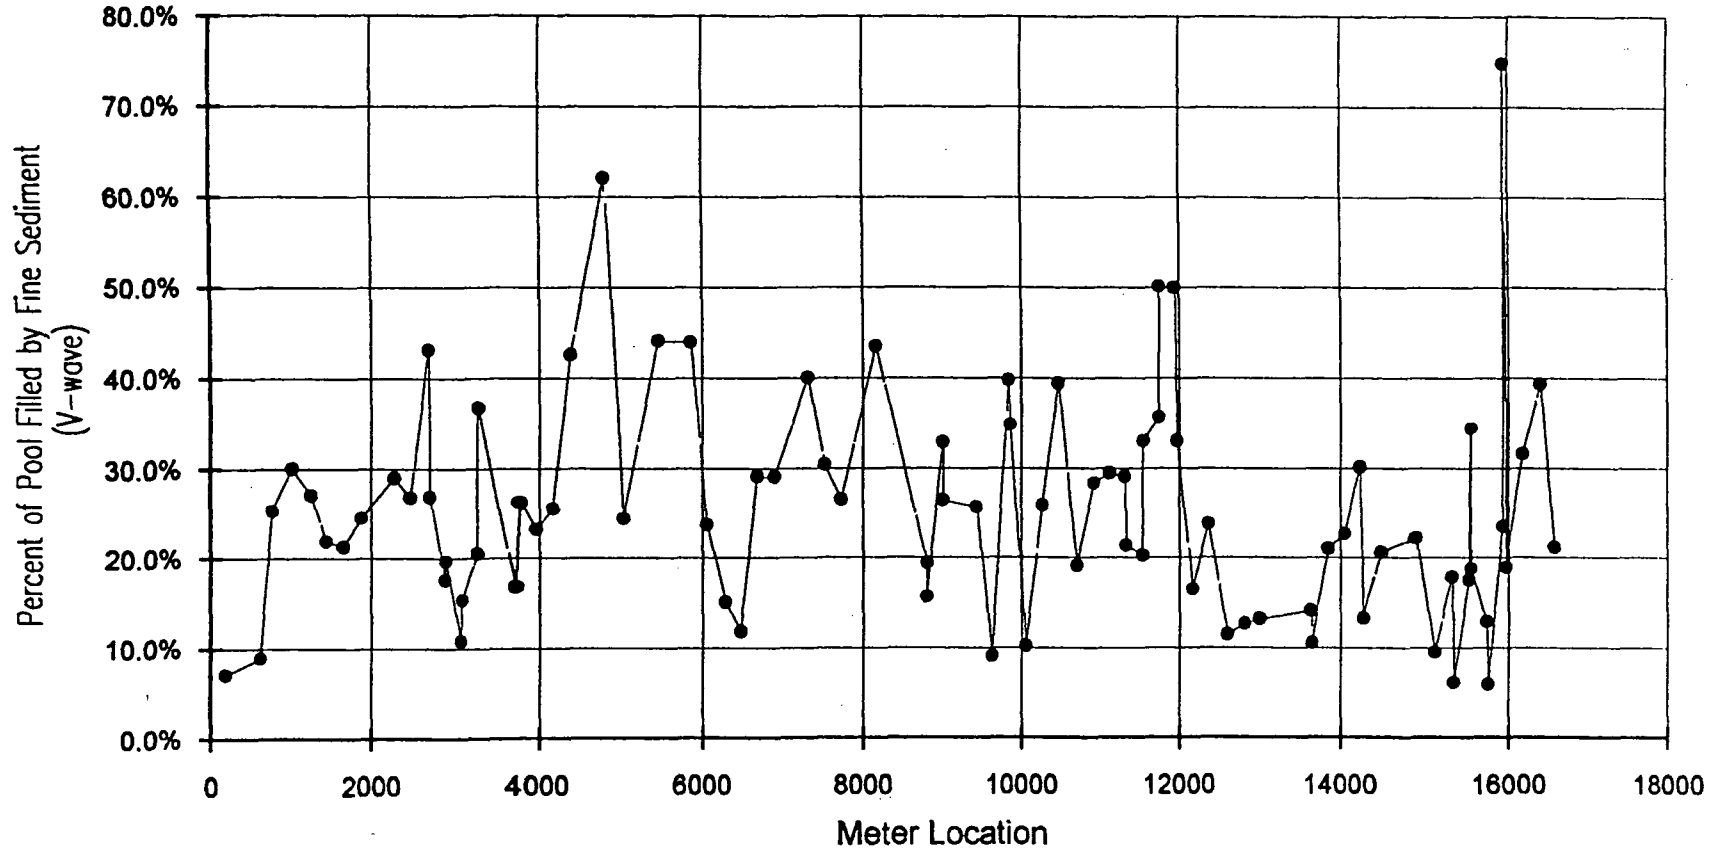
There are a few notable elements about the V-wave survey of Greenwood Creek (Figure 10). First, it shows a wide variation in pool filling, from 5.8% to 74.9%. Second, it shows wide and rapid variability of pool filling along the distance of the stream where pools were evaluated, with regular 10% and 20% differences from pool to pool among the sample set, as well as larger trends within the data set. Pools appear to go from low sedimentation levels at the 101 bridge to high levels at 5000 meters, then decline to about 15000 meters, and rise again to the upstream extent of the survey area. Third, there are places where STC's or bank collapse apparently relate directly to pool filling, though other sites of pool filling can not be traced to visible sources. Fourth, it appears that the relative size and location of the pool may strongly affect its relative sedimentation. And fifth, some pools have high sedimentation relative to the rest of the study pools and their sizes, so are good candidates for further study.

The overview of the data suggests that sedimentation follows larger trends in the whole watershed and individual variation from pool to pool. Comparison with upslope sedimentation evaluations, and analysis of these data with respect to slope and stream characteristics may explain some of the broad-scale trends, as shown in Figure 10.

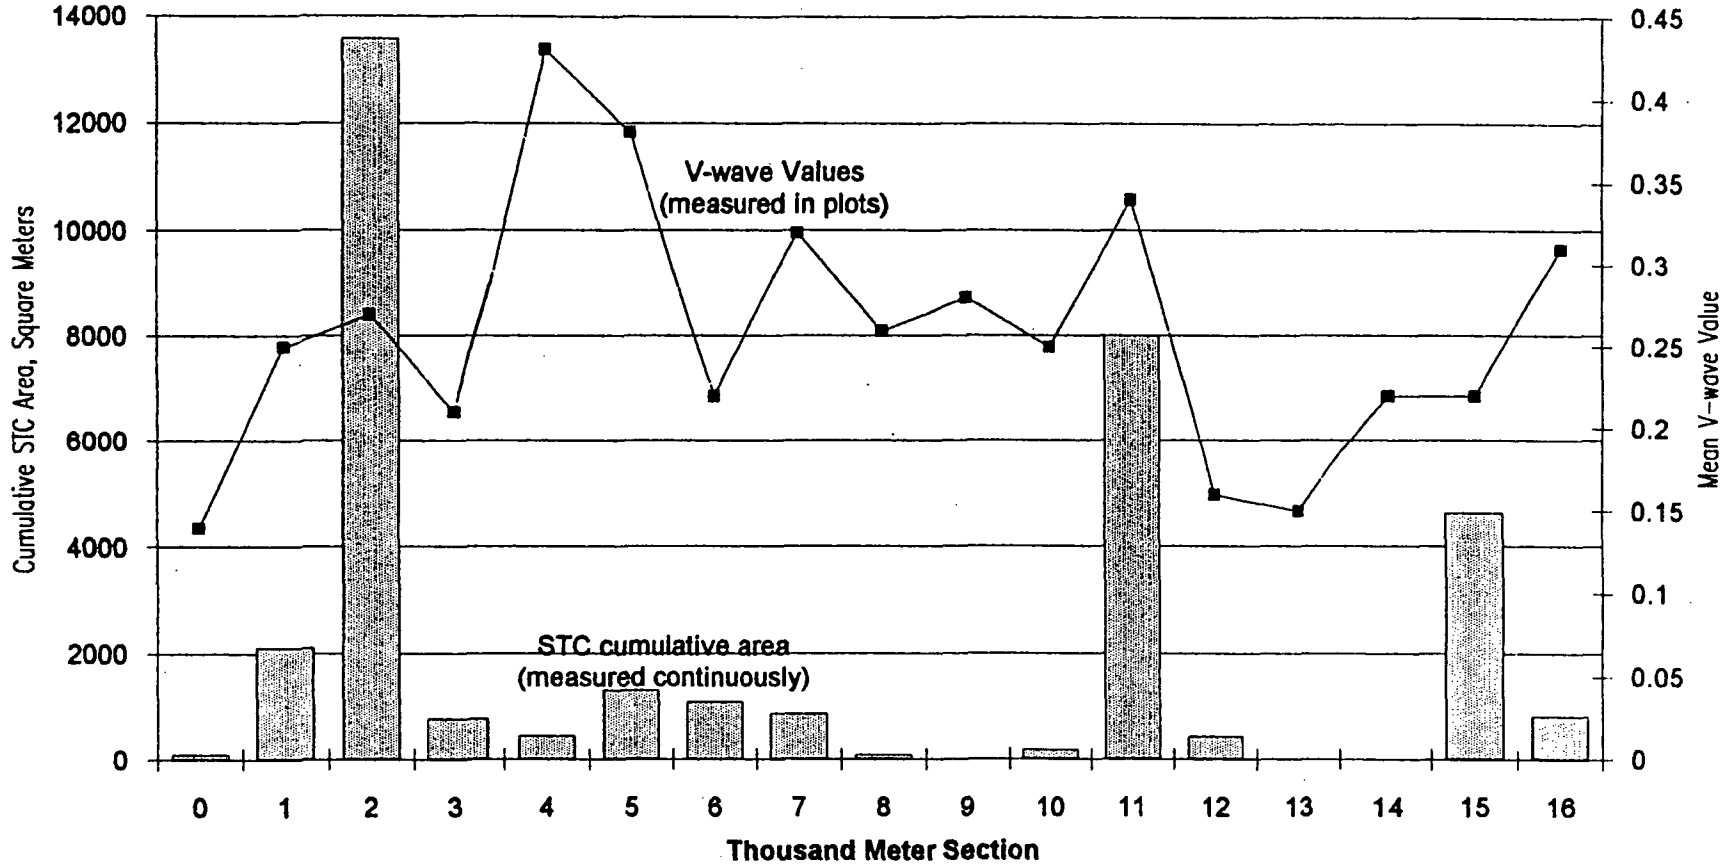
Figure 11.

While, intuitively, it seems that location of the STC's would correlate directly with pool filling, comparison of the data show several instances where this works, and several where it does not. Figure 11 shows both mean V-wave values and cumulative STC volume by location. The data show that an infusion of sediment can elevate or maintain V-wave levels above 20%, in many cases. The data are not clear, however, because some V-wave averages are high without strong STC influence, and because some large STC's appear to have little affect on the V-wave measure. Similarly, unvegetated banks occasionally track with V-wave values, but not strongly enough for statistical strength.

Figure 17 shows the location and dimensions of STC's, as calculated in square meters, per sample plot. Figure 11, in the V-wave section, shows the cumulative STC area for each 1000 meter stretch of Greenwood Creek. The two diagrams show high values for sediment entry into the following regions on Greenwood Creek:

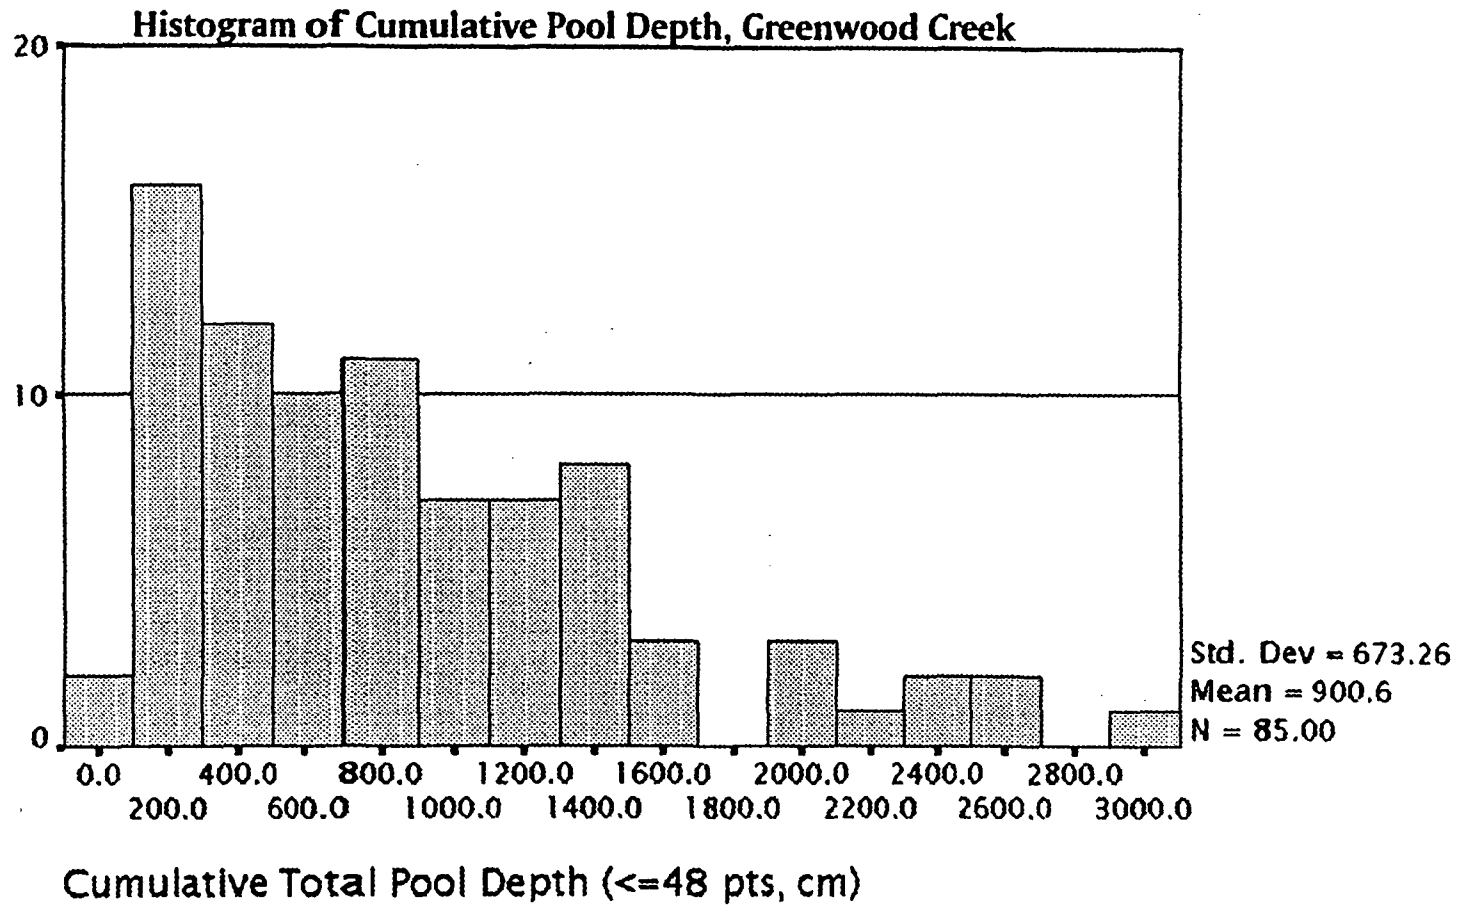
The measurements taken for the calculation of V-wave include total pool depth, which is accumulated for all points in the pool. Most pools had 48 points taken, spaced equidistantly on regular transects. Only very small pools had less than 48 points attempted, and only points with the pool bottom above the riffle crest were thrown out. Total pool depth, therefore, reflects the deepness of multiple points in pools, and is shown for all pools in the histogram in Figure 12. The histogram indicates a mode of cumulative pool depth in the 100-300 cm range and a mean of 900 cm.

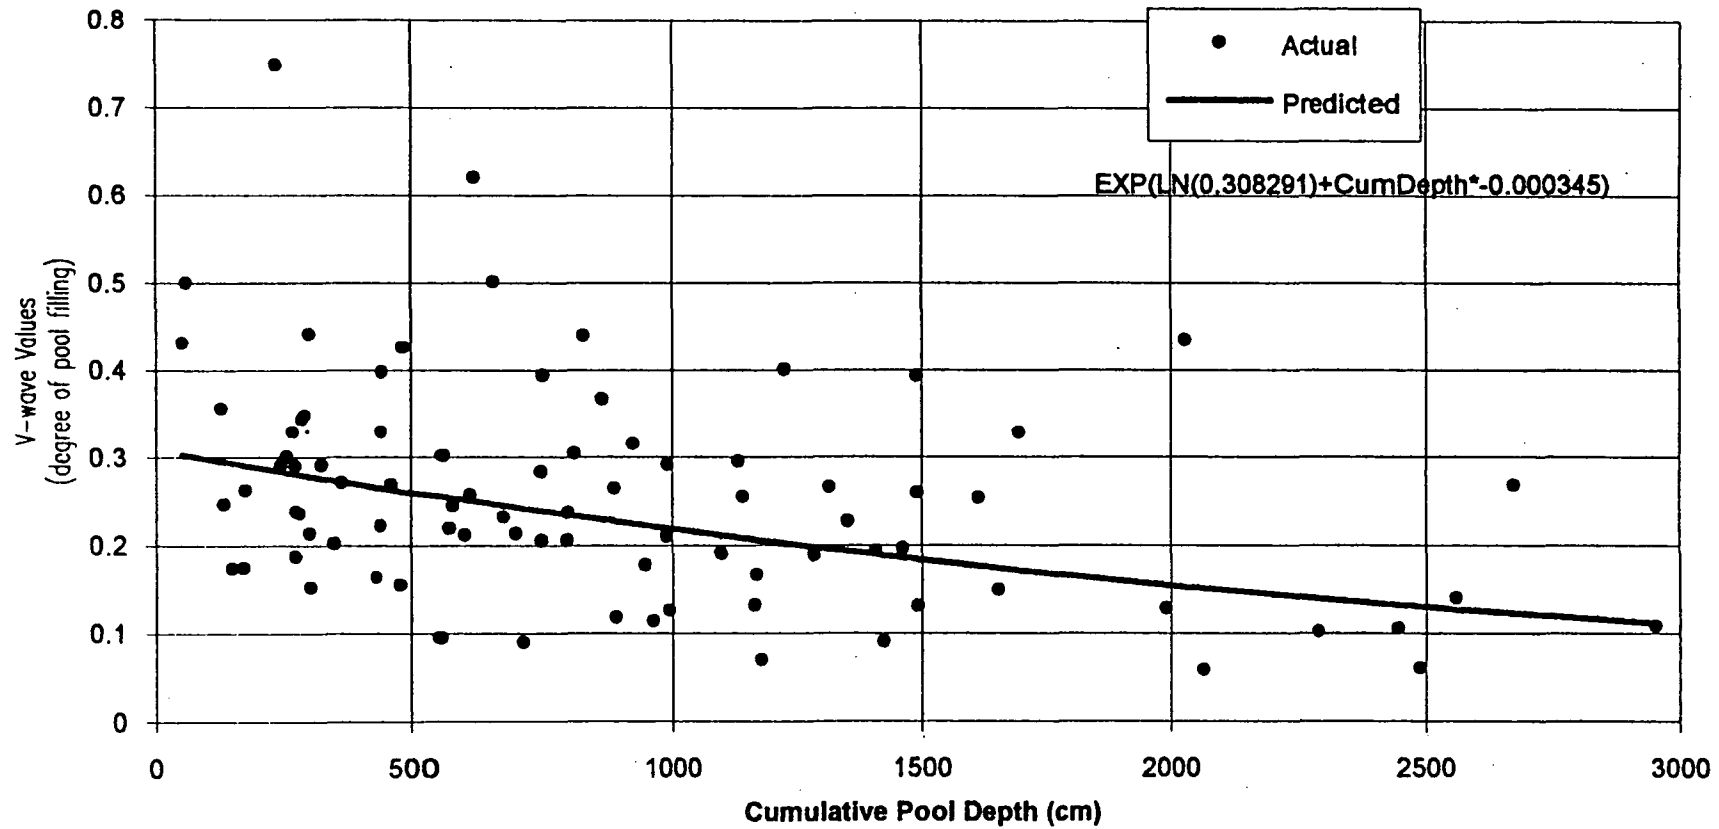
Figure 13.

Cumulative pool depth, as shown in Figures 13 and 14, correlates exponentially with V-wave, with correlation coefficients (adjusted R^2) of 0.198 for the whole data set, and 0.341 for sites 43 to 80. The significance of both of these values is >99.99%. In other words, it is statistically very certain that the cumulative depth of pools partially accounts for variation in V-wave measurements. The relationship is

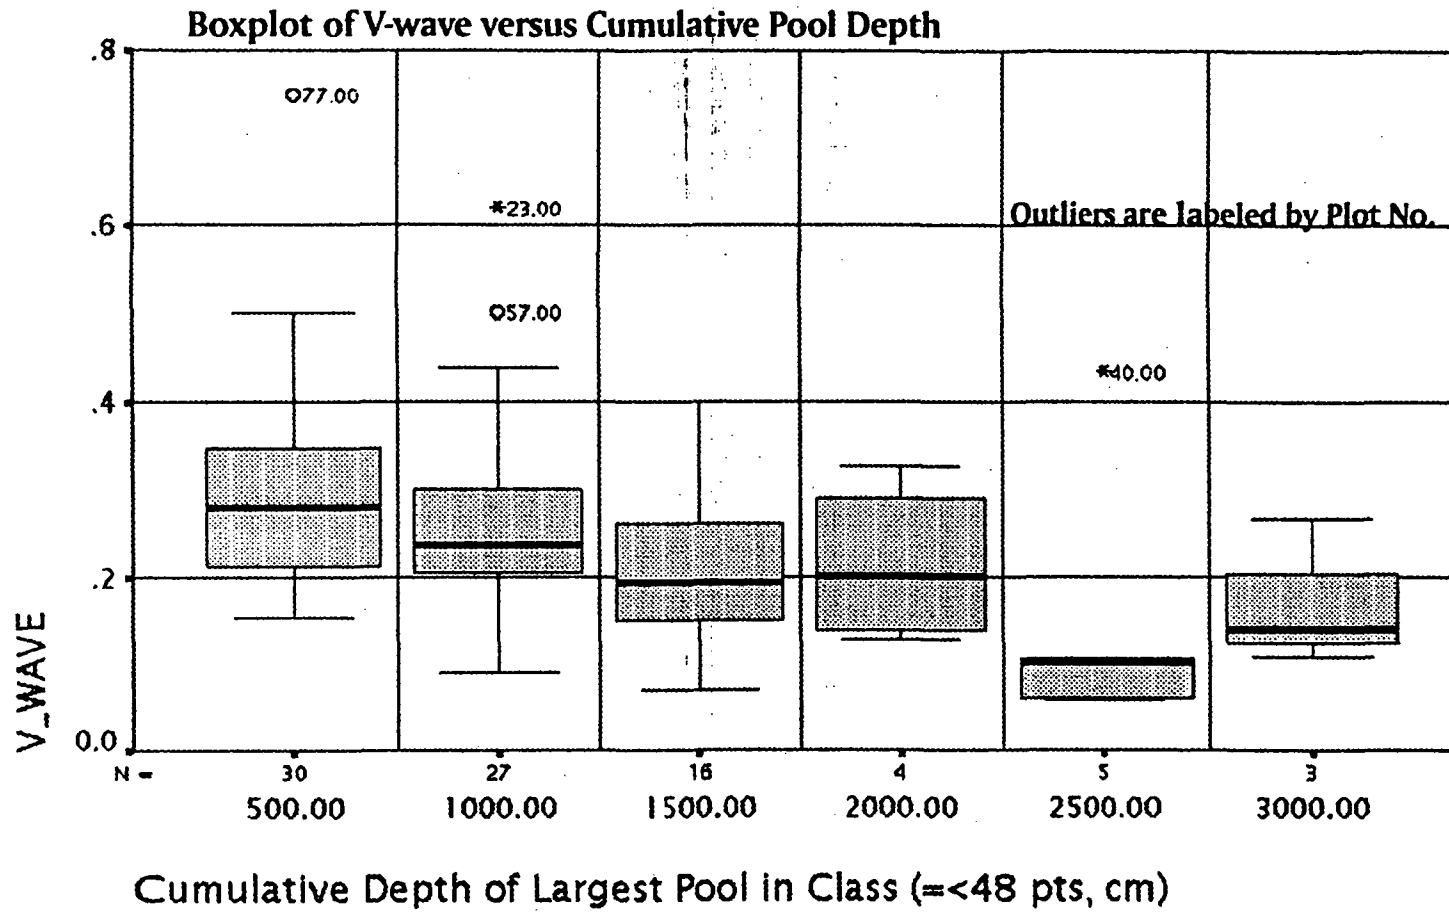
Figure 15.

The relationship of cumulative depth to V-wave allows identification of pools which have uncharacteristically high amounts of sediment, so that researchers may go to the site and consider the reasons they are in that condition. As shown in the boxplot in Figure 15, pools can be sorted by cumulative depth category, and outliers and extremes for that category determined. An outlier is a pool which, when graphed, is beyond the 75th percentile by more than 1.5 times the range from the 25th percentile to the 75th percentile, and an extreme plots at more than 3.0 times that distance. Sites which meet these criteria are in plots 57 and 77, outliers, and 32 and 40, extremes.
