Mad River Watershed Erosion Investigation

JUNE 1982

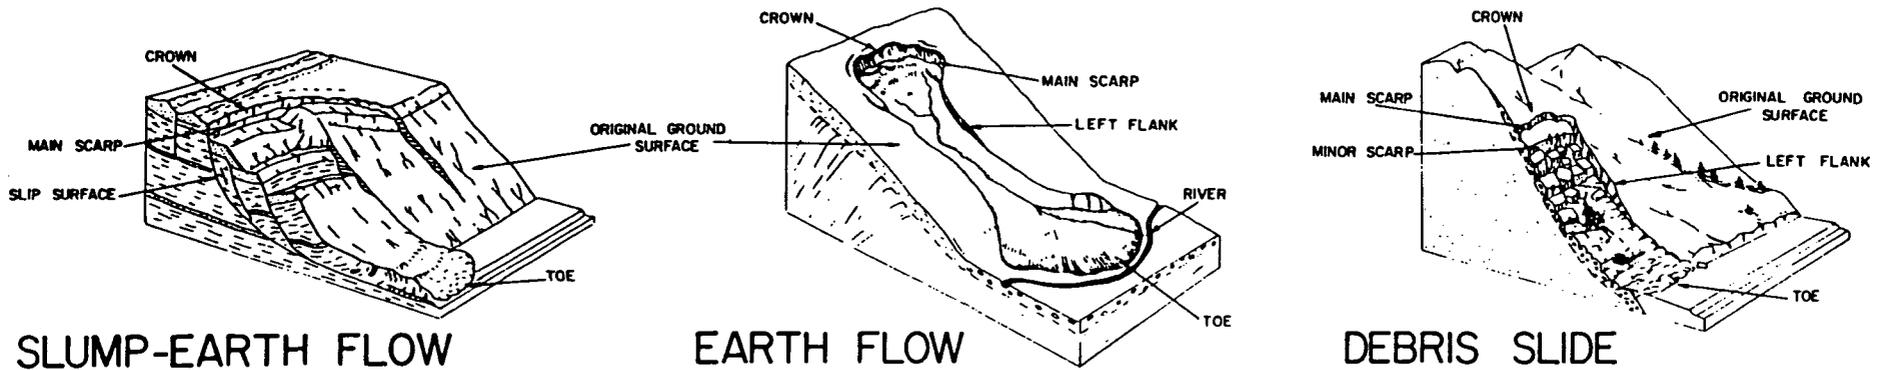
Figure 14

Landslides were not mapped according to genetic type in this study. However, common types found in the basin are debris slides, rock slides, rotational slides, earth and debris flows, and complex (combination of types) slides (Figure 14). Guttled stream channels and areas of persistent soil mantle creep are also found.
