San Luis Obispo Creek Watershed Hydrologic Survey

California Regional Water Quality Control Board
Central Coast Region
Contract No. 4-106-253-0

The Land Conservancy of San Luis Obispo County

May 1996

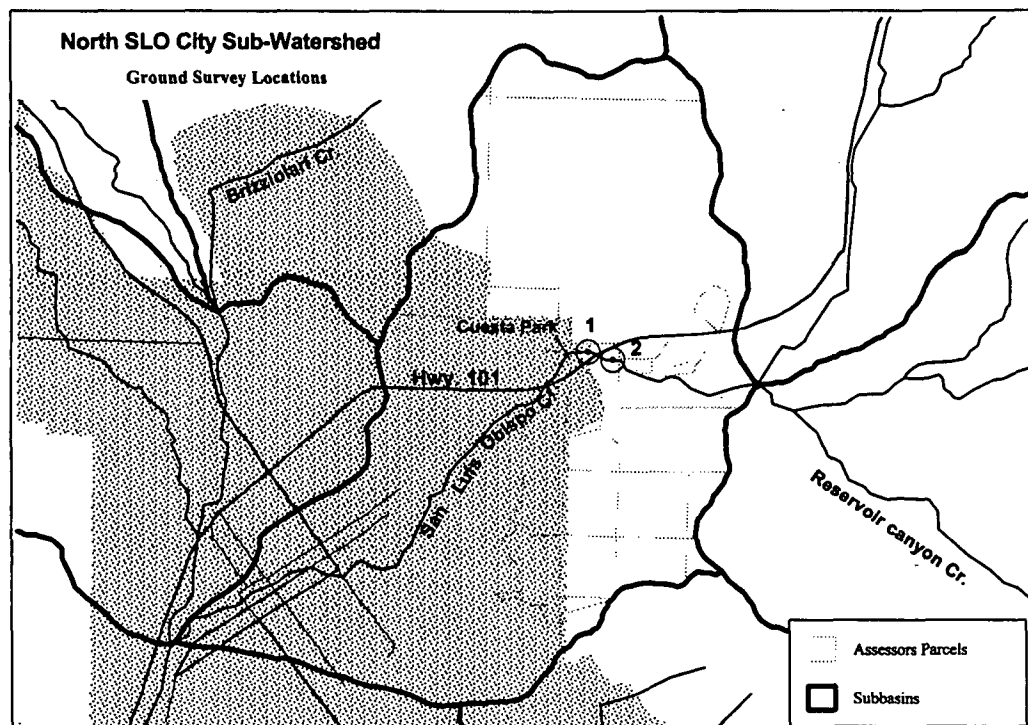
Figure 1.11 - North SLO Creek Survey Locations

1. 600' upstream from the bridge crossing SLO Creek adjacent to Cuesta Park.
2. Confluence of ephemeral stream North of the park.

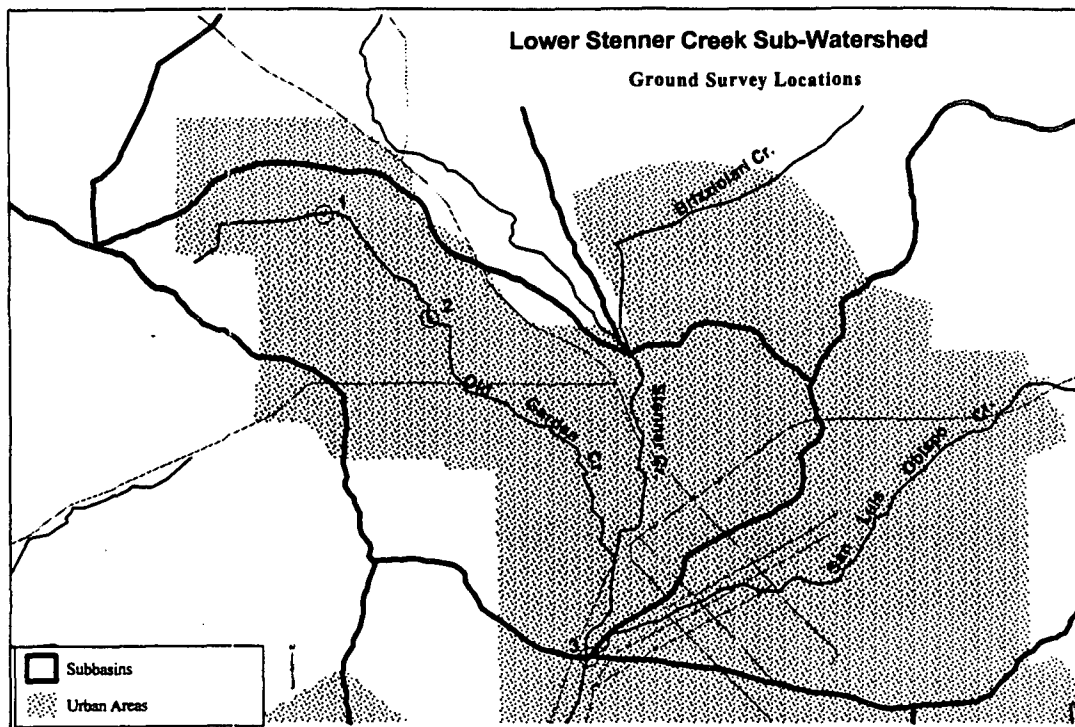
Figure 1.12 - Lower Stenner Creek Survey Locations

1. 1.5 blocks north of the intersection of Old Garden Creek and Patricia Dr.
2. Along Highland Dr.
3. At confluence with SLO Creek.

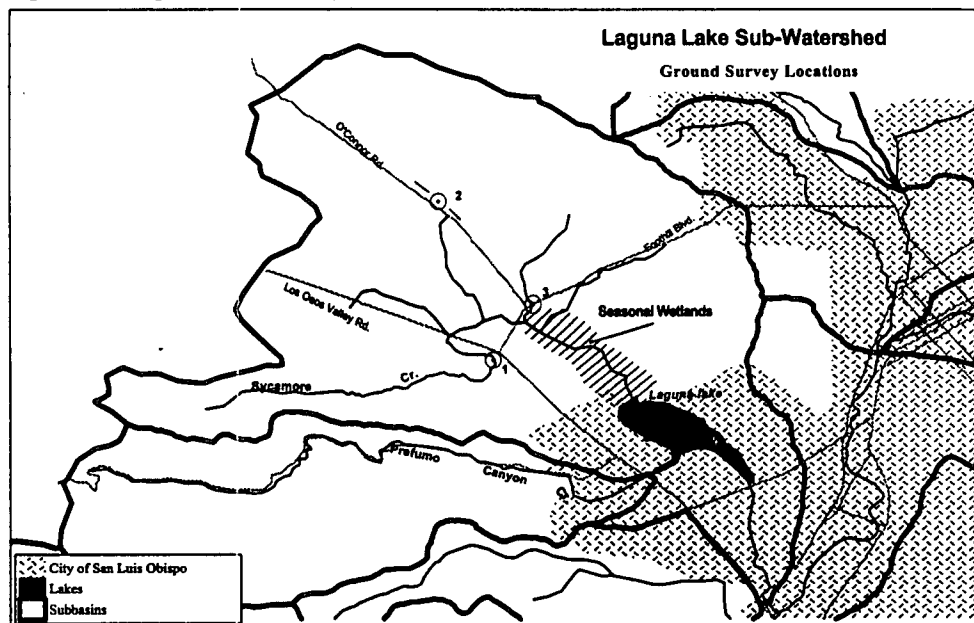
Fig. 1.13 - Laguna Lake Survey Locations

1. Intersection of Los Osos Valley Rd. and Foothill Blvd.
2. O'Connor Rd.
3. East of O'Connor Rd. where small tributary crosses under Foothill Blvd.

Loc	Vegetation	Bank Condition	Substrata	Notes
Table 1.7	Mixed hardwoods along ephemeral channel	Some bank cutting.	*	Drains to Laguna Lake.
2	Primarily grasses and a few willows.. Vegetation on banks of tributaries varies with ownership.	Some bank erosion, but minimal.	*	Drains to Laguna Lake.
3	Grasses.	Intermittent vertical erosion	*	Drains to Laguna Lake.

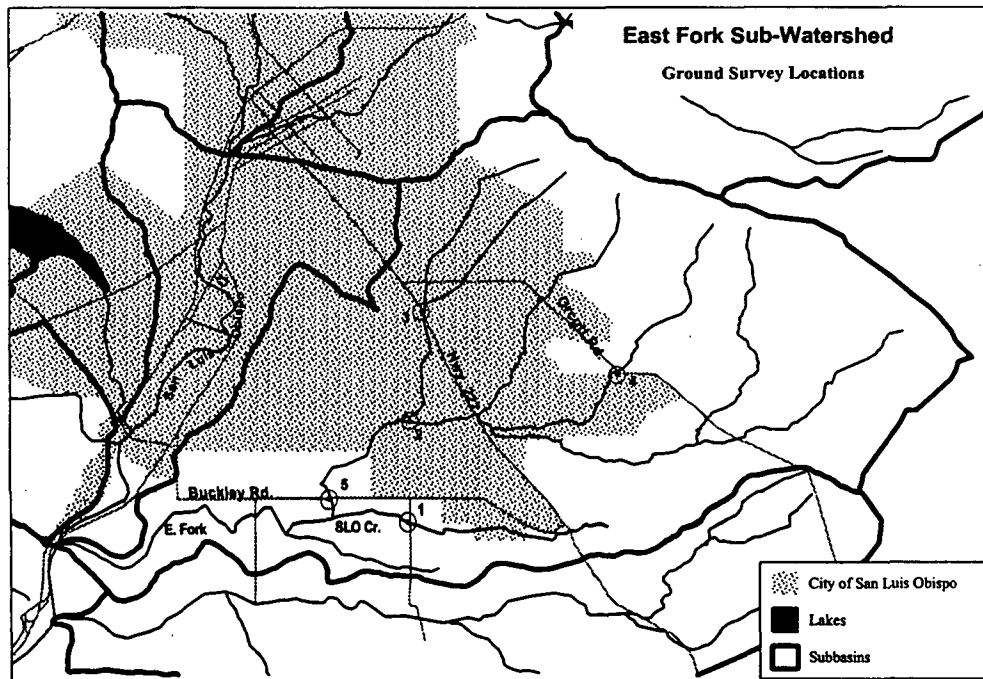
Fig. 1.14 - East Fork Survey Locations

1. Davenport Creek Rd. where it crosses the Creek.
2. Where unnamed tributary crosses Santa Fe Rd.
3. Where same tributary crosses Hwy. 227.
4. Where stream crosses Orcutt Rd at the intersection with Tank Farm Rd.
5. Where the channel crosses Buckley Rd.

Loc.	Vegetation	Bank Condition	Substrata	Notes
1	Grasses, no trees	Vertically eroded 5.5'	*	
2	Mature willows, sycamores and walnuts.	Minimal erosion, mostly stable	*	Possible vegetation encroachment problem in the future. Grazed to channel
3	Established riparian vegetation.	Minimal erosion.	*	
4	Grasses	Minimal erosion, some undercutting.	*	Cattle have access to the channel on the north side of the road. New park on S. side.
5	Grasses on east side, willow on the west where there are no cattle. Some cottonwood and walnut.	Vertical bank erosion.	*	Cattle in the channel on the east side of the bridge. Artificial debris dam west of bridge.

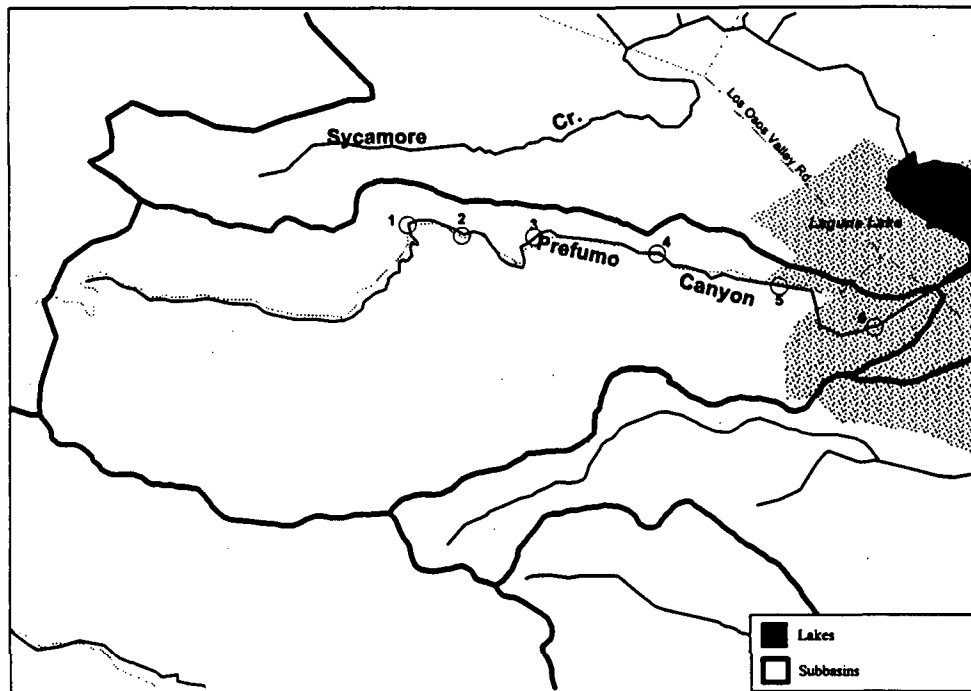
Figure 1.15 Prefumo Creek Survey Locations

Loc	Vegetation	Bank Condition	Substrata	Notes
1	(R): Sycamores, oaks, and willows. (L): Grasses only	12' vertical banks on left	Gravel / Cobble	Configuration geologically controlled
2	(R): Sycamore, Willow, Oak. (L): Home, Sycamore.	Minimal erosion.	Sand, Gravel, Cobble	Home seems to be built on mid-channel bar. Stream splits.
3	(R): Oak, Laurel, Willow. (L): Road, Willow, Sycamore.	(R): Undercut banks 6', roots exposed. (L): Riprap	Cobbles / Boulders.	Mid-channel boulders increase stream depth leading to saturation and bank failure.
4	(R): Chaparral (L): Willow.	(R): 12' vertical erosion. (L): No erosion.	Gravels / Sands	(R): 800' of exposed soil and bank failures.
5	(R): Sycamore, Oaks (L): Willow	Minimal erosion.	Cobbles / Gravels.	Mid-channel bar splits flows and may cause erosion near road. Some riprap.
6	(R) Sparse upper canopy. (L): Few Oaks	Intermittant erosion.	Gravels	Lack of woody veg. near mobile home park.

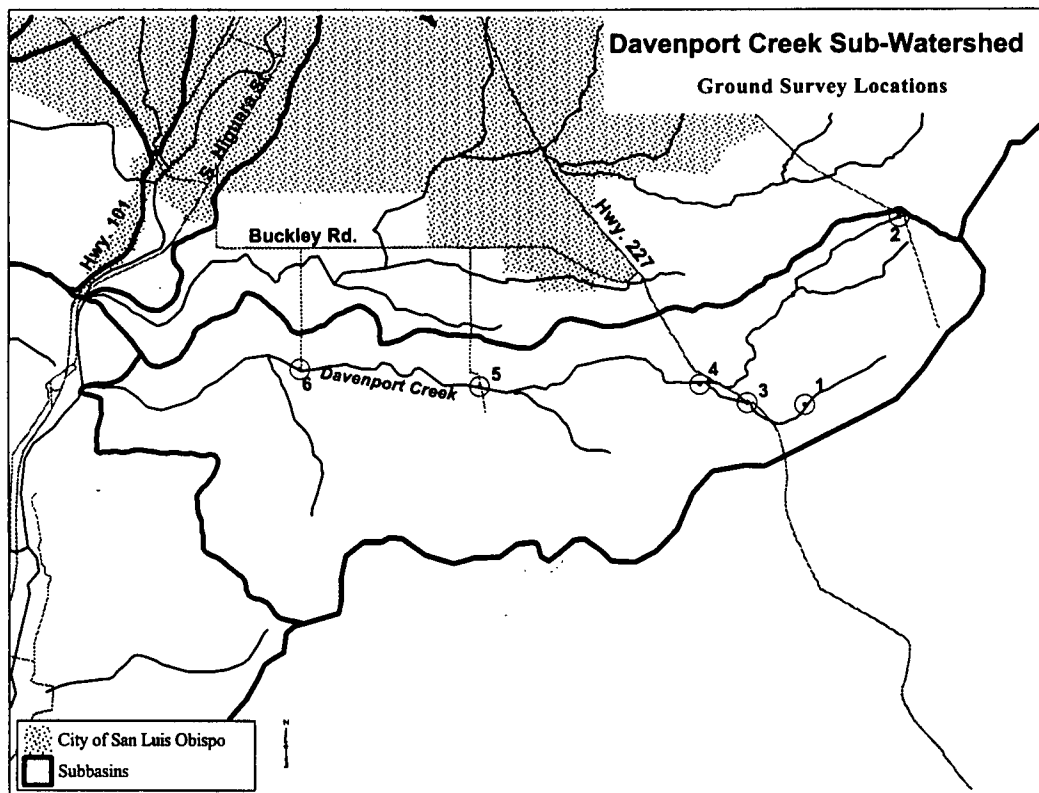
Figure 1.17 Davenport Creek Survey Locations

1. Where tributary of Davenport Creek crosses Biddle Ranch Rd.
2. Where headwaters of Davenport Creek cross Orcutt Rd.
3. Where Hwy. 227 crosses the railroad tracks.
4. Intersection of Davenport Creek and Los Ranchos Rd.
5. End of Davenport Creek Rd.
6. Intersection of Davenport Creek and Jespersen Rd.

Loc	Vegetation	Bank Condition	Substrata	Notes
1	Intermittent sycamores along active channel. Soils has been plowed into the channel on the north side.	No discernible banks.	*	Irrigated agriculture.
2	70% cover with willows and sycamores.	Extreme bank erosion on the west bank, where there is no vegetation.	*	Grazing, cattle allowed in the Creek.
3	Intermittent vegetation.	None noted.	*	
4	Willows. Charnel completely choked.	None noted.	*	
5	Willows. 15-20' tall. Encroaching in the stream channel.	Minimal erosion.	*	Grazing on both sides of the creek.
6	All grasses on the east side, and maturing willows on the west.	Vertical erosion on the east with minimal erosion on the west.	*	Grazed.

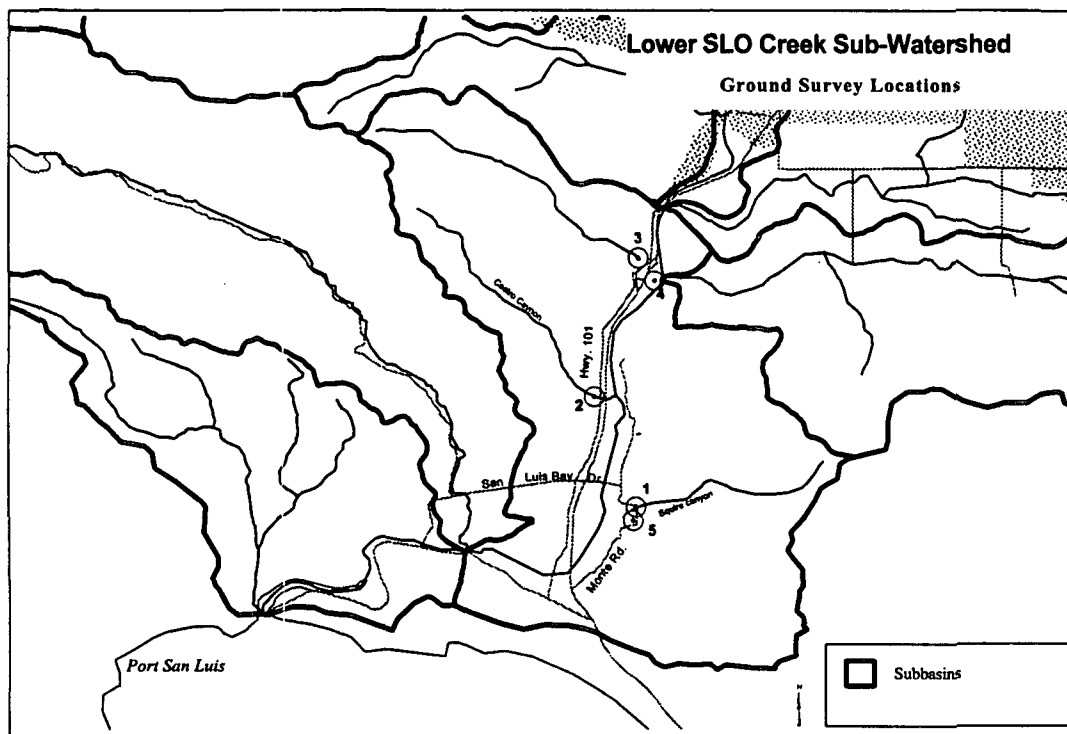
Figure 1.18 Lower San Luis Obispo Creek Survey Locations

1. Squire Canyon
2. Castro Canyon
3. Small canyon entrance west of Hwy. 101 at the Higuera St. Exit.
4. Near confluence of unnamed stream with SLO Creek
5. At 3-way intersection where unnamed stream crosses Monte Rd.

Loc	Vegetation	Bank Condition	Substrata	Notes
1	Upper watershed 70% oaks, 20% manzanita. Lower watershed mostly oaks.	Minimal erosion. Some alluviated fine in an ephemeral channel (isolated problem)	Thin soils and exposed bedrock.	
2	Sycamores and oaks.	No signs of alluviated material.	Exposed bedrock in upper watershed.	Some flooding in 1995 storms.
3	Intermittent vegetation. Oaks and sycamore.	Some erosion. Alluvial material is collecting where ephemeral stream meets Ontario Rd.	*	This watershed most likely delivers significant sediment loads to SLO Creek.
4		Minimal erosion.	Sands and gravels.	No evidence of deposition in lower reach.
5	Willows encroaching in upstream area. Downstream areas have minimal vegetation.	No erosion seen.	Thin soils and exposed bedrock.

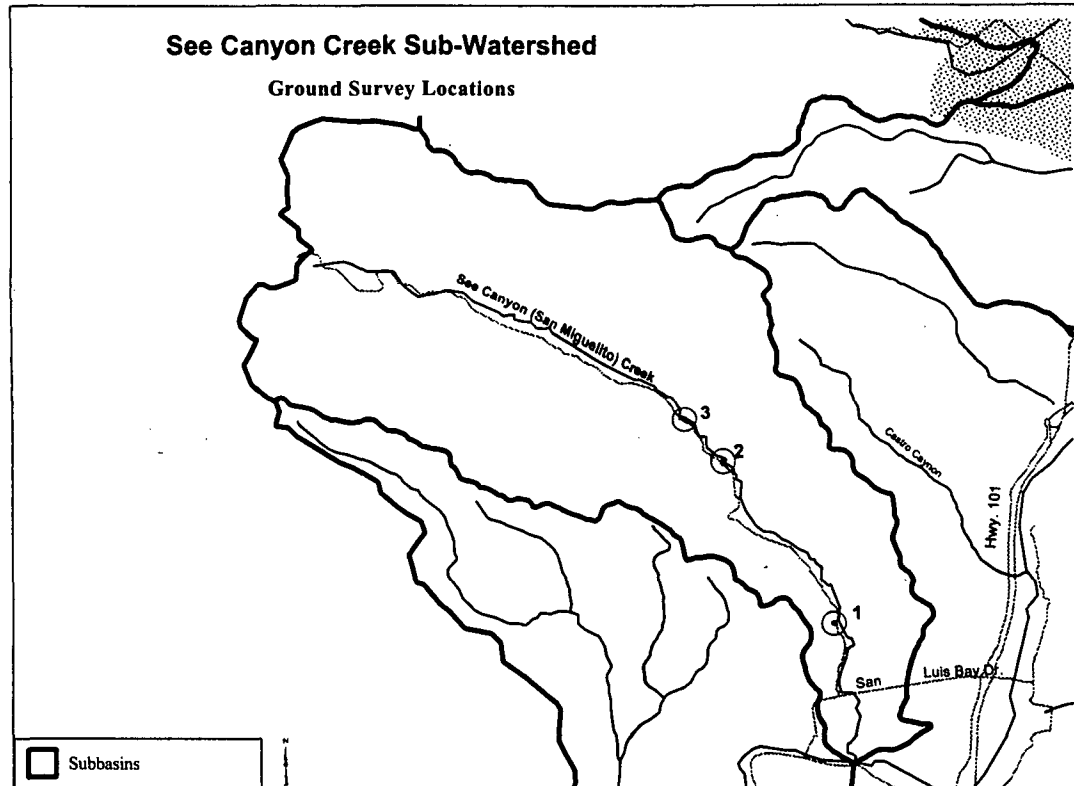
Figure 1.19 See Canyon Survey Locations

- 1. .6
- 2. 2.2
- 3. 2.6

Loc	Vegetation	Bank Condition	Substrata	Notes
1	Highly established walnuts, oaks, and sycamores.	Bank severely eroded. 25' vertical. Some undercutting.	Gravel, cobble, and some fines.	
2	Established vegetation on the east side. Grasses only on the west side.	Severely eroded section 20' deep and 120' long.	Fines, sand, and cobble along the banks. Cobbles and gravels in the thalweg.	Rip-rap placed downstream of eroded bank may have constricted flow, causing pooling. Highly unstable area.
3	Established mixed hardwoods.	Severe undercutting along the road.	*	Road falling from undercut at outer turn in the Creek.

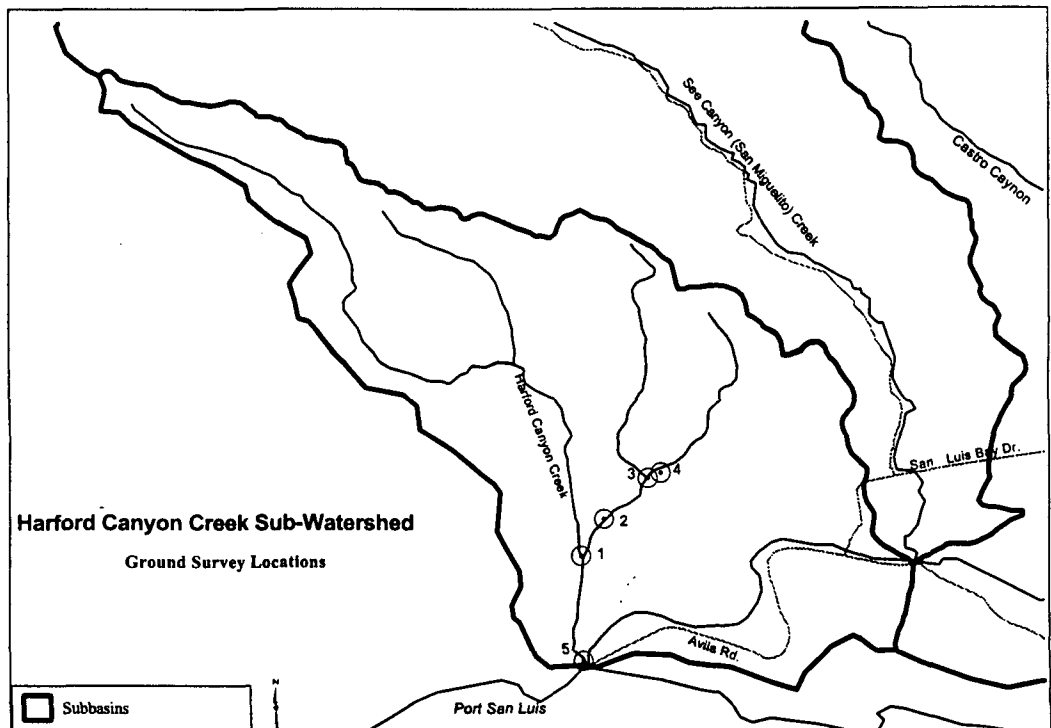
Figure 1.20 Harford Canyon Survey Locations

Loc	Vegetation	Bank Condition	Substrata	Notes
1	Mainly sycamore and willow.	L. Some vertical erosion. R. Vertical bank 7' high.	Sands, gravels, and cobbles.	Golf course.
2	Grasses only.	Vertically eroded bank 8' high. Some rip-rap.	Sands, gravels, and cobbles.	
3	Mature riparian vegetation.	Gravel deposition along banks.	Gravels.	24 " culvert under cart path.
4	Willows in thalweg. Also oaks and sycamores.	Sand and gravel deposition around willows in channel. Banks are in good condition.	Sand and gravel.	
5		Some remaining signs of vertical bank erosion. New culverts installed.	Sand and gravel.

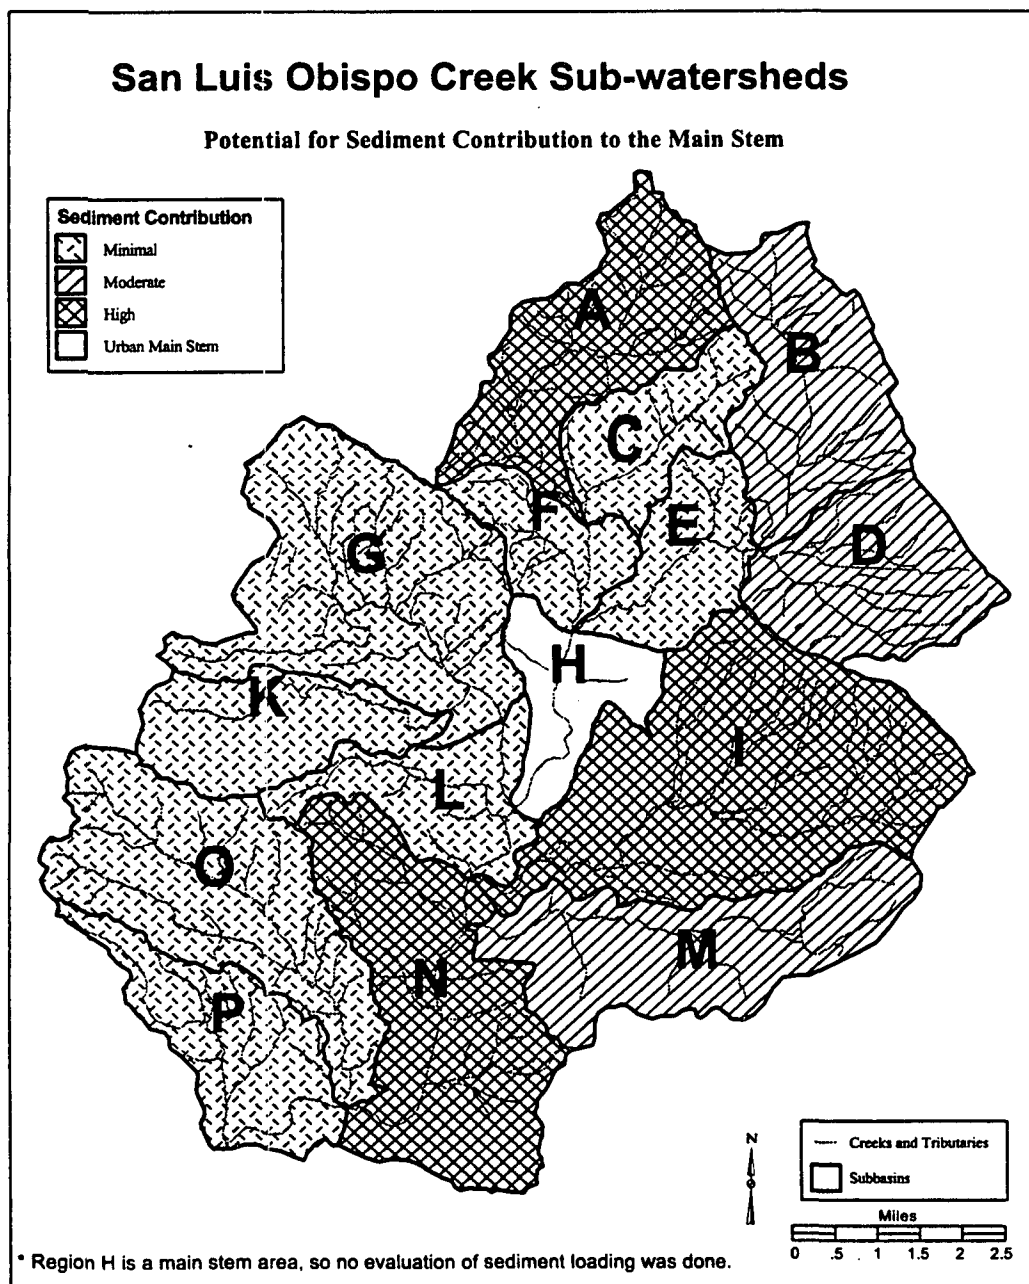
Figure 1.21 Sediment Delivery Potential

Figure 1.21 illustrates the sub-watersheds and their relative potential for sediment loading into the main stem. The designations were based on visual survey of the main tributaries near the confluence with the main stem, and the relative size amount of deposited material. These ratings address the amount of coarser sediment delivery (sand and larger), rather than the fine suspended sediment load which would be carried downstream.

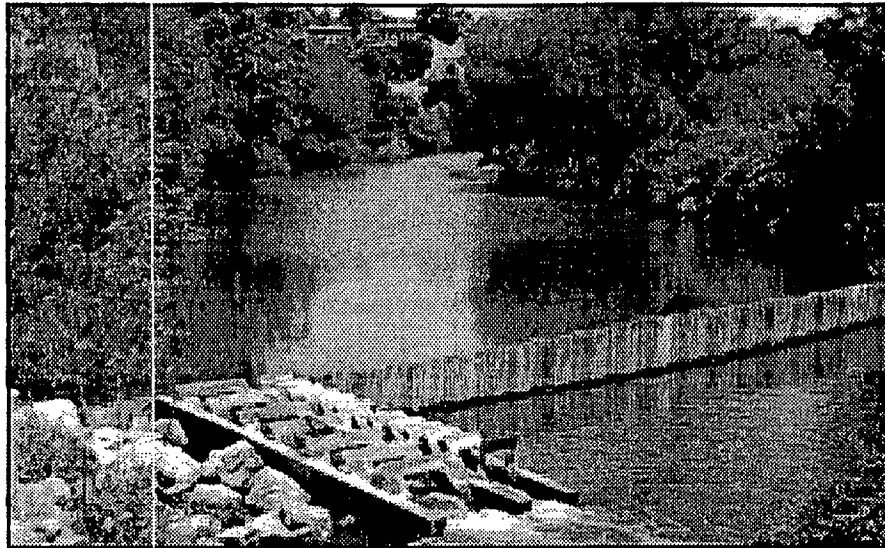
This picture shows Marre Dam, the fish ladder on the northern side of the creek and the thick riparian vegetation upstream of the dam.

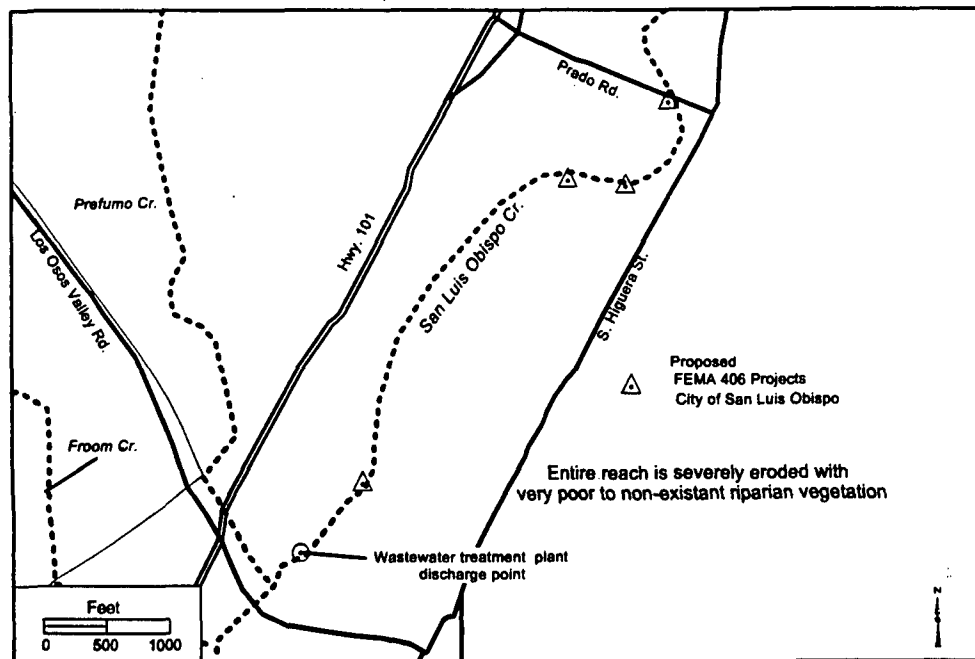
Fig. 2.9 - Reach # 8

The City of San Luis Obispo is currently pursuing four bank protection projects in this reach. These are marked on figure 2.9. The Land Conservancy will be working with the City to provide additional information necessary for permit approval. We will also attempt to find and propose innovative project designs which will enhance the riparian corridor and protect property while meeting the City's engineering standards.

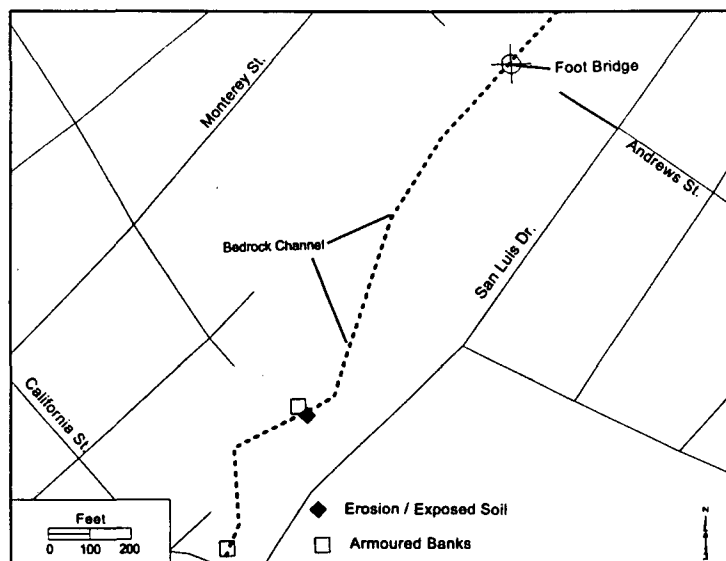
Fig. 2.13 - Reach # 12

L. REACH 12 - CALIFORNIA STREET BRIDGE TO ANDREWS ST. BRIDGE

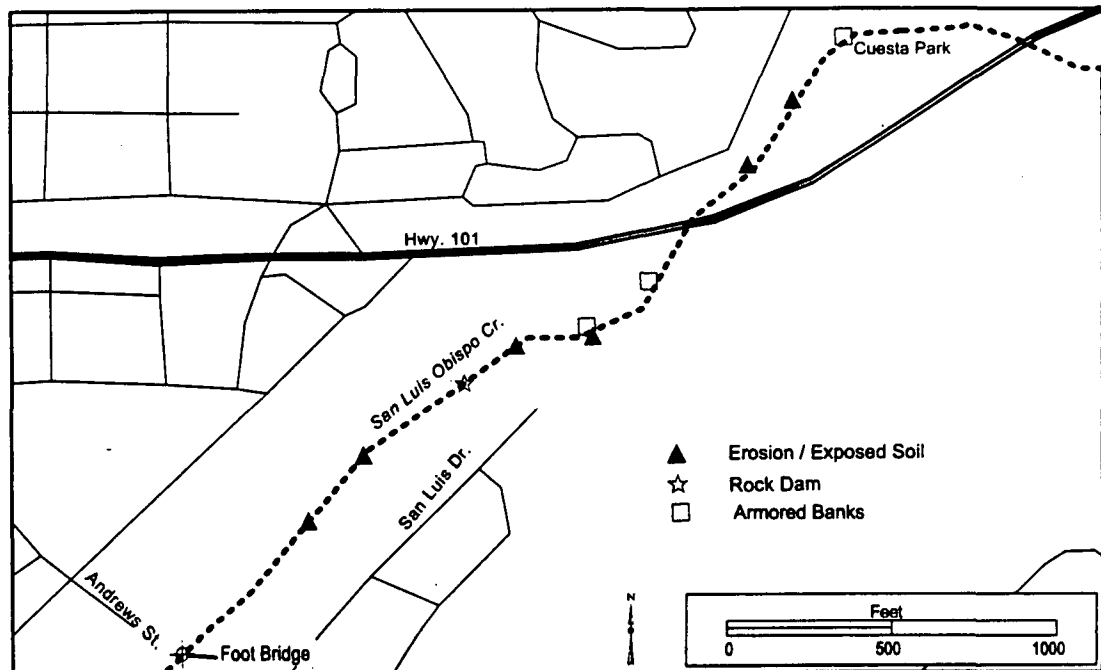
Fig. 2.14 - Reach # 13

M. REACH 13 - ANDREW STREET BRIDGE TO HIGHWAY 101 CULVERT

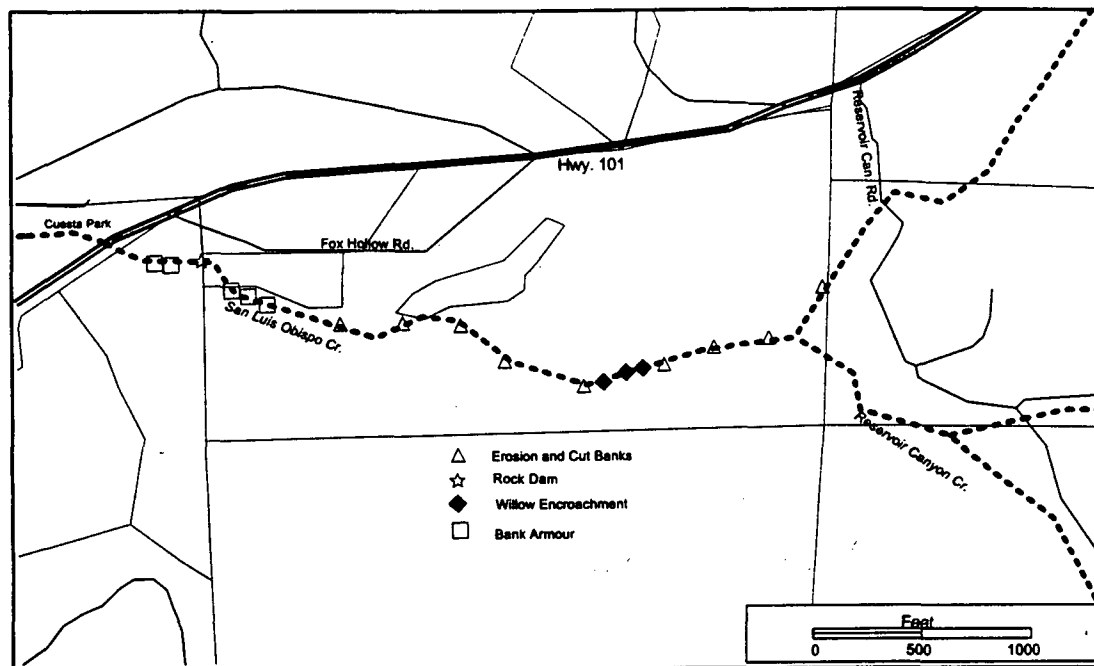
Fig. 2.15 - Reach # 14

Bank condition is variable in this section, and is reflected in variable width to depth ratios from 6.3 to 14.7. Areas of severely eroded banks coincide with cattle grazing, and have higher width to depth ratios. Improving riparian vegetation in some sections has stabilized the banks fairly well. Concrete slabs which have been placed on the banks in several places have held those banks.

Bank conditions vary widely in this reach and stabilization is necessary in several degraded sections. The single ownership of the adjacent land makes larger scale stabilization efforts possible, if the owner is interested in cooperating. Since there is little development encroachment, there is ample space for stabilization efforts.
