HYDROLOGY STUDY OF MUD
SLOUGH (NORTH), MERCED COUNTY

California Regional Water Quality Control Board
Central Valley Region
3443 Routier Road
Sacramento, California 95827-3098

February 1989

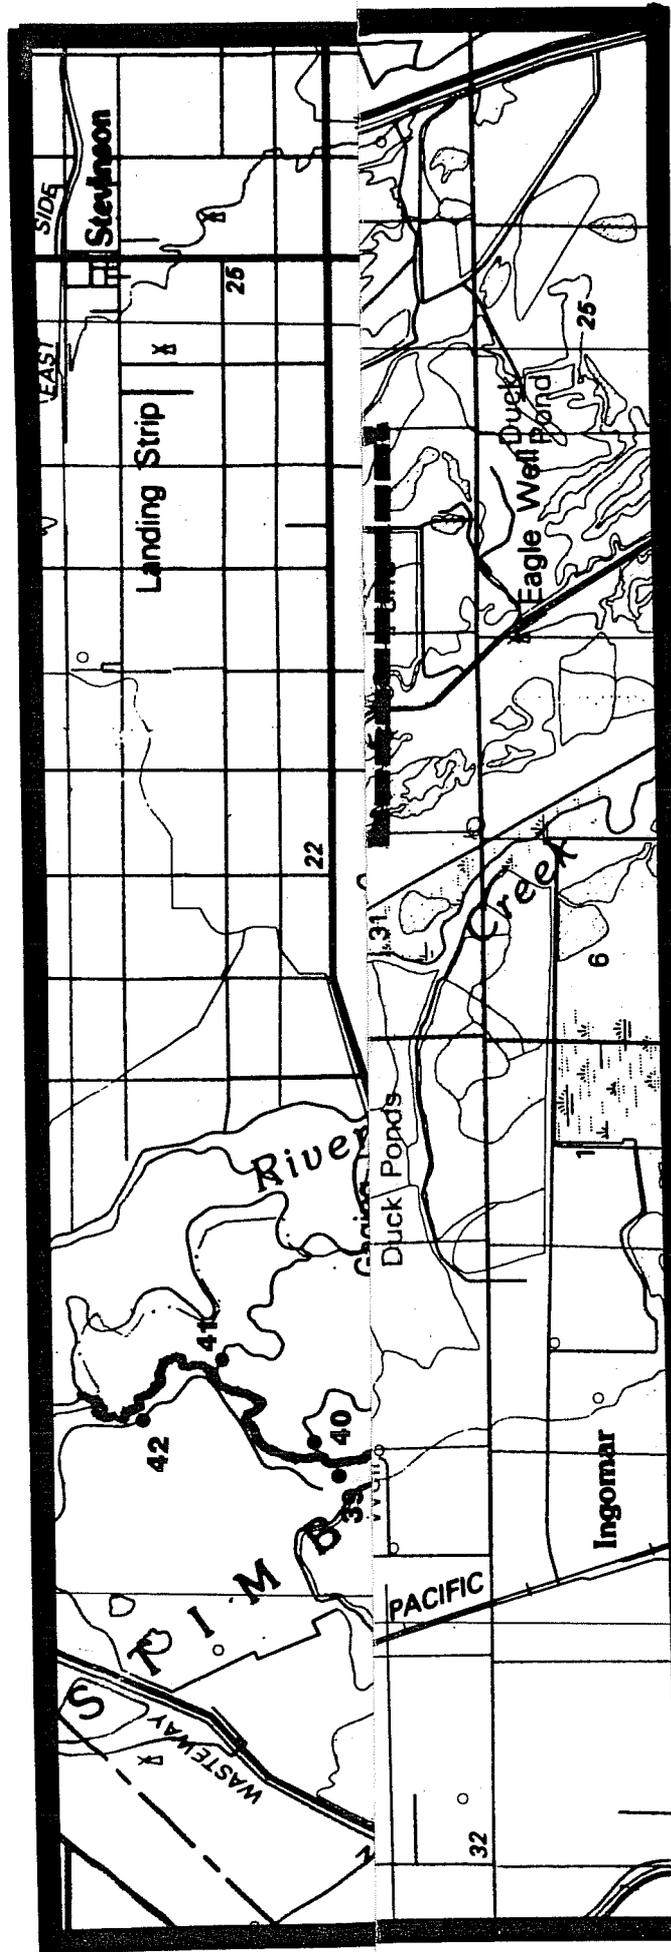
Figure 2. Discharge and Diversion Site Map

Mud Slough(North) has 42 discharges and 2 diversions. Figures 2 and 3 locate each discharge and diversion site by their unique site number. Most discharges are from wetlands areas, either private duck clubs or federal refuges and are seasonal discharges of low volume. Both diversions are by gun clubs and the water is now used for pasture irrigation and on some field crops. Prior to 1985, the water was used to maintain seasonal wetlands.

* MSL site numbers correspond to the numerical site numbers on Figures 2 and 3.

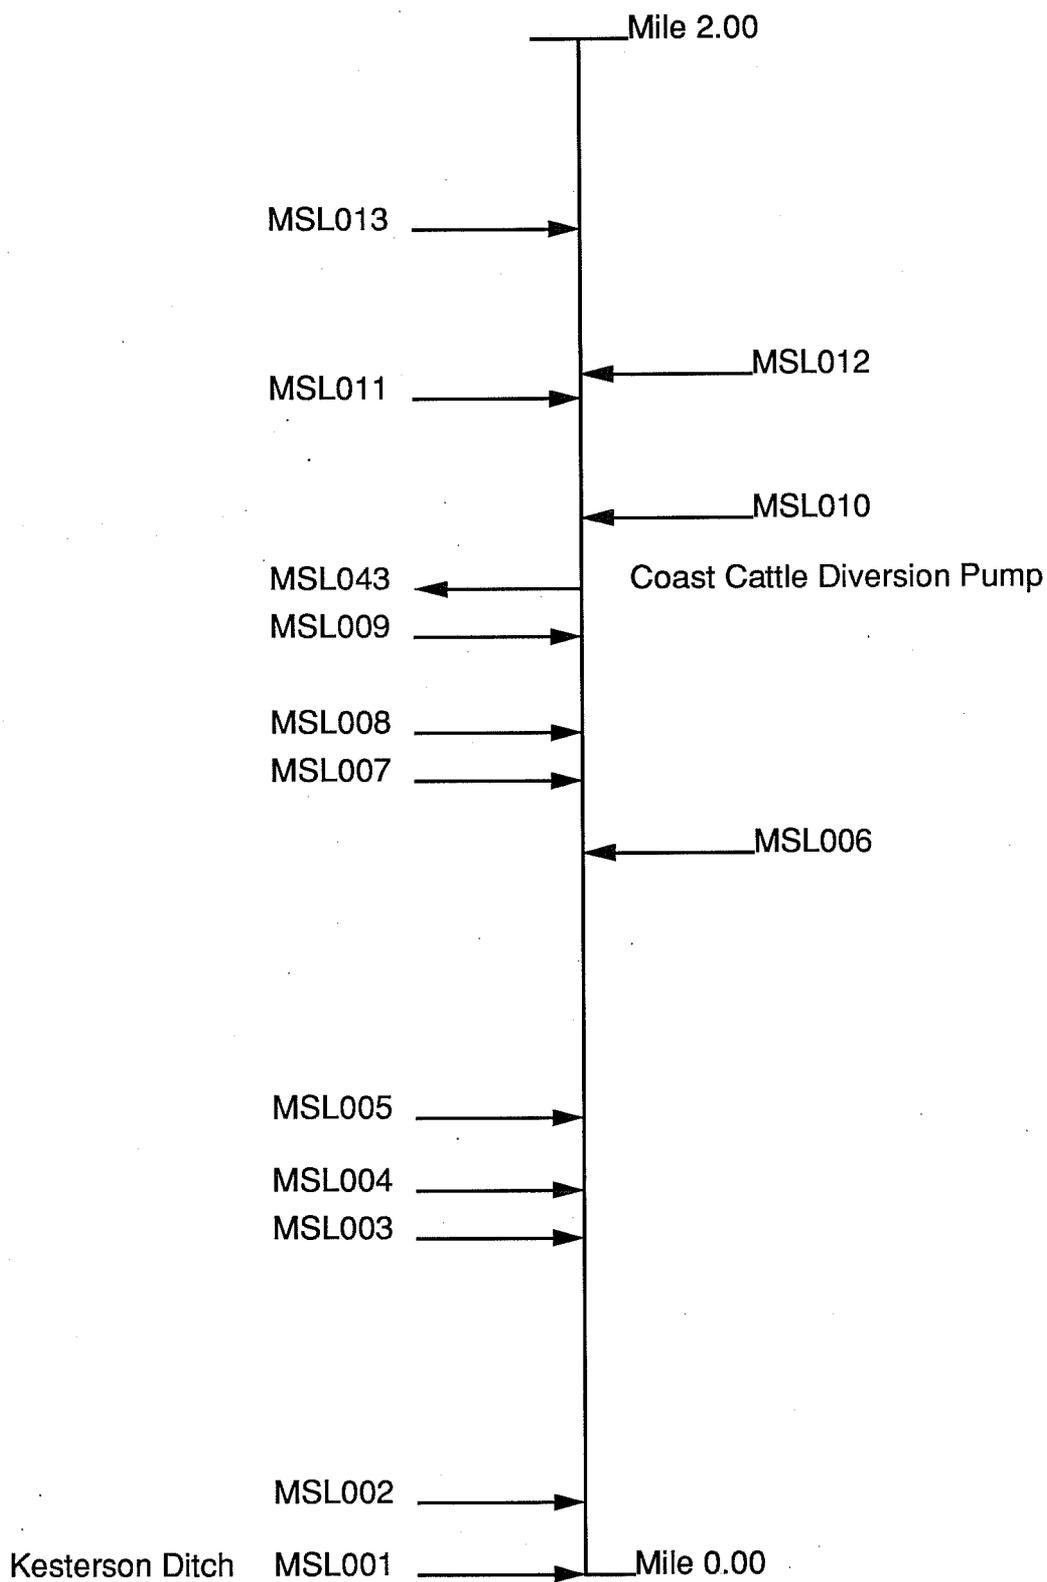
Mile 0.00 - Mile 2.00

MUD SLOUGH (NORTH)

Appendix B - Flow diagrams for Mud Slough(North)

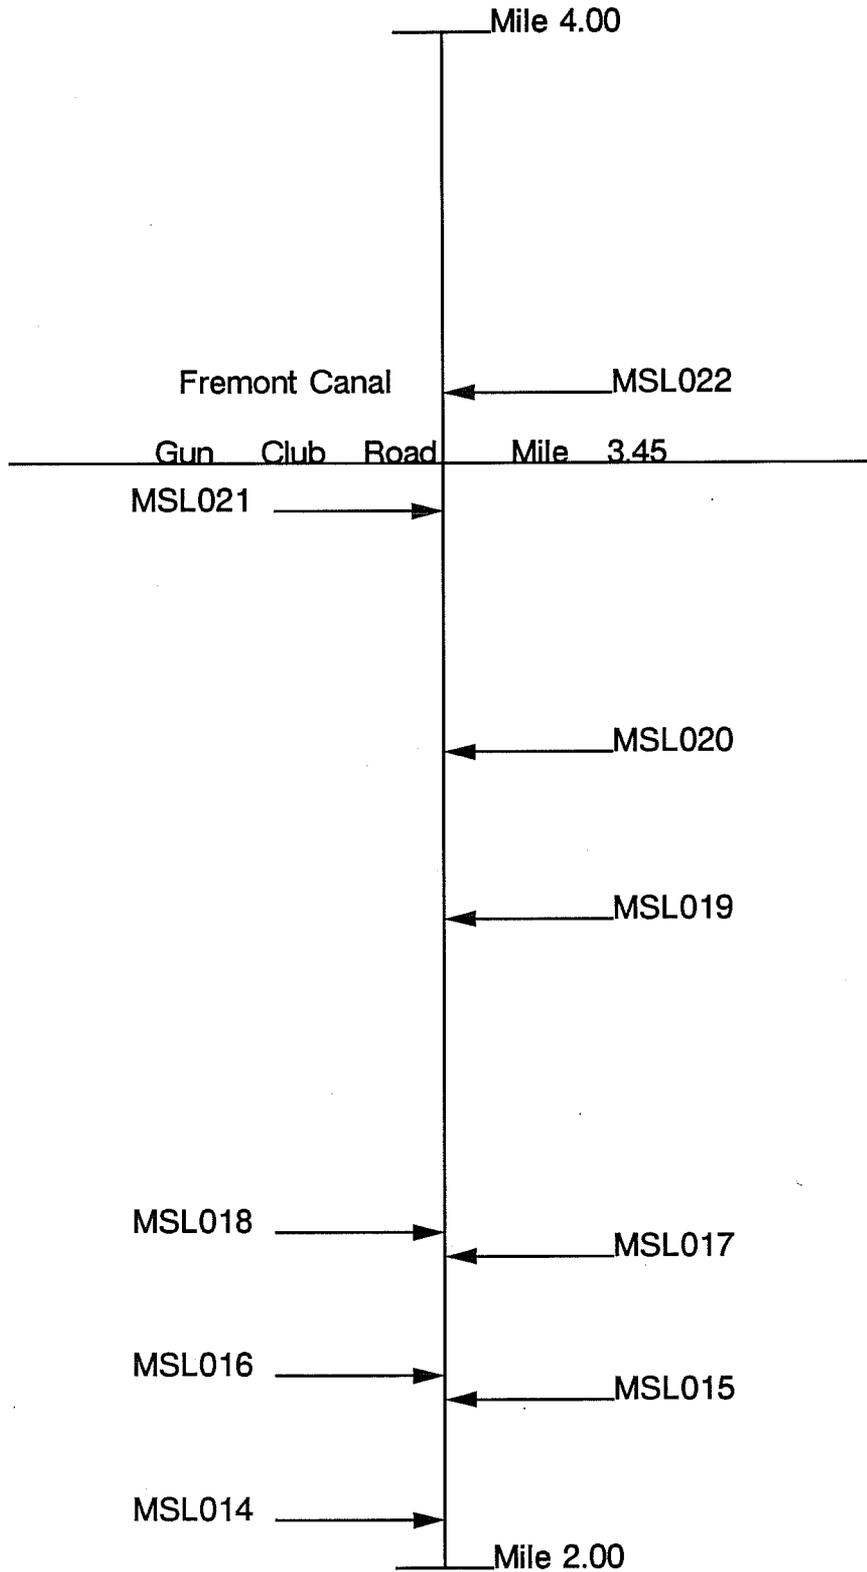
Mile 2.00 - Mile 4.00

MUD SLOUGH (NORTH)

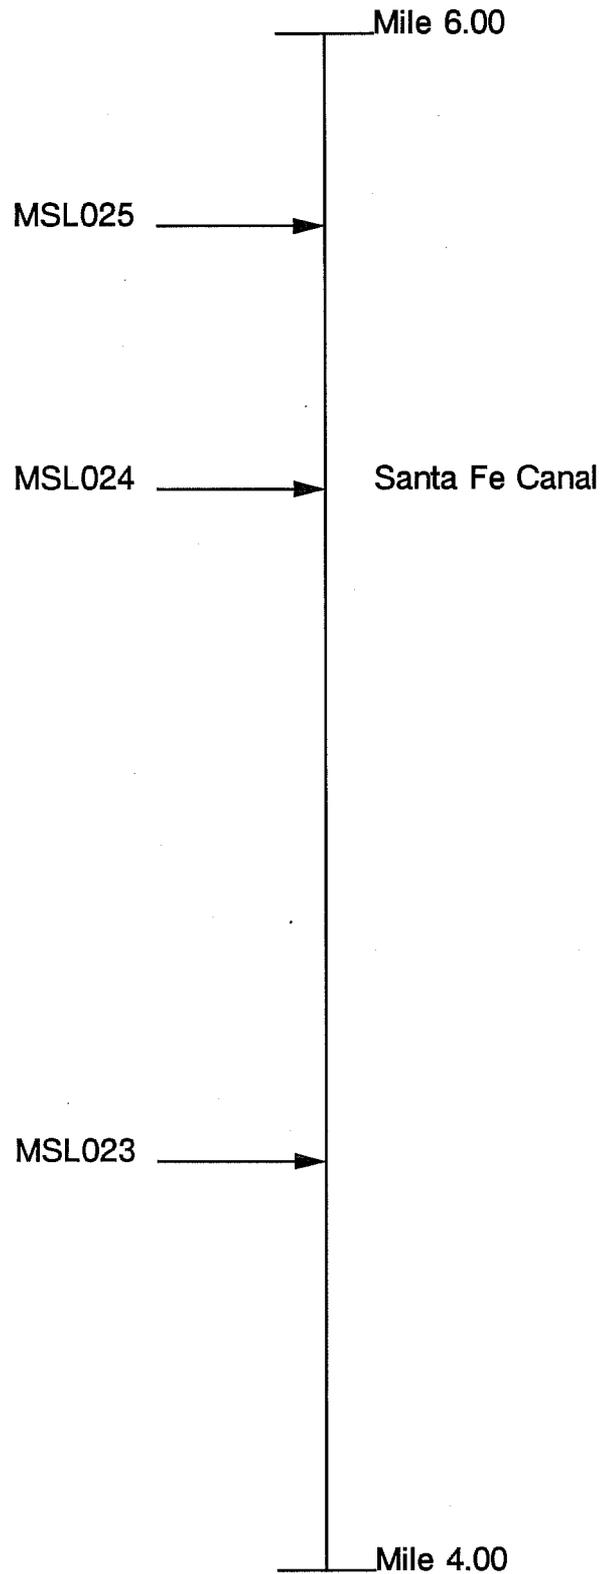
Mile 4.00 - Mile 6.00

MUD SLOUGH (NORTH)

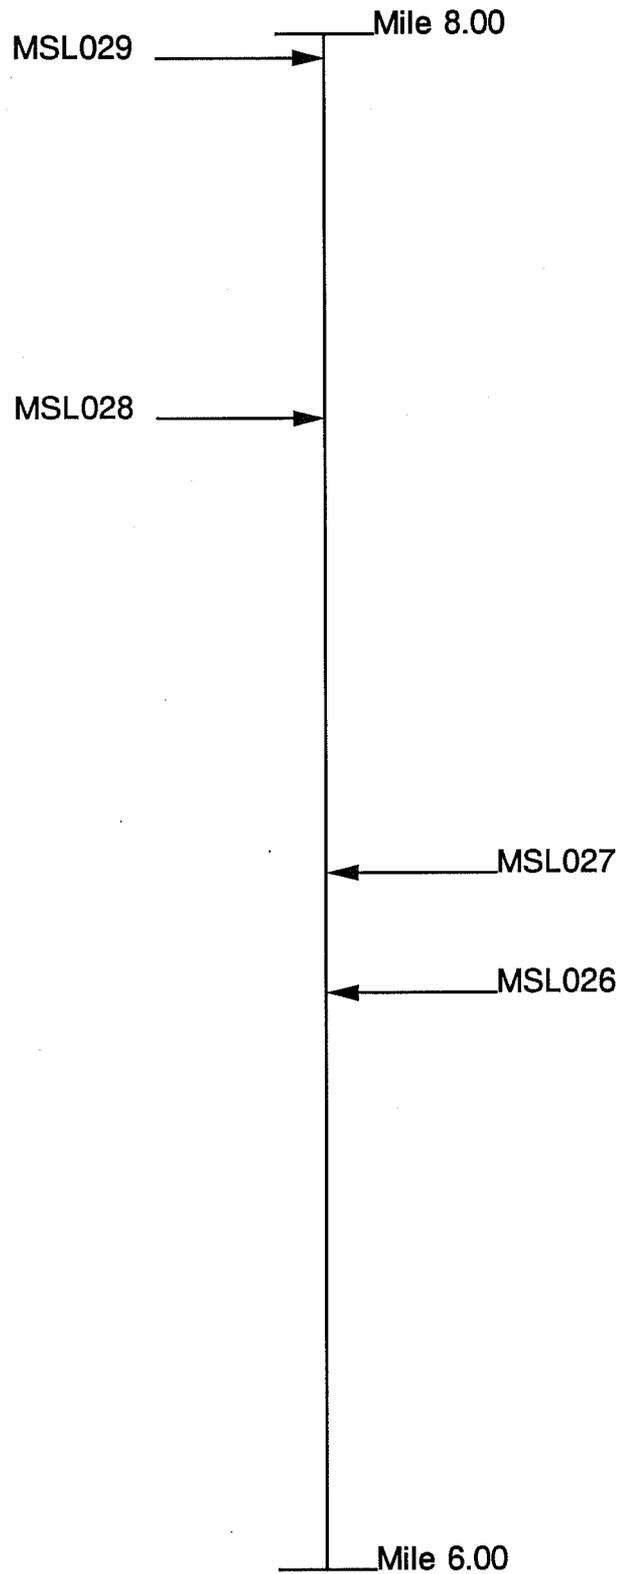
Mile 6.00 - Mile 8.00

MUD SLOUGH (NORTH)

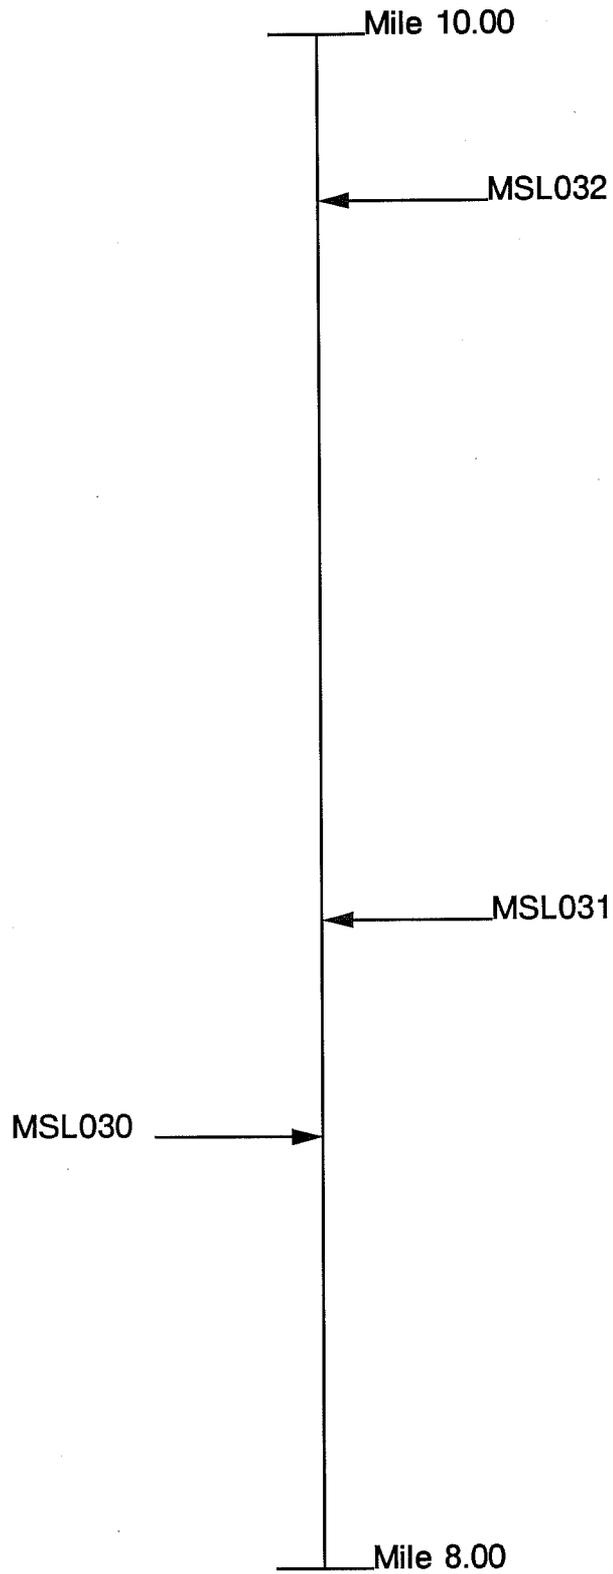
Mile 8.00 - Mile 10.00

MUD SLOUGH (NORTH)

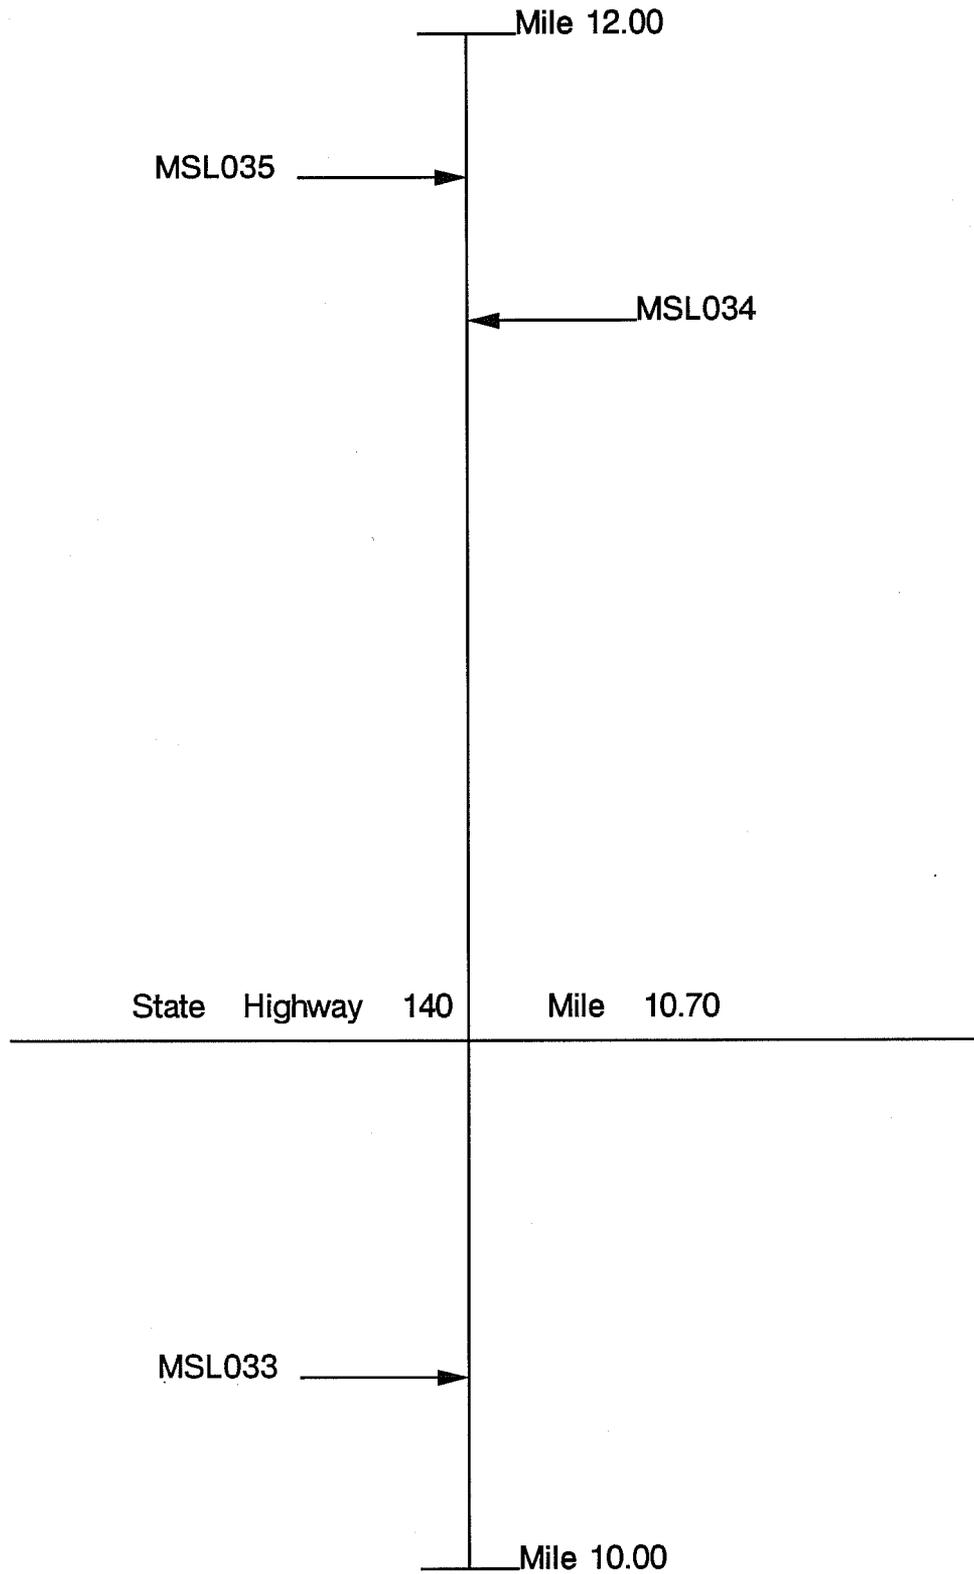
Mile 10.00 - Mile 12.00

MUD SLOUGH (NORTH)

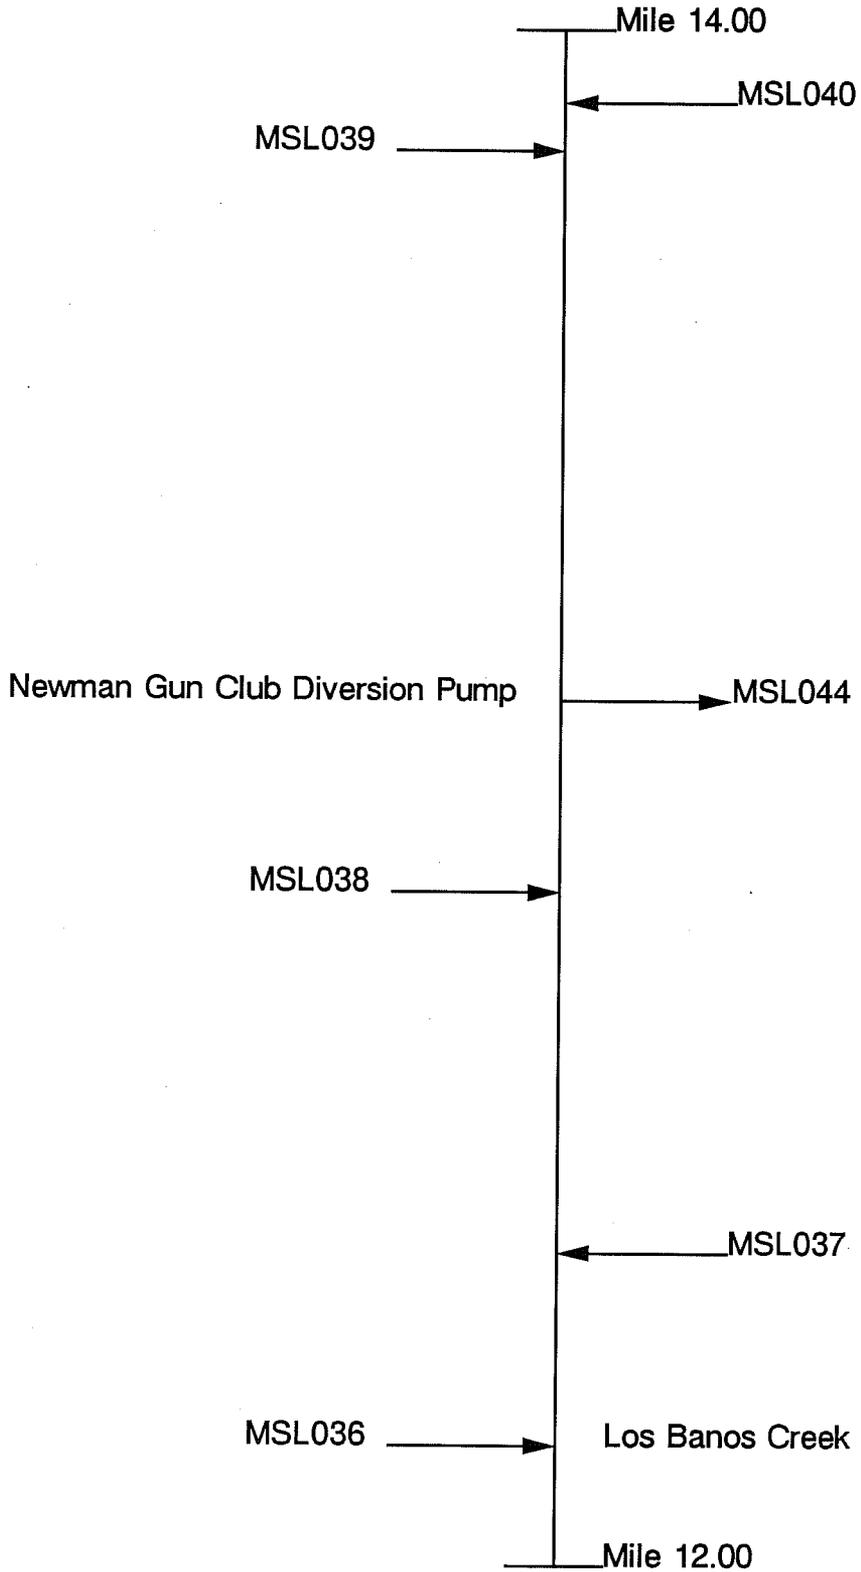
Mile 12.00 - Mile 14.00

MUD SLOUGH (NORTH)

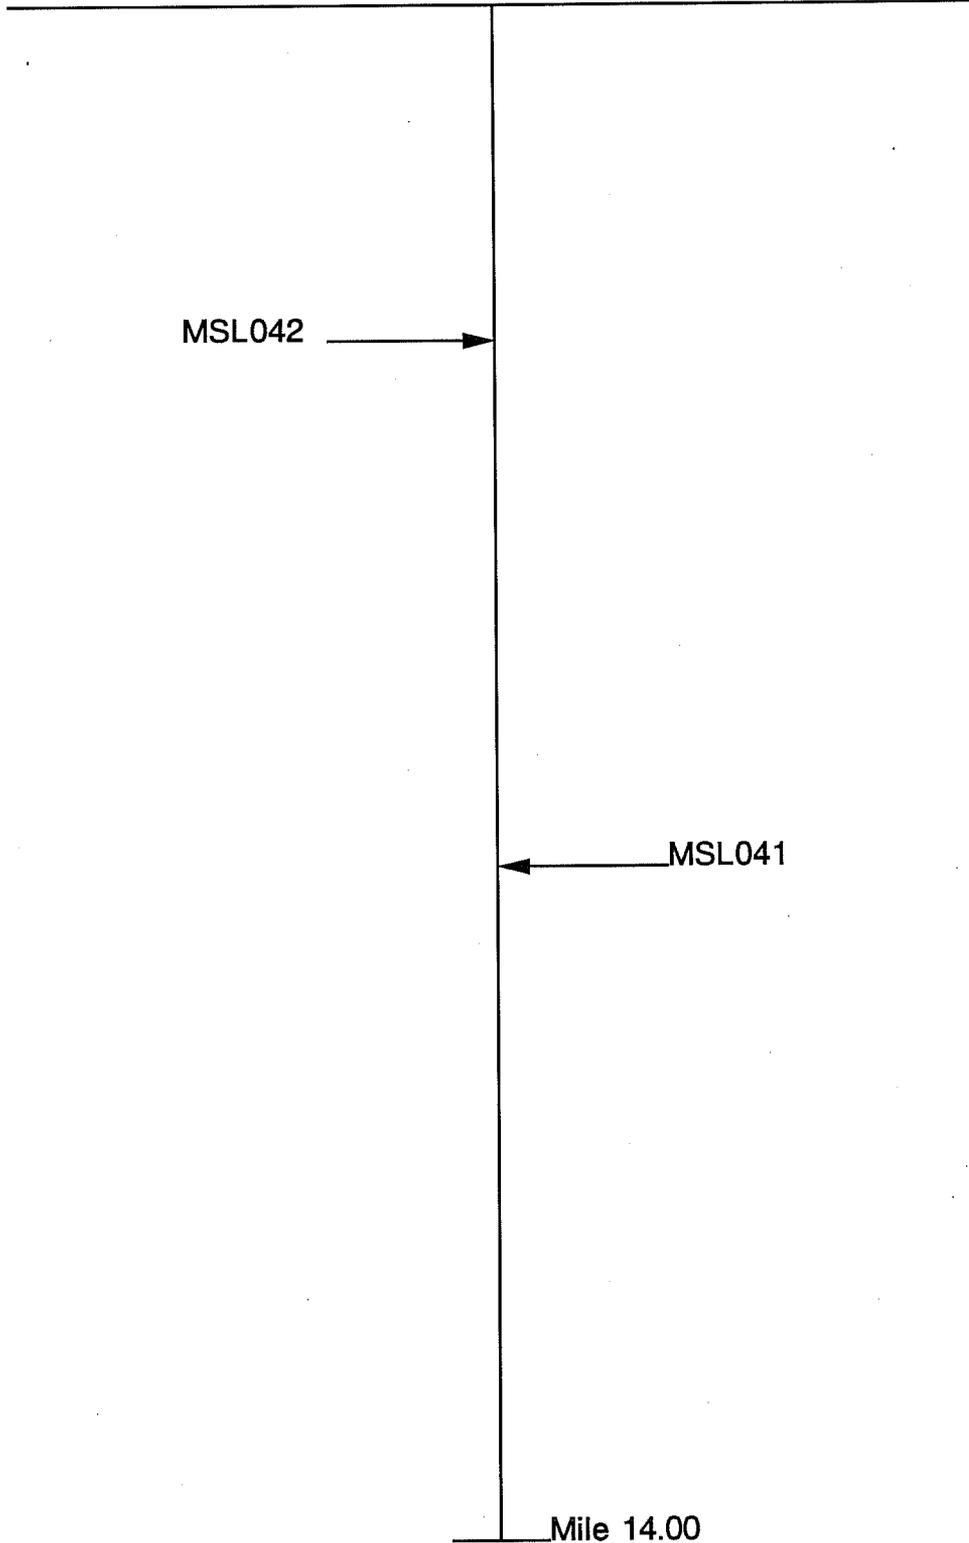
Mile 14.00 - Mile 15.98

MUD SLOUGH (NORTH)

SAN JOAQUIN RIVER MILE 15.98

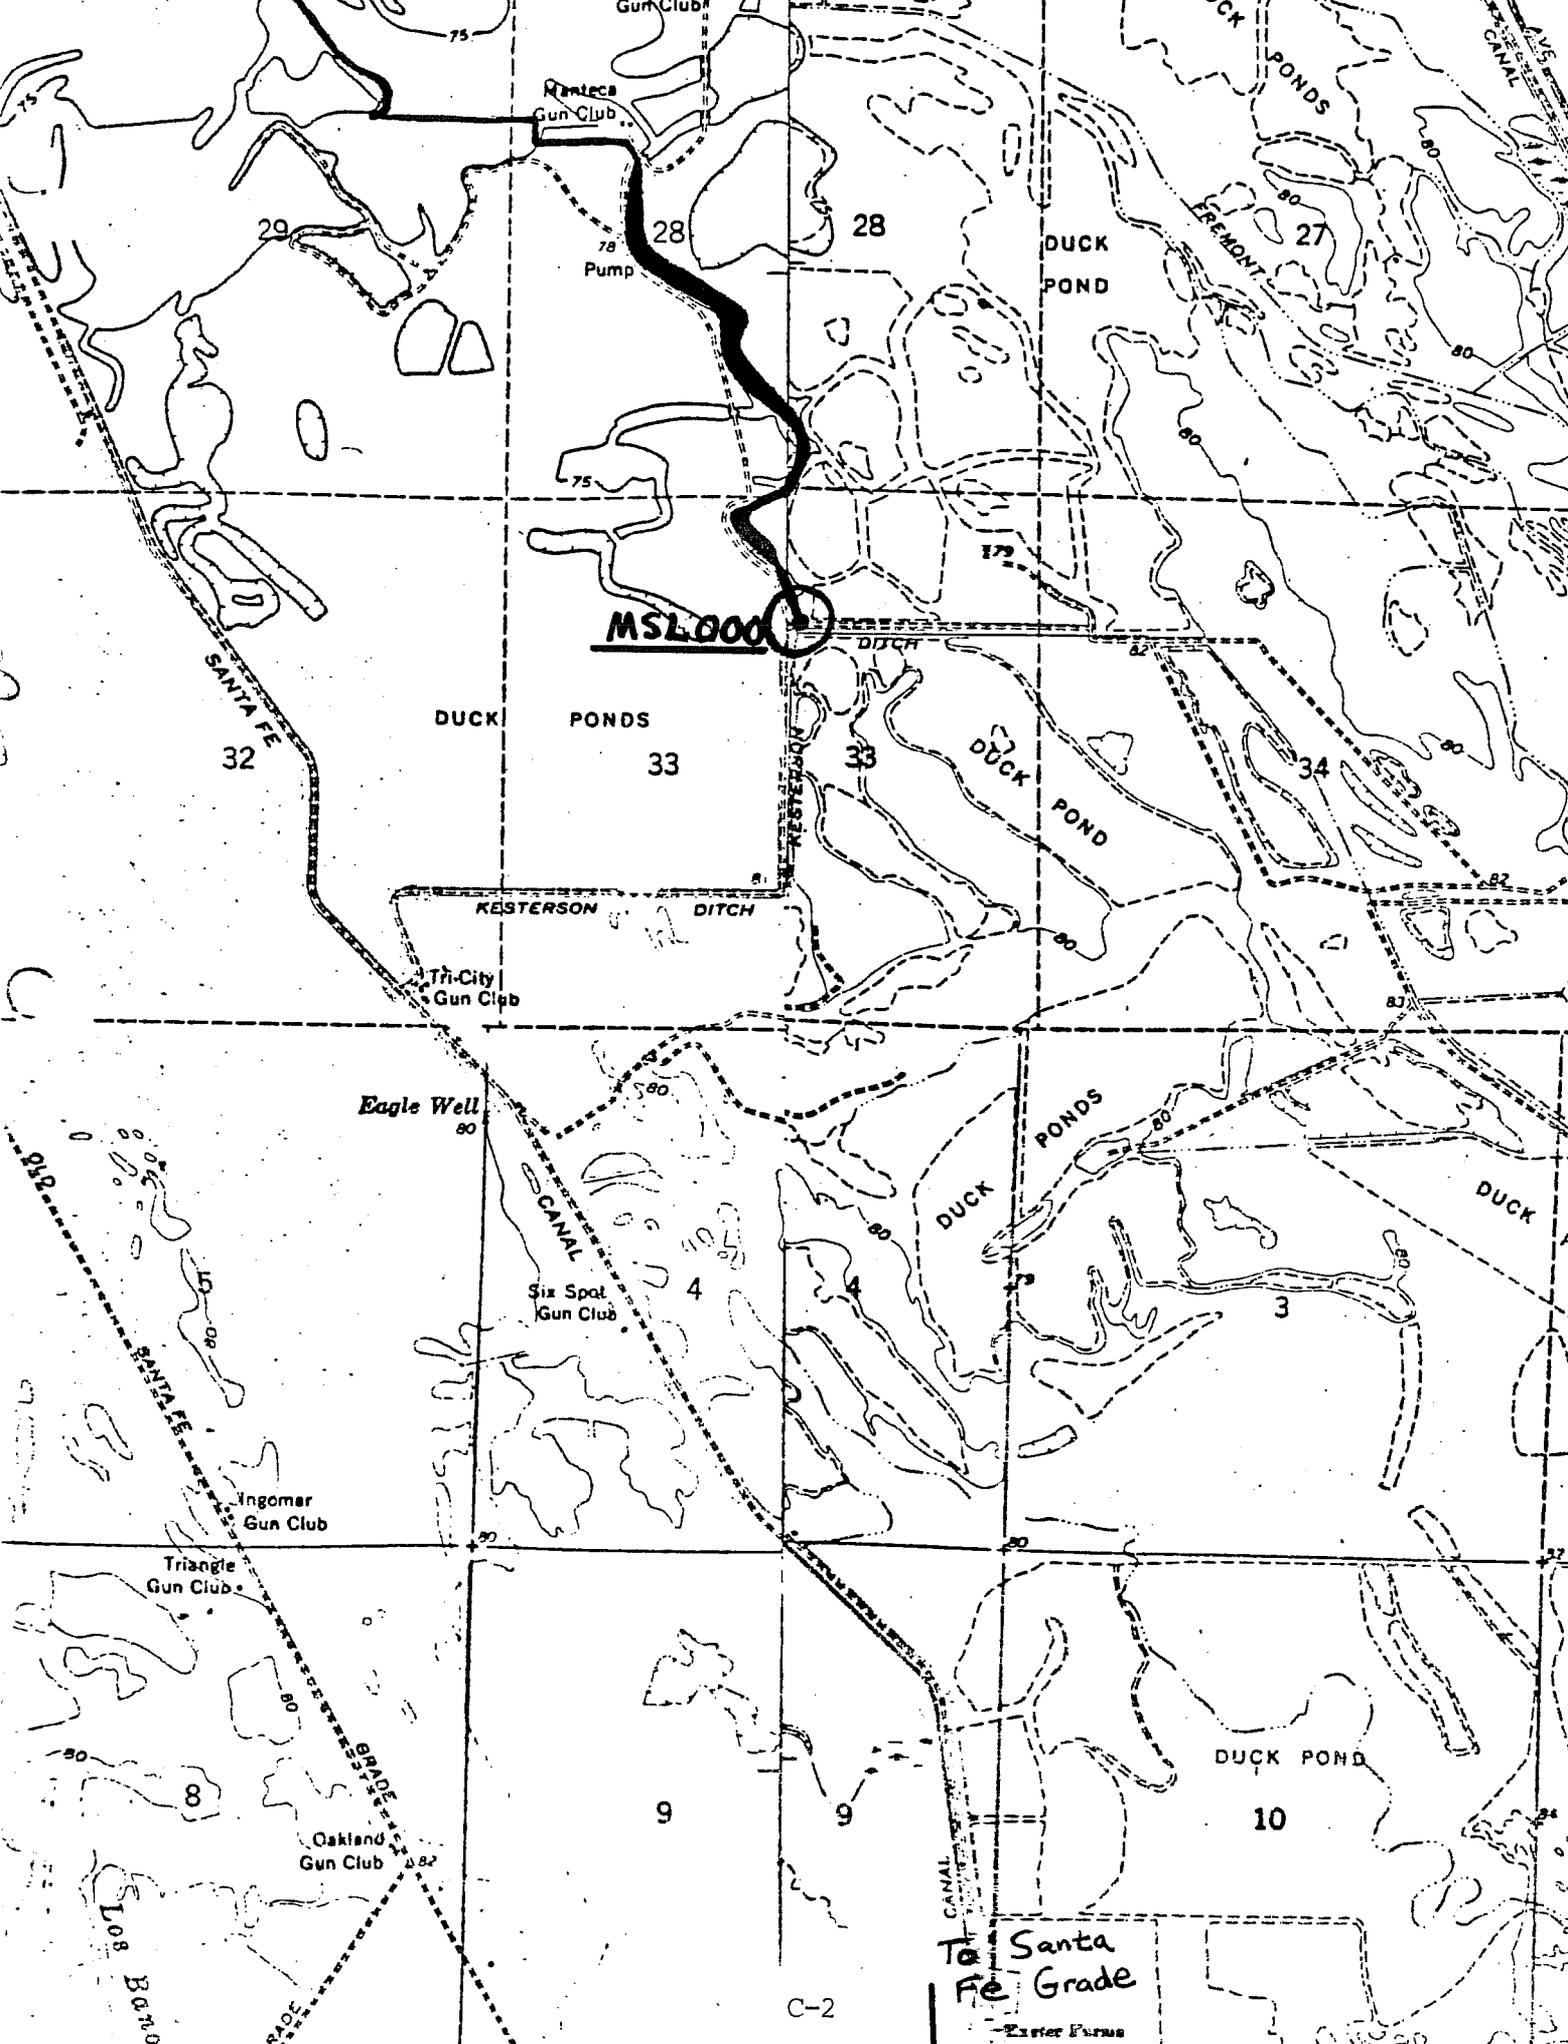
MSL000

Site description, location, and access: From Highway 152 take Mercy Springs Road north approximately 3.25 miles to the Santa Fe Grade. Head northwest on Santa Fe Grade approximately 3.4 miles to where the Santa Fe Canal turns north (0.3 miles past Wilson Road). Follow the Santa Fe Canal for approximately 3.5 miles to the Tri-City Gun Club. Kesterson Ditch begins here. Follow Kesterson Ditch for approximately 1.4 miles to where the ditch heads east. At this point two large pipes run under Kesterson Ditch from a duck pond south of the ditch to Mud Slough north of the ditch. This is the start of Mud Slough.

Type and source of water being discharged (description): The water discharged at this point is duck pond drainage from duck ponds south of Kesterson Ditch.

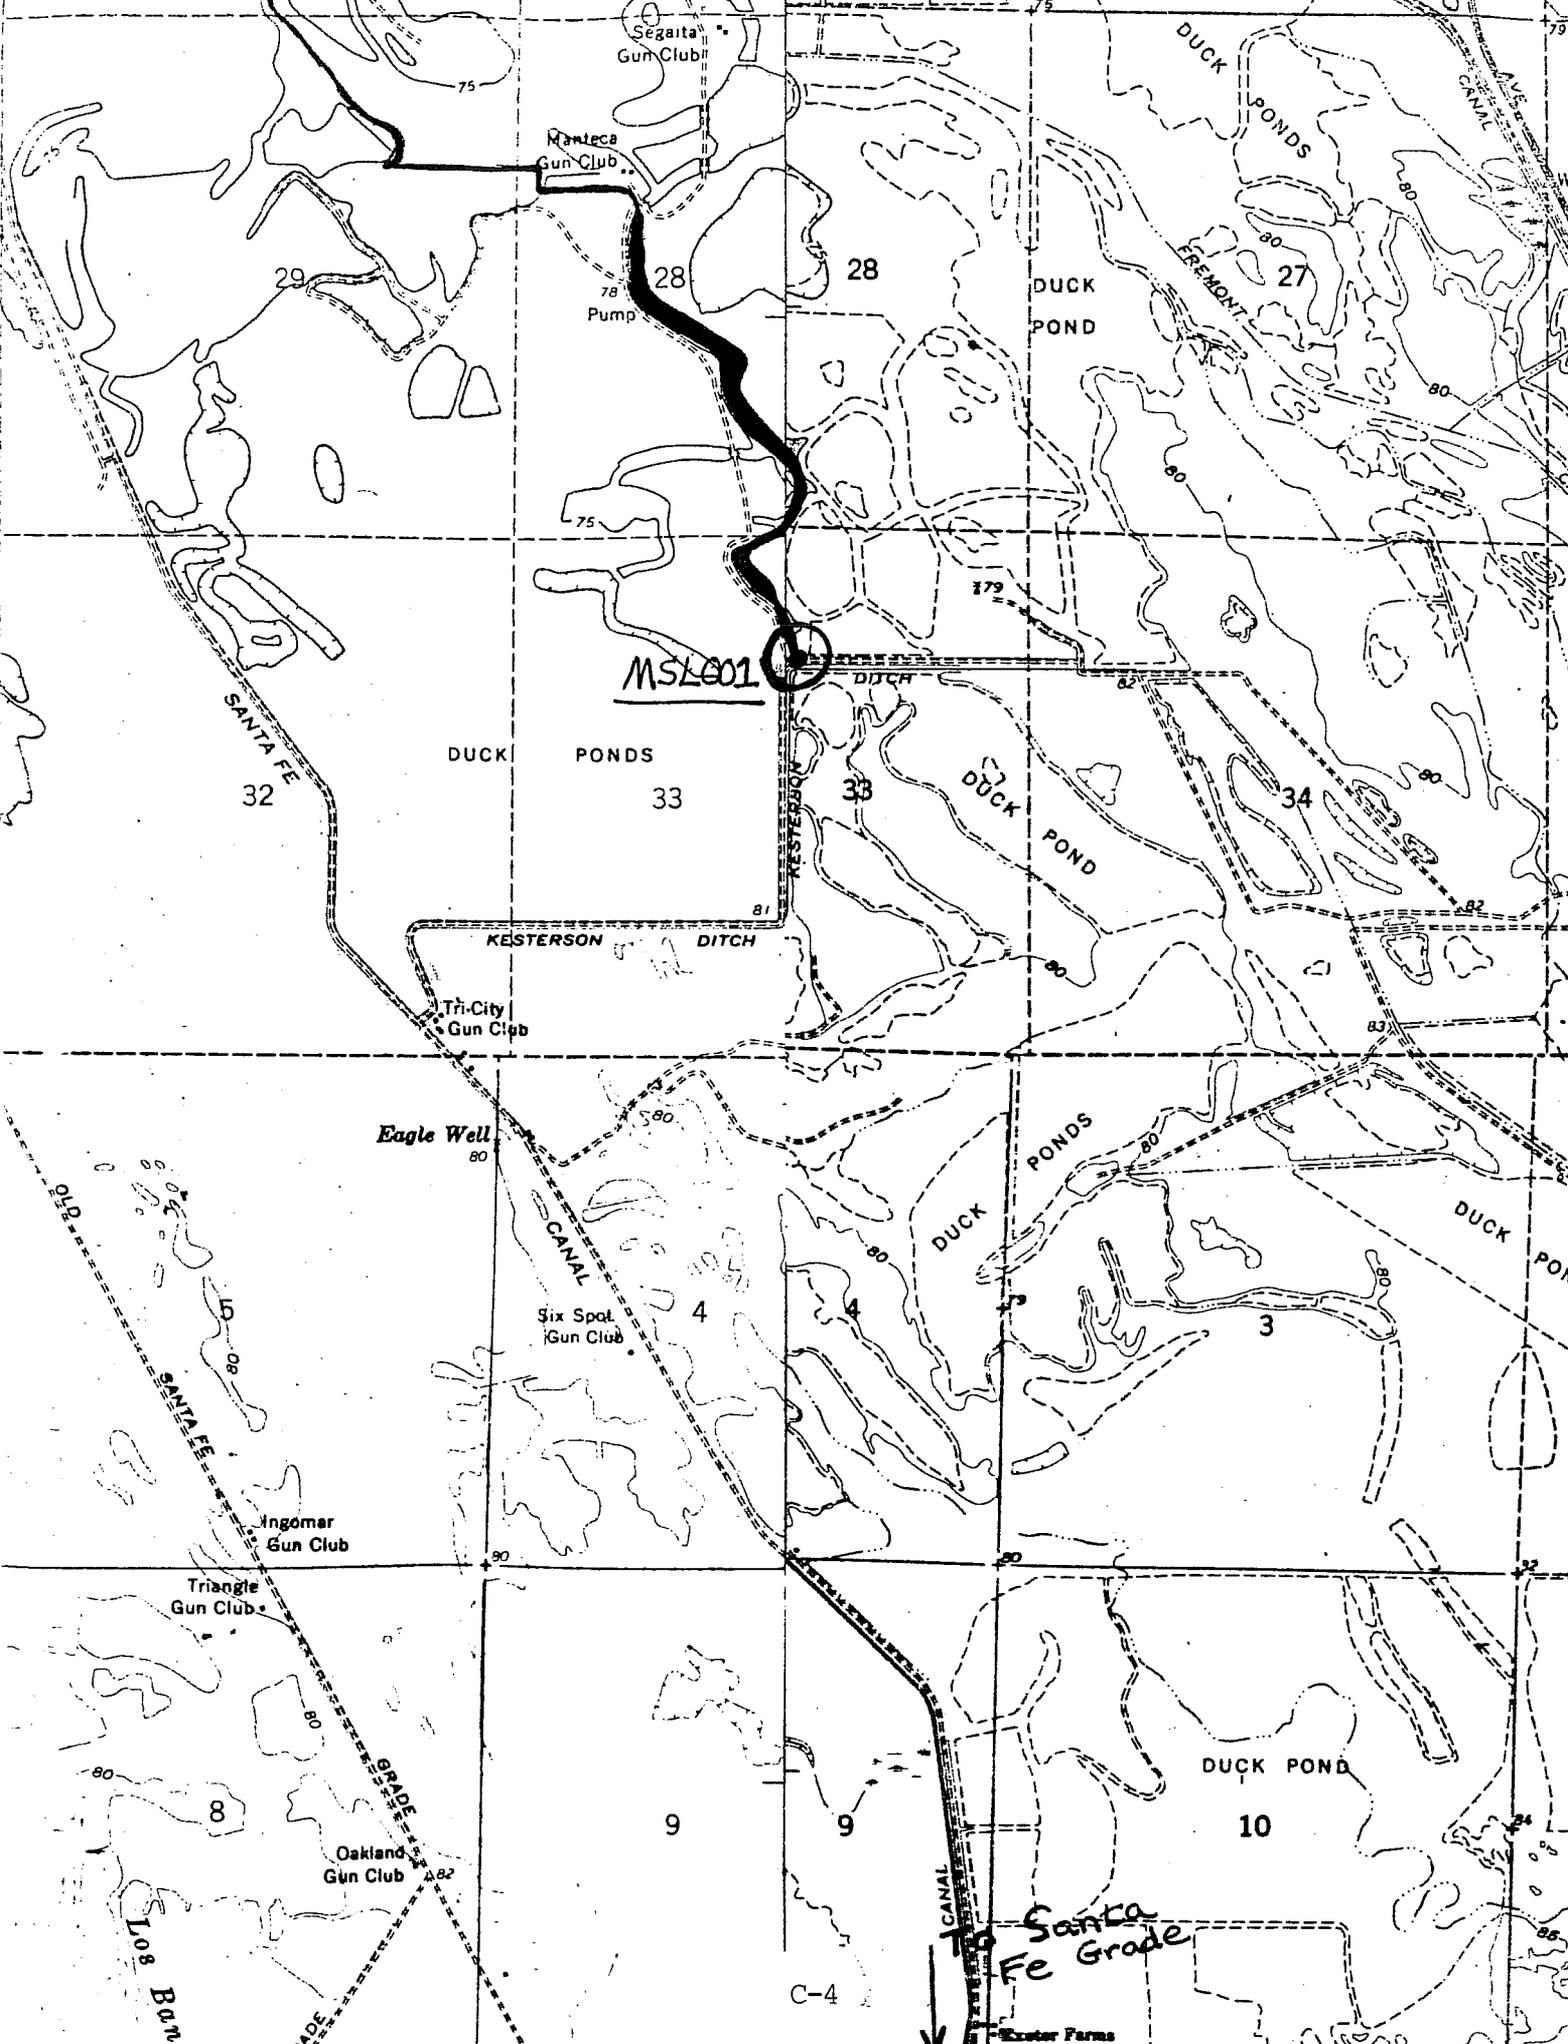
SITE ID # MSL001

Site description, location, and access: From Highway 152 take Mercy Springs Road north approximately 3.25 miles to the Santa Fe Grade. Head northwest on Santa Fe Grade approximately 3.4 miles to where the Santa Fe Canal turns north (0.3 miles past Wilson Road). Follow the Santa Fe Canal for approximately 3.5 miles to the Tri-City Gun Club. Kesterson Ditch begins here. Follow Kesterson Ditch for approximately 1.4 miles to where the ditch heads east. The Kesterson Ditch discharge to Mud Slough is a gate valve to a pipe going through the levee.

Type and source of water being discharged (description): The water discharged here comes directly from Kesterson Ditch. Kesterson Ditch receives its water from the Santa Fe Canal and is used to flood duck ponds.

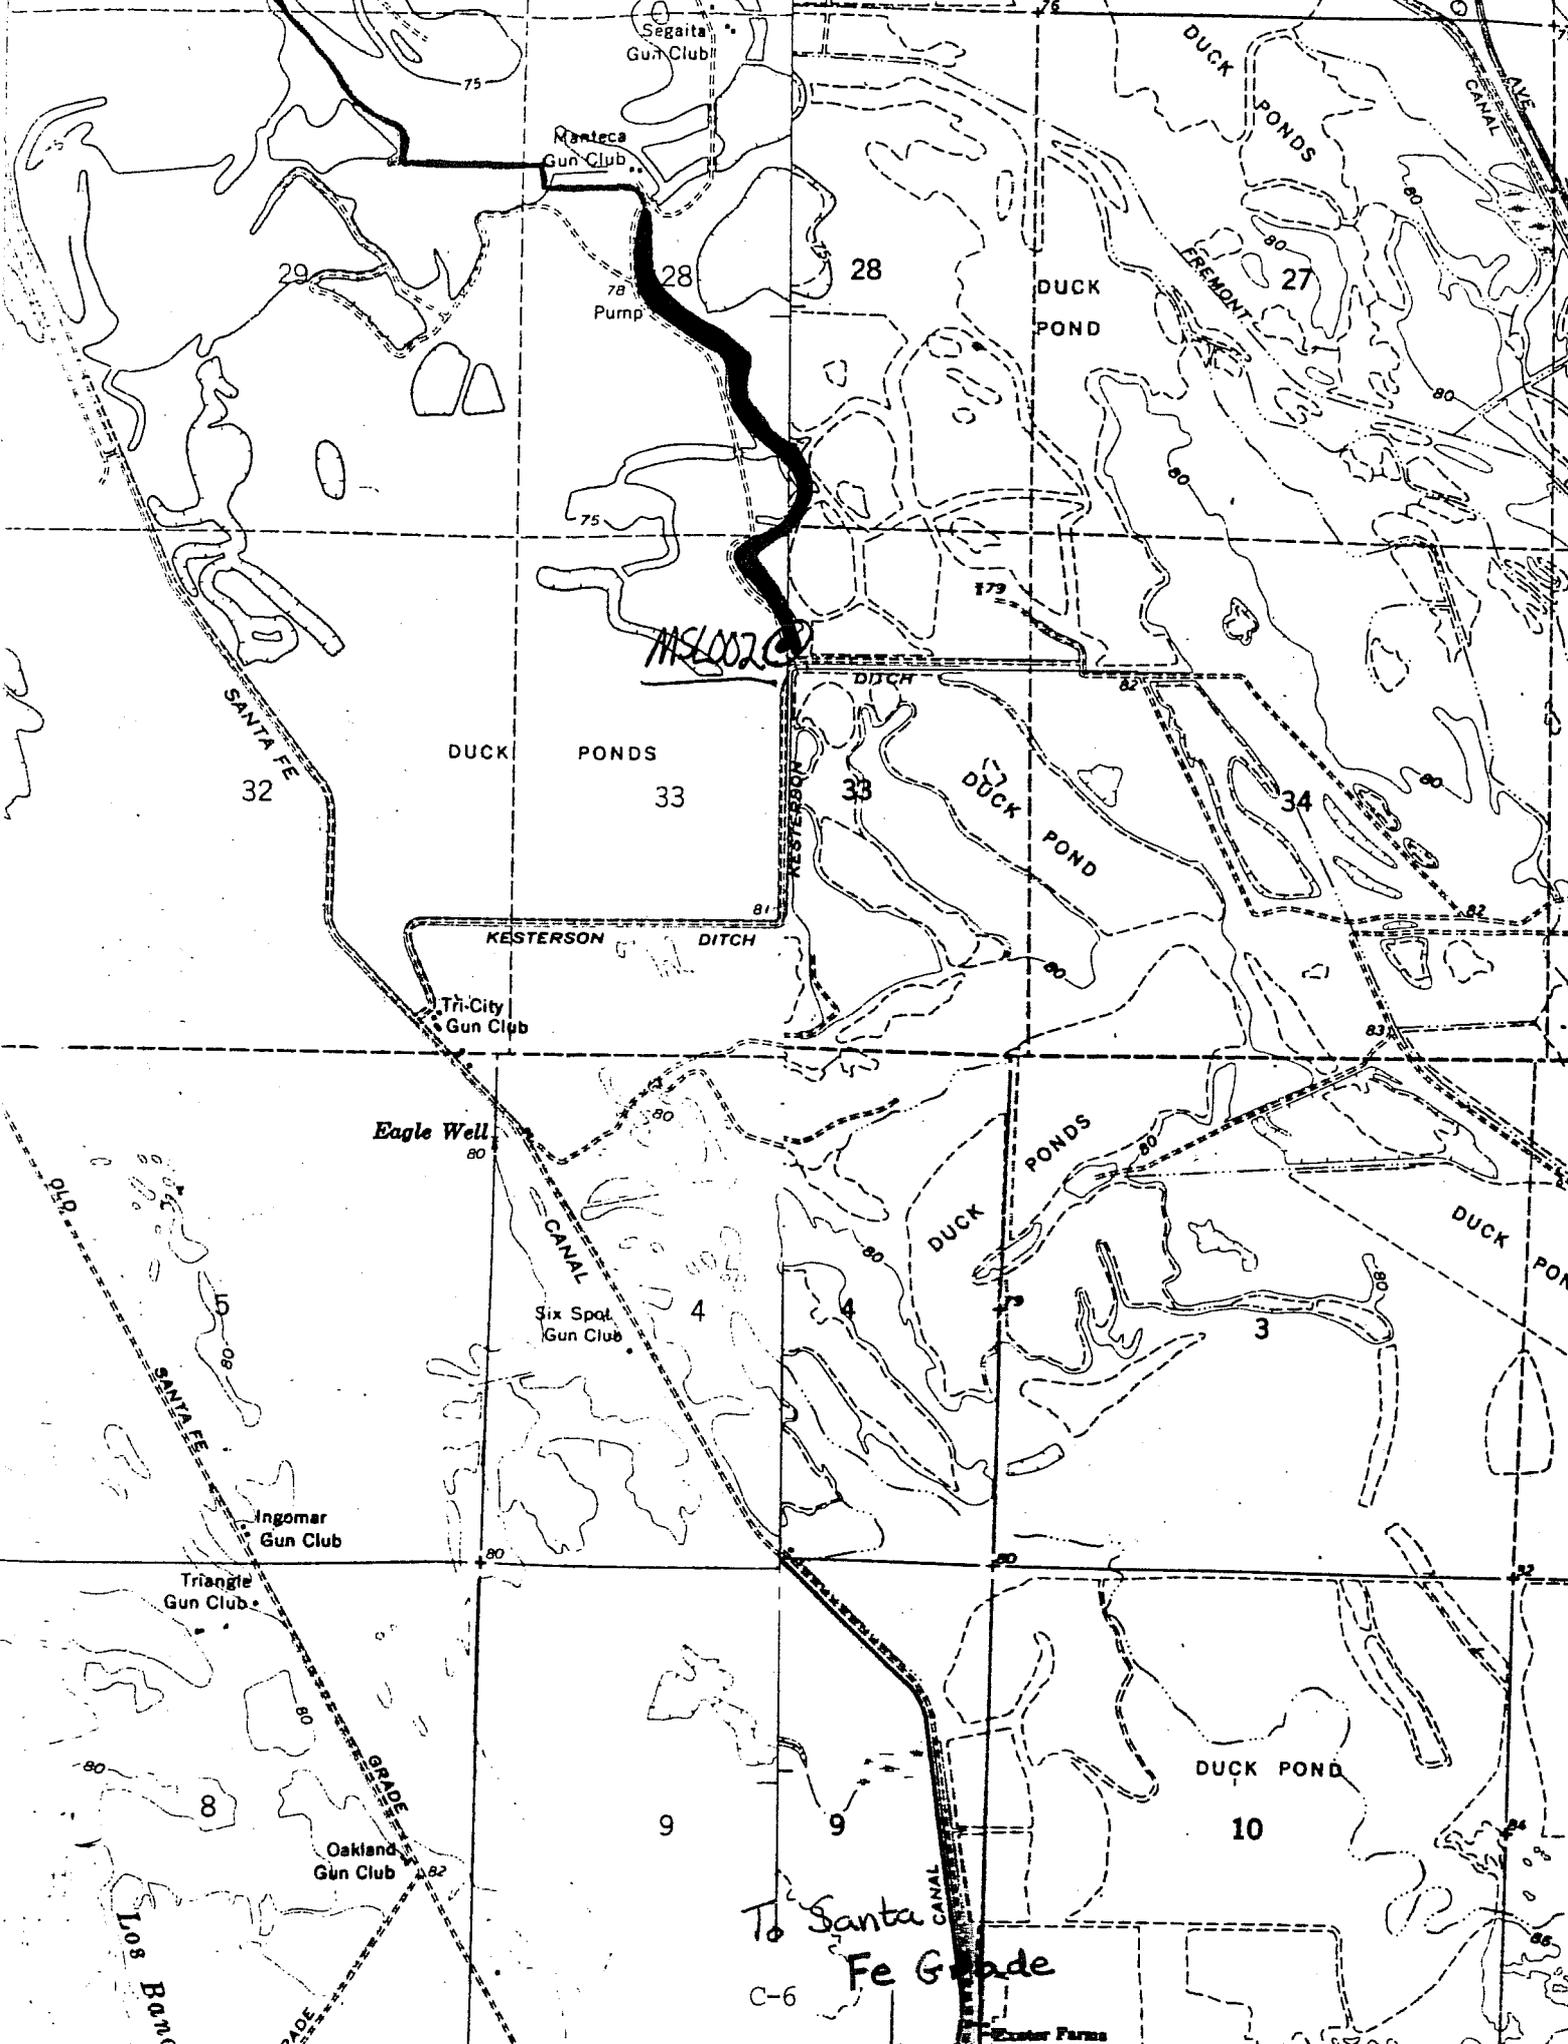
MSL002

Site description, location, and access: From Highway 152 take Mercy Springs Road north for approximately 3.25 miles to the Santa Fe Grade. Head northwest on Santa Fe Grade approximately 3.4 miles to where the Santa Fe Canal turns north (0.3 miles past Wilson Road). Follow the Santa Fe Canal for approximately 3.5 miles to the Tri-City Gun Club. Kesterson Ditch begins here. Follow Kesterson Ditch for approximately 1.4 miles to where the ditch heads east. Mud Slough begins at this point. The discharge site is a pipe to Mud Slough from a ditch paralleling it on the west side.

Type and source of water being discharged (description): The water discharged at this point is spill water from a paralleling ditch.
