HYDROLOGY STUDY OF MUD
SLOUGH (NORTH), MERCED COUNTY

California Regional Water Quality Control Board
Central Valley Region
3443 Routier Road
Sacramento, California 95827-3098

February 1989

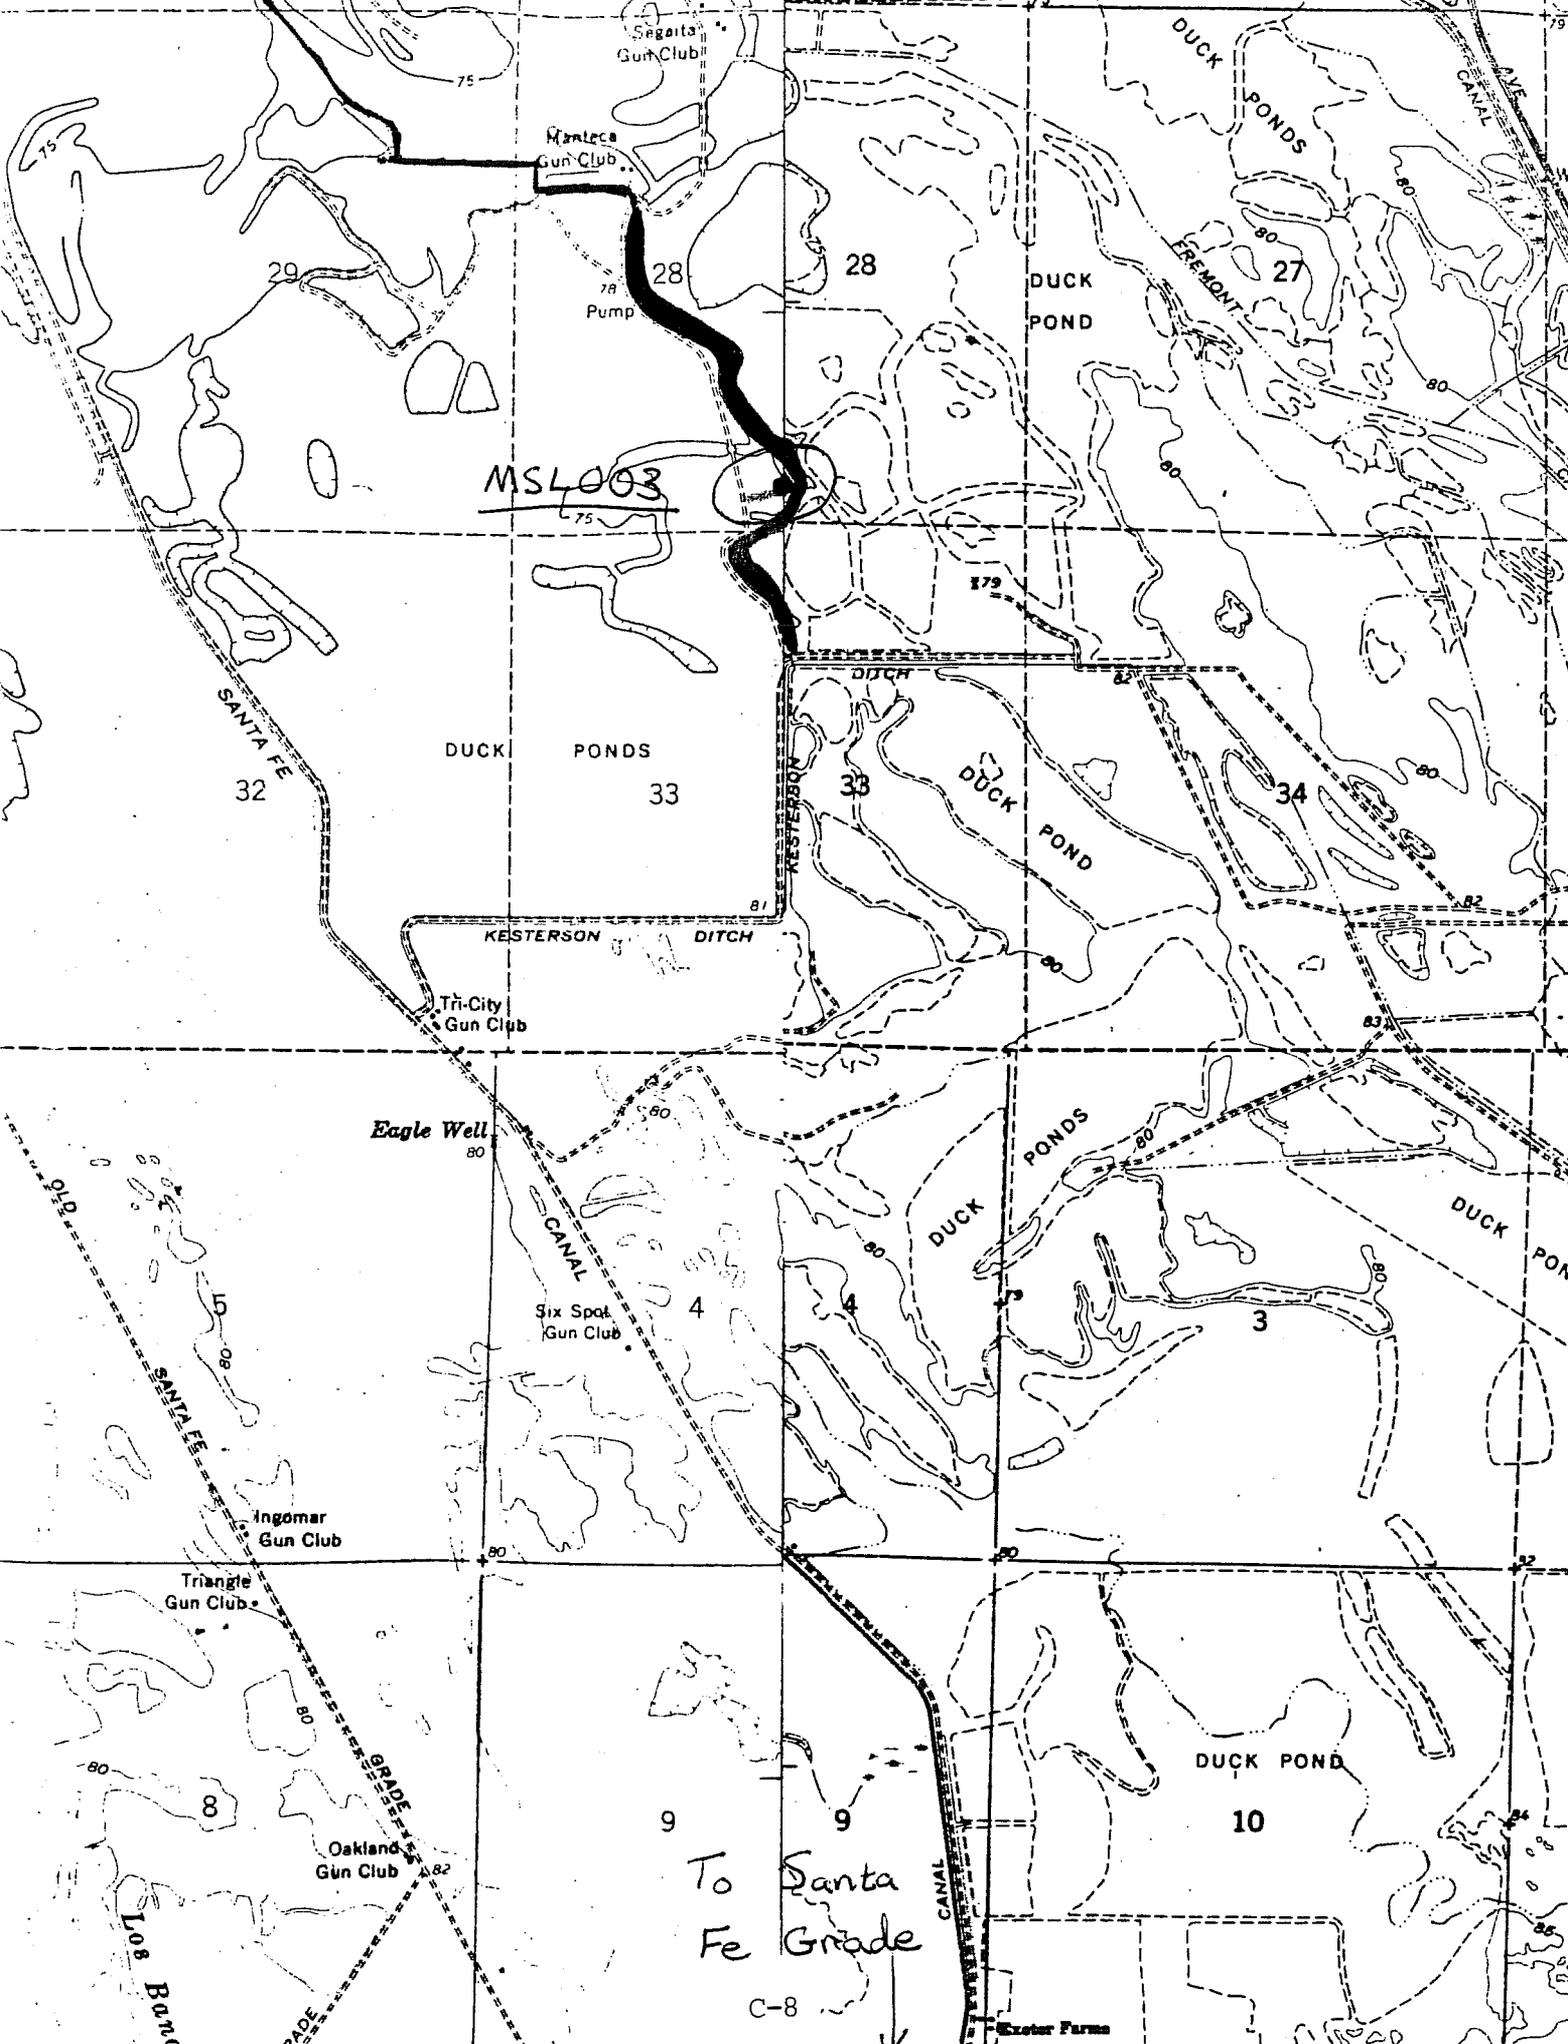
MSL 003

Site description, location, and access: From Highway 152 take Mercy Springs Road north approximately 3.25 miles to the Santa Fe Grade. Head northwest on Santa Fe Grade approximately 3.4 miles to where the Santa Fe Canal turns north (0.3 miles northwest of Wilson Road). Follow the Santa Fe Canal for approximately 3.5 miles to the Tri-City Gun Club. Kesterson Ditch begins here. Follow Kesterson Ditch for approximately 1.4 miles to where the ditch heads east. Mud Slough begins here. Follow Mud Slough north for approximately 0.4 miles to a pipe under crossing the road. At this point follow this channel (on foot) eastward to where the channel discharges to Mud Slough.

Type and source of water being discharged (description): The water discharged at this point is duck pond drainage.

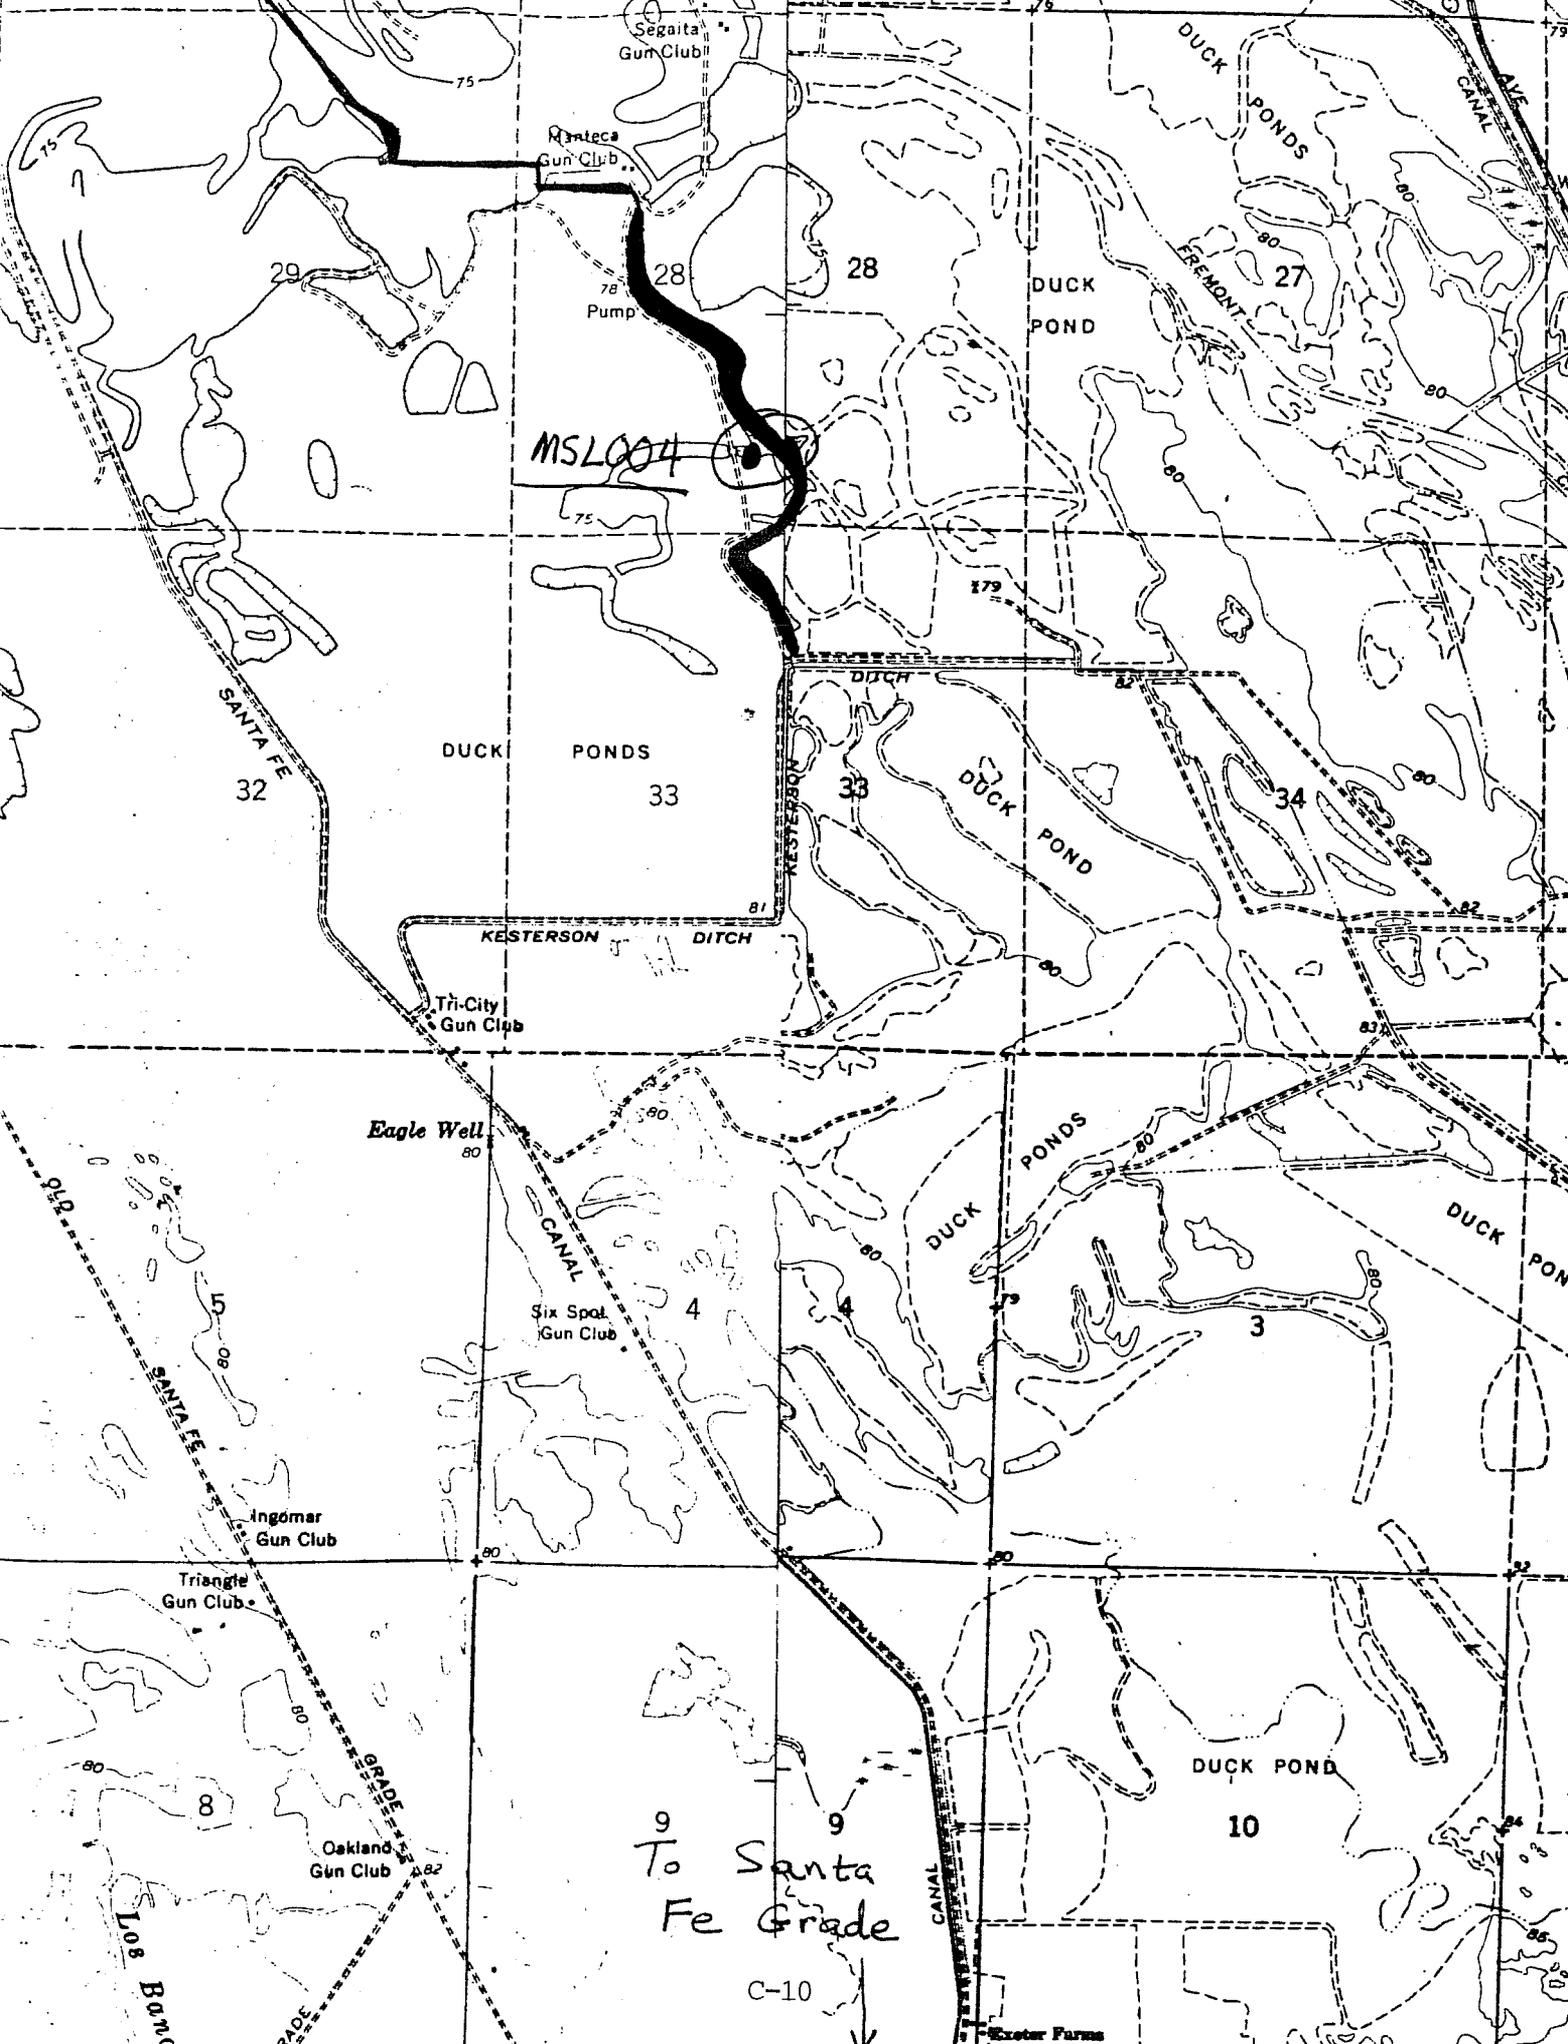
MSL 004

Site description, location, and access: From Highway 152 take Mercy Springs Road north for approximately 3.25 miles to the Santa Fe Grade. Head northwest on Santa Fe Grade approximately 3.4 miles to where the Santa Fe Canal turns north (0.3 miles northwest of Wilson Road). Follow the Santa Fe Canal for approximately 3.5 miles to the Tri-City Gun Club. Kesterson Ditch begins here. Follow Kesterson Ditch for approximately 1.4 miles to where the ditch heads east. Mud Slough begins here. Follow Mud Slough north for approximately 0.5 miles to a pipe under crossing the road. At this point follow this channel eastward to where the channel discharges to Mud Slough.

Type and source of water being discharged (description): The water discharged at this point is duck pond drainage.

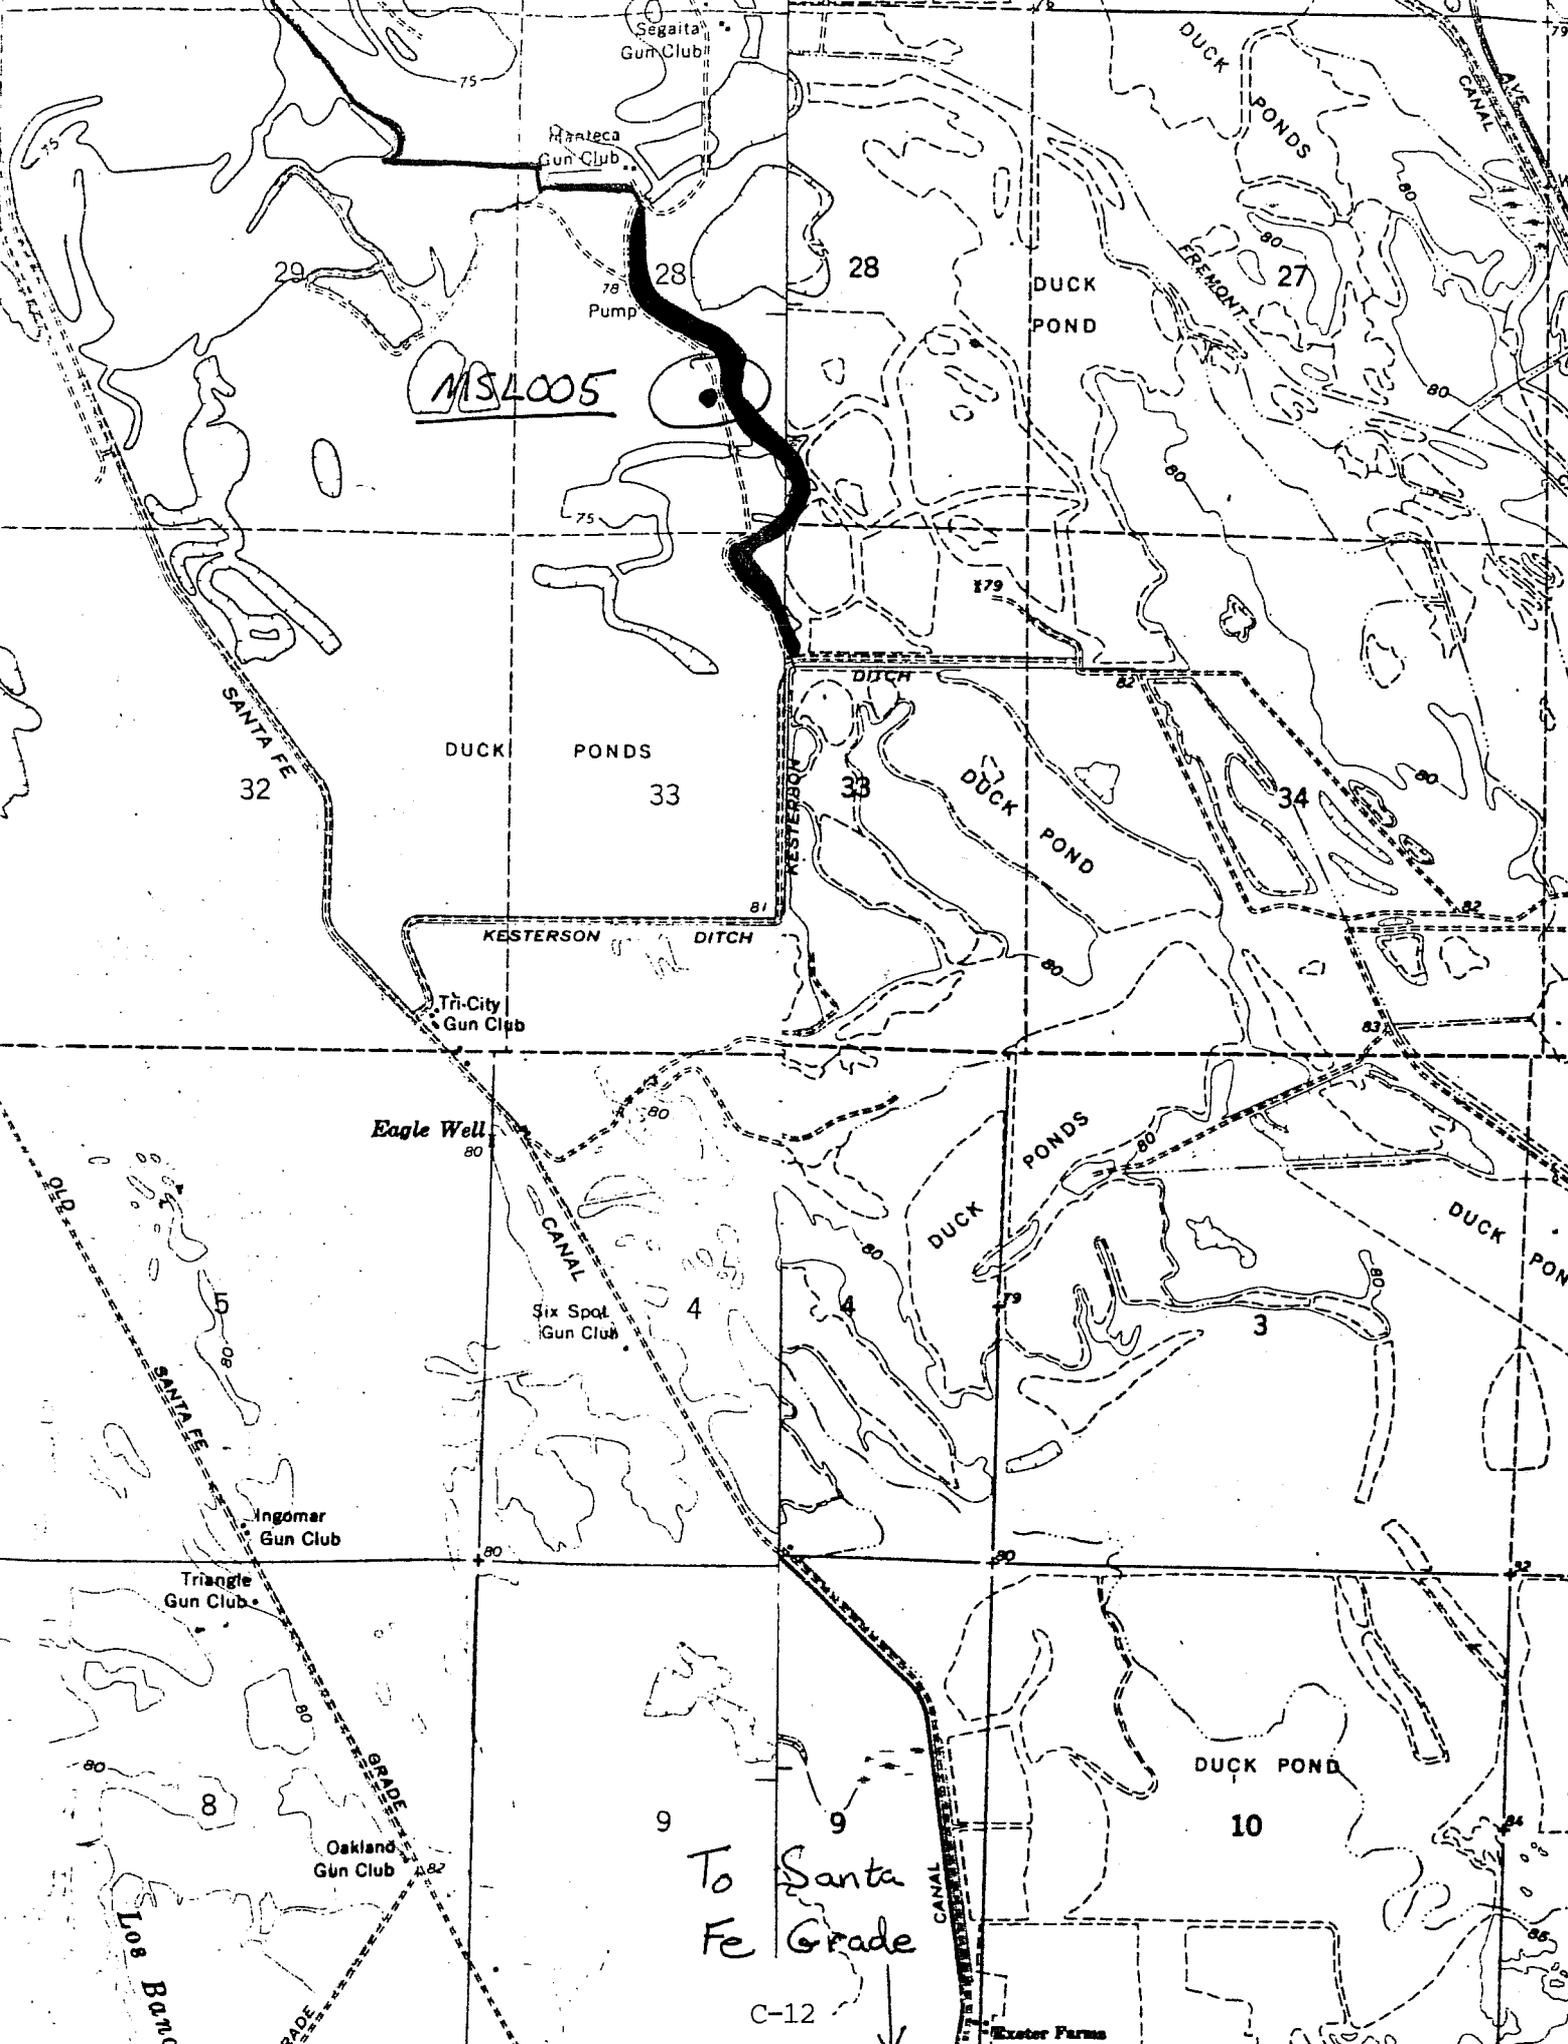
MSL005

Site description, location, and access: From Highway 152 take Mercy Springs Road north for approximately 3.25 miles to the Santa Fe Grade. Head northwest on Santa Fe Grade for approximately 3.4 miles to where the Santa Fe Canal turns north (0.3 miles northwest of Wilson Road). Follow the Santa Fe Canal for approximately 3.5 miles to the Tri-City Gun Club. Kesterson Ditch begins here. Follow Kesterson Ditch for approximately 1.4 miles to where the ditch heads east. Mud Slough begins here. Follow Mud Slough north for approximately 0.6 miles to where the road turns due west. The discharge is a channel just over the fence from this turn.

Type and source of water being discharged (description): The water discharged at this point is duck pond drainage.

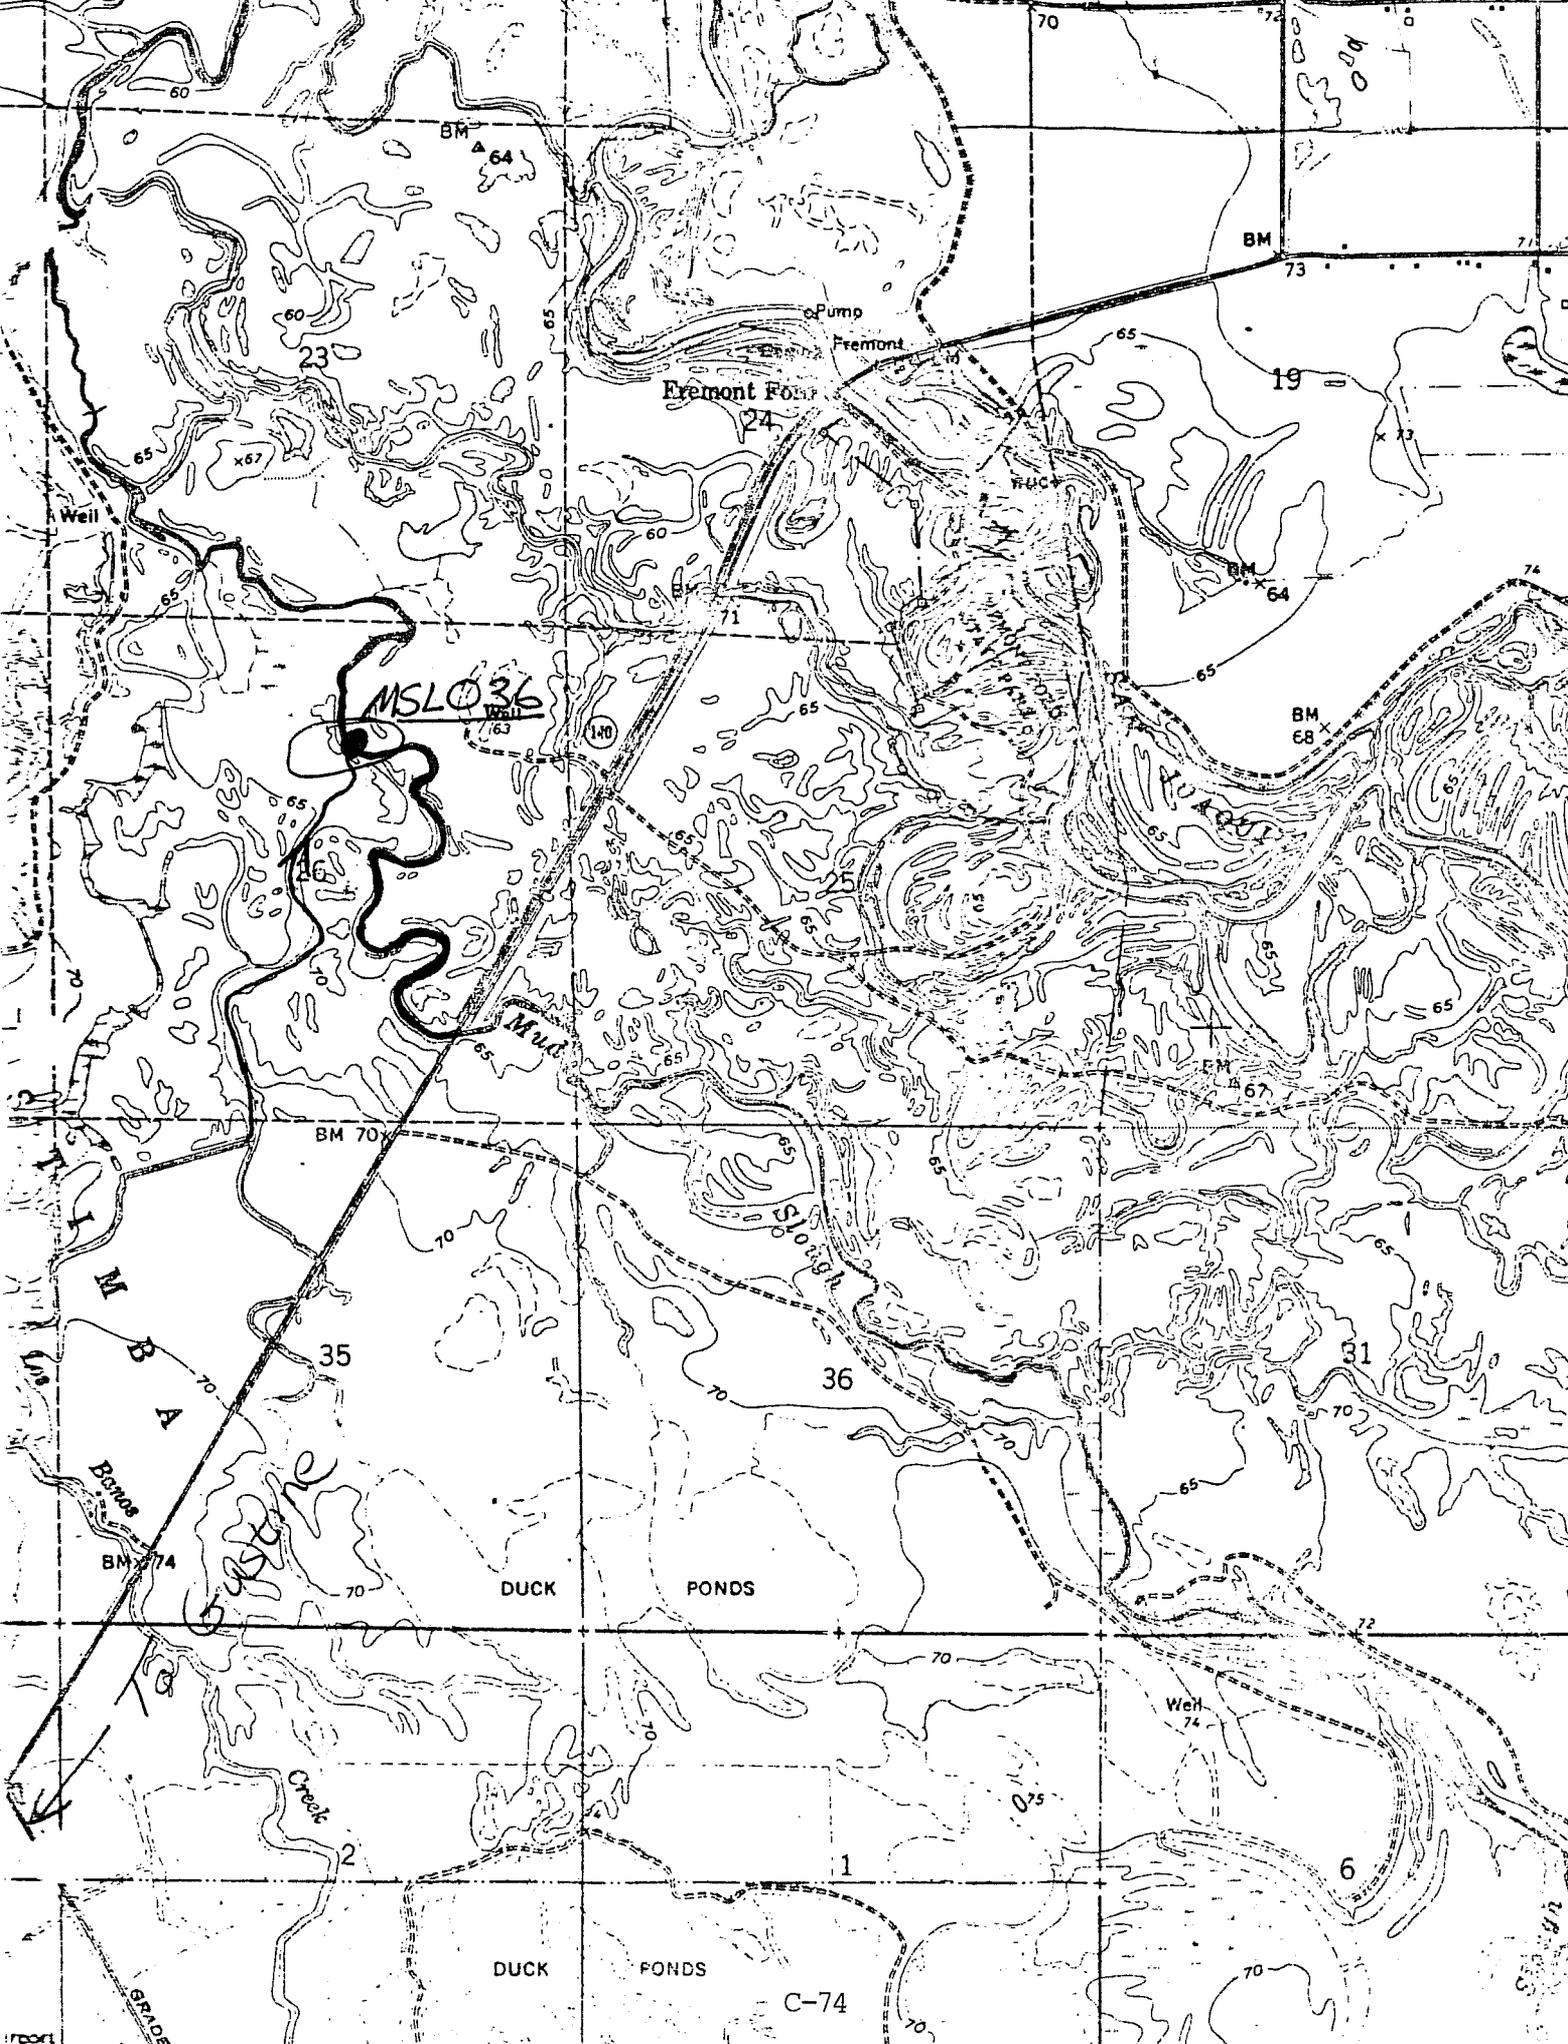
MSLO 36

Site Name: Los Banos Creek at Mud Slough Slough Mileage: 12.15W

Site description, location, and access: From Highway 33 take Highway 140 east for approximately 4.3 miles to where Mud Slough undercrosses the road. At this point hike along the slough's west bank for approximately 1.45 miles to where a large channel enters the slough from its west bank. This is Los Banos Creek.

Type and source of water being discharged (description): The majority of water discharged at this point is irrigation district spill water.

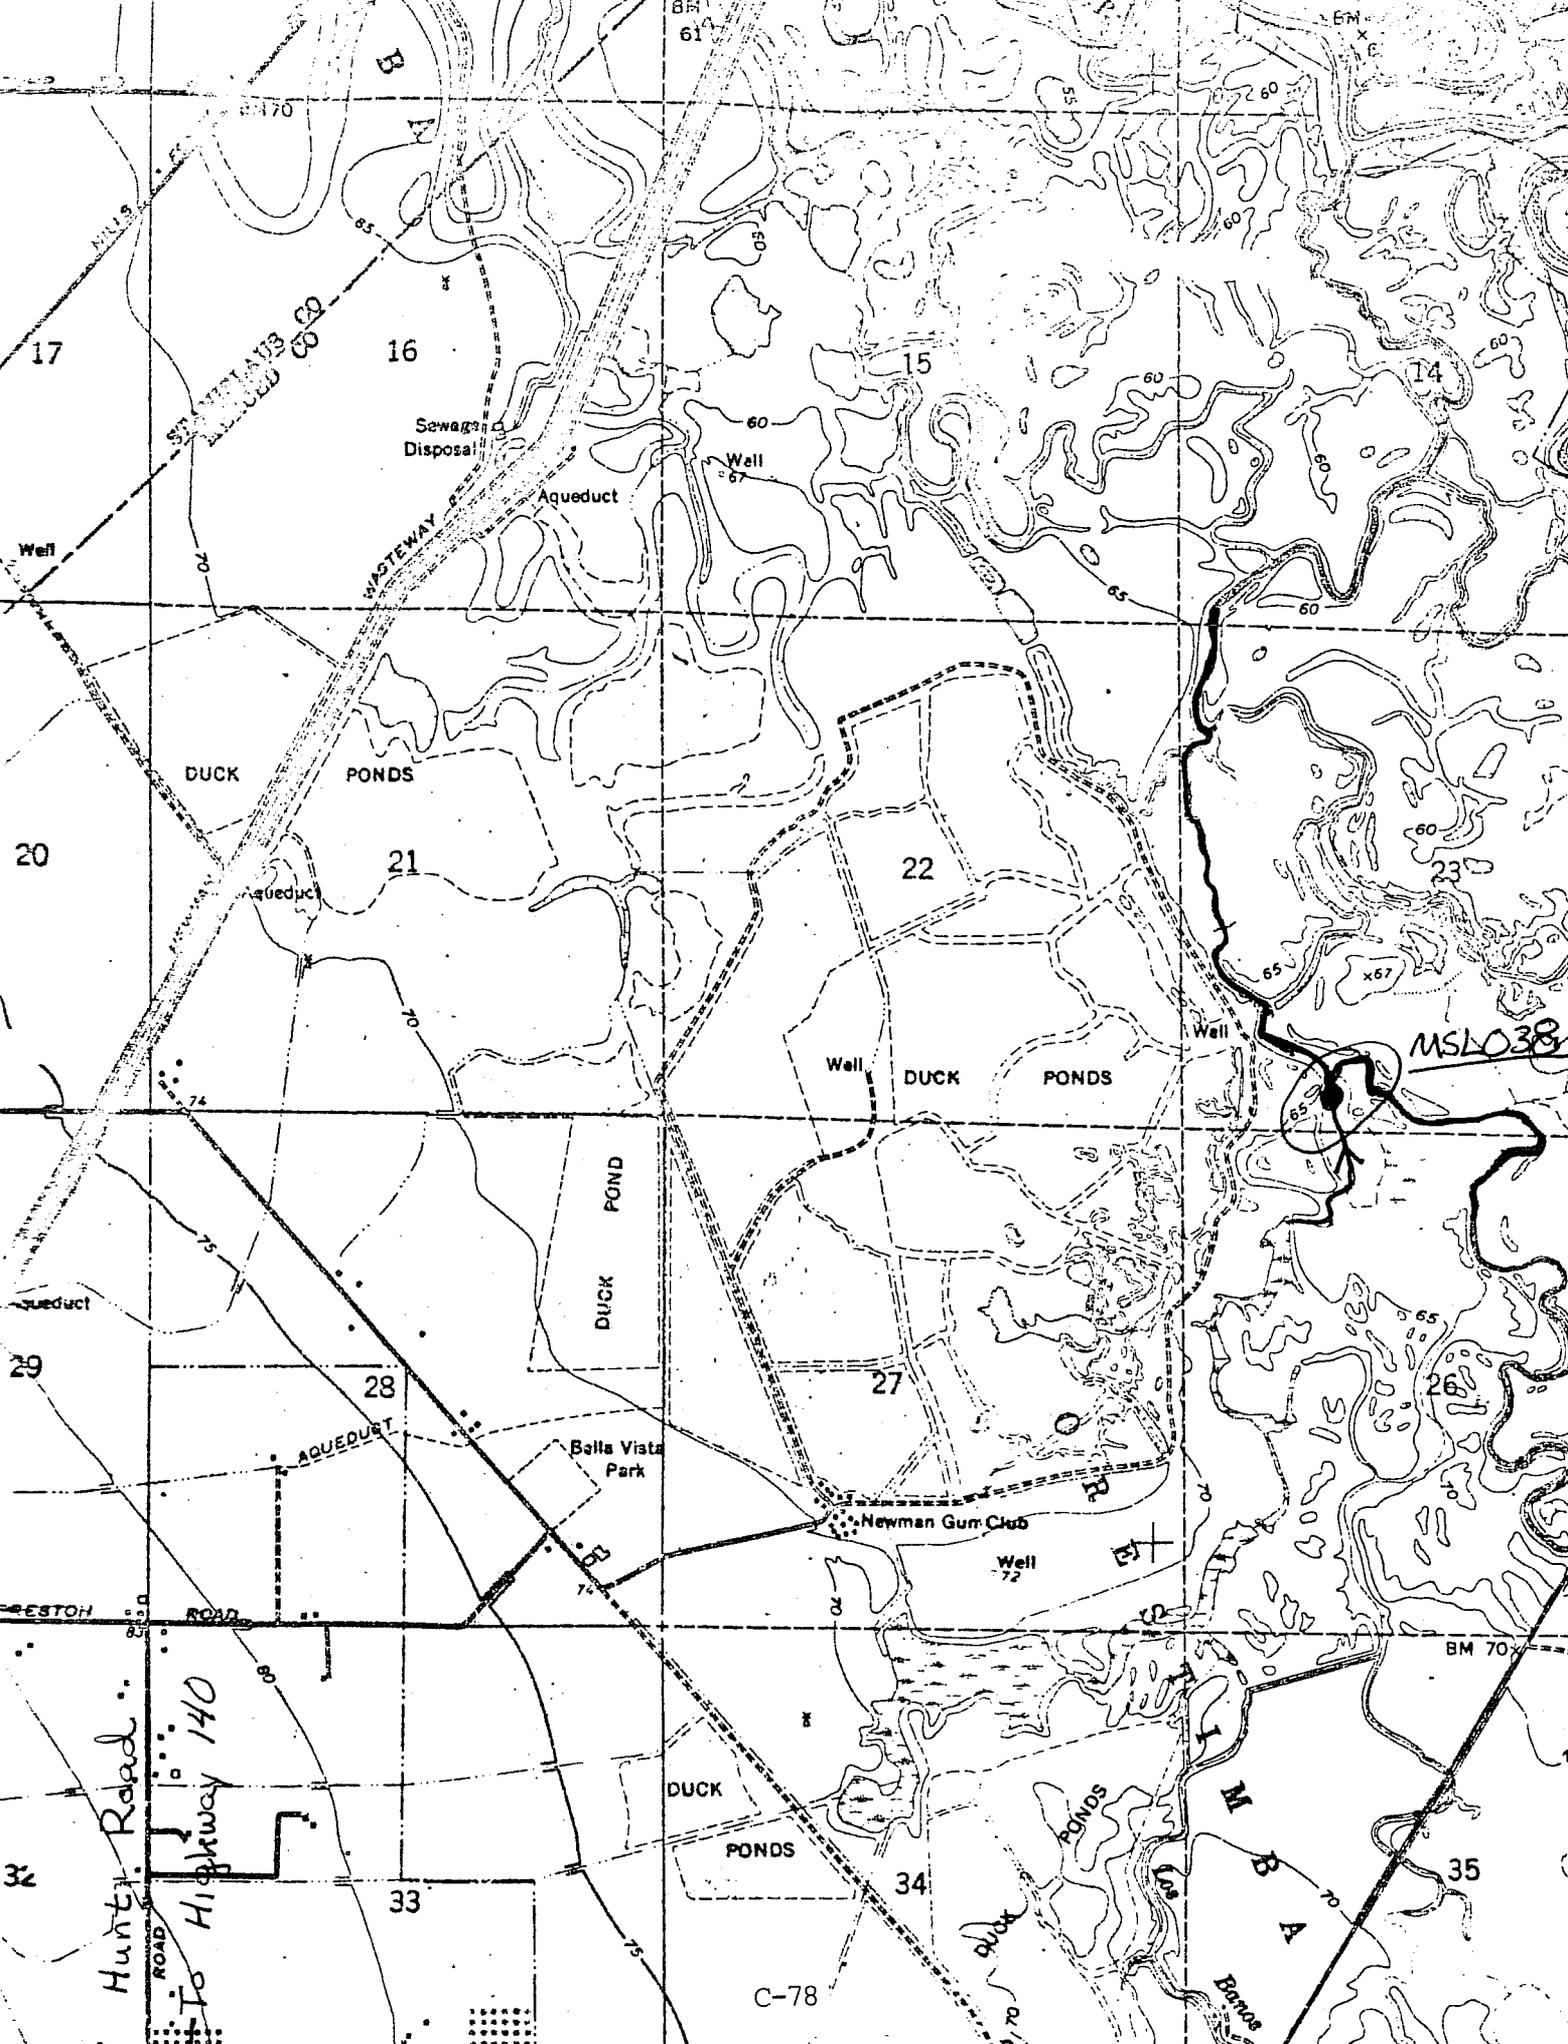
SITE ID # MSL038

Site description, location, and access: From Gustine take Hunt Road north from Highway 140. Follow Hunt Road to the end, approximately 2.0 miles, and turn east on Preston Road. Follow Preston Road to Santa Fe Grade and go south. Santa Fe Grade does not go through to the south, but the road veers east to the Newman Gun Club. Follow the road through the compound and continue on for approximately 1.7 miles to where a pump lifts water out of Mud Slough. From this pump follow the slough south for approximately 0.2 miles to where the slough forms a large pool. Follow this pool south to where it becomes channelized. This is the discharge site.
