**Prosecution Team Case-in-Chief
Confusion Hill Bypass Project**

California Regional Water Quality Control Board
North Coast Region

Administrative Civil Liability Complaint No. R1-2009-0095

In the Matter of
California Department of Transportation
Confusion Hill Bypass Project
WDID No. 1B05153WNME

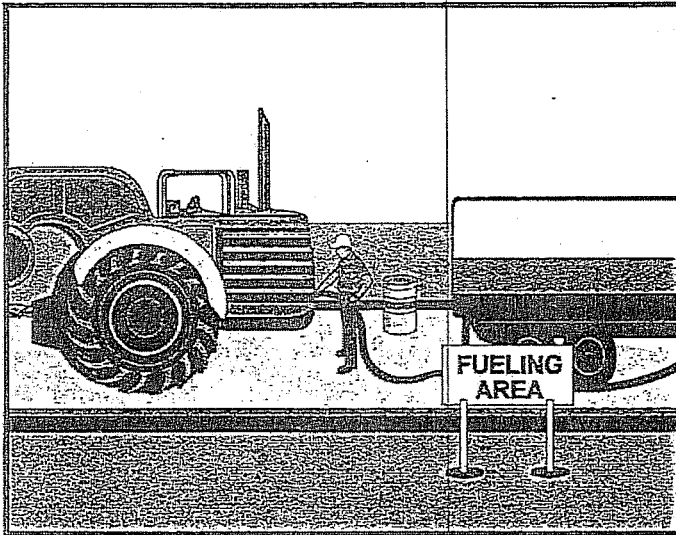
NS-9

Vehicle and Equipment Fueling

Definition and Purpose Vehicle and equipment fueling procedures and practices are designed to minimize or eliminate the discharge of fuel spills and leaks into storm drain systems or to watercourses.

- Fuel tanks shall not be "topped-off."
- Vehicles and equipment shall be inspected on each day of use for leaks. Leaks shall be repaired immediately or problem vehicles or equipment shall be removed from the project site.

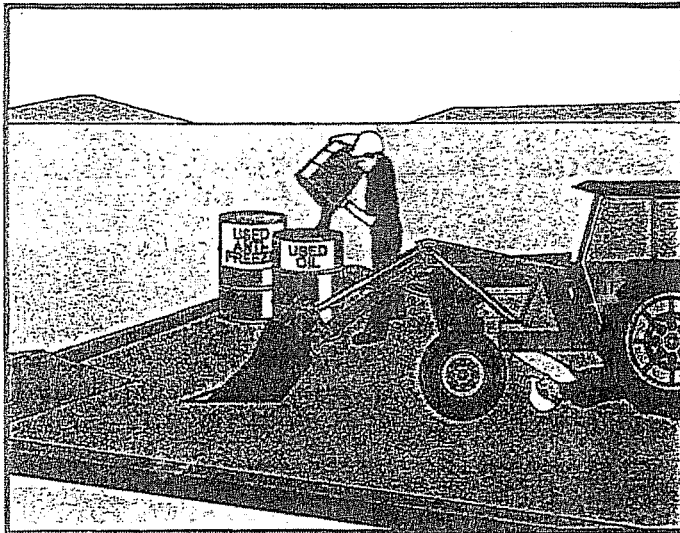
NS-10

Vehicle and Equipment Maintenance

- For long-term projects, consider constructing roofs or using portable tents over maintenance areas.
- Properly dispose of used oils, fluids, lubricants, and spill cleanup materials.
- Do not dump fuels and lubricants onto the ground.
- Do not place used oil in a dumpster or pour into a storm drain or watercourse.
- Properly dispose or recycle used batteries.
- Do not bury used tires.
- Repair of fluid and oil leaks immediately.
- Provide spill containment dikes or secondary containment around stored oil and chemical drums.

- Maintain waste fluid containers in leak proof condition.
- Vehicle and equipment maintenance areas shall be inspected regularly.
- Vehicles and equipment shall be inspected on each day of use. Leaks shall be repaired immediately or the problem vehicle(s) or equipment shall be removed from the project site.
- Inspect equipment for damaged hoses and leaky gaskets routinely. Repair or replace as needed.

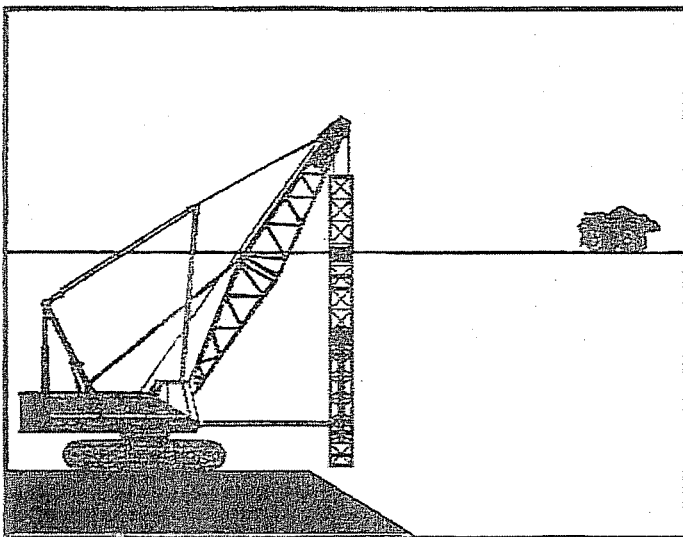
NS-11

Pile Driving Operations

Definition and Purpose The construction and retrofit of bridges and retaining walls often include driving piles for foundation support and shoring operations. Driven piles are typically constructed of concrete, steel, or timber. Driven sheet piles are used for shoring and cofferdam construction. Proper control and use of equipment, materials, and waste products from pile driving operations will reduce the discharge of potential pollutants to the storm drain system or watercourses.

- Have spill kits and cleanup materials available at all locations of pile driving. Refer to BMP WM-4 "Spill Prevention and Control."
 - Keep equipment that is in use in streambeds; or on docks, barges, or other structures over water bodies, leak free.

- When not in use, store pile driving equipment away from concentrated flows of storm water, drainage courses, and inlets. Protect hammers and other hydraulic attachments from run-on by placing them on plywood and covering them with plastic or a comparable material prior to the onset of rain.
 - Use less hazardous products, e.g. vegetable oil instead of hydraulic fluid, when practicable.
- Maintenance and Inspection
- Inspect pile driving areas and equipment for leaks and spills on a daily basis.
 - Inspect equipment routinely and repair equipment as needed (e.g., worn or damaged hoses, fittings, gaskets).

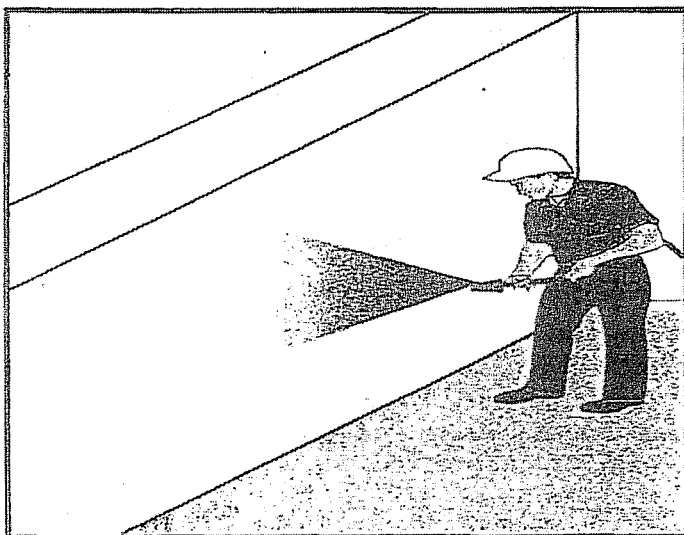
- Collect cure water and transport or dispose of water in a non-erodible manner. See BMPs SS-9, "Earth Dikes/Drainage Swales & Lined Ditches," SS-10, "Outlet Protection/Velocity Dissipation Devices," and SS-11, "Slope Drains."
- Utilize wet blankets or a similar method that maintains moisture while minimizing the use and possible discharge of water.

- Ensure that employees and subcontractors implement appropriate measures for storage, handling, and use of curing compounds.
- Inspect any temporary diversion devices, lined channels, or swales for washouts, erosion, or debris. Replace lining and remove debris as necessary.
- Inspect cure containers and spraying equipment for leaks.

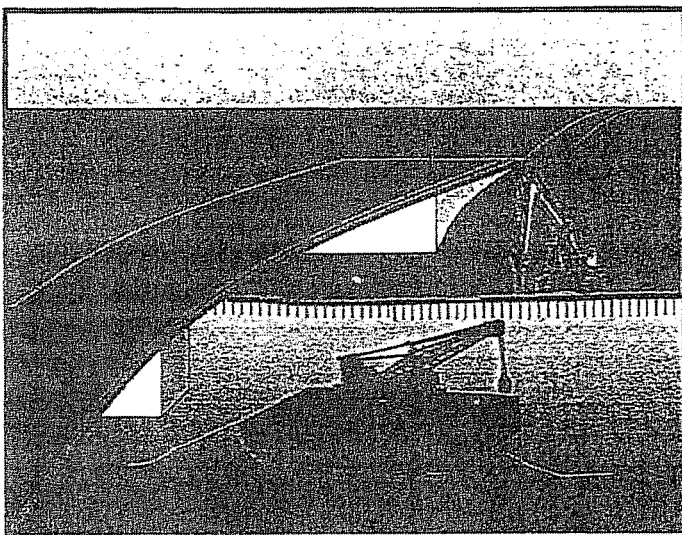
NS-13

Material and Equipment Use Over Water

- Identify types of spill control measures to be employed, including the storage of such materials and equipment. Ensure that staff are trained regarding the deployment and access of control measures and that measures are being used.
- Ensure the timely and proper removal of accumulated wastes. Refer to BMPs WM-5, "Solid Waste Management" (non-hazardous) and WM-6, "Hazardous Waste Management."
- Comply with all necessary permits required for construction within or near the watercourse, such as RWQCB, U.S. Army Corps of Engineers, Department of Fish and Game and other local permitting agencies.
- Discharges to waterways shall be reported to the RE immediately upon discovery. A written discharge notification must follow within 7 days.
- Refer to BMP NS-15, "Structure Demolition/Removal Over or Adjacent to Water."

- Inspect equipment for leaks and spills on a daily basis, and make necessary repairs.
- Ensure that employees and subcontractors implement appropriate measures for storage and use of materials and equipment.
- Inspect and maintain all associated BMPs and perimeter controls to ensure continuous protection of the watercourse.

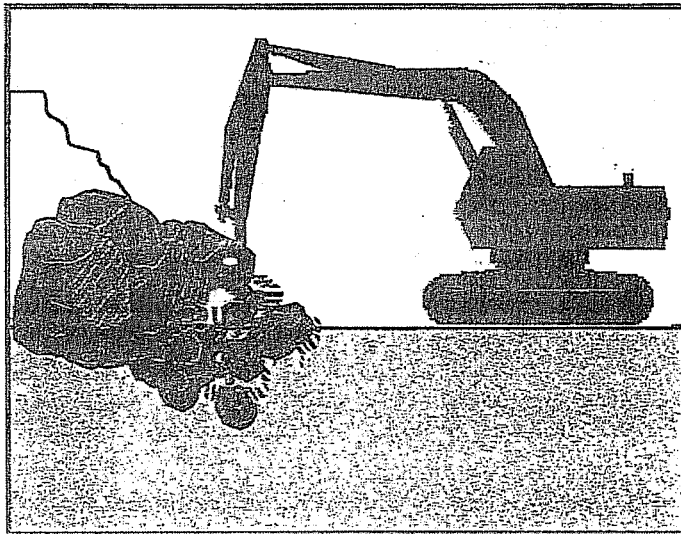
NS-15

Structure Demolition/Removal Over or Adjacent to Water

- For structures containing hazardous materials (e.g., lead paint or asbestos) refer to BMP WM-6, "Hazardous Waste Management." For demolition work involving soil excavation around lead-painted structures, refer to BMP WM-7, "Contaminated Soil Management."
- Maintenance and Inspection
 - Contractor must inspect demolition areas over or near adjacent watercourses on a daily basis.
 - Any debris-catching devices shall be emptied regularly. Collected debris shall be removed and stored away from the watercourse and protected from run-on and runoff.

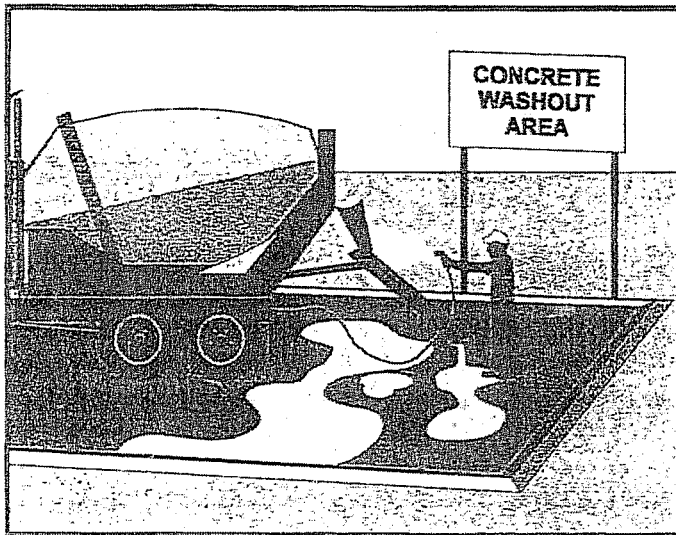
- Once concrete wastes are washed into the designated area and allowed to harden, the concrete shall be broken up, removed, and disposed of per BMP WM-5, "Solid Waste Management", and in conformance with the provisions in Standard Specifications Section 15-3.02, "Removal Methods."

- Temporary concrete washout facility Type "Above Grade" shall be constructed as shown on Page 5 or 6, with a recommended minimum length and minimum width of 3 m (10 ft), but with sufficient quantity and volume to contain all liquid and concrete waste generated by washout operations. The length and width of a facility may be increased, at the Contractor's expense, upon approval from the RE.

- Straw bales, wood stakes, and sandbag materials shall conform to the provisions in BMP SC-9, "Straw Bale Barrier."
- Plastic lining material shall be a minimum of 10-mil polyethylene sheeting and shall be free of holes, tears or other defects that compromise the impermeability of the material.
