**Declaration of Julie Macedo**

**Prosecution Team Case-in-Chief  
Confusion Hill Bypass Project**

### Notice of Discharge, Written Notice, or Order

Project Name: Realign Highway 101 and construct two bridges at Confusion Hill

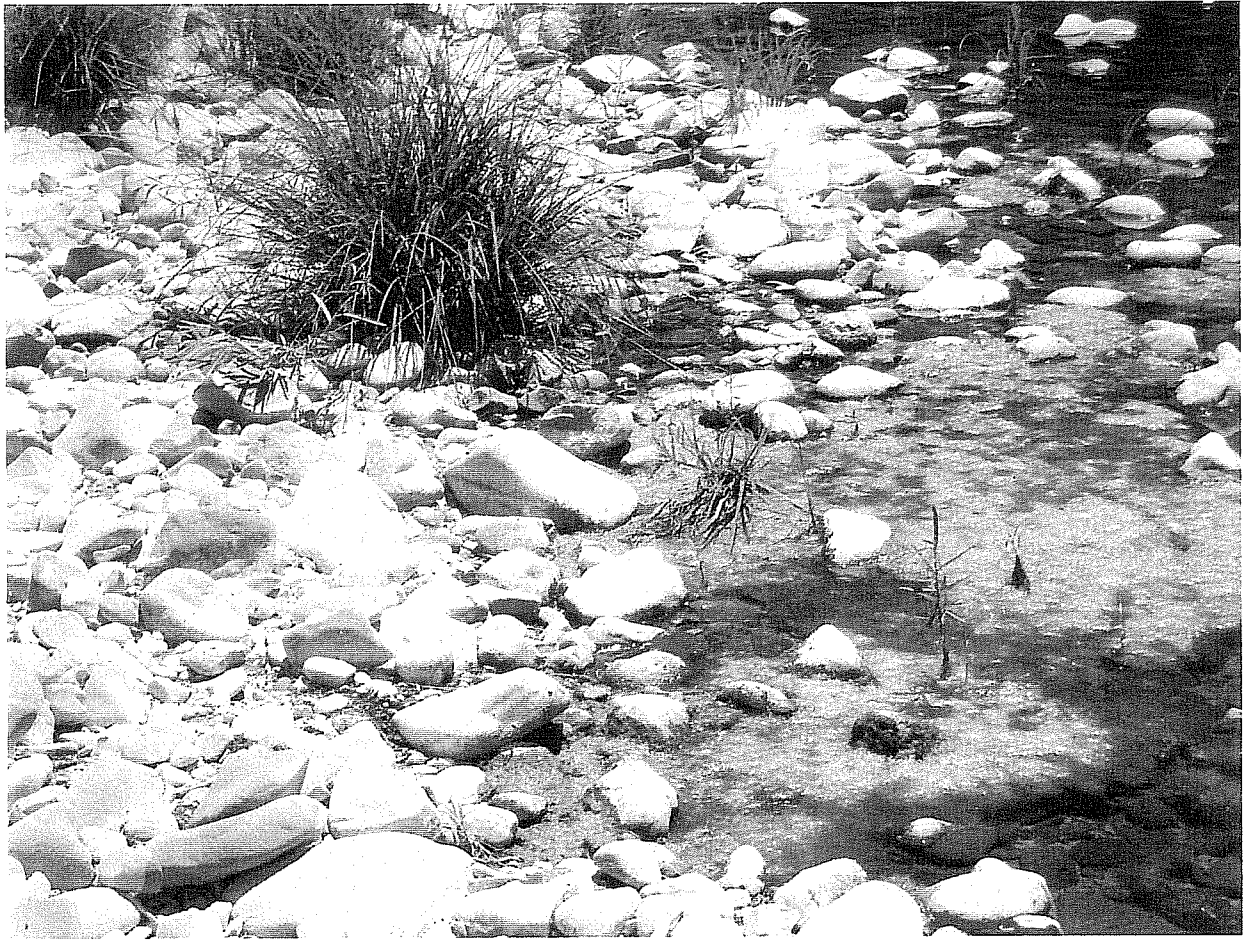
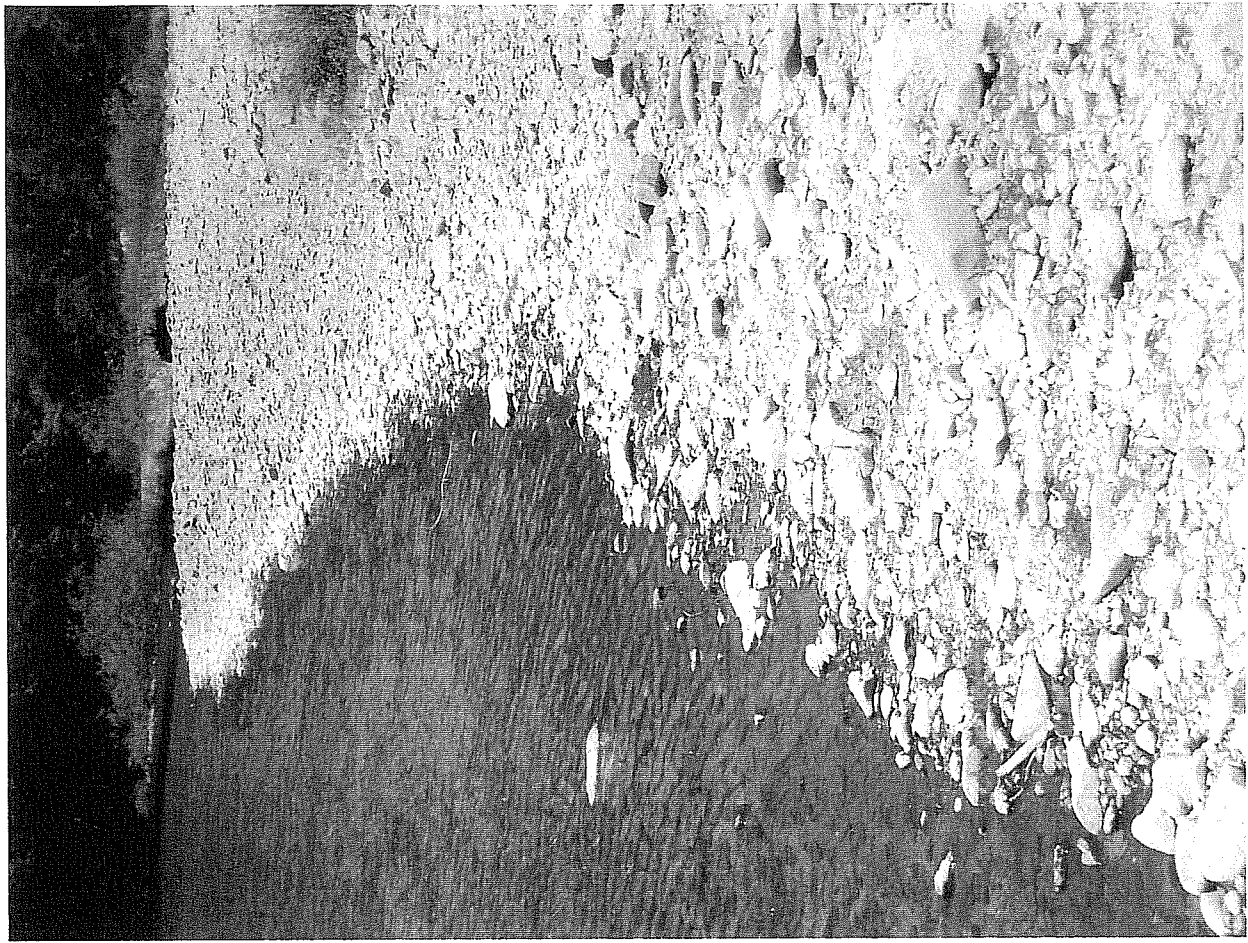
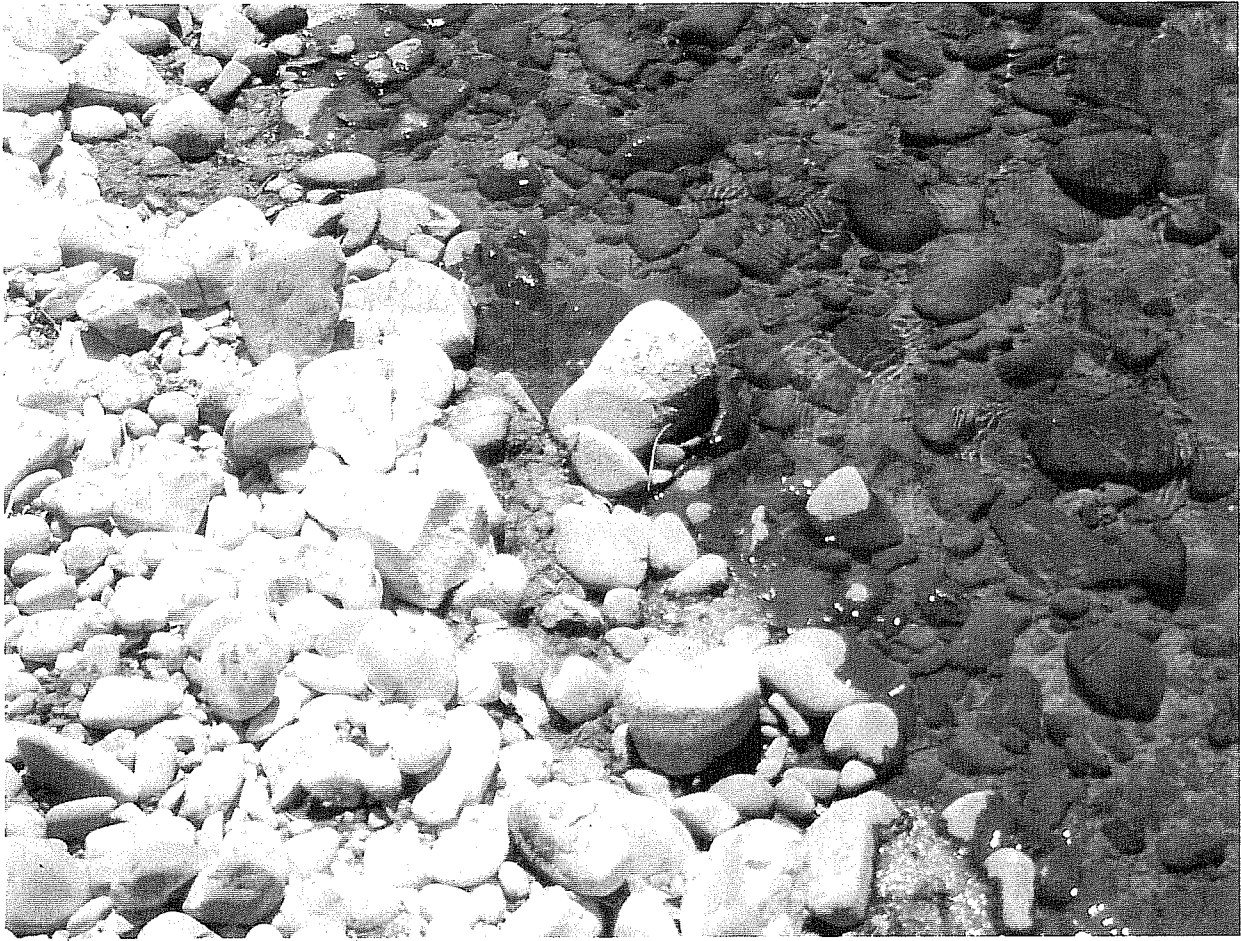
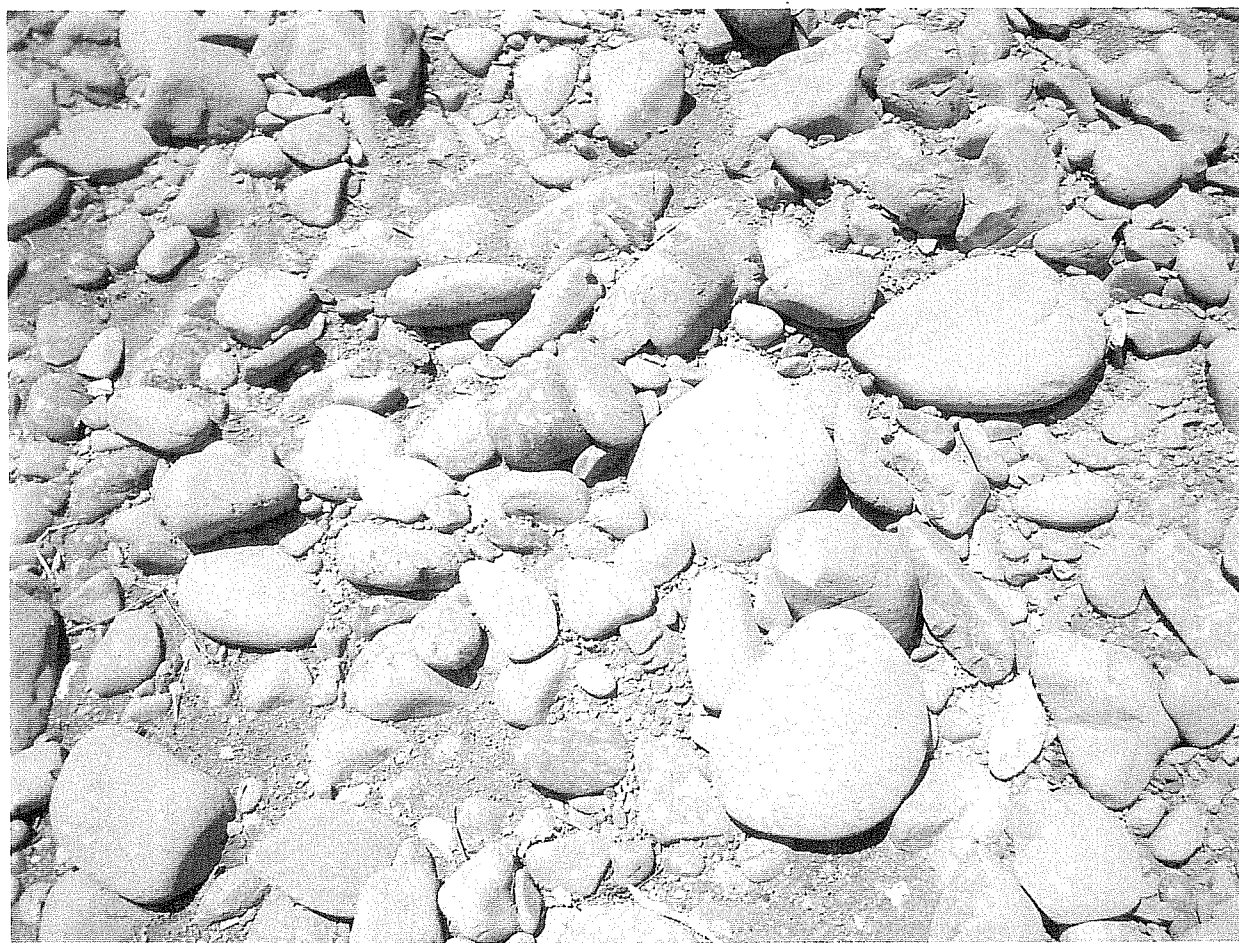
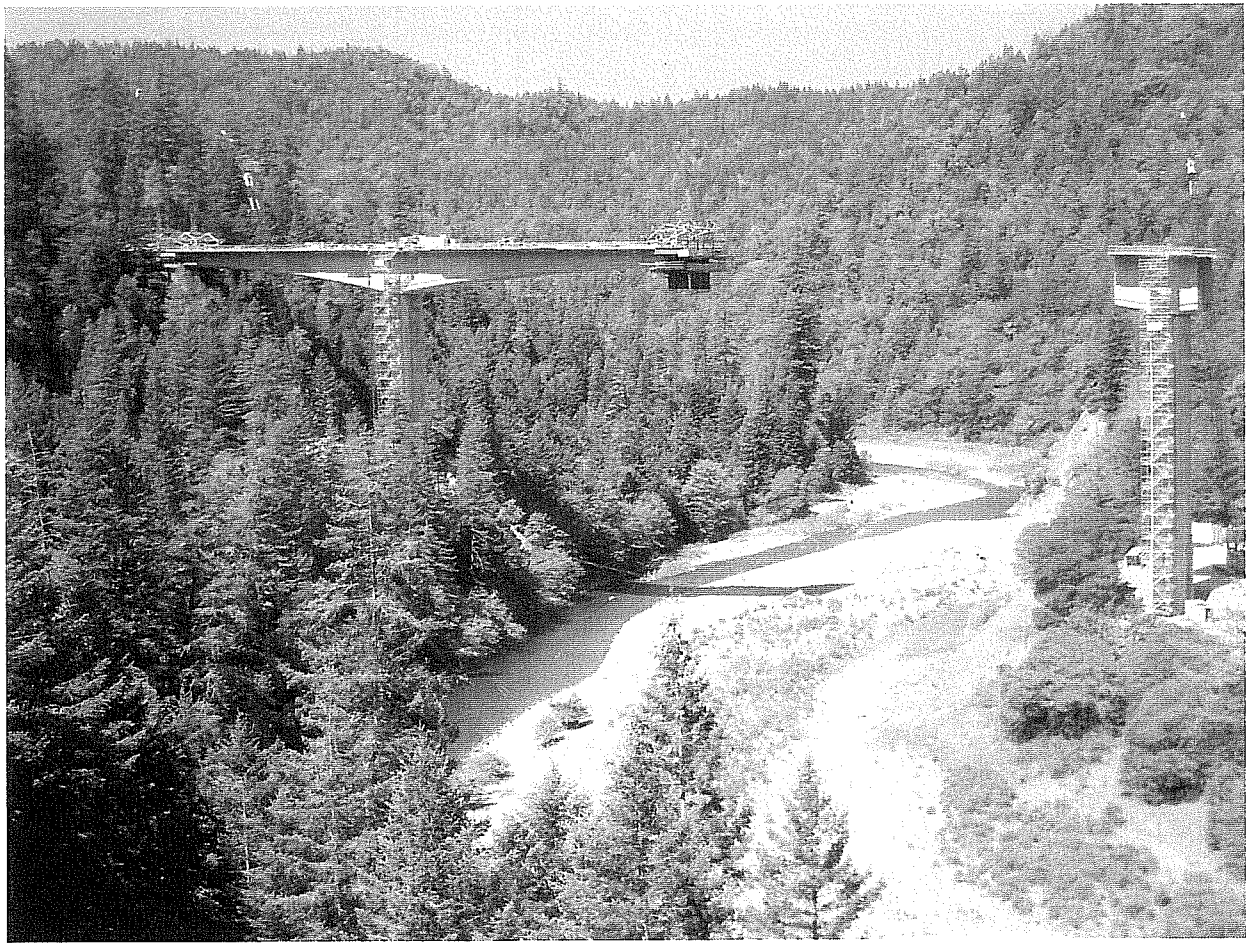
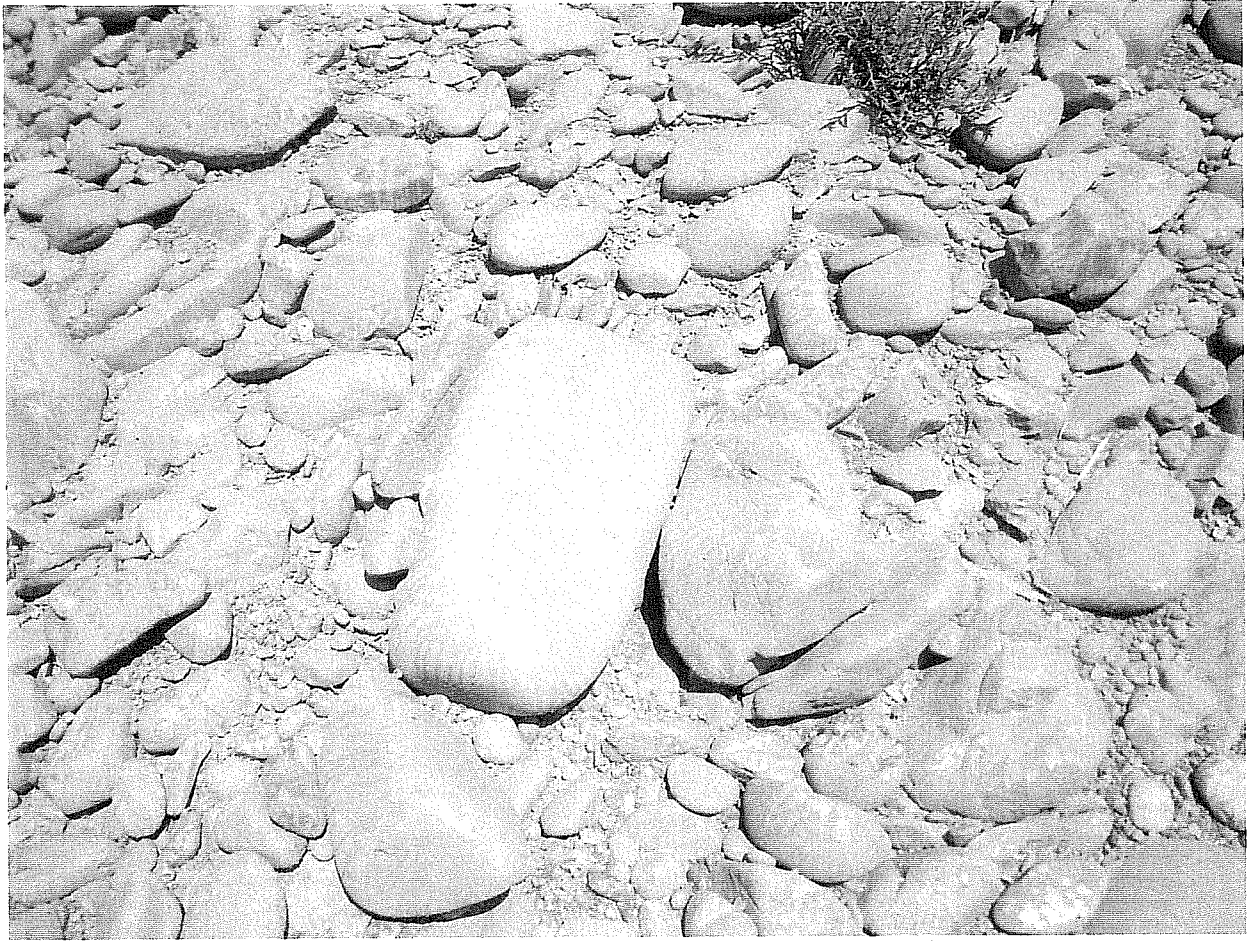
I will provide picture of the grout equipment and all apparatus in action, with BMPs installed (both for a gravity leak and a hole in the pressure

line type leak).

The grout that hit the rocks that can be seen in the photos is hard as a rock. Absolutely no cleanup was done. The prime wanted to go and clean-up all of the rocks that have grout on them, but we did not allow this as it was sure to cause more impact by going on the river bar and trying to clean dry, hard, inert grout. I told them that any clean-up orders would occur after agency consultation. My staff says that the grout dried within several minutes, as the small drips on the rocks was thin. The grout is essentially concrete waster with no aggregate, so once it is dried, it should be inert.
