Massachusetts Department of  
Environmental Protection

# The Occurrence and Sources of Perchlorate in Massachusetts

August 2005

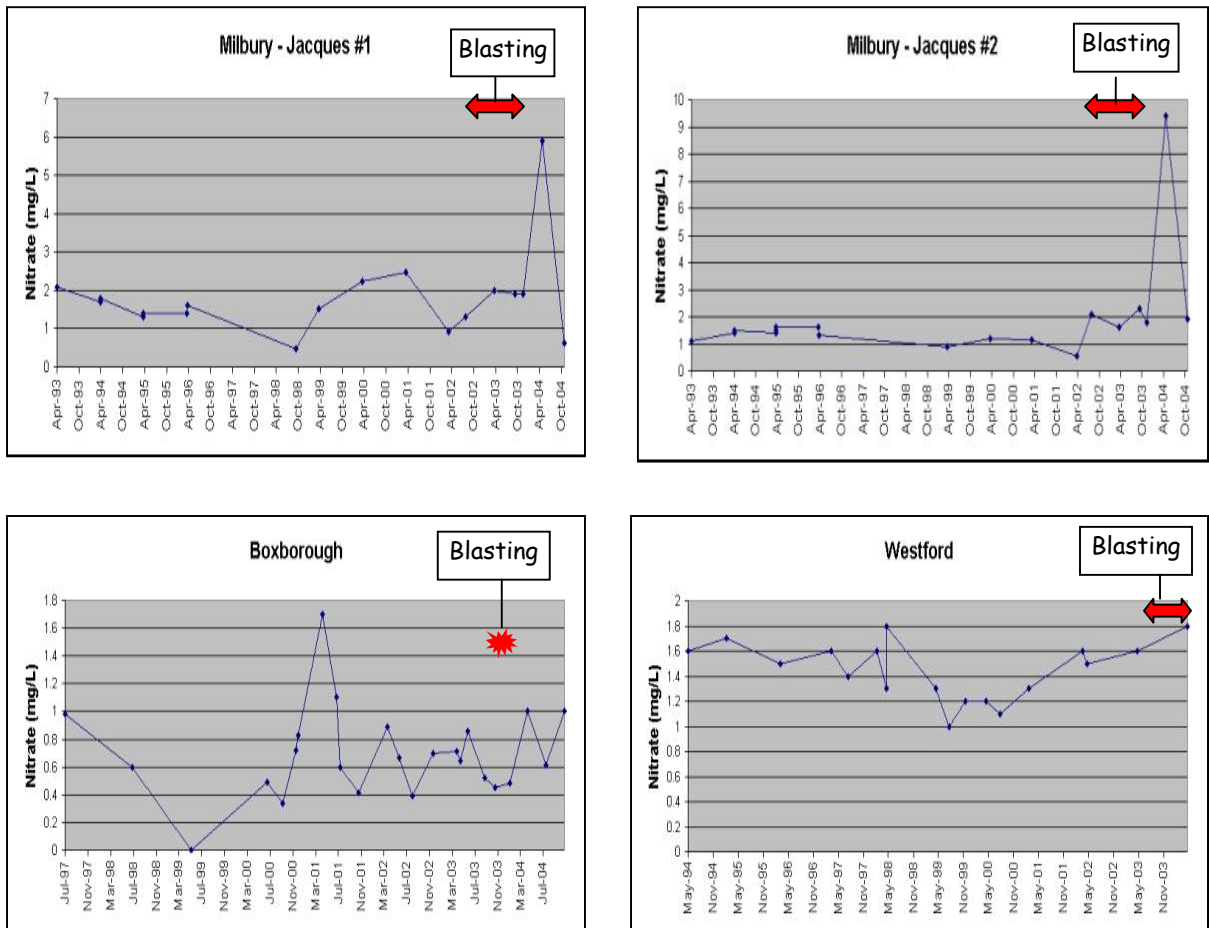
Figure 6  
Nitrate Levels in Wells Impacted by Perchlorate from Suspected Blasting Sources

Figure 6 plots the last 10 years of routine nitrate monitoring data for the 3 blasting-related impacted water supplies.

The above data suggest the possibility of a relationship between nitrates and perchlorate at the Millbury site, given the 5-10 fold increase in nitrates in Jacques Wells #1 and #2, located 800 - 1000 feet to the east of the mall construction site, approximately 18 months after the start of blasting activities. This is also the site where large amounts of ANFO were used (621,000 pounds).

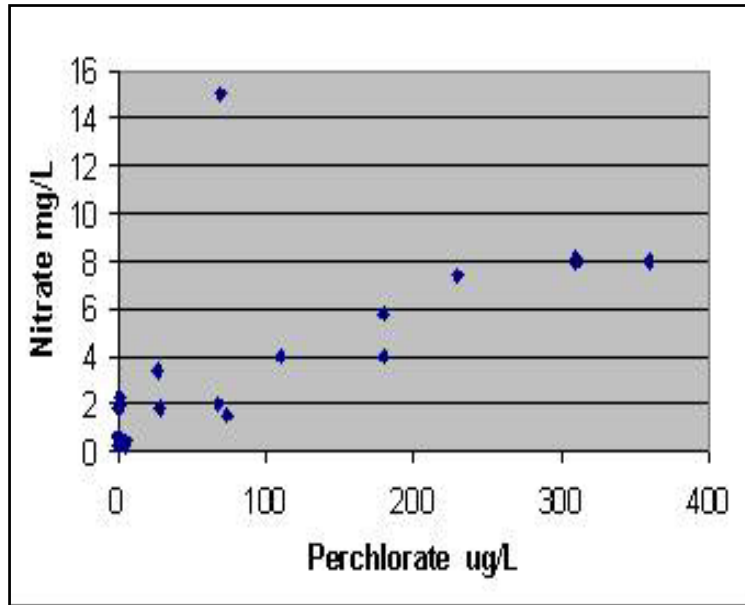
Figure 7  
Millbury, MA Perchlorate vs Nitrate  
(GeoSyntec, 2005)

This relationship was further explored by the consulting firm overseeing work at the Millbury site, during a series of sampling events in February 2005, where split samples were analyzed for perchlorate and nitrates (NO<sub>3</sub>-N). In total, 22 samples were synoptically analyzed in this manner, including 8 drainage/surface water samples, 8 overburden groundwater samples, and 6 bedrock groundwater samples. The results of all data are plotted in Figure 7. Once again, the possibility of a general correlation is suggested, though more evaluation of variables (e.g., site-wide explosive materials usage, precipitation events, groundwater elevations, etc.) would be needed to draw more definitive conclusions.

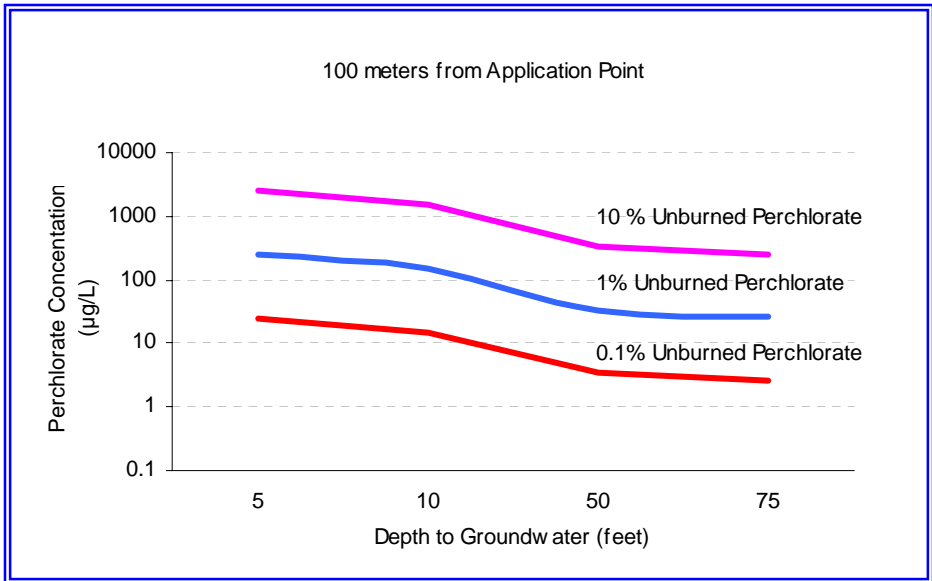
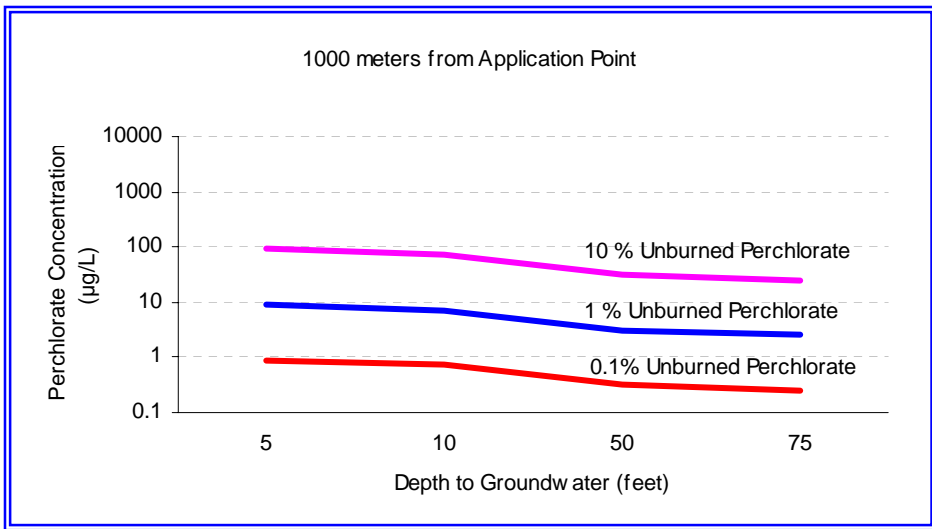
Figure 8: Modeled Perchlorate Impacts to Groundwater from Fireworks Display

Model = SESOIL/AT123D  
 Assumptions:  
 3000 lbs fireworks (1000-2000 shells)  
 Average perchlorate content = 40%  
 x = 60 meters  
 y = 60 meters  
 z = 6 inches  
 a = variable from 5 to 75 feet  
 b = variable from 100 to 1000 meters

Additional Model Inputs:

- 44 inches of precipitation per year (Massachusetts)
- Solubility of Potassium Perchlorate =  $1.5 \times 10^7$  µg/L
- Hydraulic Conductivity = 4.583 m/hr (sand)
- Hydraulic Gradient = 0.0031

MADEP has conducted limited modeling efforts of hypothetical fireworks displays, in order to better define the scope and range of potential groundwater impacts and concerns. The details and results of this modeling effort are contained in Figure 8, which assumes a mid-sized "July 4<sup>th</sup> community display" of 1000 to 2000 aerial shells, with a total weight of 3000 pounds.

While the 40% perchlorate figure may be high, it is being used in the absence of anything more definitive from the pyrotechnics industry. On the basis of this analysis, even with 99.9% destruction of perchlorates, tens of  $\mu\text{g/L}$  of perchlorate could be expected immediately (100 meters) downgradient of the fallout area, with trace amounts ( $1 \mu\text{g/L} \pm$ ) further downgradient. Higher concentrations could be expected with larger displays, use of pyrotechnics with higher amounts of perchlorates, less complete combustion, improper disposal of duds and misfires, excessive debris fallout and/or lack of post-display cleanup.
