CALIFORNIA REGIONAL WATER QUALITY CONTROL BOARD
SAN FRANCISCO BAY REGION

ORDER NO. 93-093

INNERCONN TECHNOLOGIES AND
UNION BANK

327 MOFFETT BOULEVARD
MOUNTAIN VIEW, SANTA CLARA COUNTY

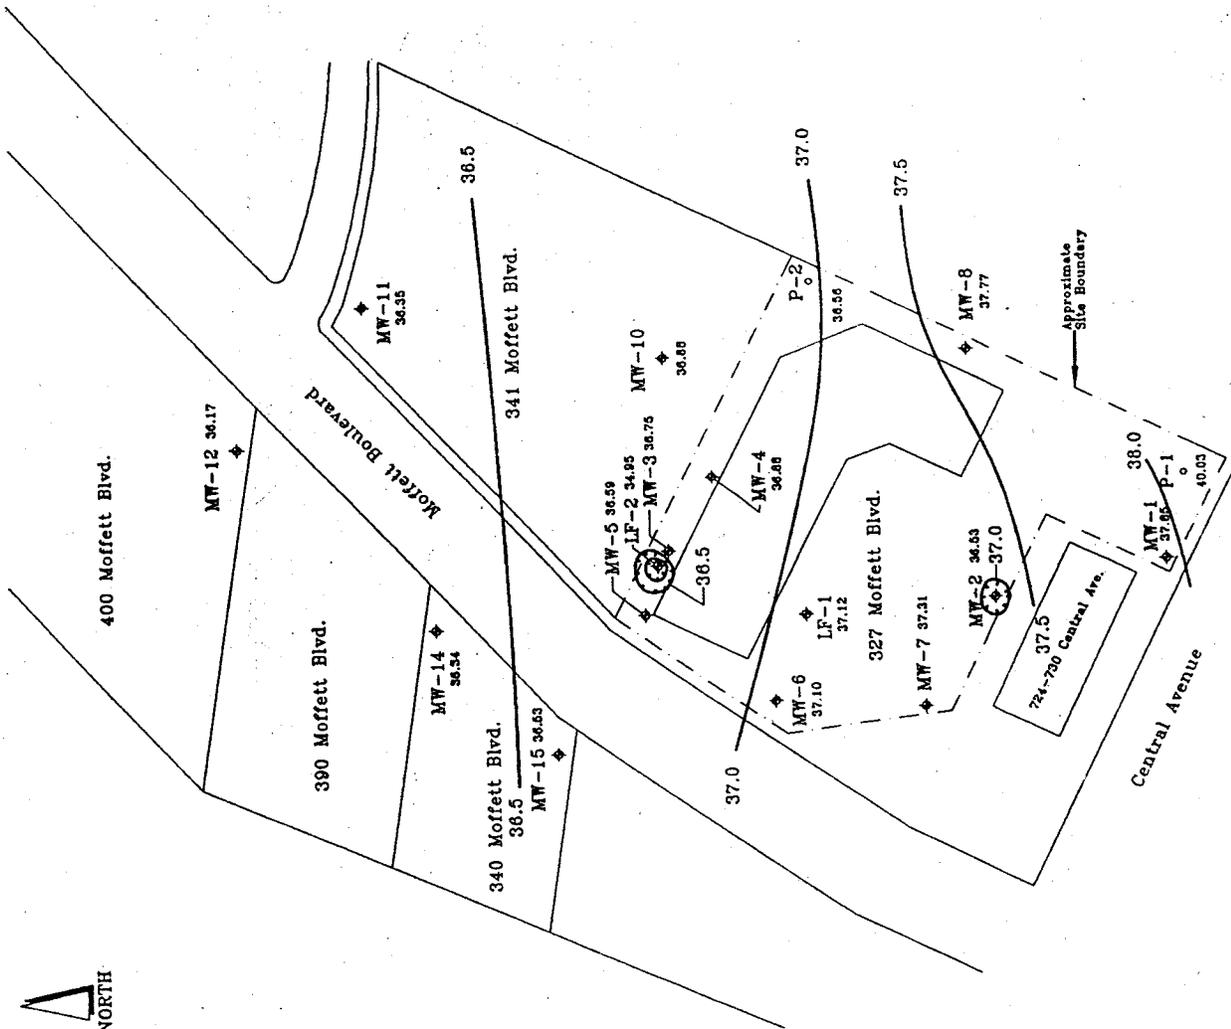
Figure 1, Map showing locations of wells and groundwater elevations

— 32.0 —
Approximate Contour of Piezometric Elevation in Shallow Aquifer Zone Groundwater

5. The Discharger thus far has completed the installation of one groundwater extraction well (LF-2) on the north property boundary (Figure 1). Polluted groundwater is being extracted and discharged to the sanitary sewer.
