CALIFORNIA REGIONAL WATER QUALITY CONTROL BOARD
SAN FRANCISCO BAY REGION

ORDER NO. 94-010

RESCINDING WASTE DISCHARGE REQUIREMENTS, ORDER NO. 85-131

ANACOMP, INC.
(FORMERLY XIDEX CORPORATION)
5200 AND 5440 PATRICK HENRY DRIVE
SANTA CLARA
SANTA CLARA COUNTY

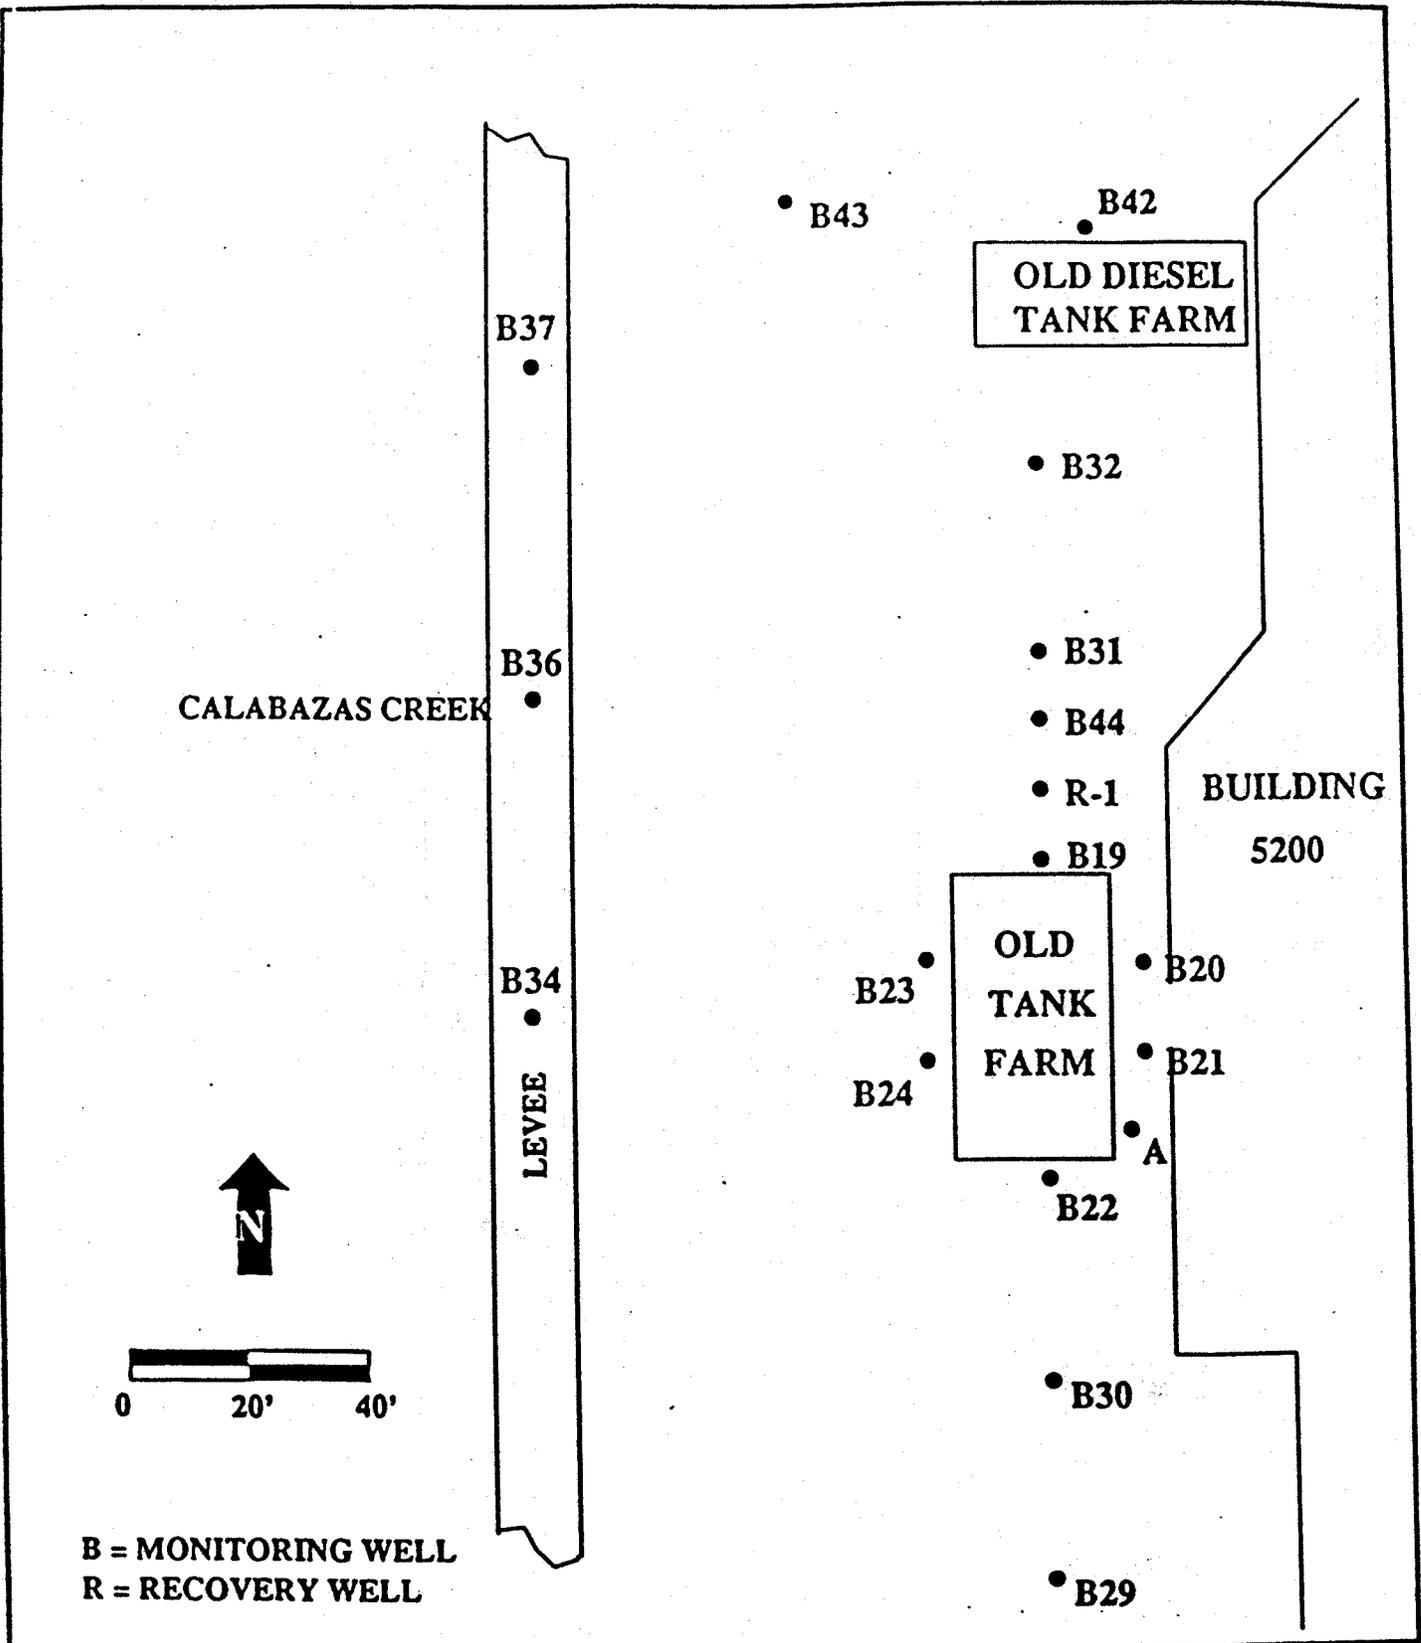
FIGURE 1

5200 Patrick Henry Drive

3. In 1979, the discharger installed three tank farms that consists of six 7,300 gallon underground storage tanks for storing organic solvents such as methyl ethyl ketone, cyclohexanone, and diglyme (diethylene glycol dimethyl ether) and four 10,000 gallon underground storage tanks for storing total petroleum hydrocarbon as diesel (TPH-diesel). The tank farms were located west of the 5200 and 5440 facilities and east of the Calabazas Creek levee (see Figures 1 & 2).

Attachments: Figure 1 - 5200 Tank Farm Locations
Figure 2 - 5440 Tank Farm Location

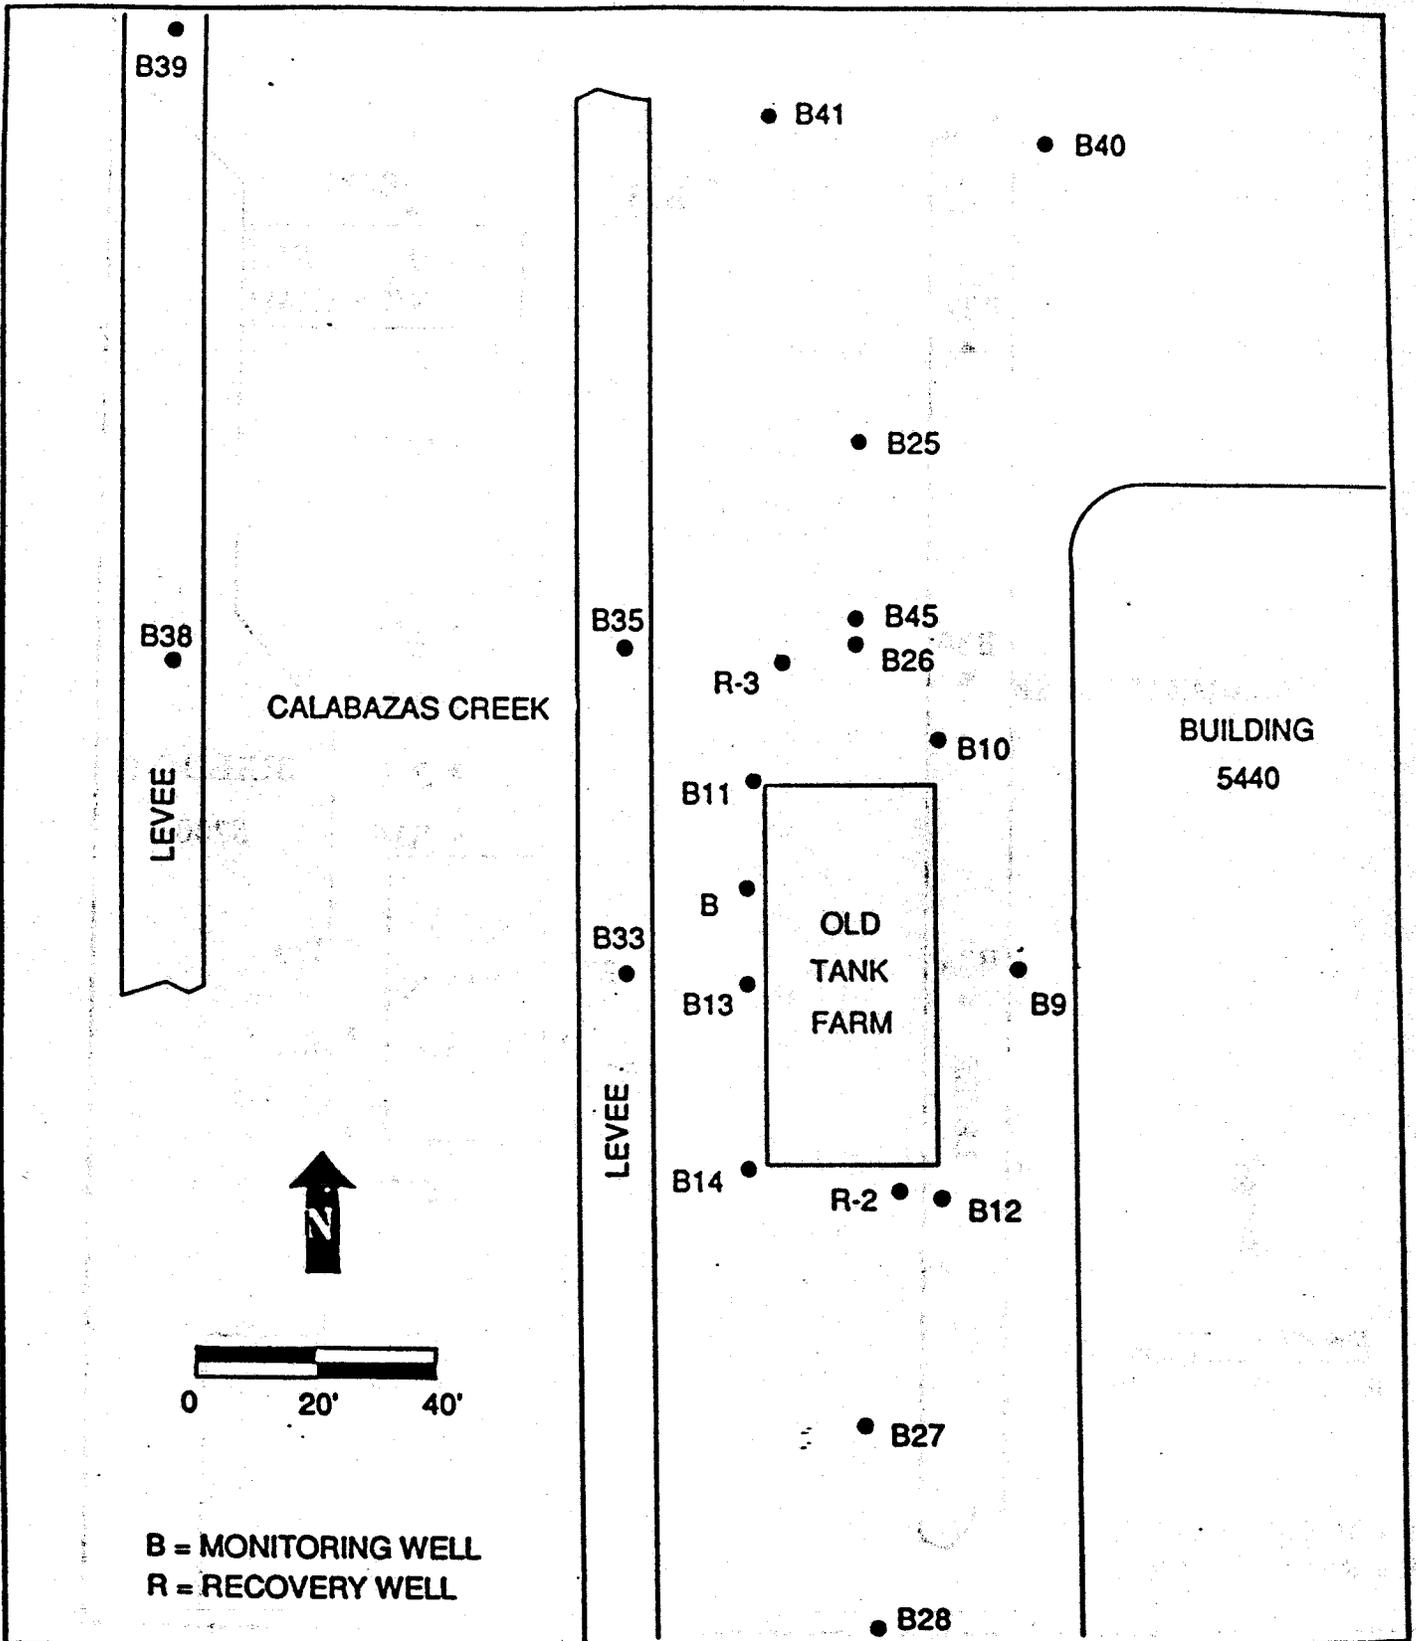
FIGURE 2

5440 Patrick Henry Drive
