Subject: Tentative Order – Initial Site Cleanup Requirements for
1643 Contra Costa Boulevard Pleasant Hill, CA (“Site 1”)
Regional Board File No. 07S0132 (KEB)

Tentative Order – Initial Site Cleanup Requirements for
1705 Contra Costa Boulevard Pleasant Hill, CA (“Site 2”)
Regional Board File No. 07S0204 (KEB)

CENTRAL VALLEY
CITIES WHERE MUNICIPAL WELLS ARE AFFECTED BY
TETRACHLOROETHYLENE (PCE)

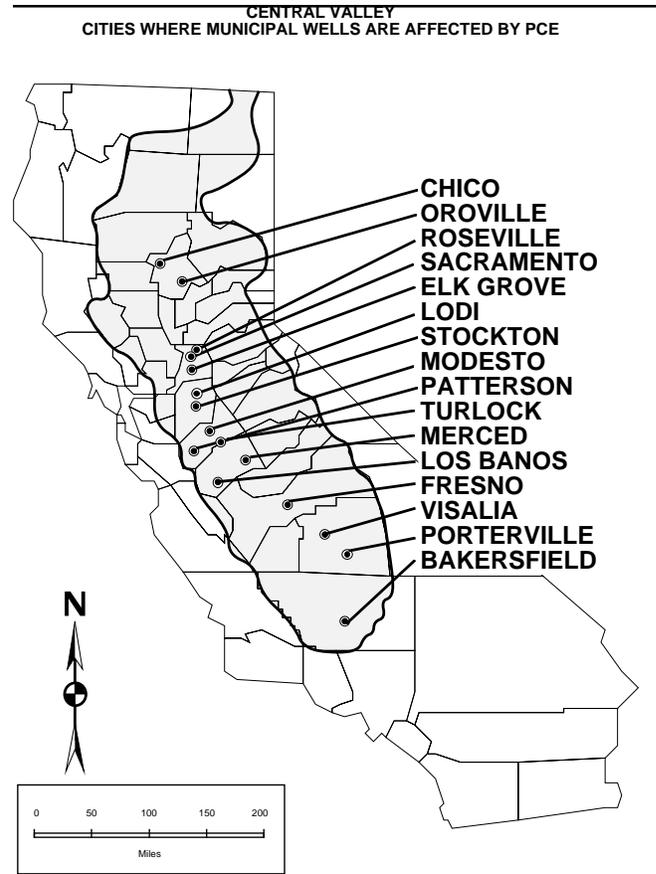
Tetrachloroethylene (PCE), a known carcinogen, has degraded at least 215 wells in the Central Valley of California. Figure 1 illustrates the extent of the problem. The majority of these wells are large system municipal wells of 200 connections of more. The Chico, Sacramento, Modesto, Fresno, Turlock, Lodi and Merced areas all have wells with levels of PCE above 0.8 ppb which is the estimated one in a million incremental cancer risk (8). The Maximum Contaminant Level (MCL) set by the Department of Health Services for drinking water is five ppb. Forty-seven of the 215 wells have PCE levels above the MCL.

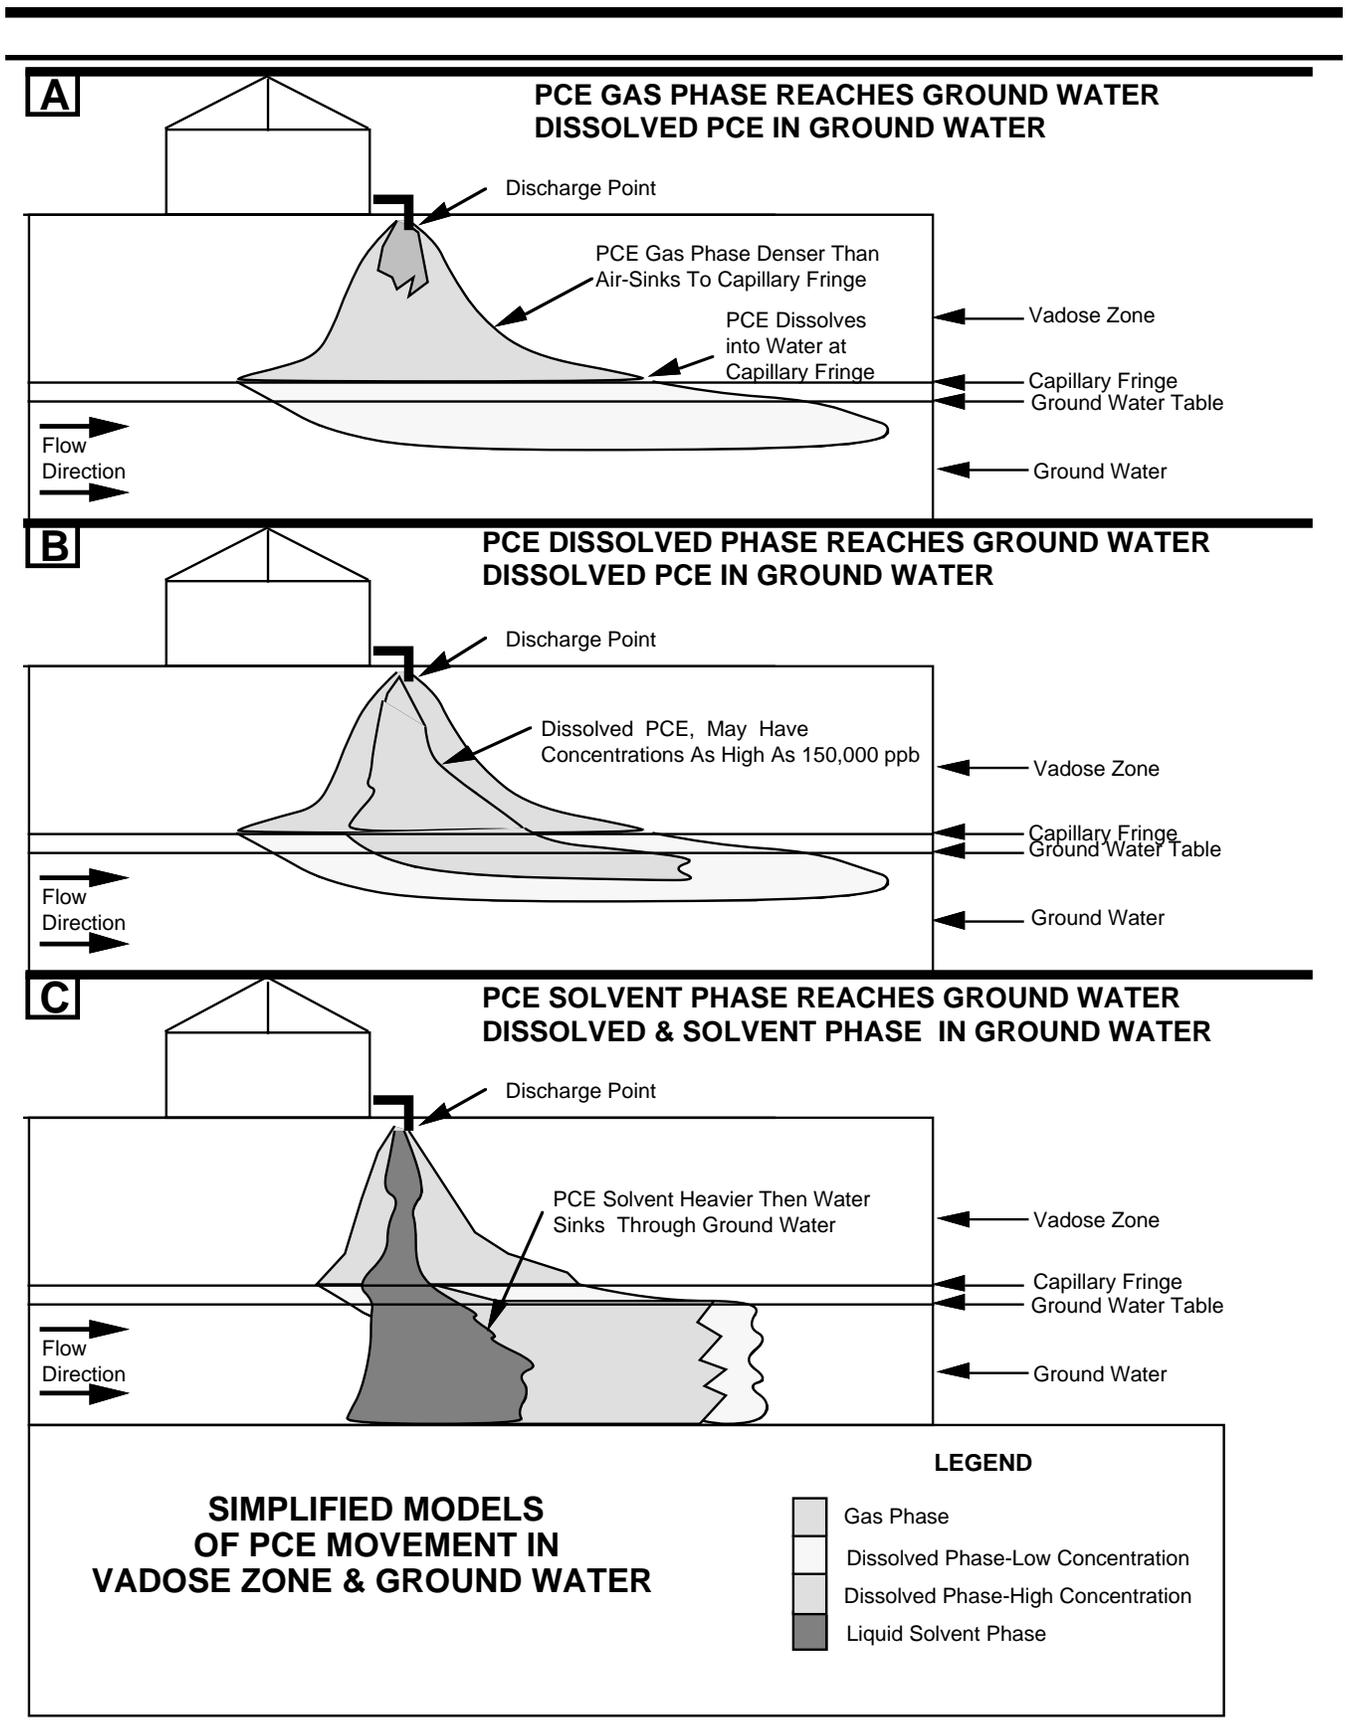
PCE is generally found in three phases in the subsurface: liquid, vapor, and dissolved in water. More than one phase usually exists in the subsurface after discharge. Figure 2 shows three possible scenarios at a discharge point.

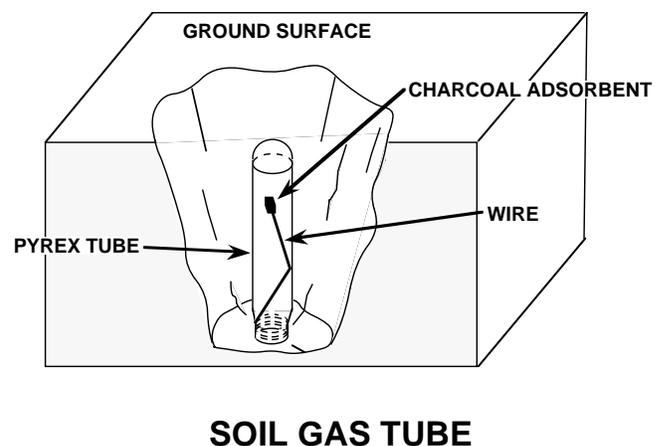
Figure 3

In step 5, the soil gas survey is used to identify areas of VOCs in the soil and ground water. A survey involves placing glass tubes, each containing a carbon coated wire, open end down, 10-12 inches below the soil surface (Figure 3). After placement, the tubes are covered with soil. The evaporating VOC gasses disperse through the soils and reach the survey

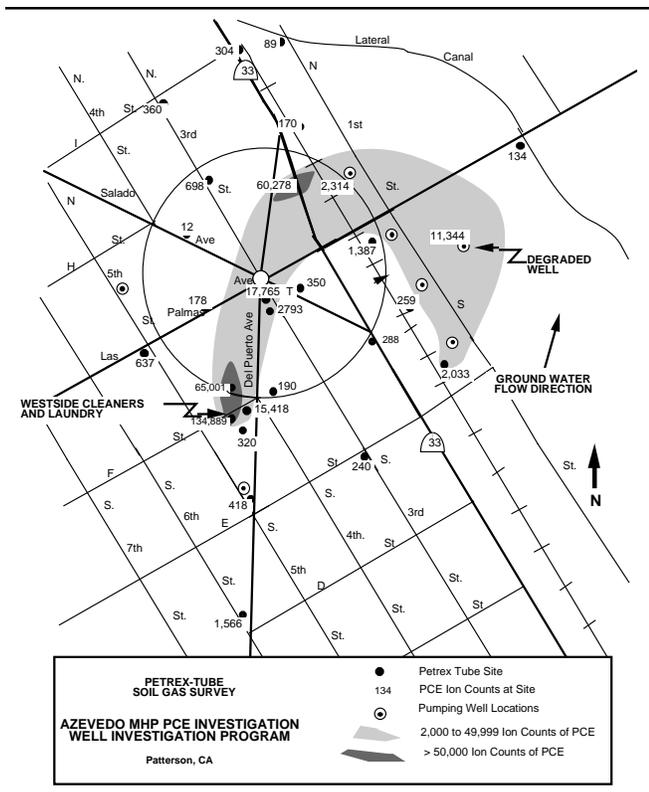
equipment. Approximately six week later, the tubes are removed and sent to the laboratory for VOC analysis. The results are in numbers of a specific VOC molecule retained by the carbon coated wire. The numbers are not concentrations, but are relative to each other. Locations with high counts have more of that VOC in the soil vapor than areas with low counts. Figure 4 is an example of the results of one of these surveys.

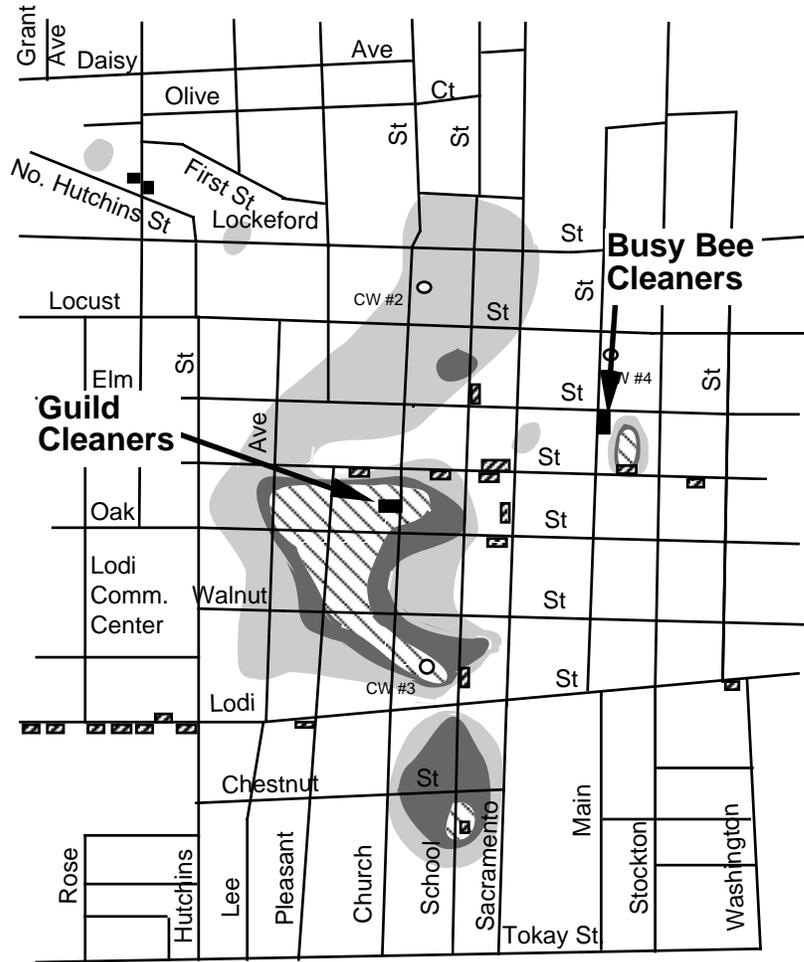
Figure 6

The staff soil gas surveys, which include all solvent users, show dry cleaners as the source areas. Figures 6 and 7 are two examples. None of the soil gas surveys have shown PCE vapor plumes near other solvent users.

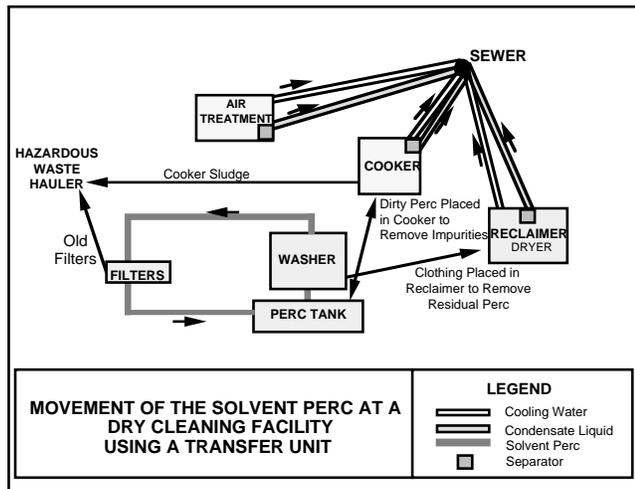
Figure 8

Dry cleaning transfer systems include a dry cleaning wash unit, PCE storage tank (generally part of the wash unit), reclaimer (dryer), cooker and vapor condenser (Figure 8). Pure PCE solvent is added directly from the PCE tank to the wash unit. A small amount of water and soap is usually added to remove stains that PCE will not. Most facilities send the spent solvent (after washing cycle) through solid filter canisters to remove solids and then return it to the PCE tank in a closed system. The solvent in the PCE tank also is periodically purified by physical transfer to the cooker, which separates solvent from solids through distillation and forms a sludge at the bottom.

In general, information provided by dry cleaner operators, inspections done by staff, and manufacturers' service manuals show that dry cleaning equipment is designed to discharge wastewater to the sewer. Figures 8 and 9 are schematics showing the two main types of wastewater discharges from dry cleaning equipment: liquid from the PCE-water separators and cooling water. Figure 10 is a schematic from one manufacturer's service manual that shows that wastewater should be discharged to the drain (11). This is typical of service manuals.

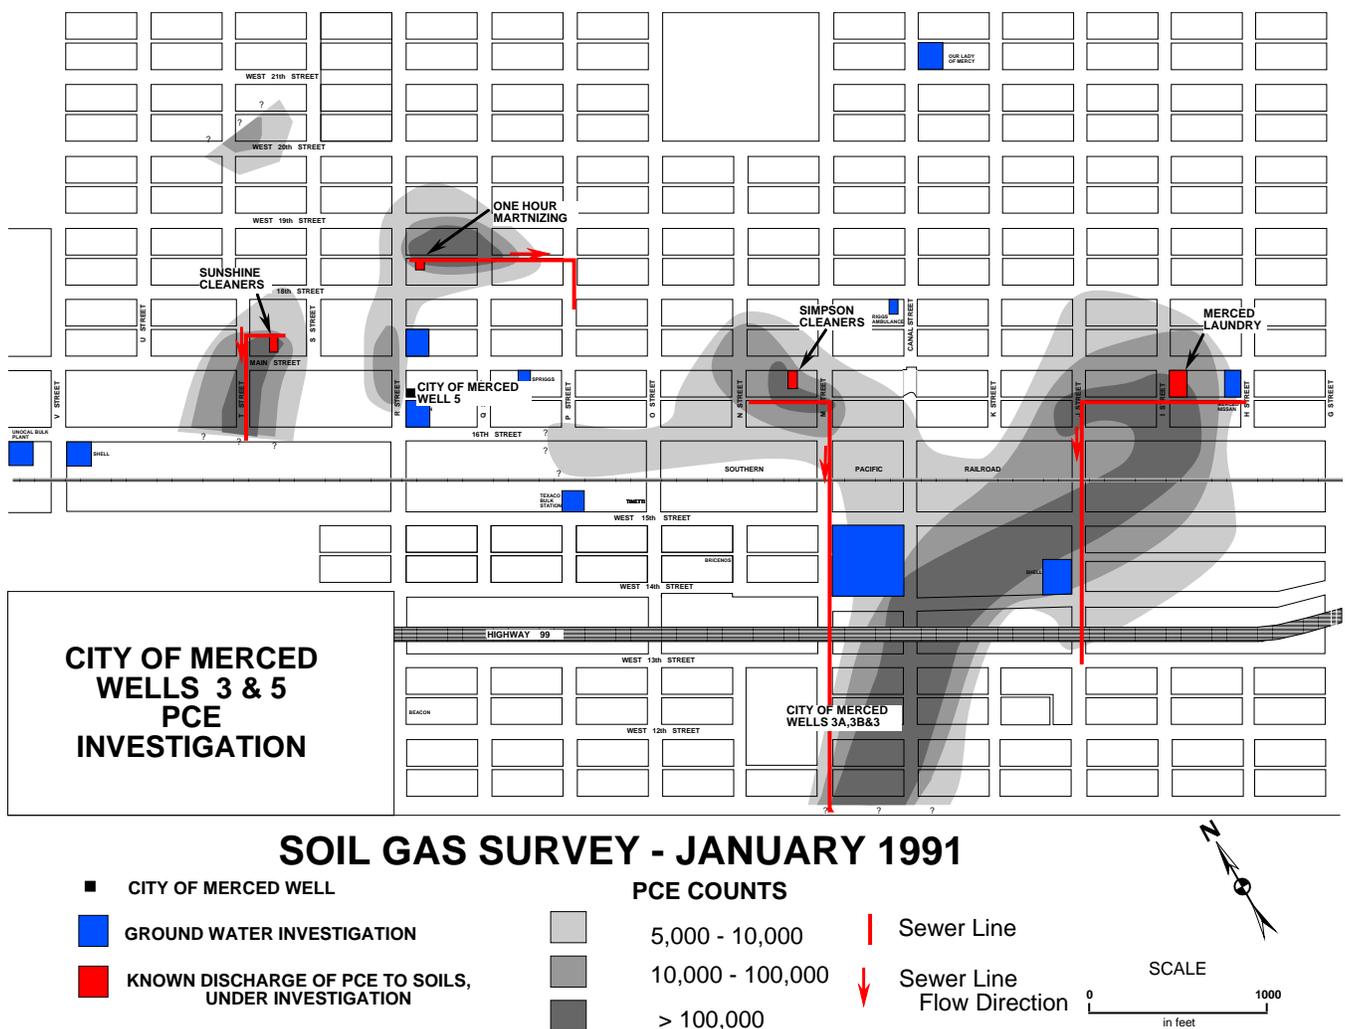
FIGURE 13

Figures 13 through 16 are maps showing results of soil gas surveys from Turlock, Modesto, Lodi and Merced which illustrate that PCE vapors are higher along the sewer lines. The highest counts are usually near the cleaners, but the counts continue high from the sites down the sewer line.

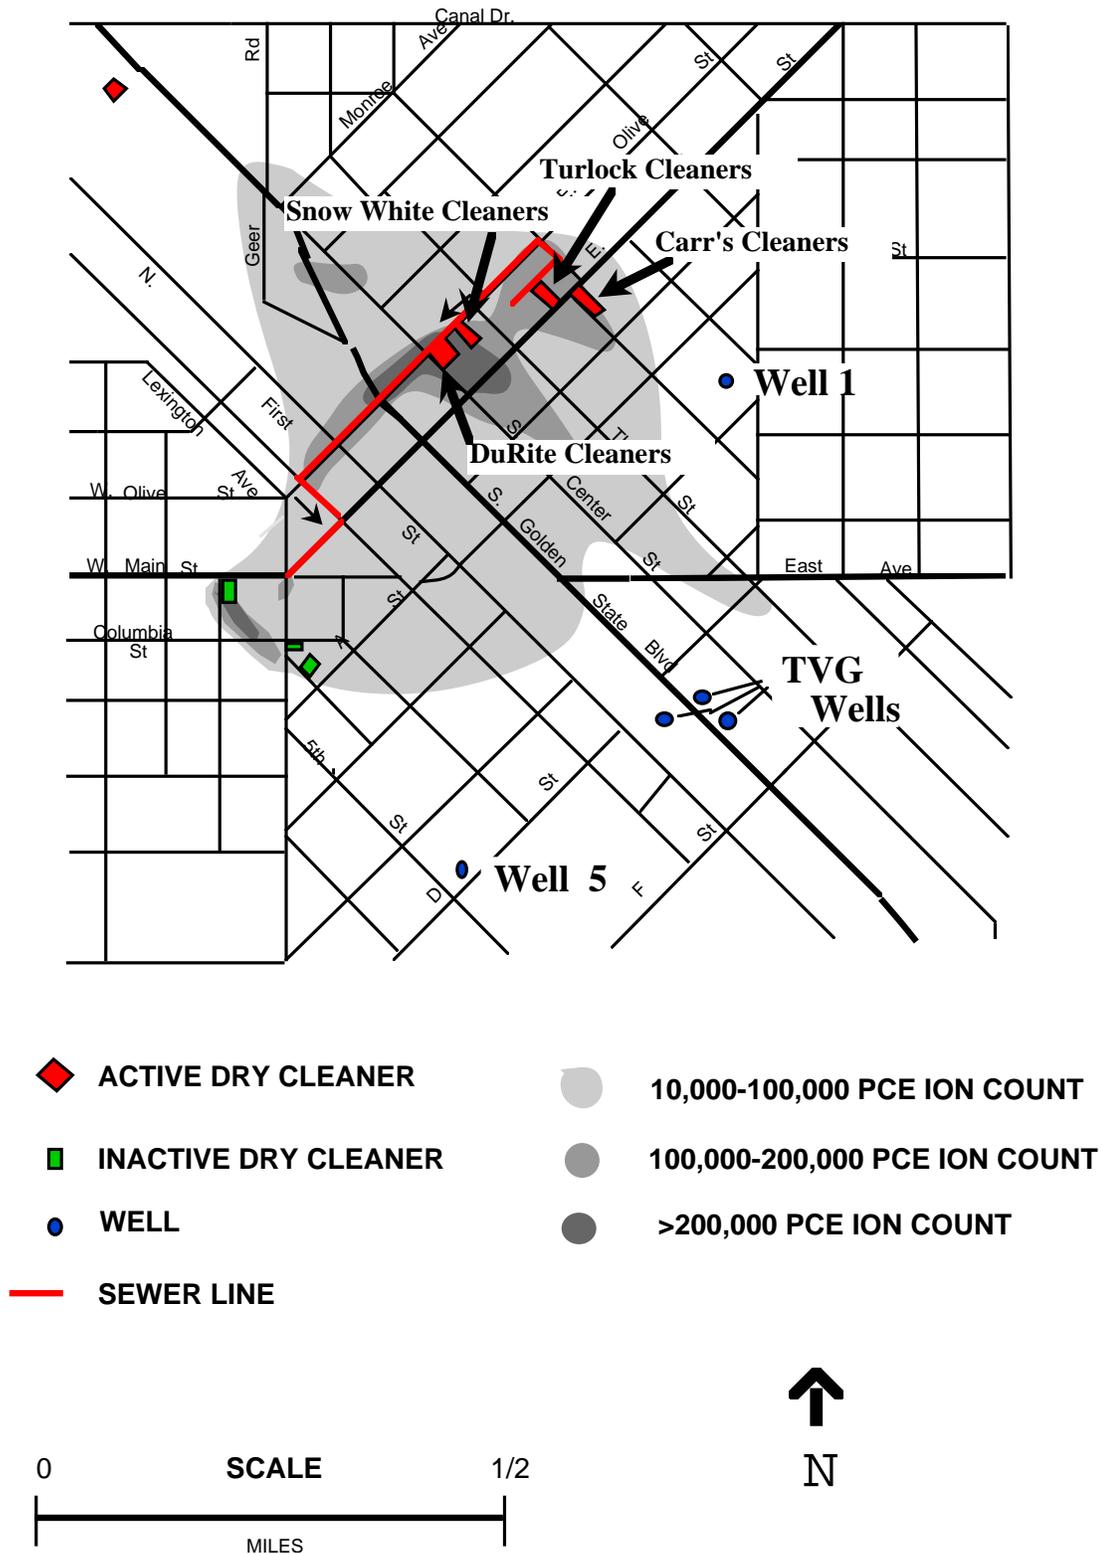
Figure 16

TURLOCK SOIL GAS SURVEY

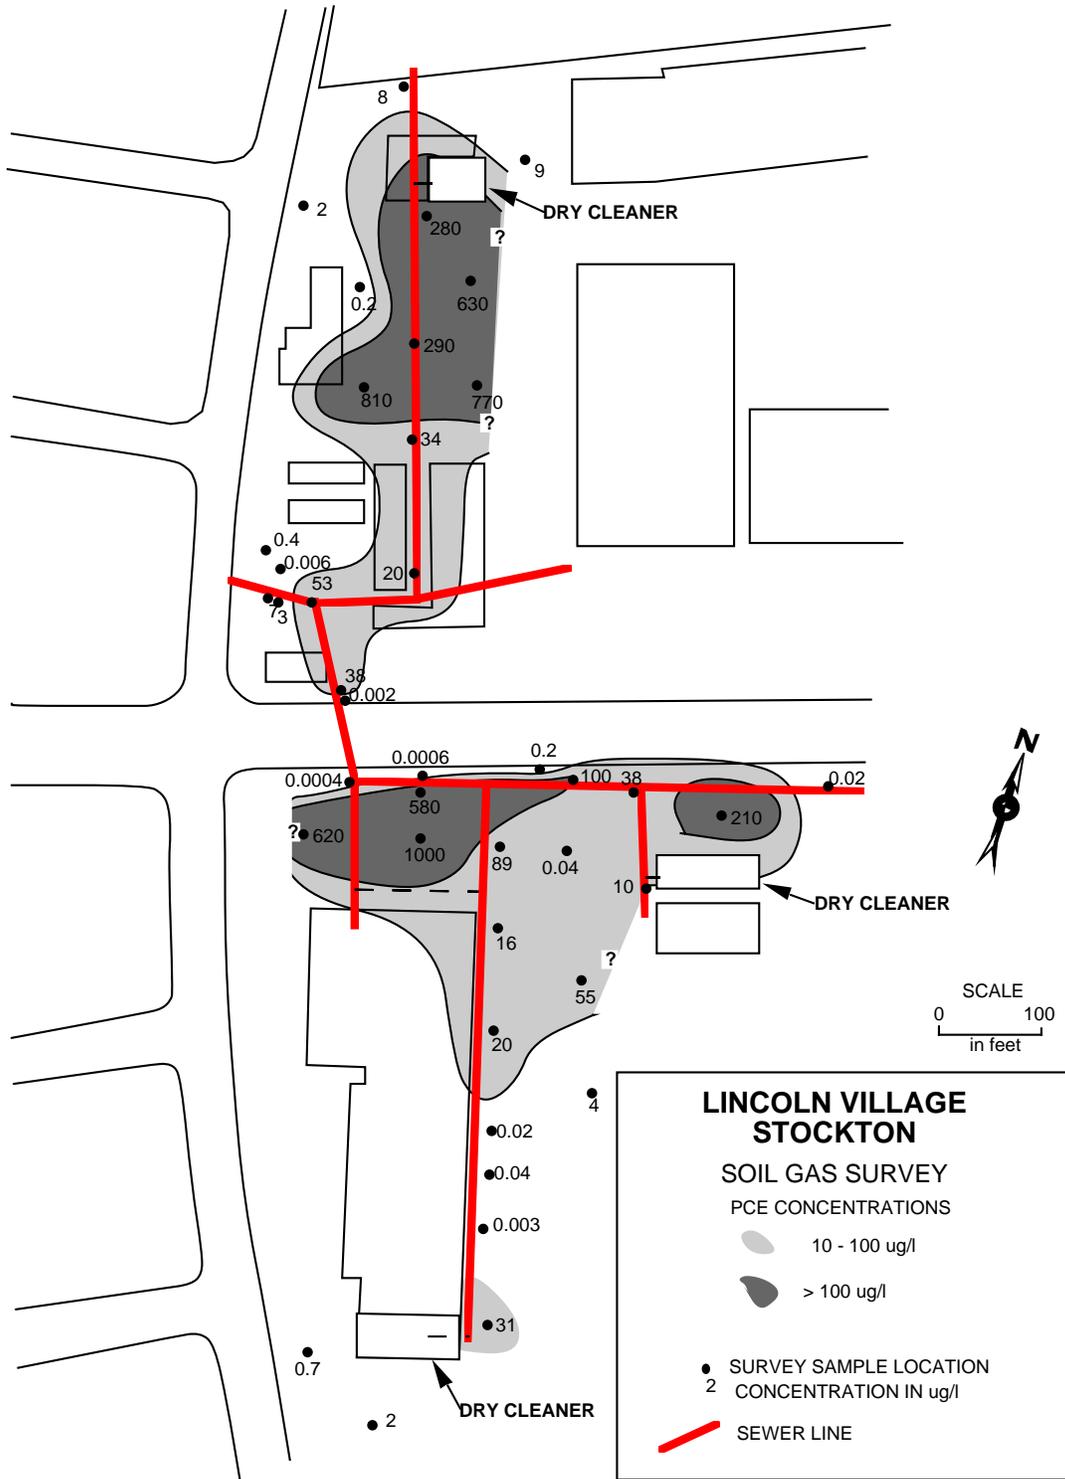
Figure 17

and ran the sample through a gas chromatograph. This survey also indicates high concentrations of PCE vapor along the sewer line (Figure 17). There are

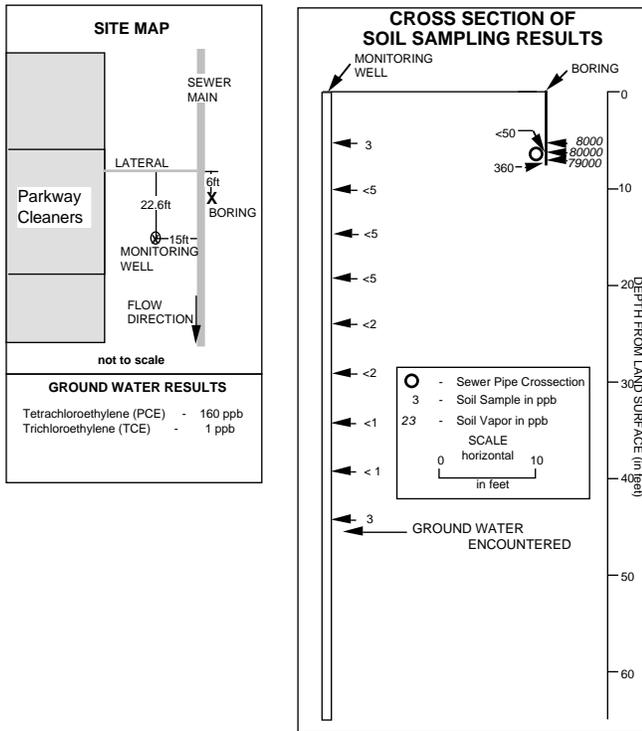
Figure 19 contains the data from the Parkway Cleaners site. The MW was drilled approximately 22 feet from Parkway's sewer lateral and 15 feet from the sewer main. Soil samples from the well boring had low levels of PCE (<5 ppb). The concentration of PCE in the ground water was 160 ppb.

PARKWAY CLEANERS

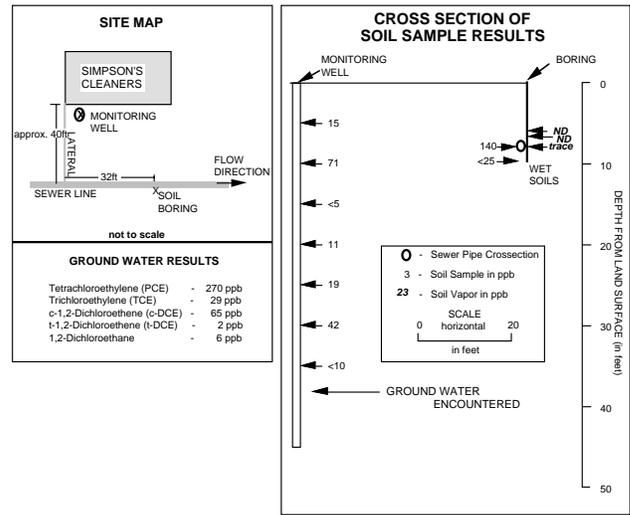
Figure 20 illustrates the data from the Simpson's Cleaners site. Soil samples taken during the drilling of the MW at the southwest corner of the facility had PCE levels from non-detect to 71 ppb. The shallow ground water sample had 270 ppb PCE and also contained 29 ppb trichloroethylene (TCE), 65 ppb cis-1,2-dichloroethene (DCE), two ppb trans-1,2-DCE, and 6 ppb 1,2-dichloroethane, all of which are breakdown

SIMPSON'S CLEANERS

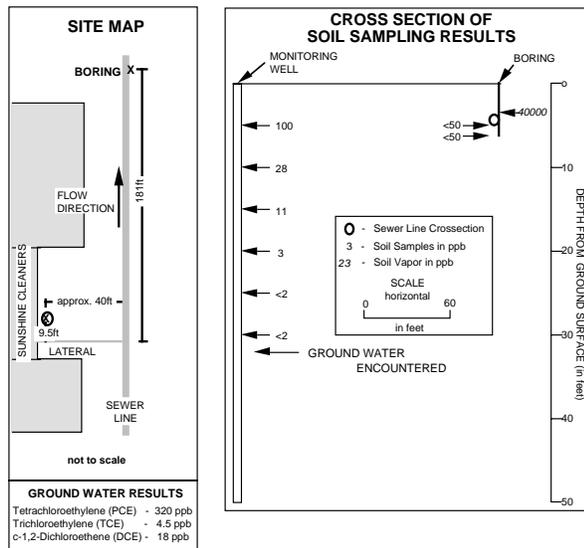
Figure 21 contains the data from the Sunshine Cleaners site. The MW was drilled near the northeast corner of the cleaners, 9.5 feet from its sewer lateral. The soil samples from the MW had PCE concentrations up to

SUNSHINE CLEANERS

100 ppb. The ground water sample had 320 ppb PCE, 4.5 ppb TCE and 18 ppb DCE.

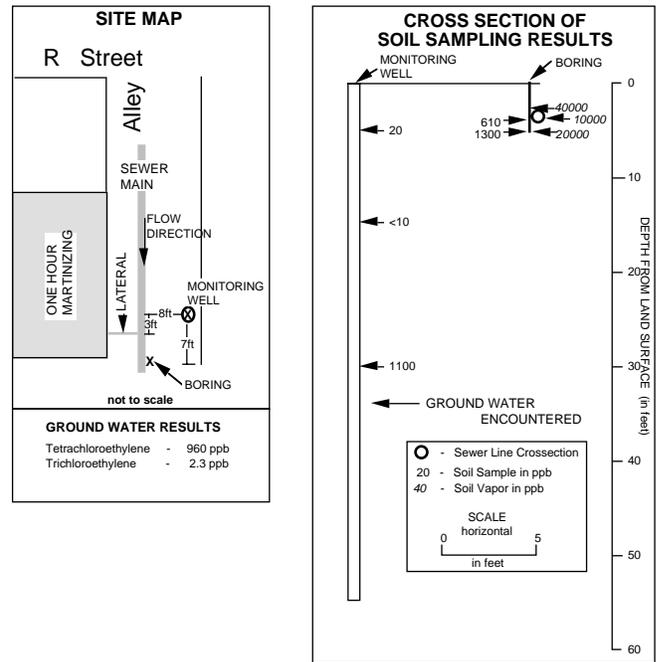
Figure 22 shows the data from the One Hour Martinizing "R" Street site. The MW was drilled eight feet northwest of the sewer line approximately 16 feet

from the cleaner's northwest wall. PCE levels in the soil samples taken during drilling of the MW were low in the upper 20 feet ranging from nondetect to 20 ppb, but near the ground water a soil sample had 1,100 ppb PCE. The ground water sample had PCE and TCE with concentrations of 960 ppb and 2.3 ppb, respectively.

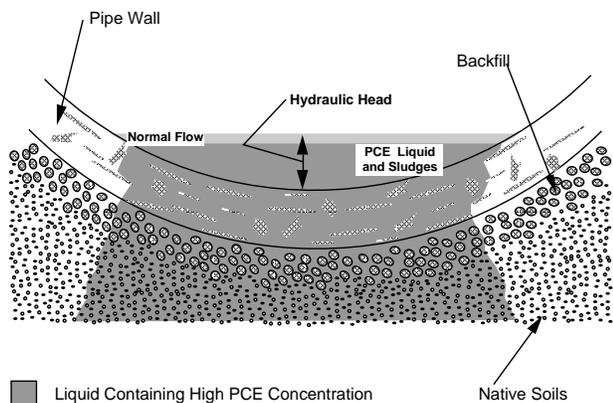
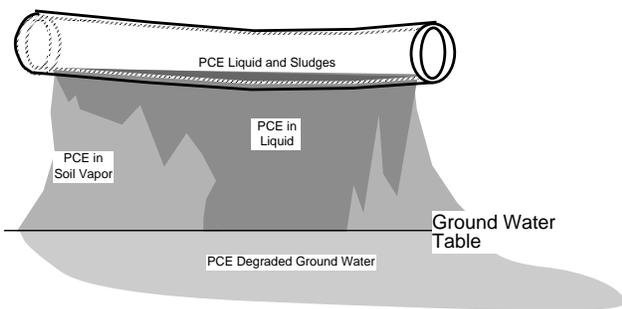
Figure 23

By this method, PCE-containing wastewater or PCE liquid penetrates a sewer pipe without any breaks. In this case liquid leaves the pipe and enters the vadose zone (Figure 23). Sewer pipe is not impermeable to water or PCE. When liquid collects in a low spot of the sewer pipe, it cause an increase in the hydraulic

**PIPE EXFILTRATION
PCE IN LIQUID PHASE**

FLOW FROM PIPE TO GROUND WATER

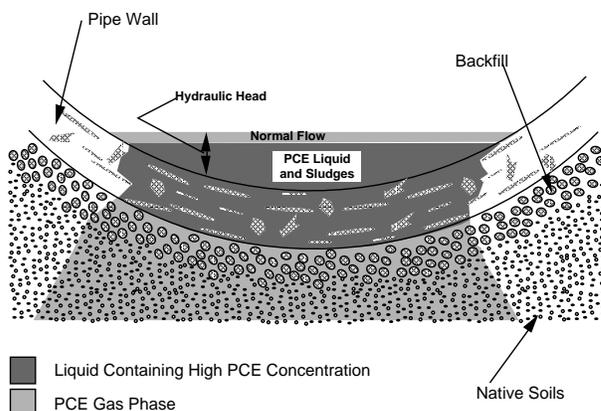
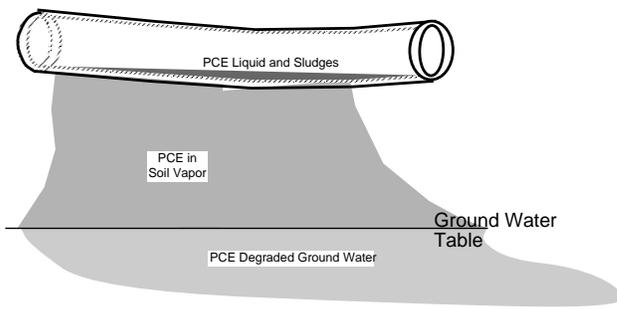
Figure 24

into the vadose zone. In this method, the pipe walls still have a high concentration of PCE-containing liquids (Figure 24). Being volatile, PCE turns into a gas at the liquid-soil vapor interface at the outer edge of the pipe. Since the vapor density of PCE is 5.83 times greater than air, the PCE gas in soil vapor would sink towards ground water, causing ground water degradation.

**PIPE EXFILTRATION
PCE ENTERS PIPE WALL AS A LIQUID
AND THE SOIL AS A GAS**

FLOW FROM PIPE TO GROUND WATER

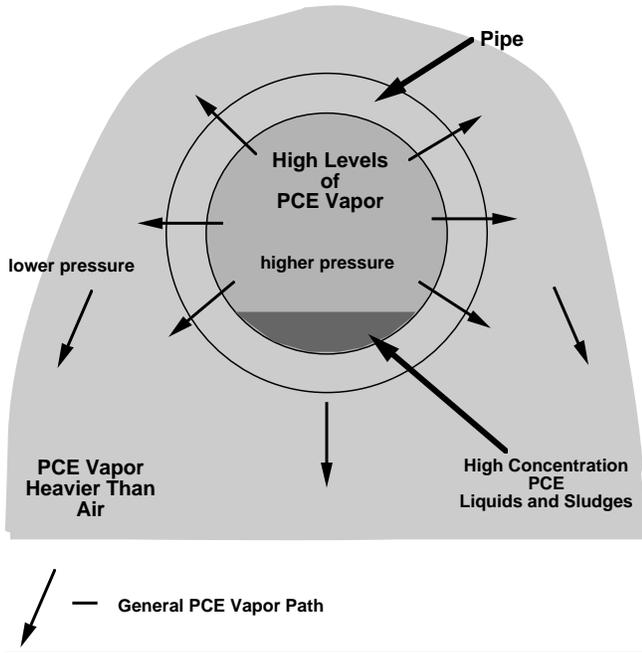
Figure 25

In this method, PCE volatilizes inside the pipe and moves as a gas through the sewer pipe wall (Figure 25). The piping material is not designed to contain gas. The concentration of PCE gas in the pipe is greater than in the surrounding soils causing a concentration gradient. This causes a dispersion through the

PCE PENETRATES A PIPE AS A GAS

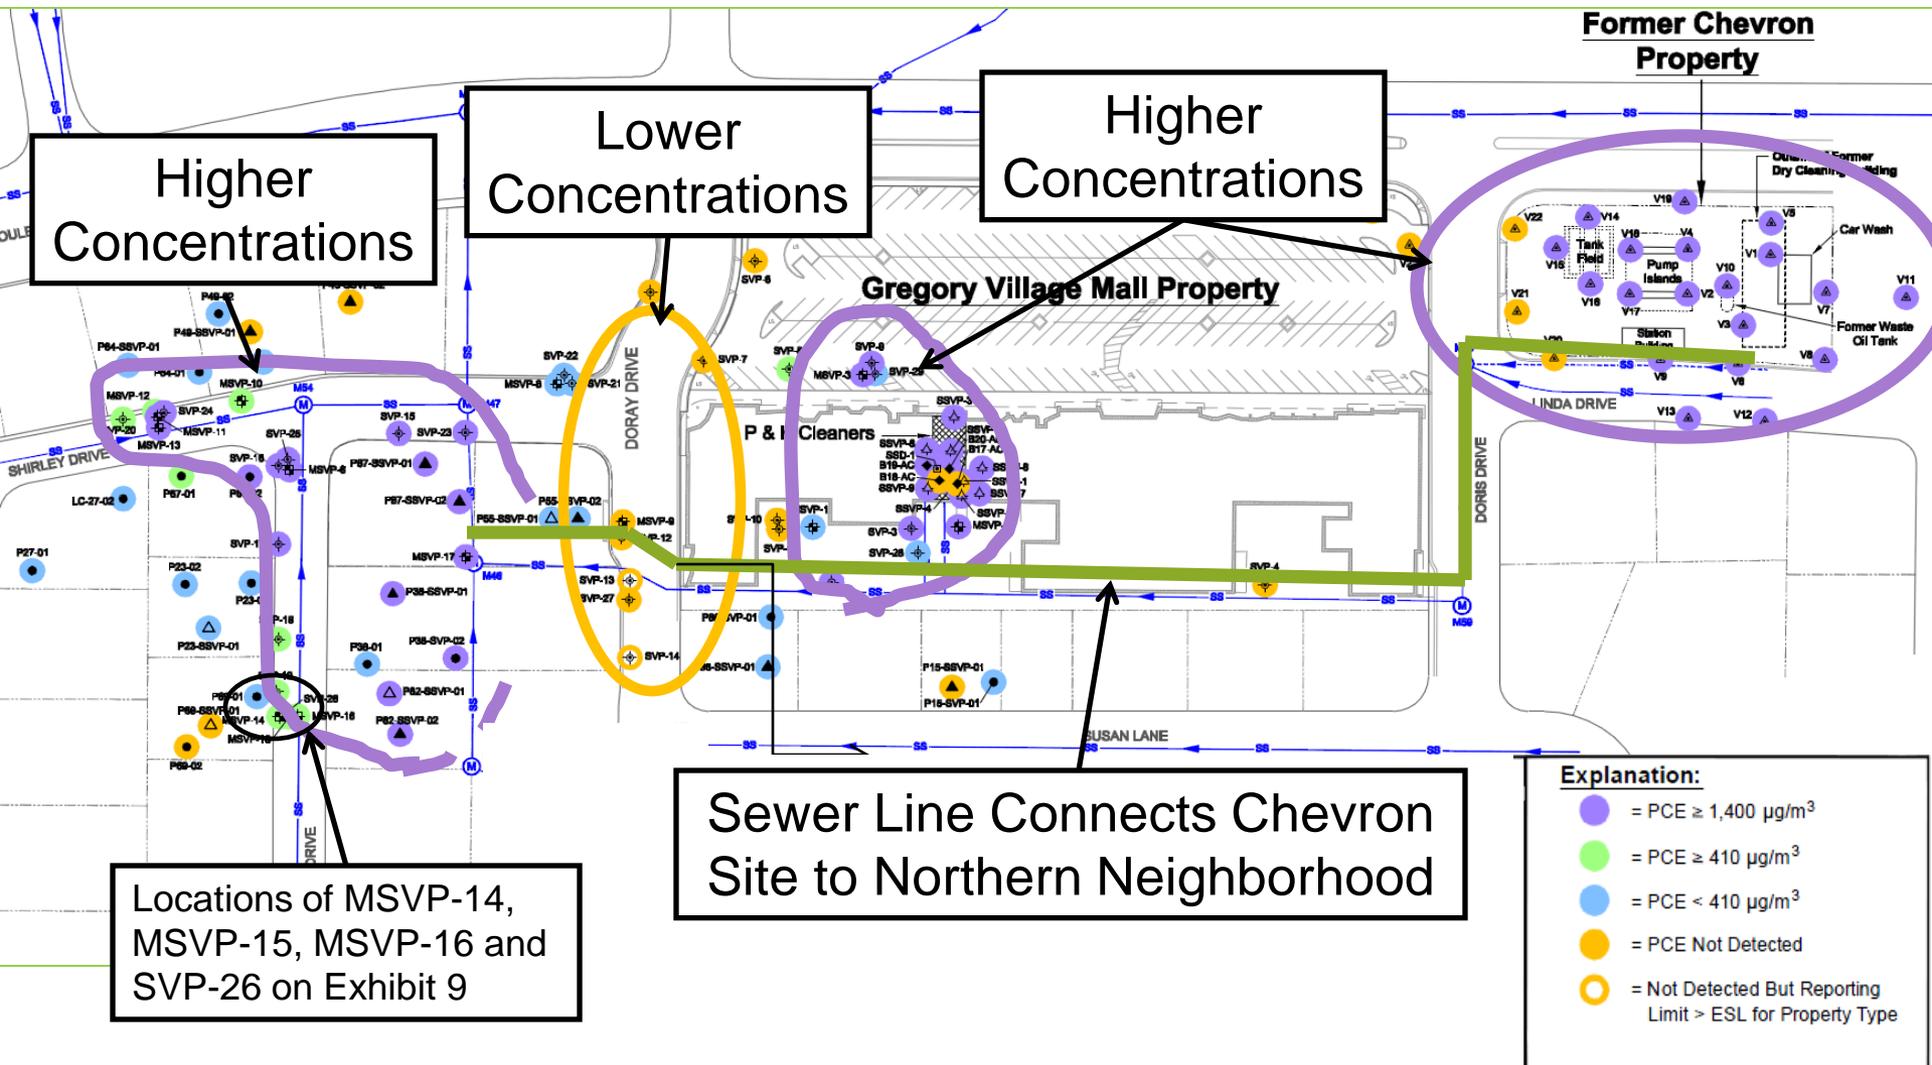
Separate Areas of High PCE Concentrations in Soil Vapor Indicate Separate Releases

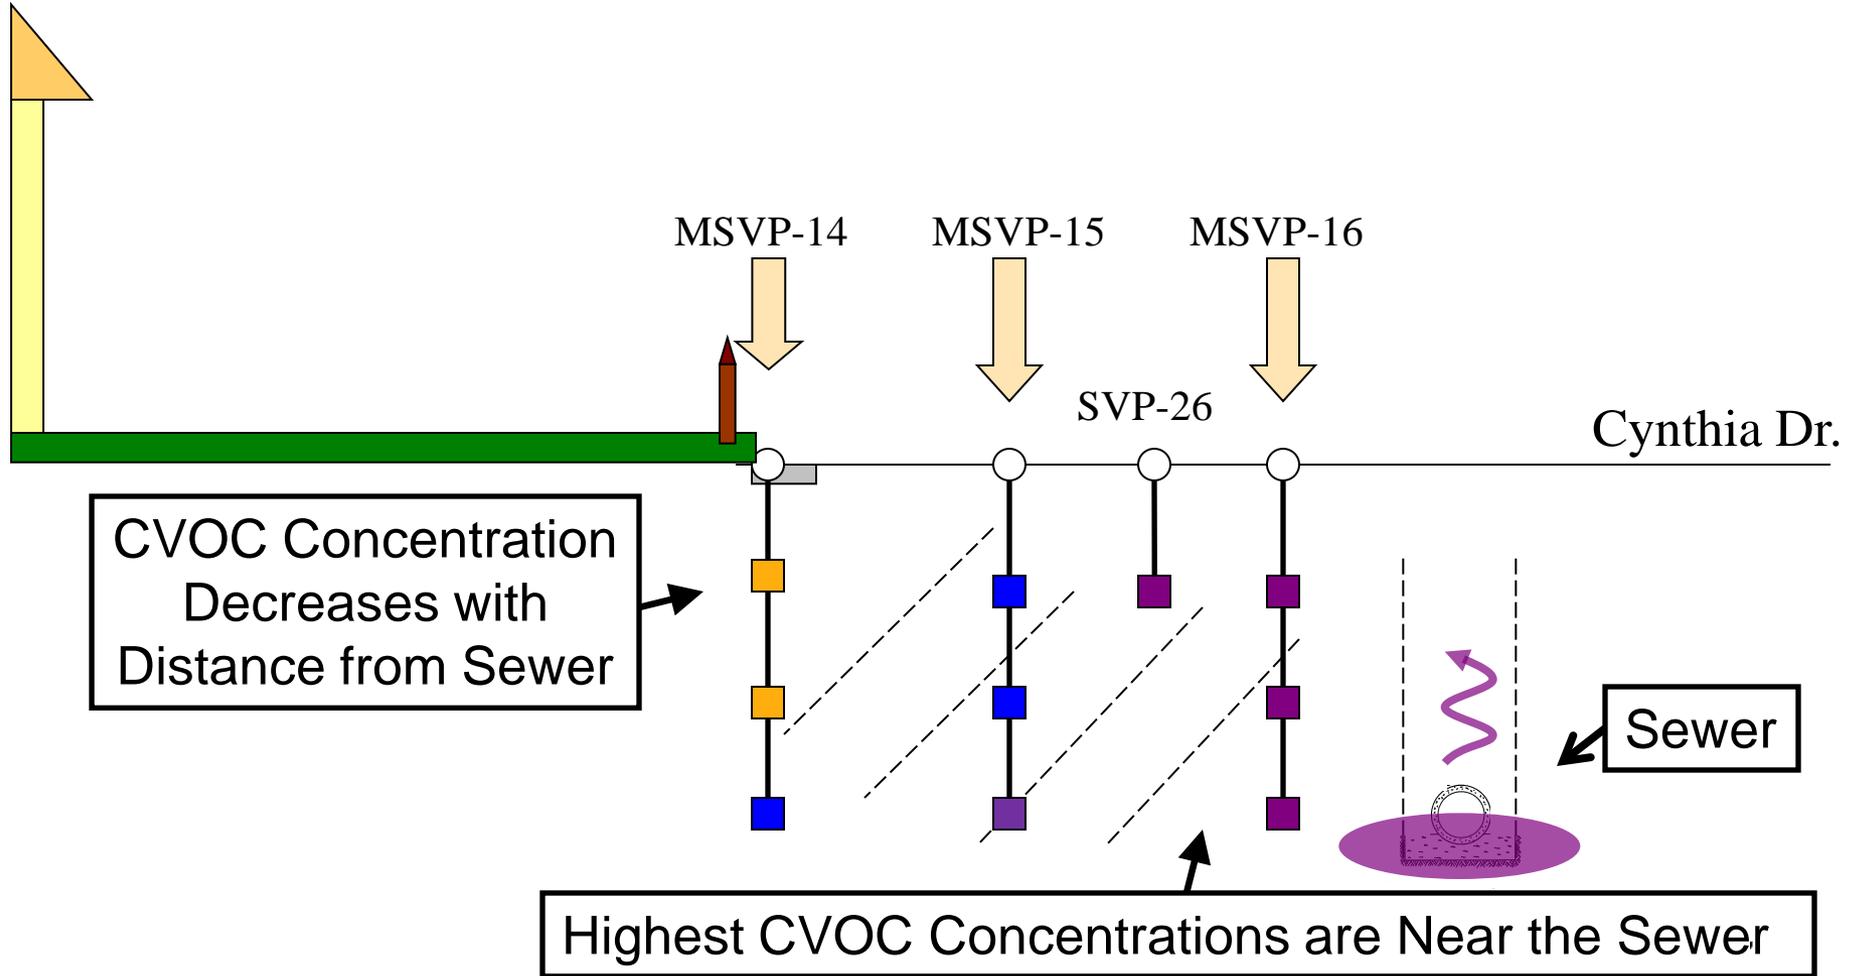
CVOC Concentrations In Soil Vapor are Highest Near the Sewer

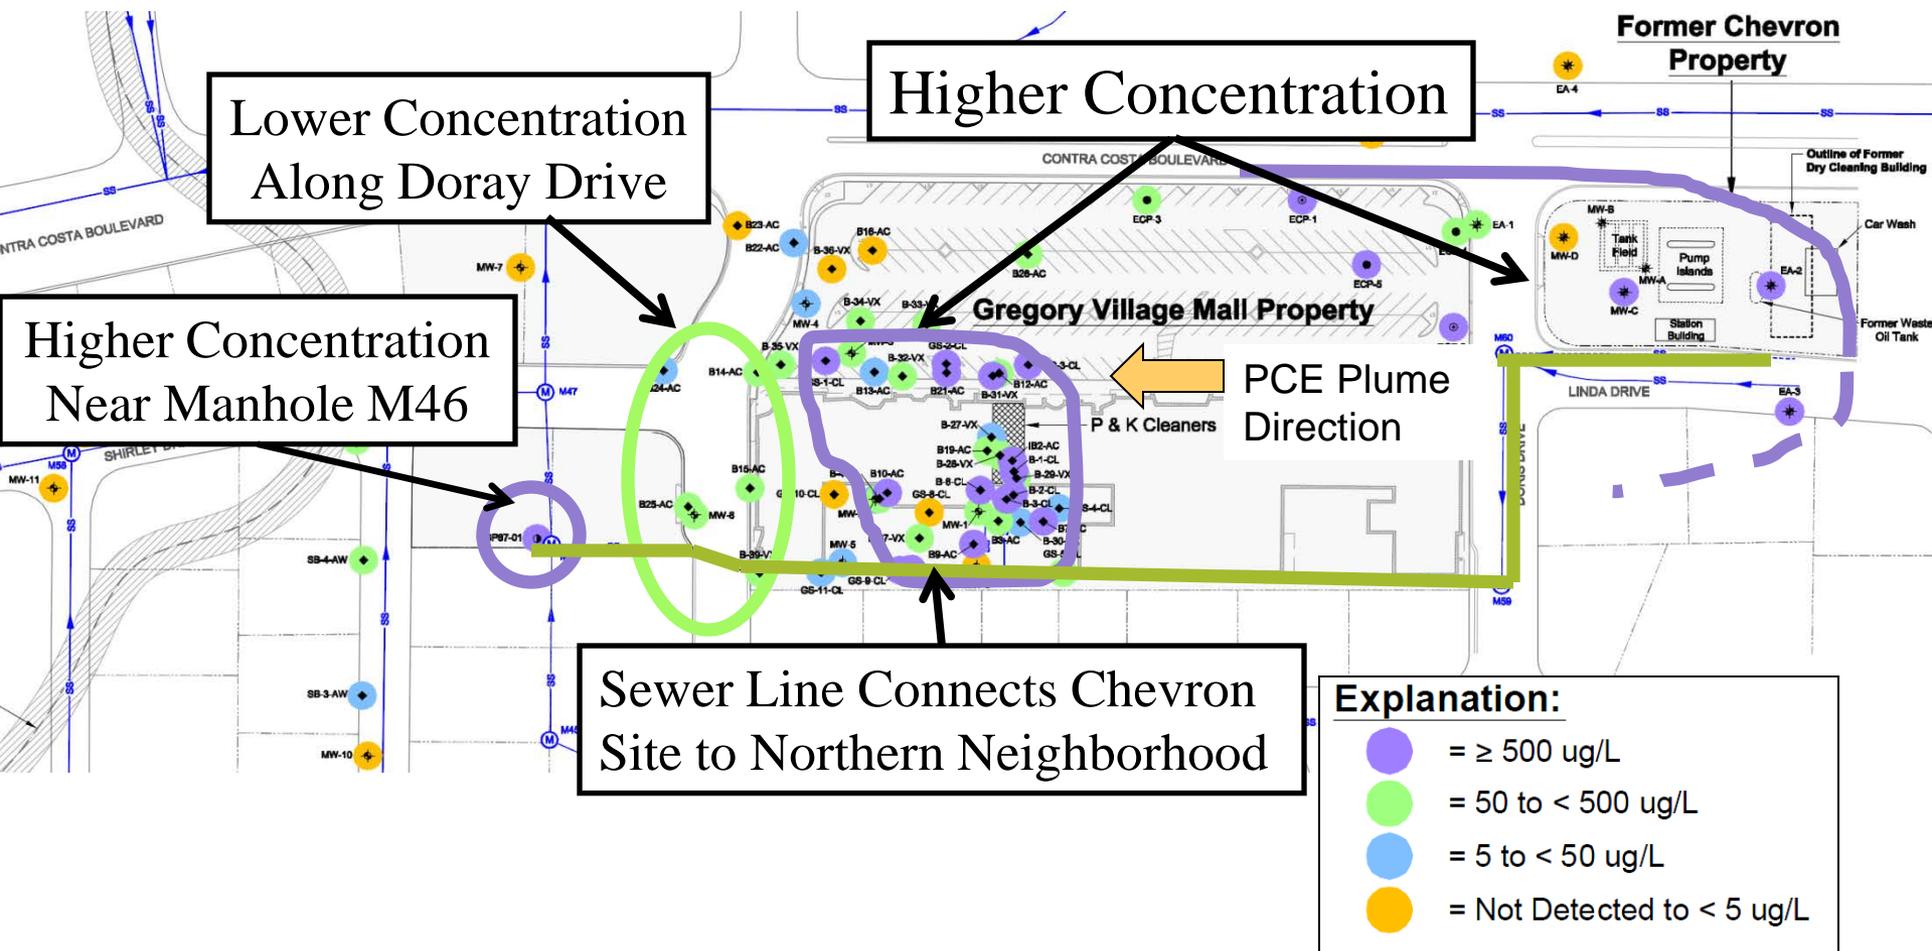
Separate Areas of High PCE Concentrations in Groundwater Indicate Separate Releases

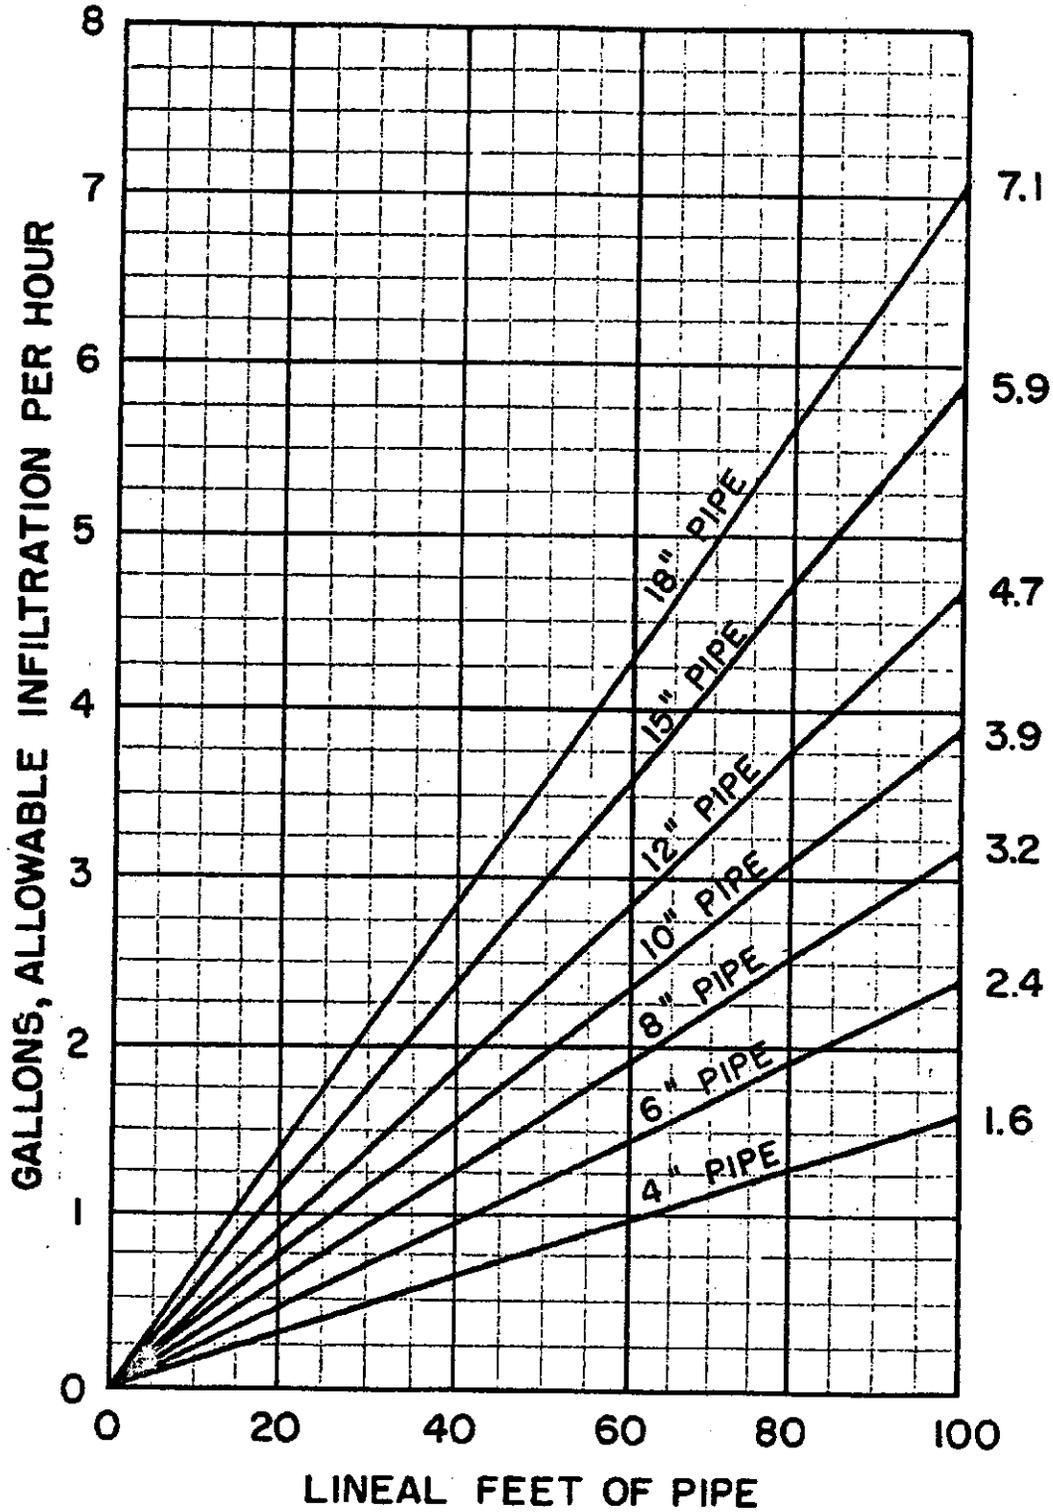
ALLOWABLE INFILTRATION CHART

500 GALS. PER INCH DIA. PER MILE OF PIPE PER DAY

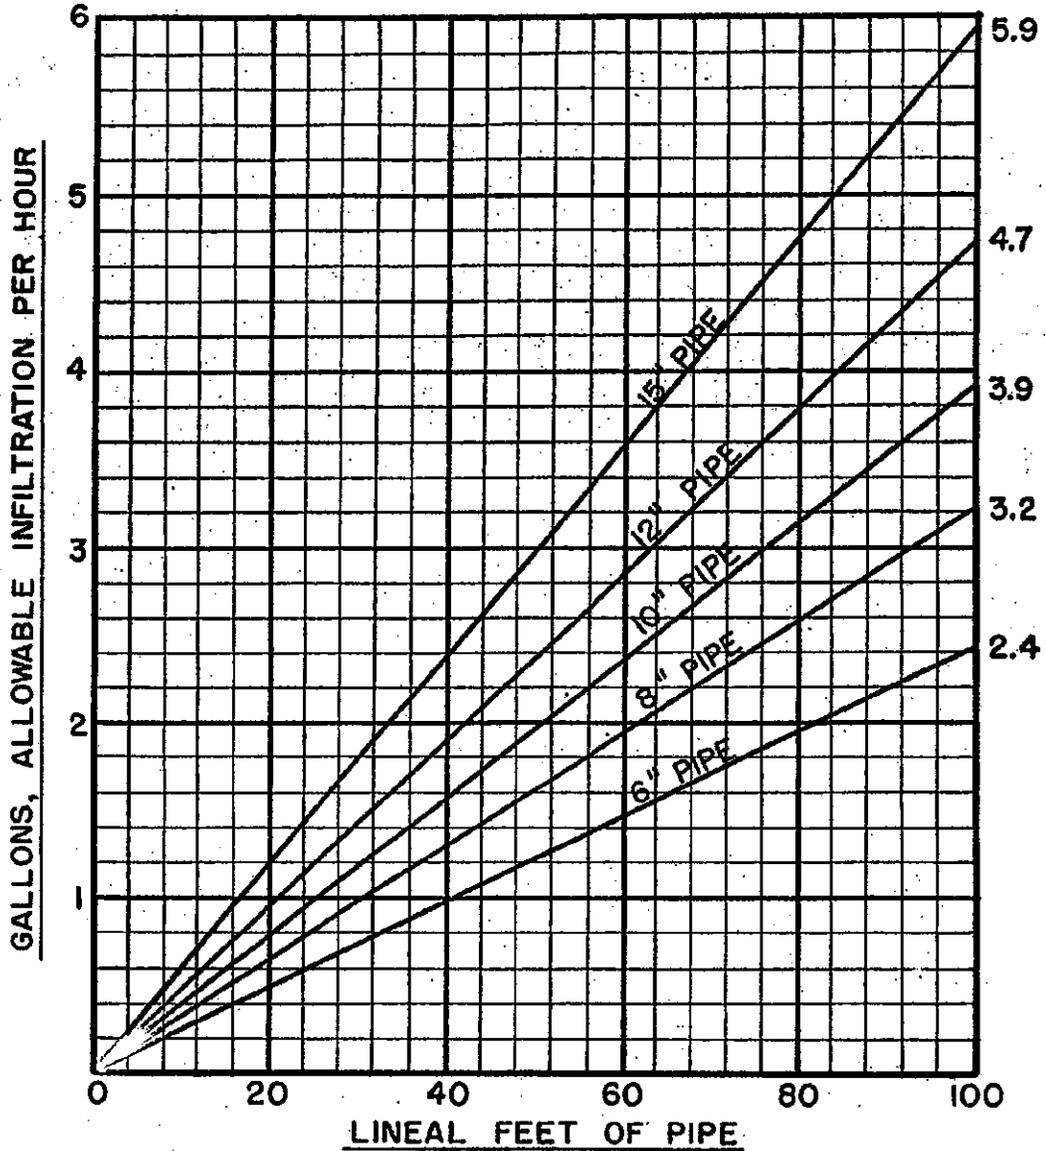
ALLOWABLE INFILTRATION CHART FOR MAIN SEWERS

ALLOWABLE LEAKAGE- 500 GALS. PER INCH DIA. PER MILE OF PIPE PER DAY
