Subject: Tentative Order – Initial Site Cleanup Requirements for
1643 Contra Costa Boulevard Pleasant Hill, CA (“Site 1”)
Regional Board File No. 07S0132 (KEB)

Tentative Order – Initial Site Cleanup Requirements for
1705 Contra Costa Boulevard Pleasant Hill, CA (“Site 2”)
Regional Board File No. 07S0204 (KEB)

CENTRAL VALLEY
CITIES WHERE MUNICIPAL WELLS ARE AFFECTED BY
TETRACHLOROETHYLENE (PCE)

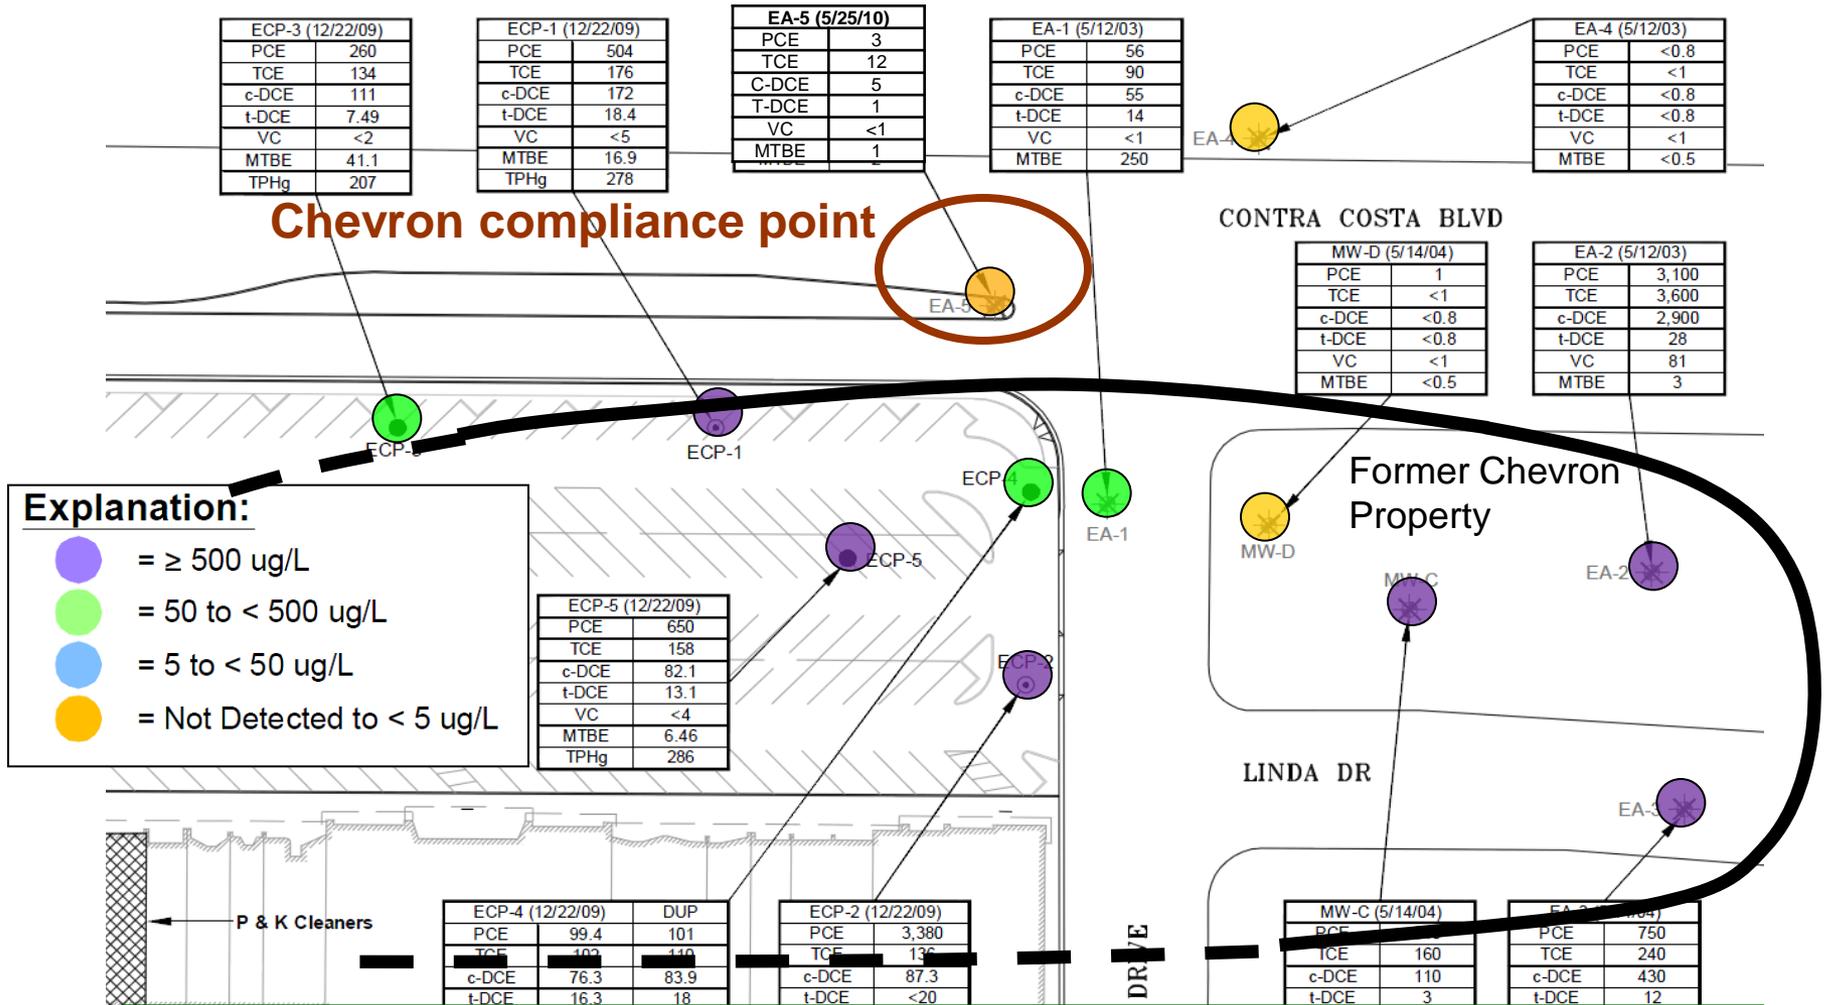
Chevron Compliance Point and Only Well is NOT in the Chevron Plume

Note: Except at the Chevron compliance point (existing well EA-5), the color dots are one time grab sample locations or wells that have been destroyed by Chevron.

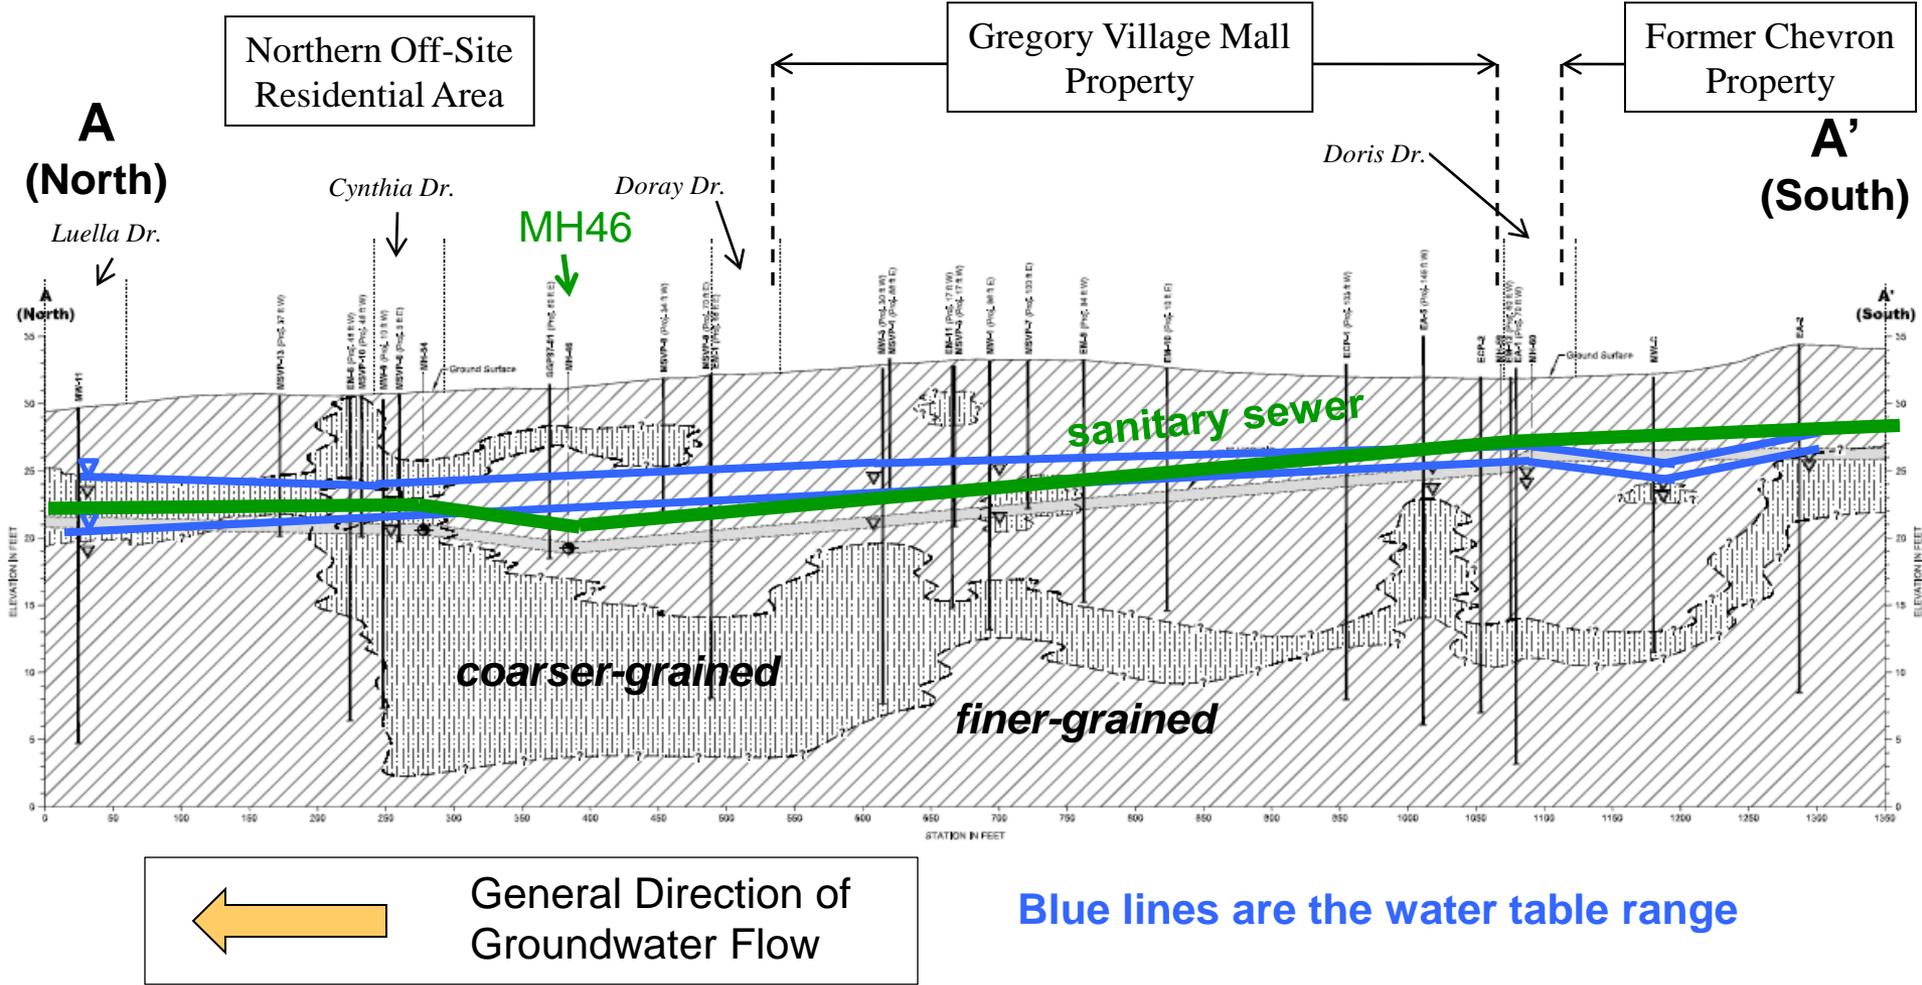
CCCSD's Sanitary Sewer is Installed Near or Below the Water Table

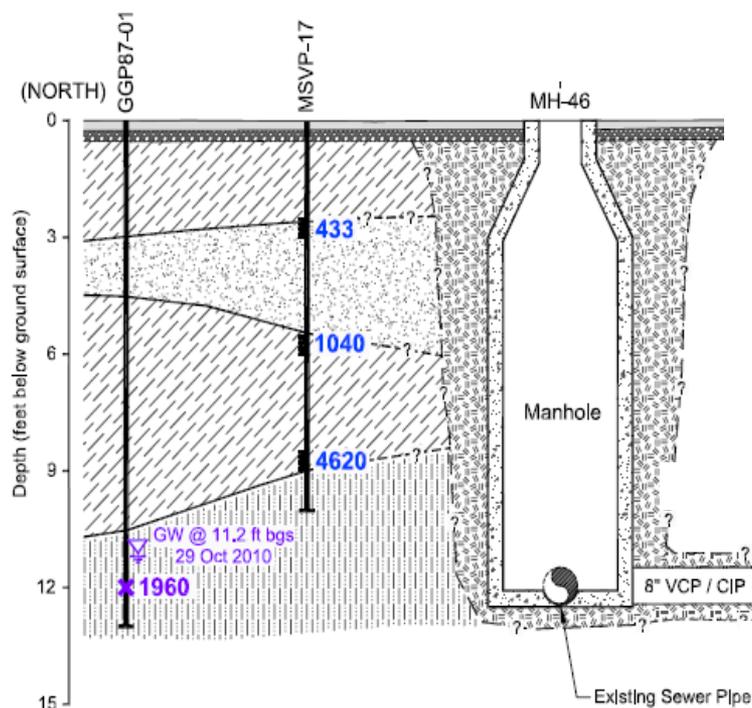
PCE in Soil Vapor and Groundwater Near Manhole M46 is Consistent with a Sewer Leak

Sewer line and bottom of manhole M46 are at or below the water table

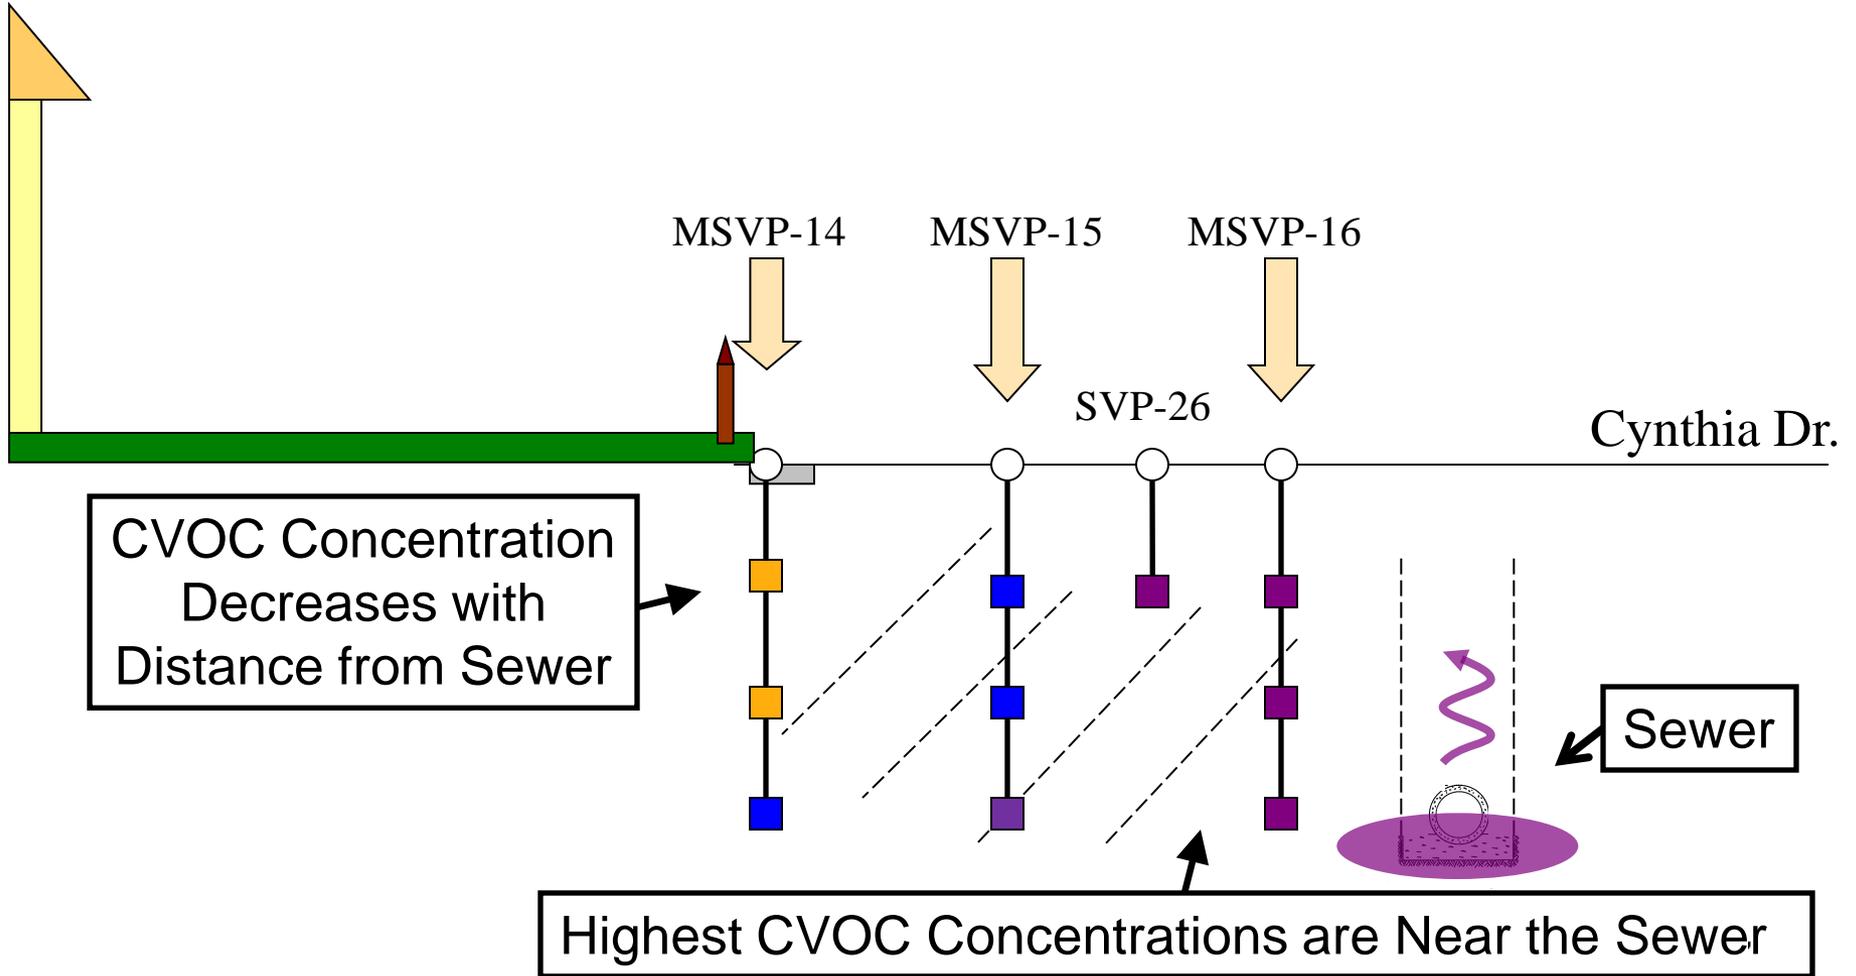
CVOC Concentrations In Soil Vapor are Highest Near the Sewer

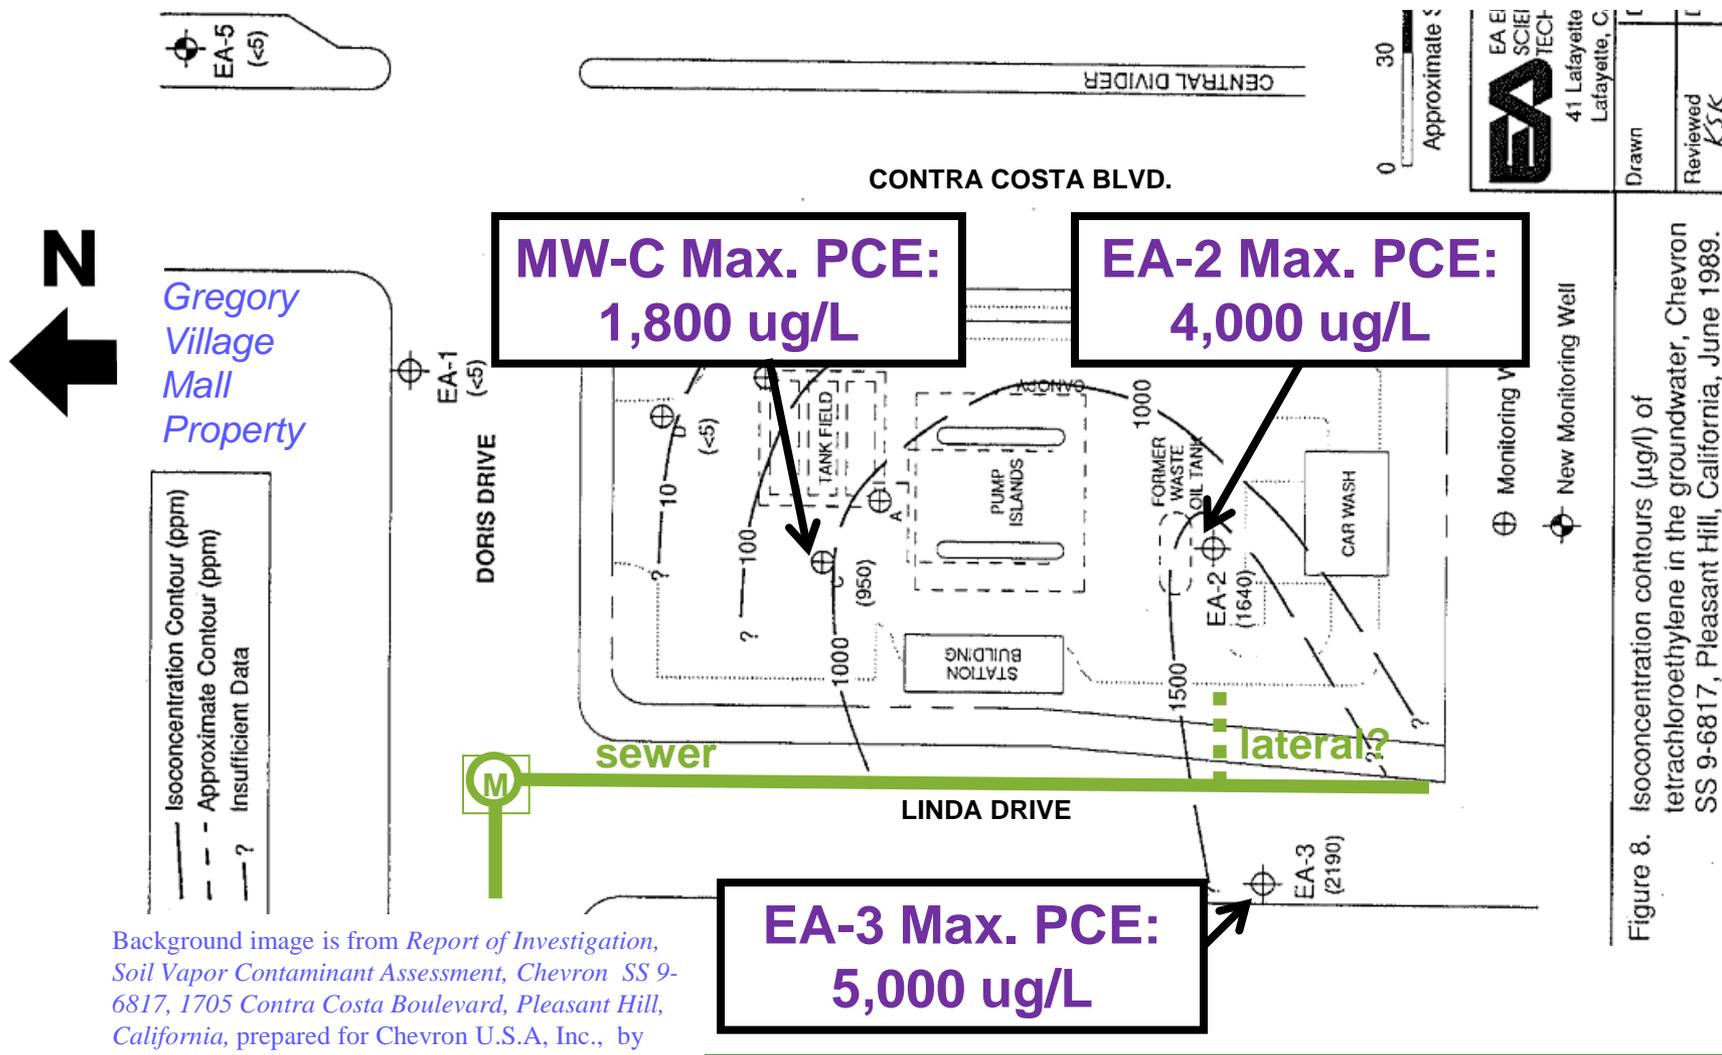
PCE in Groundwater in Linda Drive Cross-Gradient from Chevron Site Indicative of a Sewer Leak

Figure 8. Isoconcentration contours (ug/l) of tetrachloroethylene in the groundwater, Chevron SS 9-6817, Pleasant Hill, California, June 1989.

The highest concentration of PCE in groundwater anywhere at the Chevron Site is in Linda Drive near the CCCSD sewer at former monitoring well EA-3 located cross-gradient from the Chevron Site. Chevron's investigations show very high concentrations of PCE and other CVOCs in soil, soil vapor, and groundwater on the Chevron Site and in Linda Drive near the sewer line (*Report of Investigation* by EA Engineering, Science and Technology, Inc., 3 February 1989, and *Additional Site Investigation Report and Site Conceptual Model* by Conestoga-Rovers & Associates, Inc., 2 March 2012). At monitoring well EA-3 in Linda Drive, Chevron detected PCE in soil at 328 micrograms per kilogram from a sample that would have been collected from above the groundwater table and thus resulted from sewer leakage. PCE was detected in groundwater at 5,000 ug/L (Exhibit 10 attached), the highest concentration detected anywhere at Sites 1 and 2, at the same location. A 1977 CCCSD sewer inspection report for Linda Drive describes the sewer as "in very poor shape has lots of cracks," but the replacement apparently did not occur until 10 years later (see Firestone 7/3/2012 letter to B. Wolfe (see Exhibit 23 to that letter)).
