WATERSHED REHABILITATION IN REDWOOD NATIONAL PARK AND OTHER PACIFIC COASTAL AREAS

Proceedings of a symposium held August 24-28, 1981
Edited by R.N. Coats

PROCEEDINGS OF A
SYMPOSIUM ON WATERSHED REHABILITATION
IN REDWOOD NATIONAL PARK
AND OTHER PACIFIC COASTAL AREAS

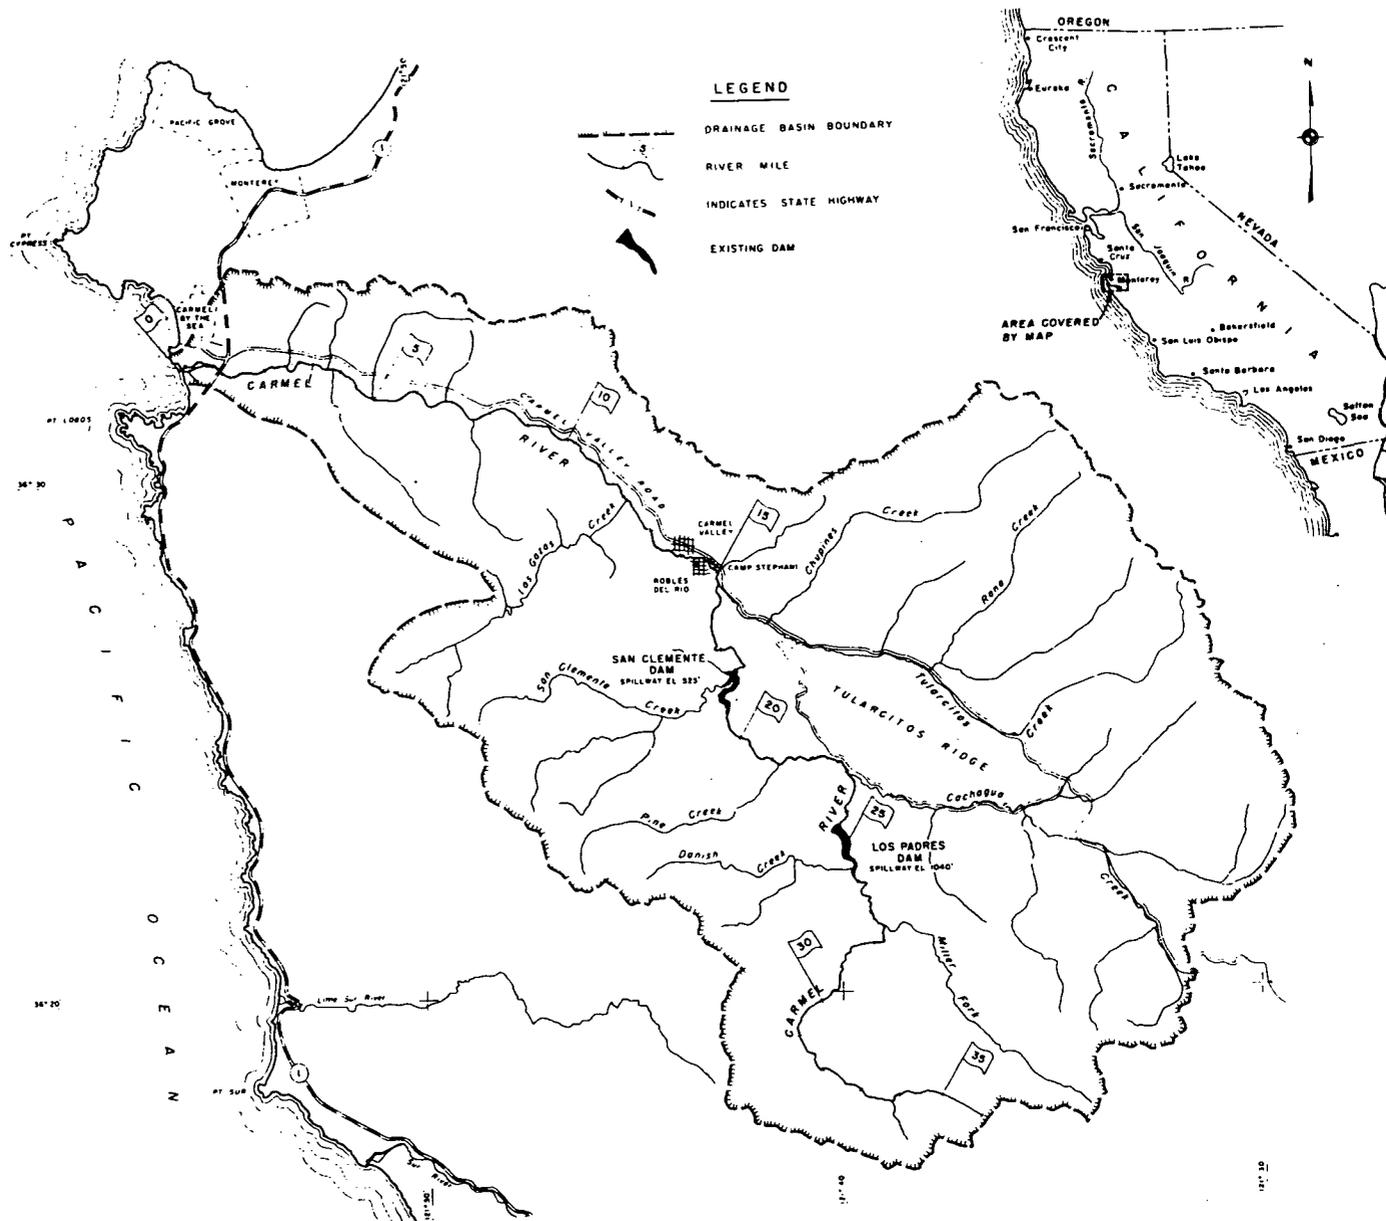
Figure 1a) Vicinity map of the Carmel River Basin.
 1b) General map of the Carmel River Basin. (U.S. Army Corps of Engineers, 1967)

The Carmel River drains a 670 km² (255 mi²) basin. Rising in the rugged Santa Lucia Mountains and passing through the 24 km (15 mi) long, alluviated Carmel Valley, it ultimately discharges into the Pacific near Carmel, Calif. (fig. 1). This alluvial reach is sub-divided by a bedrock constriction and narrowing of the valley (the "Narrows") into a lower 16 km (10 mi) reach (the "Lower Carmel") and a middle 8 km (5 mi) reach (the "Middle Carmel"). The "Upper Carmel" refers to the segment above San Clemente Dam (fig. 2). Average annual rainfall in the mountainous headwaters with elevations to 2133 m (7000 ft) is 1040 mm (41 in) but decreases to 430 mm (17 in) in the lower valley. While the upper river is perennial, the lower river is intermittent, with surface flow typically from December through June. Near the river's mouth, average discharge is 2.7 cms (97 cfs), and the bankfull discharge (here, the 2.4 yr flow) is 79.2 cms (2800 cfs).

Two water supply dams, the Los Padres and San Clemente Dams, together impound about 3000 ac-ft (fig. 1). The Carmel basin supplies most of the water for the Monterey Peninsula cities of Monterey, Pacific Grove, Seaside, and Carmel. As these areas have grown, demand for water has risen substantially. To meet demand, California-American Water Company (Cal-Am), a private utility, has drawn increasingly upon water supply wells in the alluvium along the lower and middle Carmel valley over the past two decades. Of the 13,000 ac-

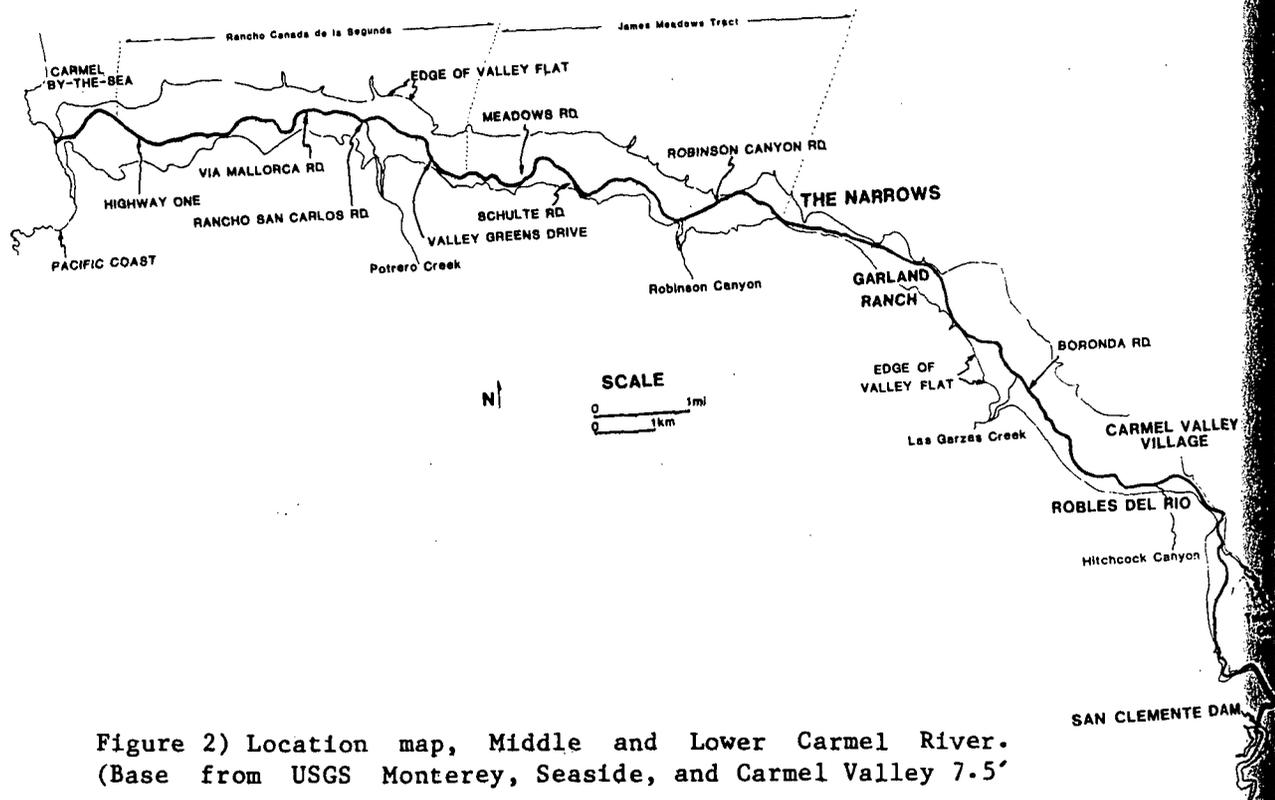
Figure 2) Location map, Middle and Lower Carmel River.
 (Base from USGS Monterey, Seaside, and Carmel Valley 7.5'
 Quadrangles)

By the late 1960s, residents were complaining that vegetation was dying off near the wells in the "mid-valley" region, in the vicinity of Robinson Canyon Road (fig. 2, also see Lee, 1974). The Carmel Valley Property Owners Association hired a forestry consultant to study the vegetation problem; he concluded that lowered water tables near the wells killed the vegetation (Zinke, 1971). Cal-Am hired another consultant, who acknowledged that lowered water tables near the wells affected vegetation, but observed that the effect was simply an acceleration the "natural succession" of vegetation (Stone, 1971).

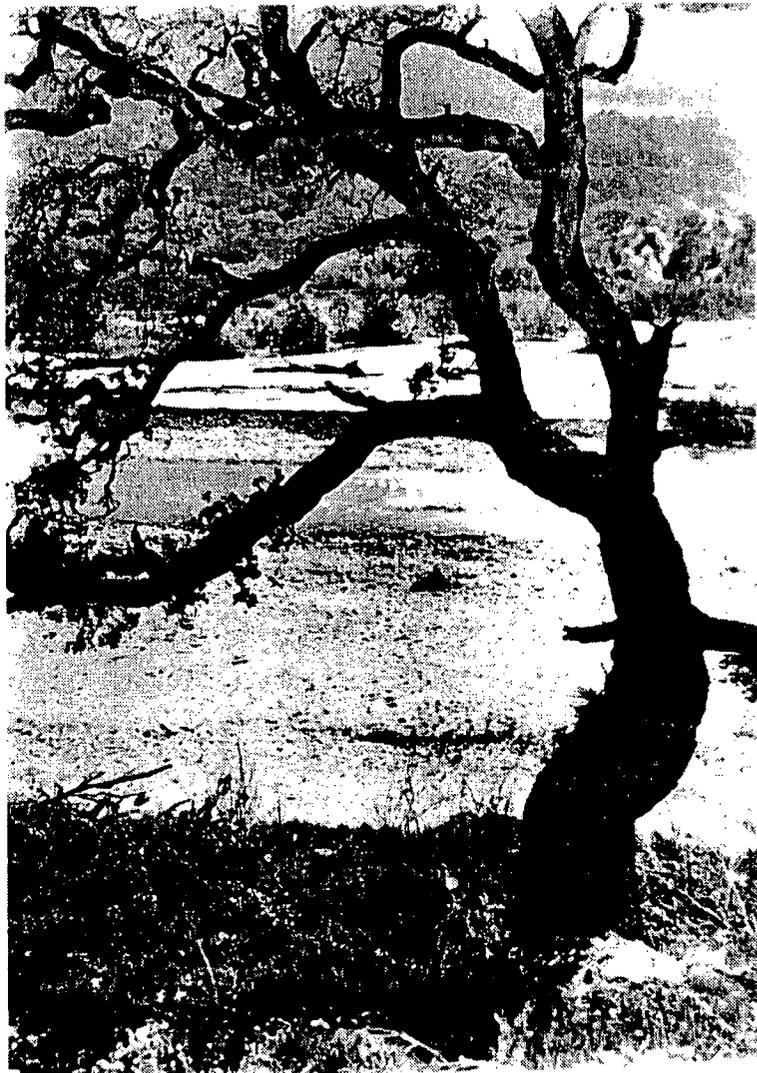
Plate 1) Carmel River channel, 1918, viewed from right bank upstream from location of present Robinson Canyon Road bridge. (Slevin Collection, Bancroft Library, U.C. Berkeley)

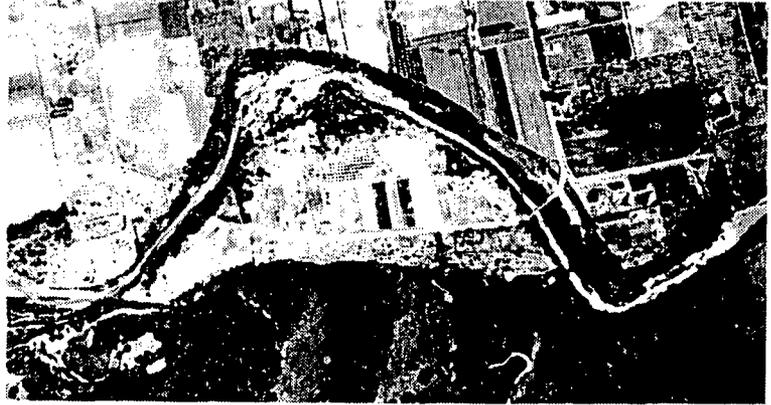
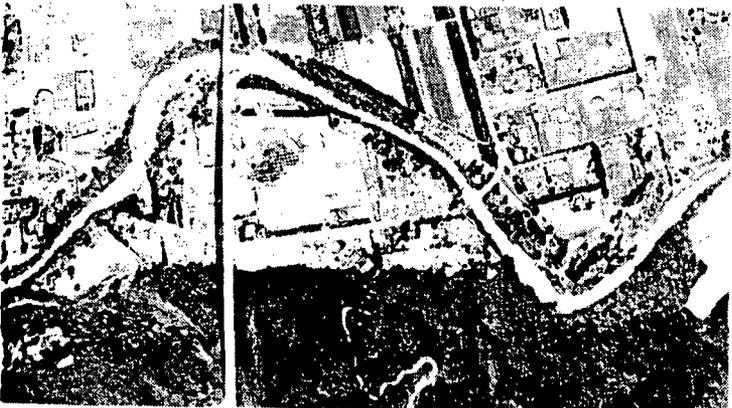
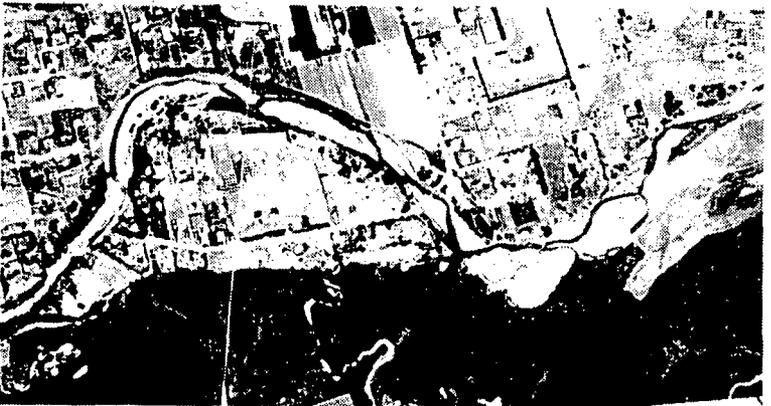
Plate 2) Aerial photographs of the Carmel River near Schulte Road bridge. a) 1939, b) 1965, c) 1977, d) 1980. (Air photo collection, Monterey County Flood Control, Salinas)

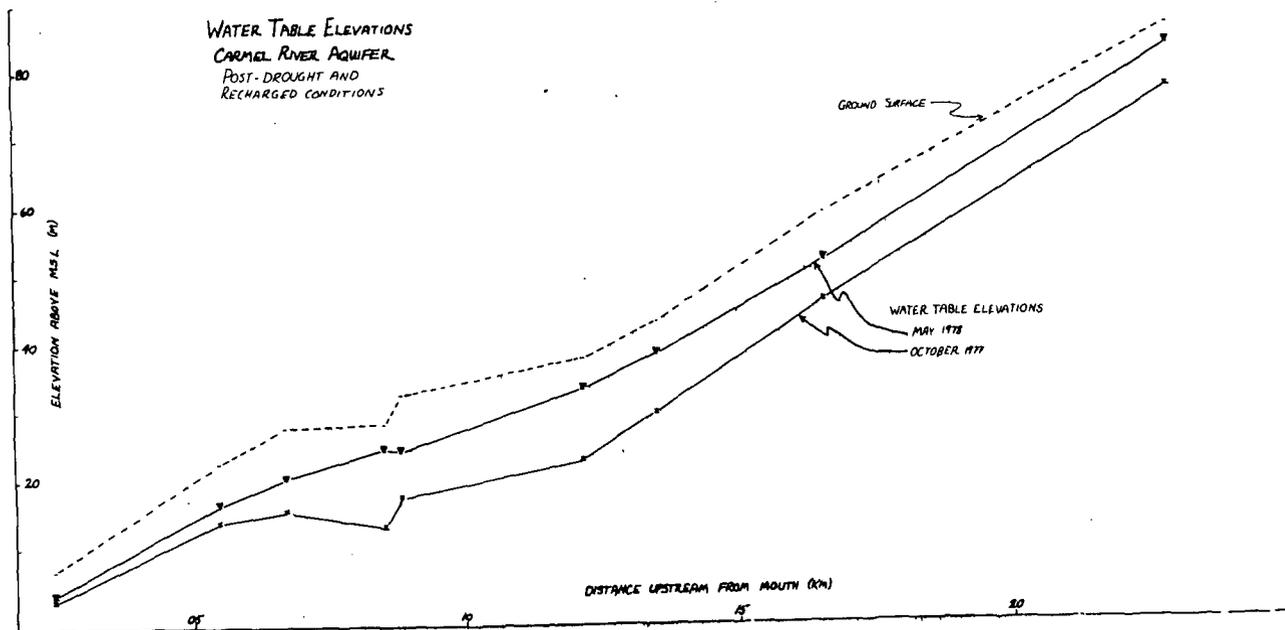
• Figure 3) Water table elevations, drought and recharged conditions. (Data from Monterey County Flood Control well level records)

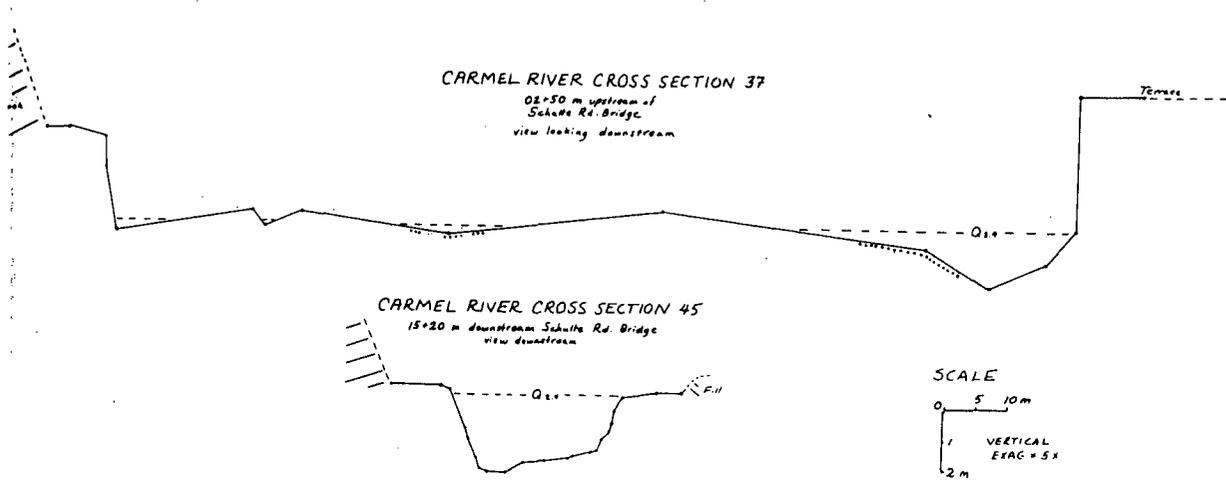
Figure 4) Channel cross sections of the Carmel River near Schulte Road Bridge. Section 37: 250 m (820 ft) upstream of bridge, Section 45: 1520 m (5000 ft) downstream of bridge. Discharge remains essentially unchanged between reaches. (From field surveys by the authors)

For the Carmel River, the stable reaches downstream of the disturbed reaches can serve as models for design geometries. In figure 4, cross sections are plotted for an eroded reach upstream of Schulte Road (section 37) and for a stable reach about 1.5 km (1 mile) downstream (section 45). No tributaries enter between these sections, so discharge remains essentially constant. Yet the present-day geometries are vastly different. Surveys by the U.S. Army Corps of Engineers in 1965 indicate that the reach encompassing section 37 was characterized by a geometry closely resembling that of the present-day section 45. Thus, a design stable geometry for section 37 could be drawn largely from the existing geometry at section 45. Certain corrections would have to be made for differences in gradient, sinuosity, and bed material size between these reaches. Fortunately, many of these parameters are well documented for the stable, pre-disturbance Carmel River.

Width-to-depth ratios for vegetated channels that had stabilized following dam construction were, in 1965, on the order of 15-25:1 for a 2.4-year recurrence interval bankfull flow. Design of restabilized channels will emulate these ratios. Vegetated permeable jacks will be used to constrain the channel to these widths. Since aggradation has gone on locally during the recent destabilization, depth and gradient manipulation will have to be accomplished to restore stability. Current plans are to investigate opportunities for "flushing flows" that can be augmented with reservoir releases during periods of seasonal high flow. Preliminary field evidence suggests that flows on the order of magnitude of the mean annual flood are effective for bedload transport and channel incision. Primary goals are to develop sediment transport and sediment routing models that will optimize transport while minimizing bank erosion and local overbank flooding caused by aggradation. Since sequential or long-duration low magnitude flows lead to bed armoring and cessation of further downcutting, management models must accommodate natural or induced flows that will effectively mobilize armor layers.

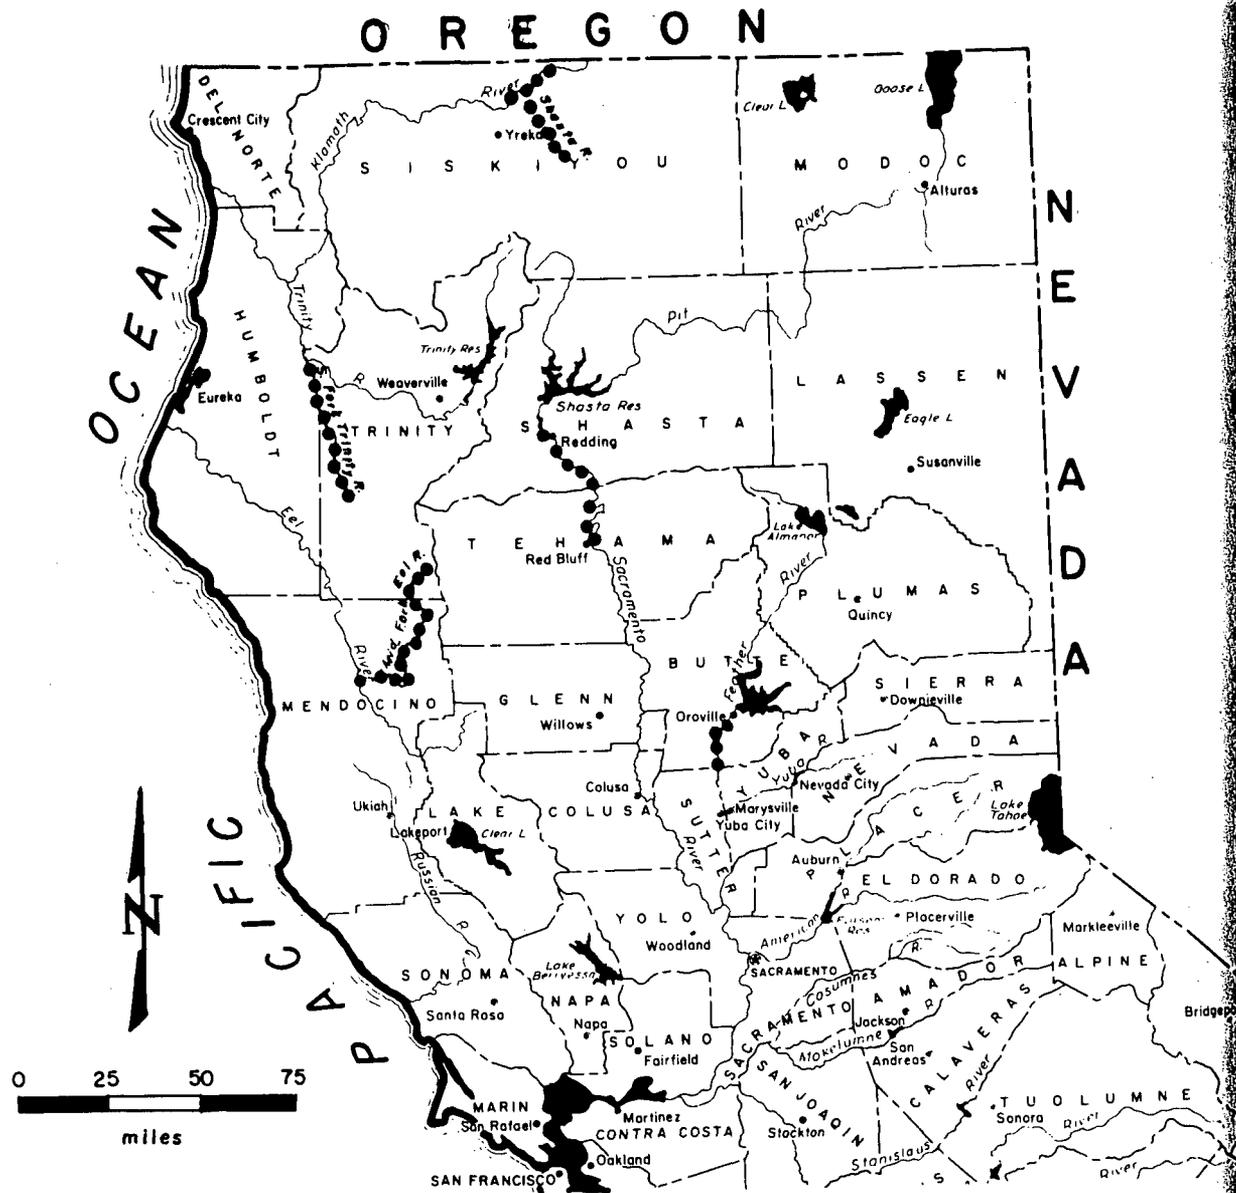
Figure 1. Northern California with darkened circles showing the locations of spawning gravel enhancement and stream geomorphology studies by the Department of Water Resources, Northern District Geology Section.

As part of the Resources Agency's Resource Investment Fund and the Wild and Scenic Rivers Program, the Department of Water Resources (DWR) is studying spawning gravel enhancement techniques and locating potential new spawning areas in six California rivers (Fig. 1). Three studies have been completed. These are the Sacramento River between Keswick Dam and Red Bluff (Parfitt and Buer 1980), the Klamath River between Iron Gate Dam and Humbug Creek, and the Shasta River between Lake Shastina and the mouth (Buer 1981). Construction of these proposed spawning areas would provide for an additional 16,000 salmon pair. Similar studies are in progress for the Feather River and the Wild and Scenic portions of the South Fork Trinity and Middle Fork Eel.

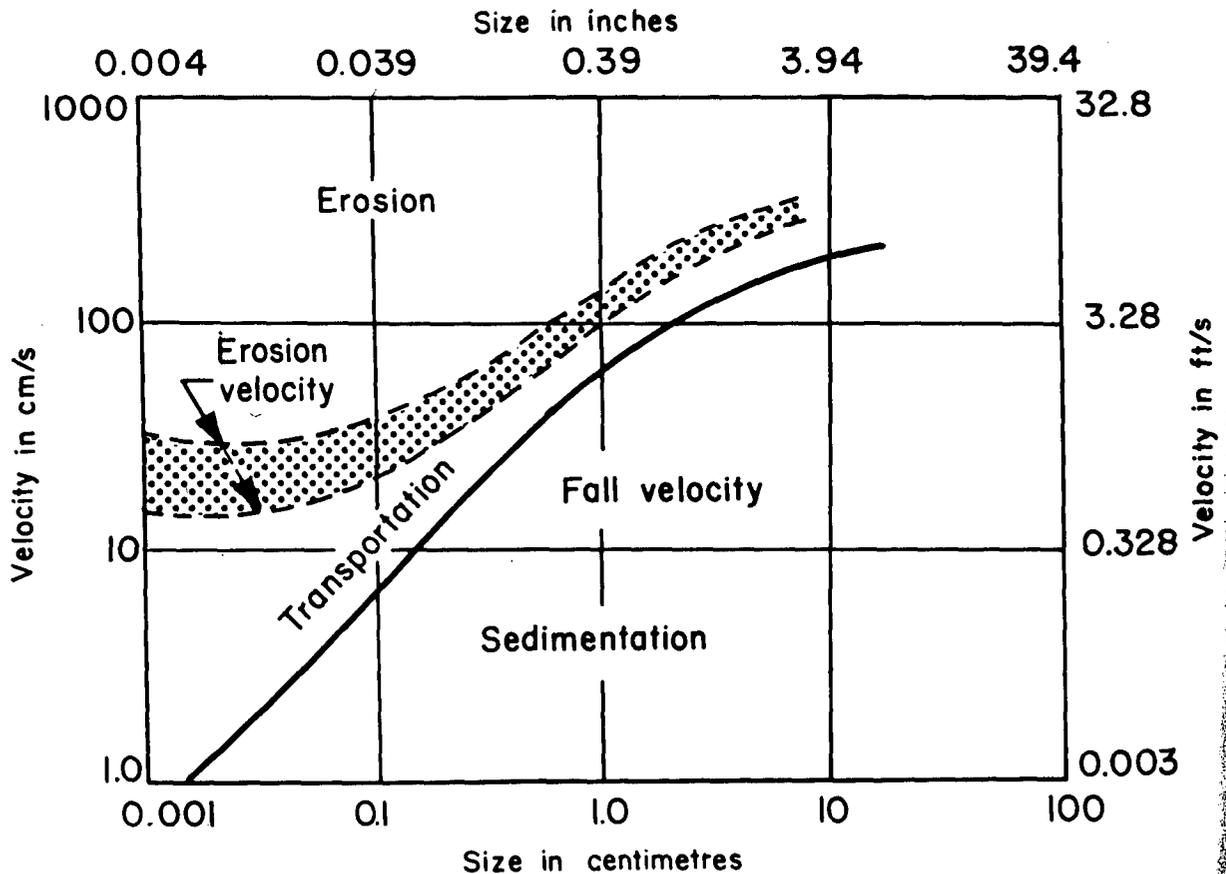
Figure 2. Curves of erosion and deposition for uniform material. Erosion velocity shown as a band. (Redrawn from Hjulstrom 1935)

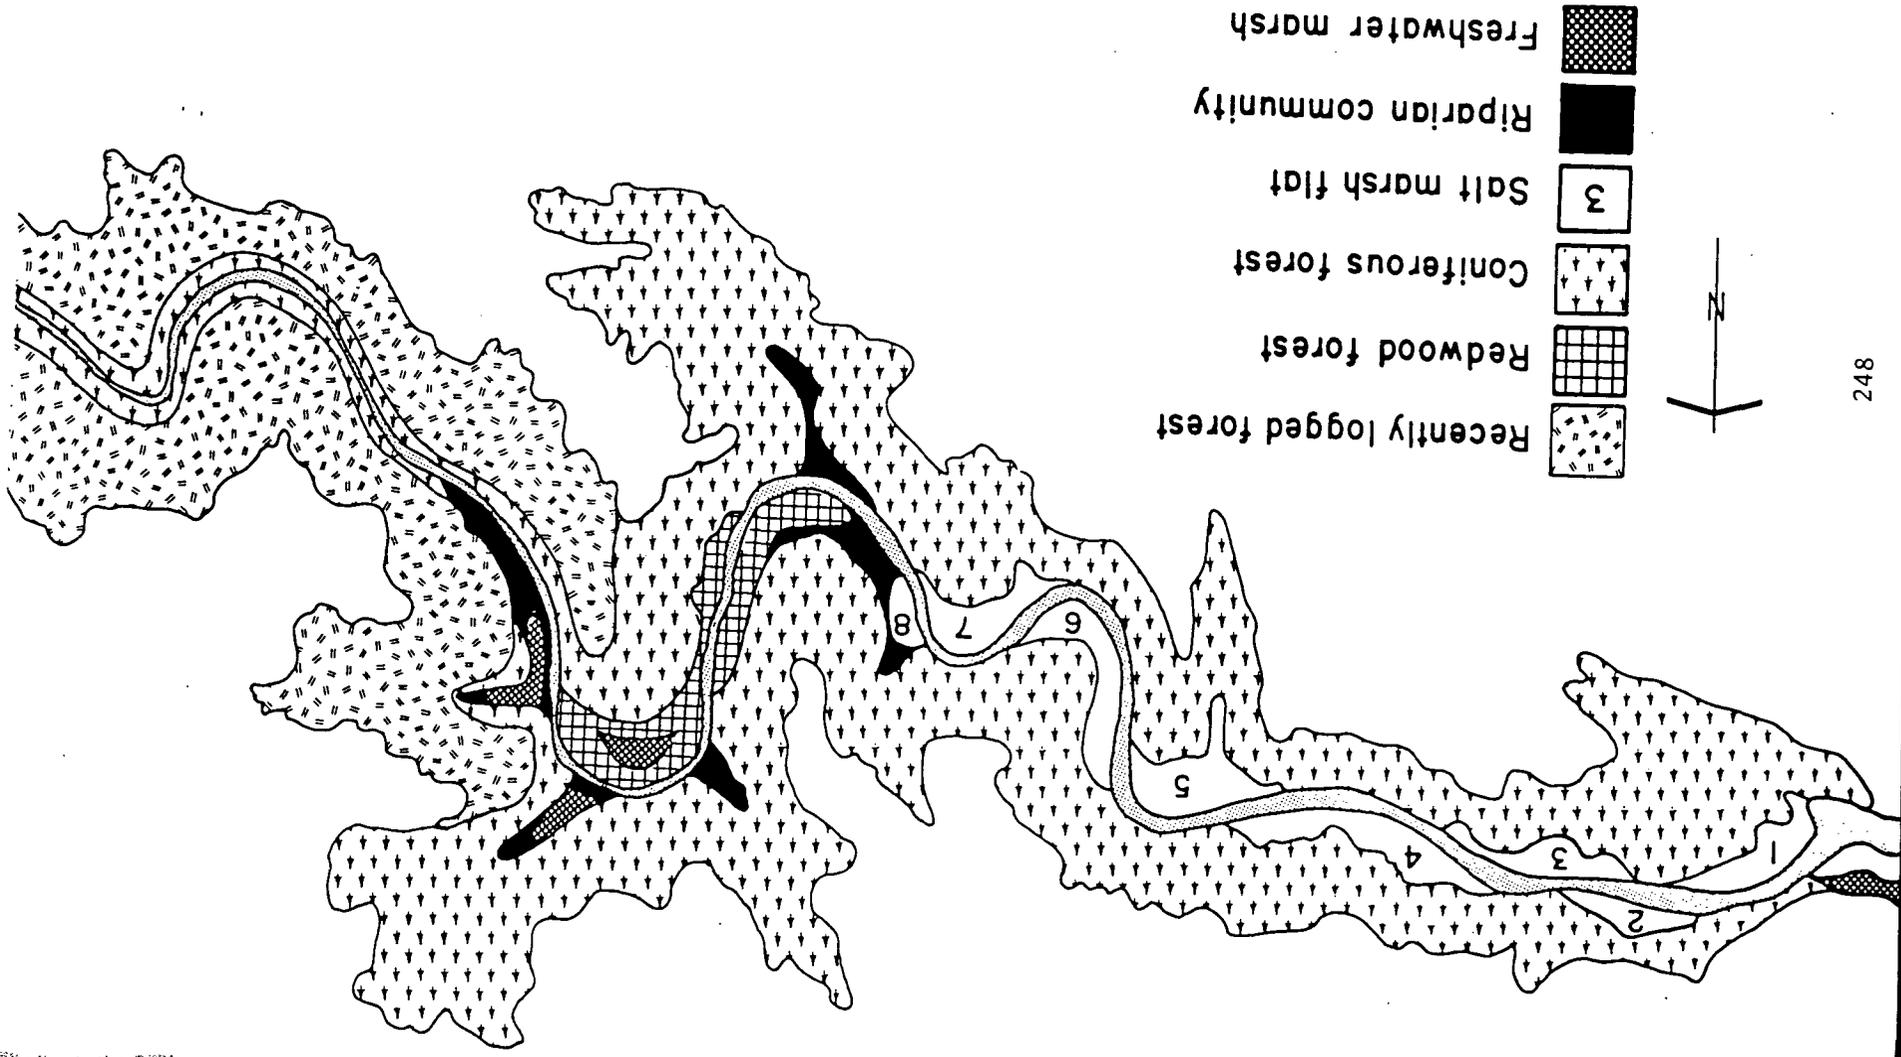
Figure 1. Big River Estuary, reference map of salt marsh flats.

Big River is amongst the largest watersheds along the Mendocino coastline, draining an area of approximately 165 square miles. As with other north coast rivers, discharge is concentrated during the winter and early spring, and summer outflows are quite low. Tidewater extends up the lower 8 miles and a series of eight salt marsh flats border the lower three miles. Unlike many estuaries, Big River estuary is not lagoonal but instead has a long linear channel. Crescent-shaped tidal flats alternate on either side of the channel corresponding with the alluvial deposits of the river. Redwood and mixed coniferous forest cover the steep slopes which border the channel (Figure 1).

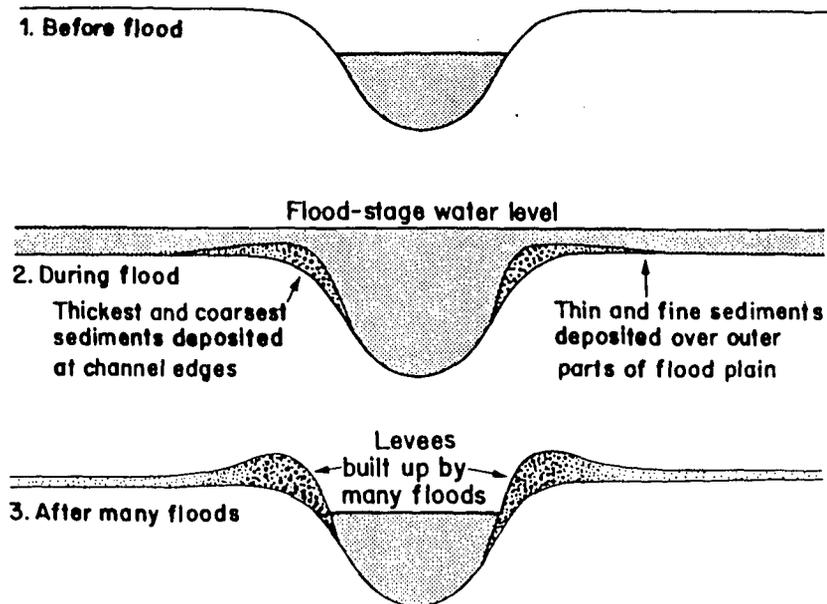
Figure 2. Formation of levees by river floods. As a river in flood stage overflows its banks, it rapidly decreases in velocity away from the channel and so drops most of its sediment, the coarser parts near the channel and the finer parts as a thinner layer of silt and clay over most of the floodplain. Successive floods build up the levees to ridges many meters high.

These levees are formed as silt laden flood waters are slowed along the edges of the channel (Figure 2). The coarser, heavier sediments settle out forming an embankment along tidal flats and estuary channels. Driftwood and eelgrass beds located along the edges of the channel as well as tidal inflows act to slow down the flood waters and permit the sediment to settle out. Flocculation of clay particles in the estuary may also contribute to this process. The increased sediment load resulting from erosion in the watershed cannot be transported out of the system by winter floods. The result is storage of the sediment in levees and on tidal flats.

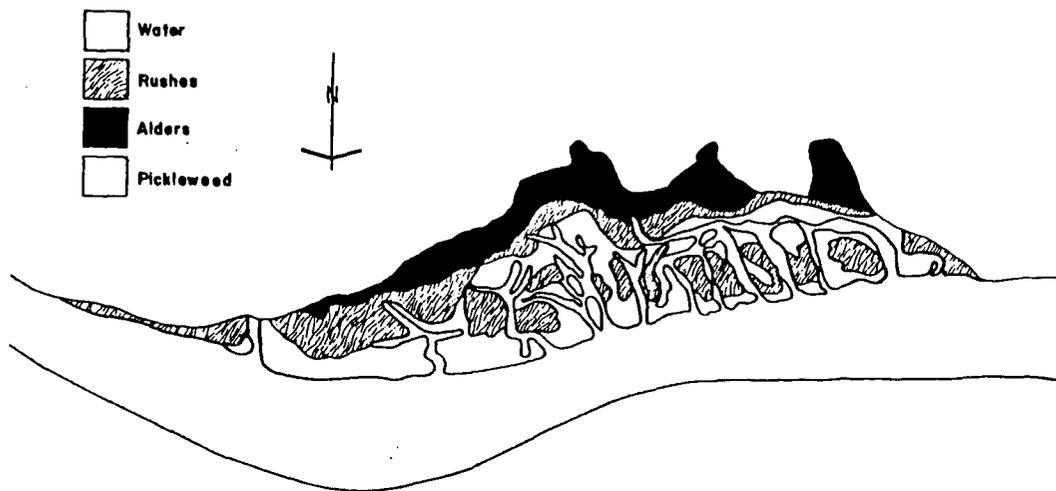
Figure 3. Vegetation map of Flat 3. An extensive slough system and predominance of halophytic vegetation characterize the lower flats.

The various flats along the estuary have distinctly different vegetation. The lower three flats exhibit extensive slough systems and are covered with halophytic plants, pickleweed and rushes. The rushes, being less salt tolerant, occupy the more elevated areas of marsh where soils are less saline (see Figure 3).

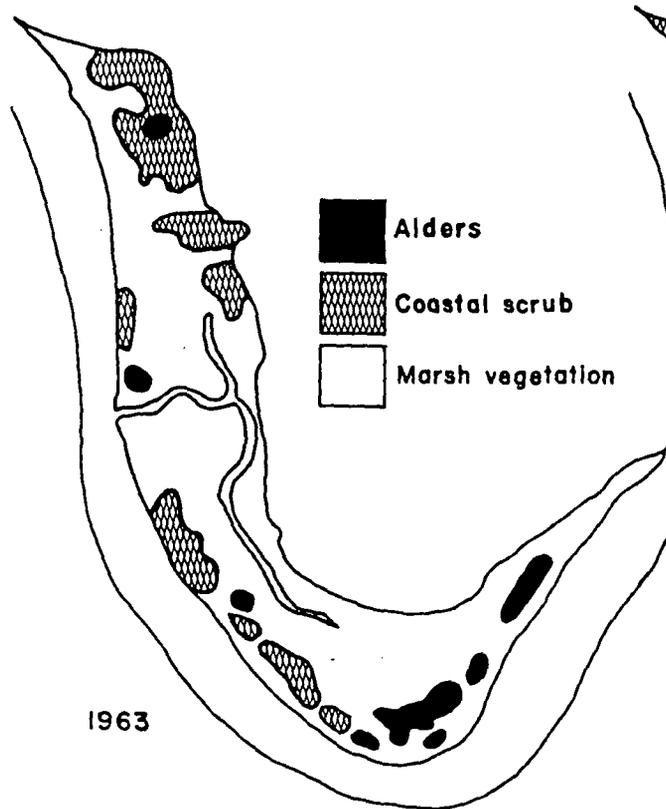
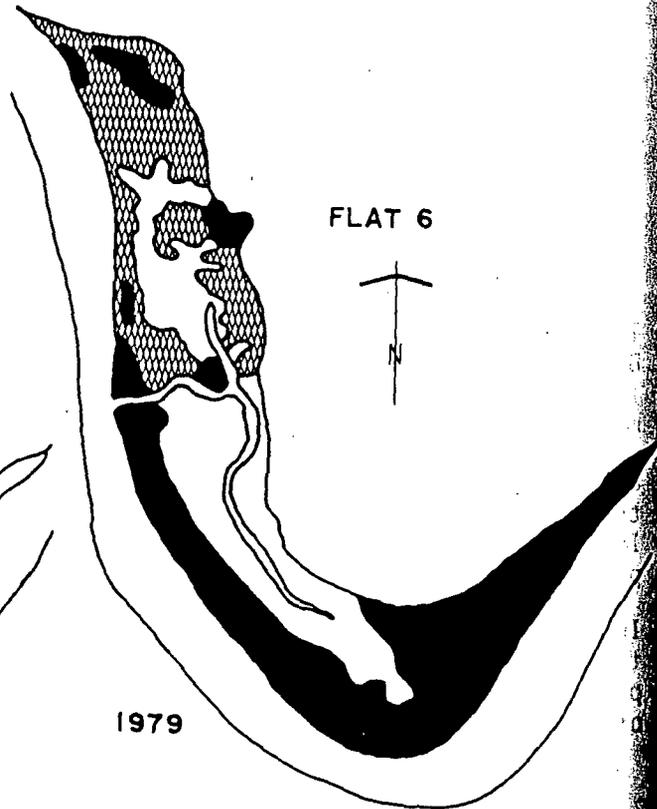
Figure 4. Comparison of vegetation in Flats 5 and 6.

Figures 4 and 5 illustrate the vegetative changes which have occurred in the upper flats over the past 30 years. The replacement of marsh vegetation by coastal scrub and eventually alder, indicate a significant loss of salt marsh in the estuary. The enlargement of the levee is also illustrated in Flats 5 and 7.

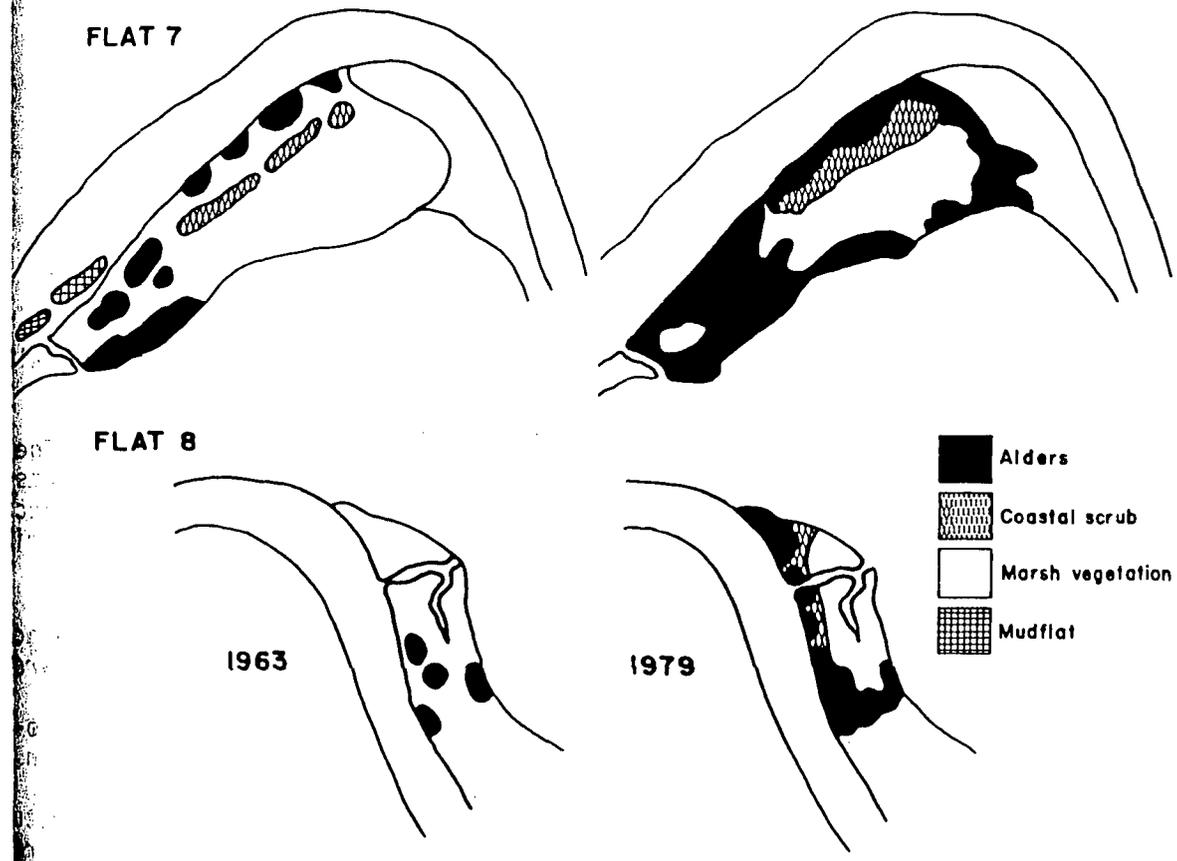
Figure 5. Comparison of vegetation in Flats 7 and 8.

In Flats 5-8 a levee encloses the perimeter of much of the marsh, restricting sidewater inflows. Slough systems are greatly reduced or non-existent. Dead pickleweed patches which occur within Flat 7 are enclosed by a thick corridor of alder and scrub plants (see Figure 5). In this flat tidal inflows have been

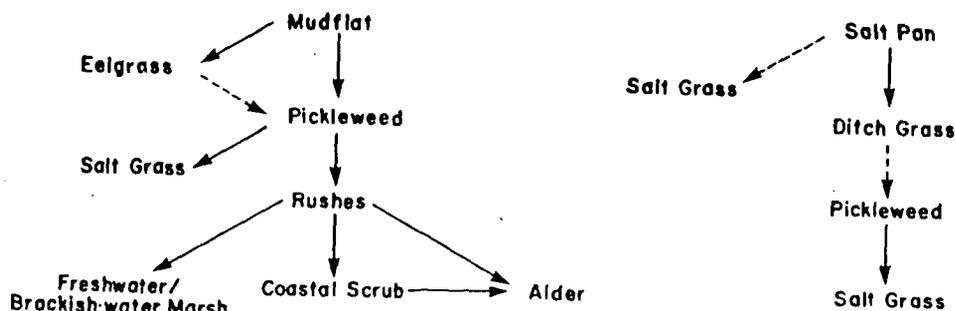
Figure 6. Salt marsh vegetation succession at Big River Estuary. Dotted arrow indicates hypothesized future vegetation succession.

By comparing the changes in the flats over time and between marshes, we have devised a successional scheme (Figure 6). The most unusual change in this salt marsh succession is the direct replacement of rushes by alder and coastal scrub. Other successional patterns (Chapman 1976) for European marshes result in freshwater marsh ultimately replacing salt marsh. While coastal scrub species are occasionally distributed around the periphery of salt marshes (Wherry 1920) wetland areas are not normally replaced by this community. The direct colonization of newly deposited levees by alder and coastal scrub acts to produce riparian woodlands over former wetlands. In addition sediment accretion in other salt marshes is commonly a gradual process with sediment distributed approximately evenly over the flooded area (Steers 1948).

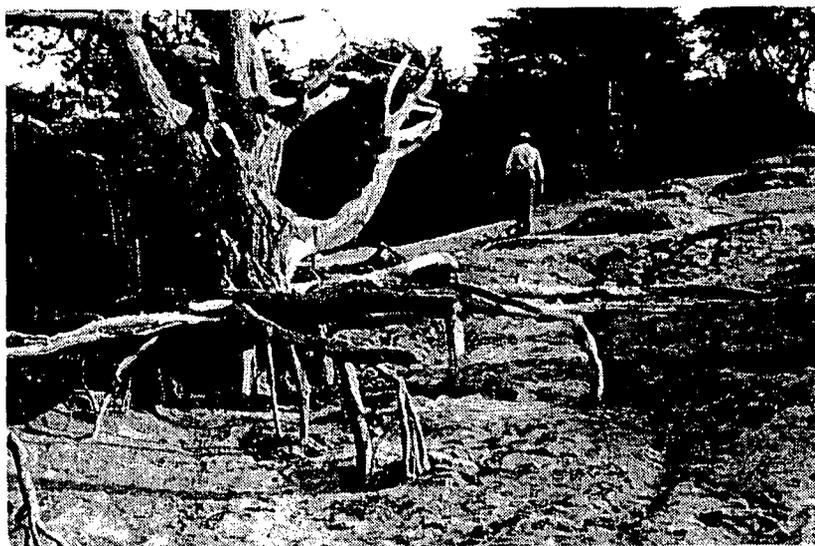
Fig. 2
Exposed tree roots as a result of severe trampling

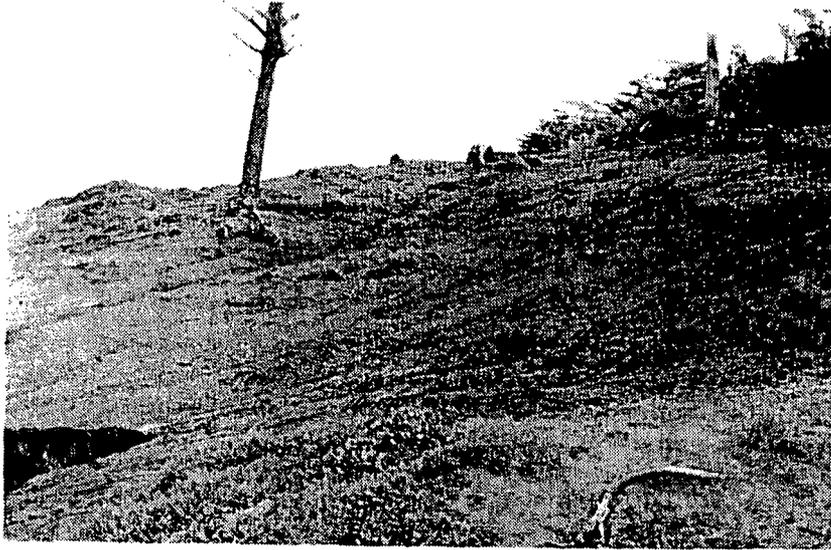
Fig. 3

View looking east across main gully and basin, note bare soil and exposed tree roots.

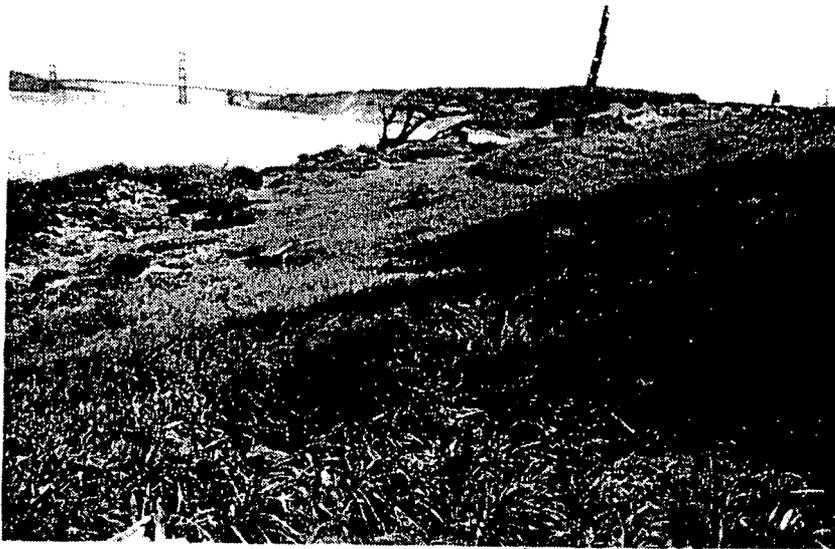
Fig. 4

Same view as Fig. 3 seven months later with a ground cover established and tree roots buried.
