California State Water Project

Volume III
Storage
Facilities

Bulletin Number 200
November 1974

State of California
The Resources Agency
Department of Water Resources

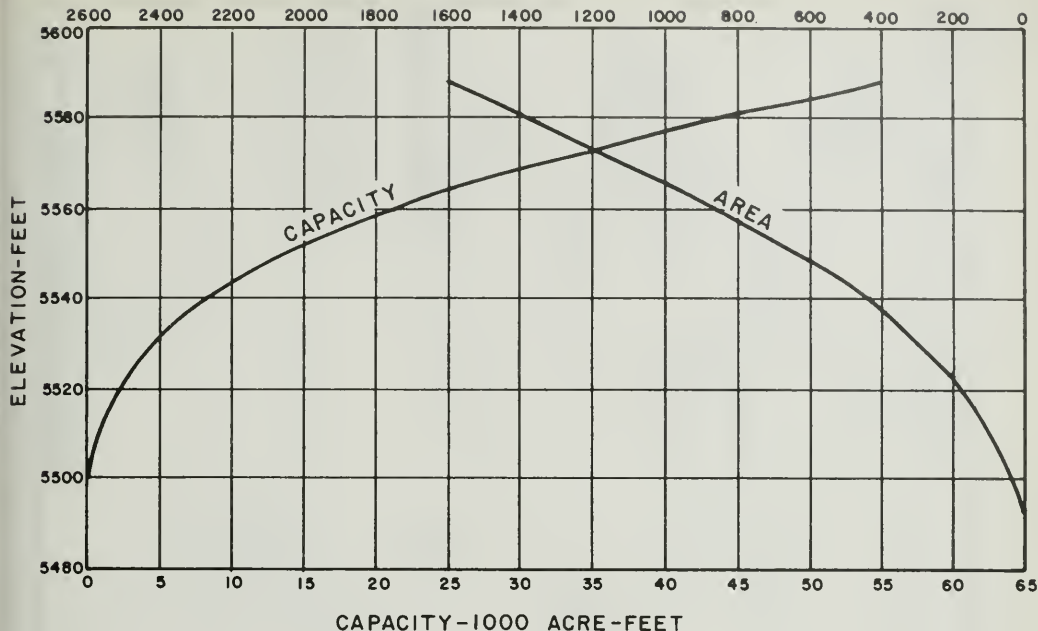
Figure 12. Area-Capacity Curves

A statistical summary of Frenchman Dam and Lake is shown in Table 2, and the area-capacity curves are shown on Figure 12.

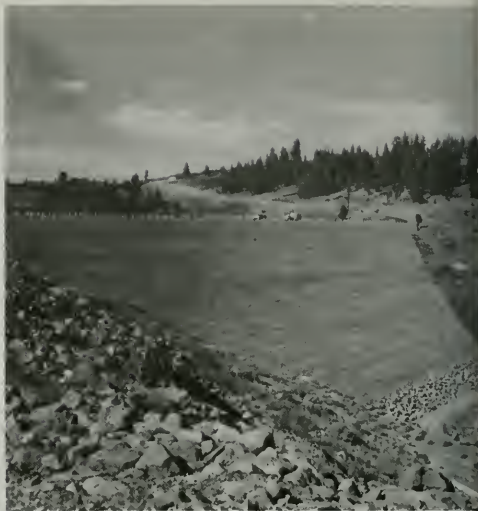
Figure 22. Completed Embankment

tion were: (1) rejection of material with a maximum dry density of less than 104 pounds per cubic foot, (2) a desirable relative compaction of 98%, and (3) rejection of material below 95% relative compaction. Average dry density for all rolled fill tested was 107.0 pounds per cubic foot (pcf) ranging from 90.7 to 115.2 pcf, with an average relative compaction of 97.7% ranging from 91.4 to 103.8%. Average dry density for specially compacted fill (hand-held compactors) was 107.8 pcf, ranging from 100.9 to 117.2 pcf, with an average relative compaction of 98.8% ranging from 94.5 to 102.9%. Only borrow materials with maximum dry density exceeding 104 pcf were drawn from the borrow areas. Areas within the borrow where light materials were known to exist in substantial quantities were avoided. Fill with a relative compaction of less than 95% was either rejected or reworked and retested. The embankment under construction is shown on Figure 21 and the completed Dam on Figure 22.

the upstream dam slope which had been trimmed to firm material. Riprap then was end-dumped onto the bedding and selectively placed by a clamshell bucket and hand labor. Rock spalls were end-dumped on the downstream face of the Dam, shaped, then compacted by backing a vibratory roller over the slope with a tractor.

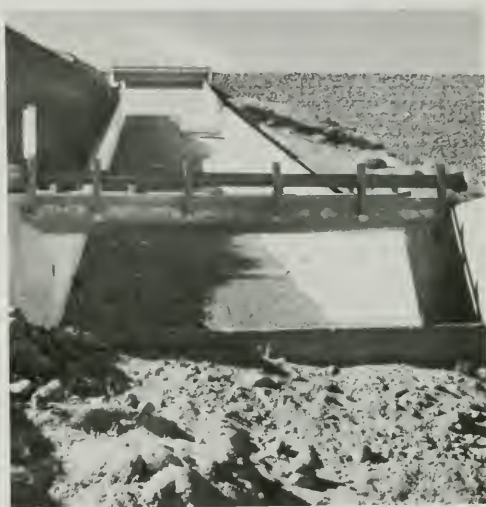
Figure 24. Spillway Chute

Placement of the spillway concrete was started in the fall of 1960 and completed in the spring of 1961. The sequence of construction was the floor slab first, then the crest, flip bucket, outlet works bridge and, finally, the walls and crest bridge. A total of 1,678 cubic yards of concrete was placed in the spillway and 83 cubic yards in the bridges crossing the spillway (Figures 24 and 25).

degrees Fahrenheit for the first three days after placement and above 32 degrees Fahrenheit for the next three days. To accomplish this, a plastic tent was placed over the walls of the spillway chute and steam was piped in from a steam generator for six days. The tent then was removed and a curing compound applied.

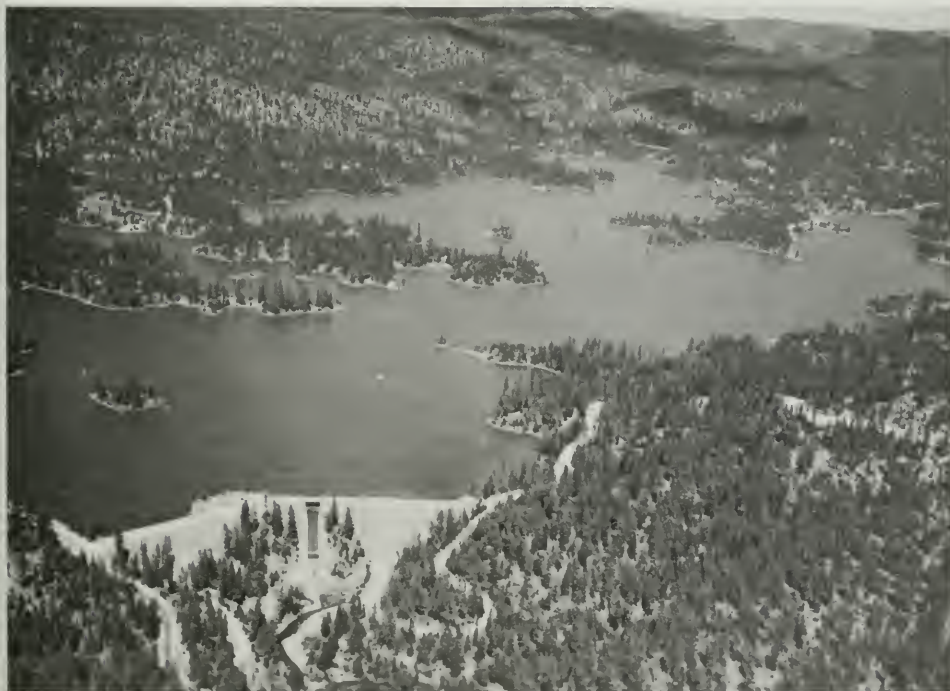
Figure 27. Aerial View—Antelope Dam and Lake

Antelope Dam and Lake are located entirely within the Plumas National Forest on Upper Indian Creek, a tributary of the North Fork Feather River, 43 miles by road northeast of Quincy. The nearest major roads are State Highways 70 and 89 (Figures 26 and 27).

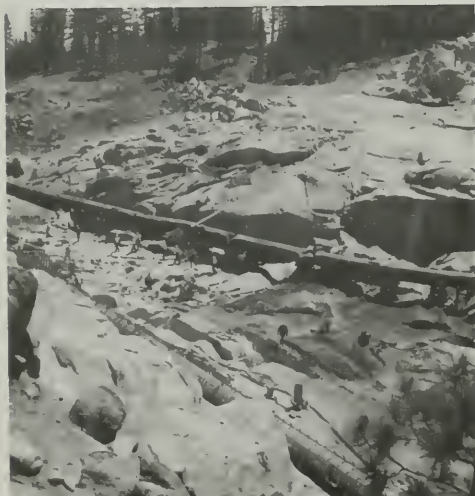
Figure 34. Temporary Diversion Pipe and Outlet Works Conduit

Dewatering. Dewatering of the foundation posed no problems other than the capping of several small springs encountered in the main dam foundation. Stream diversion was accomplished through a temporary pipeline laid through the foundation area (Figure 34).

Excavation. The entire length of the outlet works conduit is founded in rock (Figure 34). When rock was not encountered at grade, overexcavation was directed to sound rock and backfilled to subgrade with concrete. Blasting was required to shape the trench and to obtain foundation grade. A backhoe was used to remove material, and all foundation overbreak was backfilled with concrete.

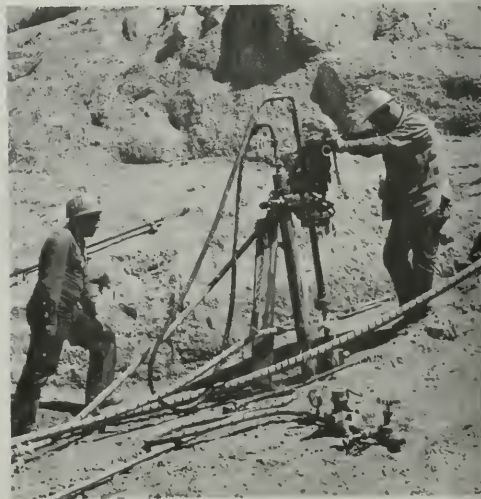
Figure 35. Drilling Grout Hole—Left Abutment Auxiliary Dam

Grouting. Grout caps were necessary at only three locations: at the bottom of the left abutment of the auxiliary dam (Figure 35), at each side of the spillway crest, and on the upper left abutment of the main dam. A single grout curtain 50 feet in depth was placed in two 25-foot zones for the full length of the main dam. Several 100-foot holes were grouted, and a secondary grout curtain across the outlet works foundation was added. Although no grouting of the auxiliary dam was assumed necessary during design, a short reach of the foundation was grouted because of a shear found in that area. A total of 724 cubic feet of grout was injected into the foundation.

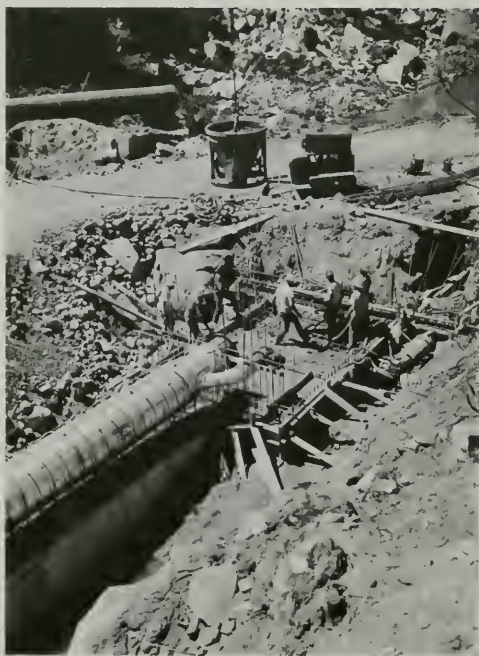
Figure 37. Outlet Works Control Structure

Concrete. Placement generally was routine and was accomplished with a truck crane and a bottom-dump bucket (Figure 37).

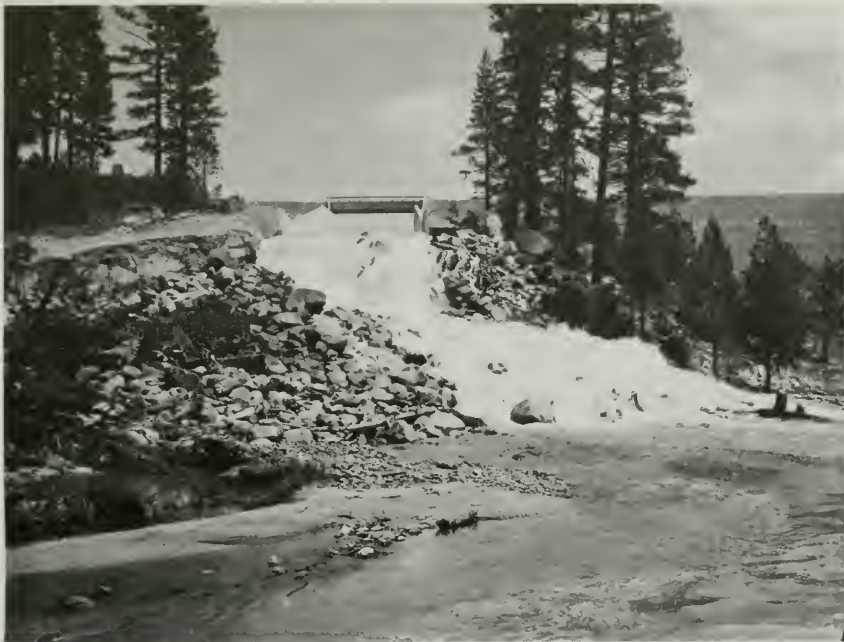
Figure 38. Spillway

Concrete. Placement generally was routine and was accomplished with a truck crane and a bottom-dump bucket. The completed spillway is shown on Figure 38.

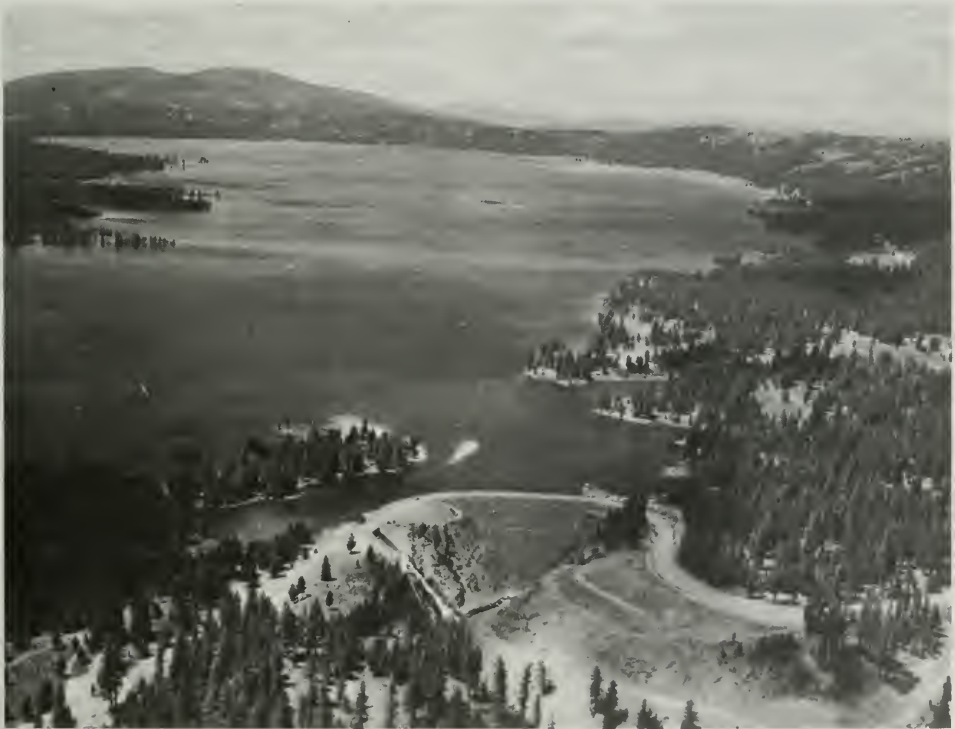
Figure 41. Aerial View—Grizzly Valley Dam and Lake Davis

The Dam is located 8 miles north of Portola within the Plumas National Forest on Big Grizzly Creek, a tributary of the Middle Fork Feather River. The nearest major road is State Highway 70 (Figures 40 and 41).

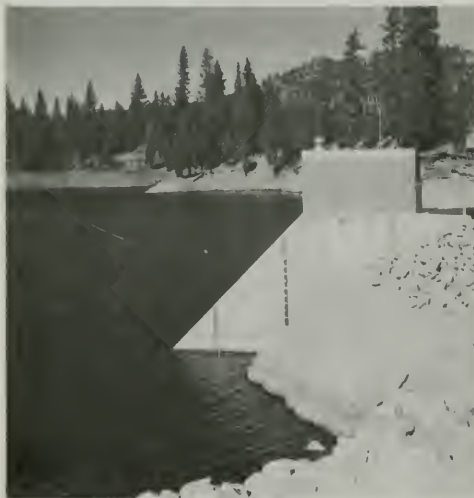
Figure 50. Control House at Dam Crest

To avoid flooding of the conduit by winter runoff, both low-level and inclined intakes were placed under adverse weather conditions to elevation 5,694 feet. Mixing water was heated to maintain placement temperature at approximately 50 degrees Fahrenheit. After placement, the structures were tented with polyethylene and heated by salamanders. The balance of the concrete for the two structures was placed under favorable weather conditions and cured by normal methods. Both control houses are concrete block structures with reinforced-concrete slab roofs (Figures 50 and 51). A total of 1,412 cubic yards of concrete was placed in the outlet works.

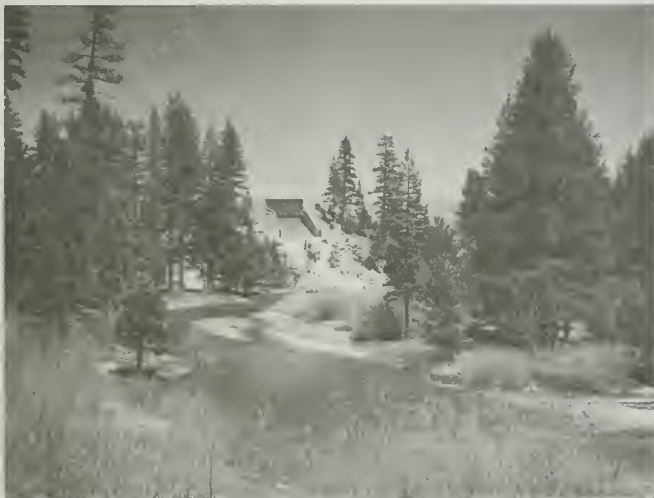
Figure 53. Spillway Chute

The completed spillway chute is shown on Figure 53 and the spillway approach with log boom on Figure 54.

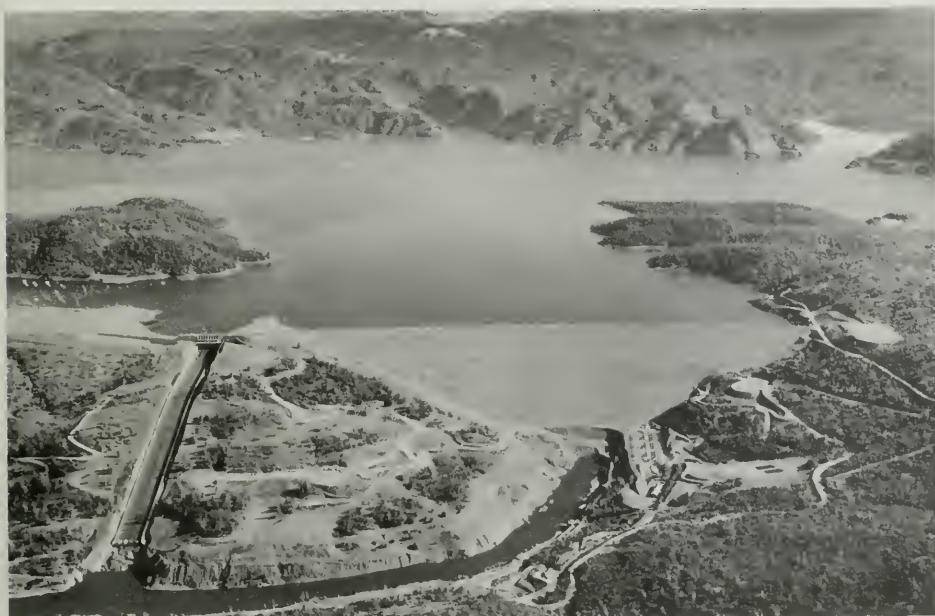
Figure 56. Aerial View—Oroville Dam and Lake Oroville

Table 8 shows the statistical summary of Oroville Dam and Lake Oroville, Figure 55 is a location map, Figure 56 is an aerial view, and Figure 57 contains the area-capacity curves.

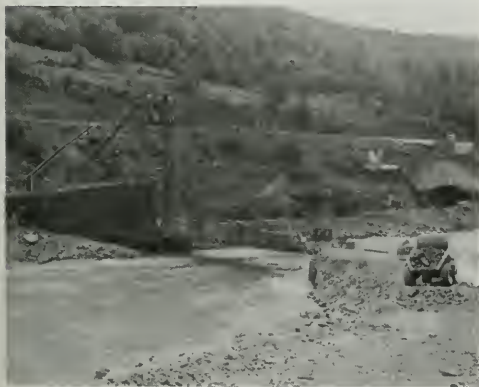
Figure 93. Diversion Tunnel No. 1 Intake Portal After Backfilling

The upstream portal was cut in moderately to strongly weathered, moderately hard, blocky amphibolite and deep soil cover at slopes of 1½:1, and 2:1 above the bench. Because of the blocky nature of the rock at the intake portal, drill steel was installed to serve as crown bars to support the arch.

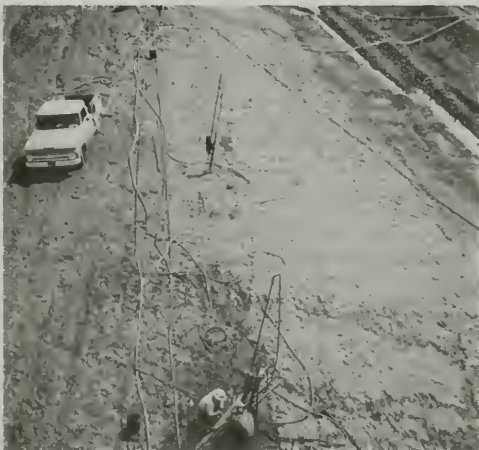
Figure 152. Grouting Foundation at Forebay Main Dam

Grouting. The grout curtain under the main Forebay Dam was continuous with the powerplant grouting and included the length of the dam resting on basalt foundation as well as an extension 100 feet out onto the Red Bluff formation (Figure 152). In this last area, emphasis was placed on grouting the rubble lens at their contact. Eighty-five holes were drilled on the curtain line in three zones: (1) from the surface to 25 feet and pressure-tested at 25 pounds per square inch (psi); (2) from 25 feet to penetration of the interflow in the basalt and pressure-tested at 50 to 65 psi, depending on the depth of penetration; and (3) maximum depth of 100 feet and pressure-tested at 75 to 85 psi.

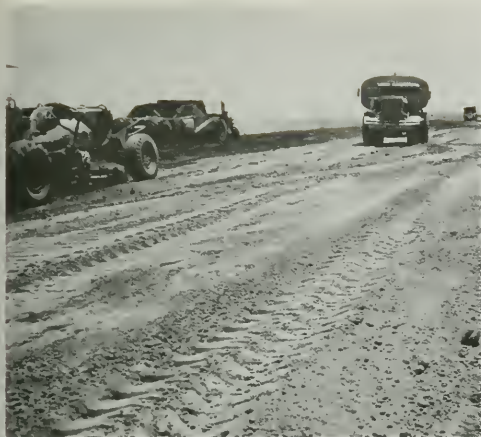
Figure 154. Afterbay Dam Construction

Transportation and placement of the Zone 1A material were performed in a manner similar to Zone 1F and 2F placement in the Forebay Dam (Figure 154).

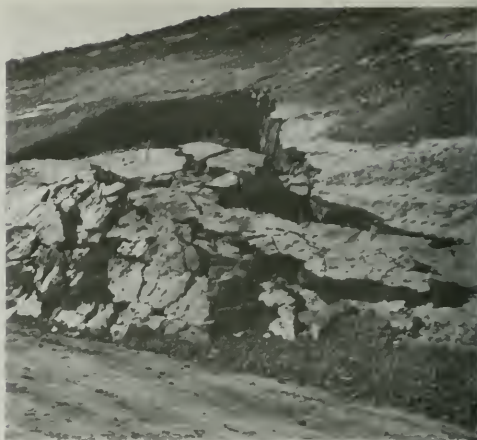
Figure 157. Slide at Left Side of Power Canal

Beginning in early August 1966, the first indication of serious slide trouble became apparent when earth slides developed in both cut banks 1,000 to 2,000 feet west of Oroville-Cherokee Road Bridge. Fissures and cracks observed at various other locations along the canal gave evidence of possible future slides. These slides and indications of slides were not of any great magnitude at first; however, attempts to remove the slide material triggered further movement. The slides were attributed to failure, or "breaking down", of unsupported lone formation clay, which was exposed during canal excavation (Figure 157).

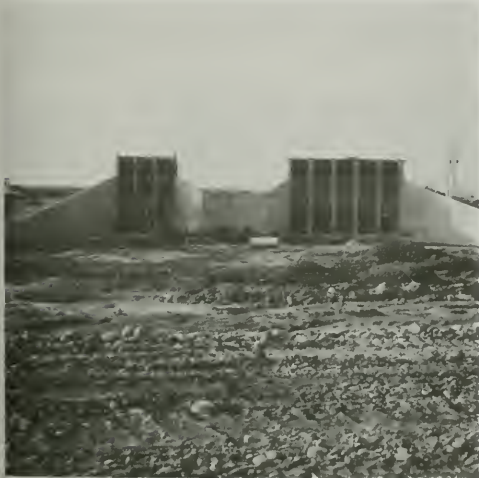
Figure 165. Western Canal and Richvale Canal Outlets—Upstream View

Western Canal and Richvale Canal. Western Canal and Richvale Canal outlet structures were built immediately north of the existing canal alignment so that the canal could be used during construction (Figure 165). At the upstream end, the structures are connected by a retaining wall, footing, and cutoff wall. The entire area between the two structures and the adjoining area for the structures themselves were excavated in one operation. This made dewatering easier since drainage channels could be cut across the entire area and fewer sumps were required.

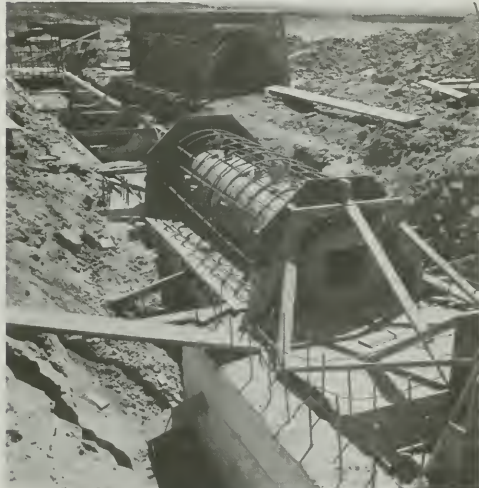
Figure 166. Pacific Gas and Electric Lateral Outlet Conduit

Conduit concrete (Figure 166) was placed in a series of sections as determined by construction joints. Each section was placed in two lifts, the first of which was made with the inside conduit forms and all of the

reinforcing steel in place. The concrete was placed in the bottom section and brought up to a level an inch or two below the invert. This anchored the reinforcing and inside forms, thus preventing the forms from floating during the placement of the second lift. Outside forms then were installed and weighted in place and the second lift placed through the top.

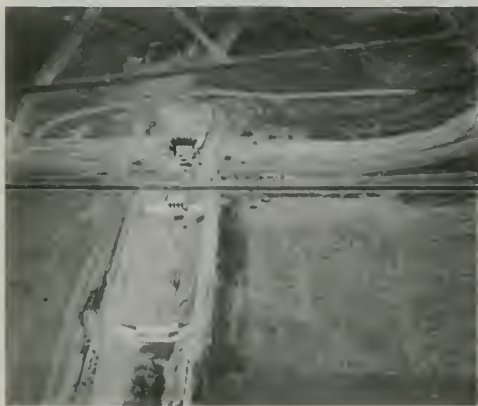
Figure 167. Sutter-Butte Canal Outlet

Sutter-Butte Canal. Sutter-Butte outlet structure (Figure 167) consists of an approach and headworks section, four 6- by 7-foot rectangular conduits approximately 340 feet long, and an exit structure. A rectangular, modified V-notch, sharp-crested weir was constructed 370 feet downstream of the exit structure. Incorporated in the headworks section are 4- by 6-foot, steel, slide gates and hoists.

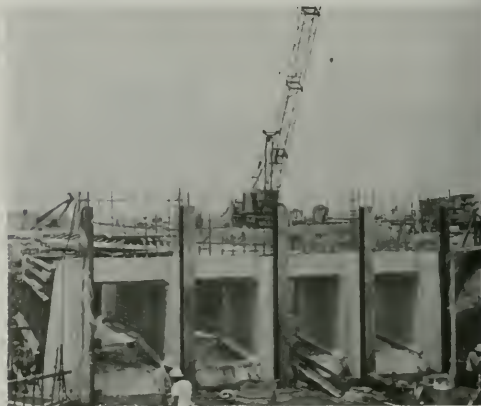
Figure 168. Sutter-Butte Canal Outlet Conduits

Bottom slabs of the conduits were placed in alternate 25-foot-long sections for the full width of the structure. The walls and top slab of the conduit sections were placed next, in a like manner (Figure 168).

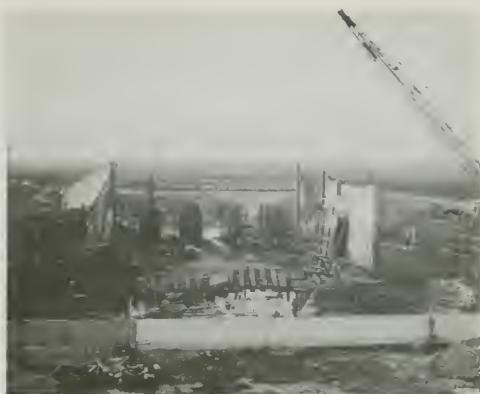
Figure 170. River Outlet

The river outlet structure (Figure 170) is located in the southeast corner of the Afterbay (Figure 130).

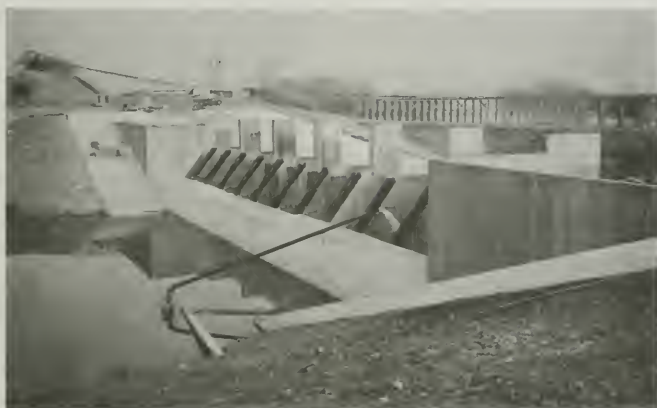
Figure 171. River Outlet—Fish Barrier Weir

Fish Barrier Weir. The fish barrier weir structure (Figure 171) is located on the bank of the Feather River approximately 860 feet southeast of the river outlet headworks.

A hammer, powered by compressed air supplied by a 900-cubic-foot-per-minute rotary compressor, was used to drive the sheet piling cutoffs under the weir. The downstream cutoff was driven to tip elevation 80 feet with head or cutoff elevation 99 feet in the channel invert. Upstream sheet piling was driven to tip elevation 60 feet with head or cutoff elevation 101 feet in the channel invert. No difficulty was encountered in driving the downstream sheet pile tips to elevation 80 feet but, when the upstream sheet pile tips reached elevation 70 feet, 1-inch penetration required 150 to 300 hammer blows. It was agreed that 150 blows per inch of penetration of the sheet piling would be accepted as refusal.

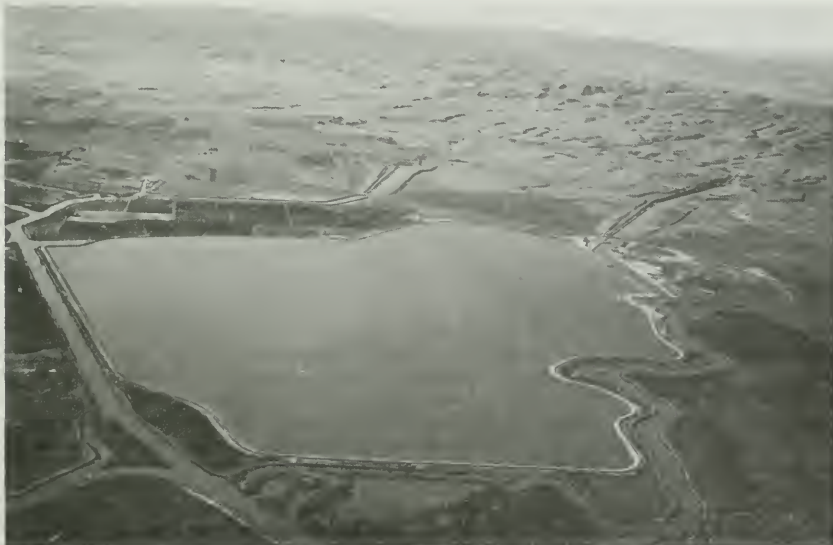
Figure 173. Aerial View—Clifton Court Forebay

Clifton Court Forebay is a shallow 28,653-acre-foot reservoir at the head of the California Aqueduct. It was formed by constructing a low dam inside the levees of Clifton Court Tract. The Forebay is located in the southeast corner of Contra Costa County about 10 miles northwest of the City of Tracy adjacent to Byron Road (Figures 172 and 173).

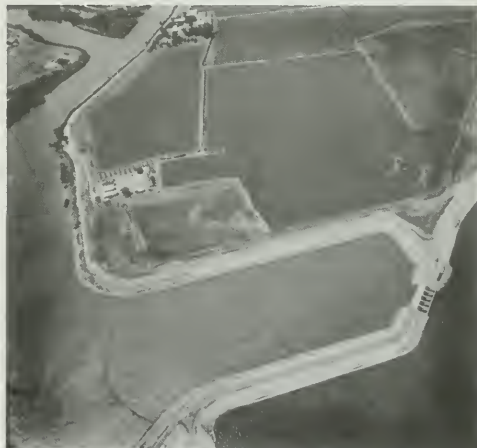
Figure 178. Control Structure and Inlet Channel Connection to West Canal and Old River (in background)

To regulate flow into Clifton Court Forebay and to isolate the Forebay from the Delta, a gated control structure was required (Figures 177 and 178). It will serve only as emergency control once the Peripheral Canal is completed. This structure consists of five 20-foot-wide by 25.5-foot-high radial gates, housed in a reinforced-concrete gate bay structure. The gate structure includes a 10-foot-wide bridge for vehicular traffic, one set of stoplog slots, and a hoist platform. A riprapped earthen transition extends from both the inlet and outlet of the structure. A 1,000-foot-long riprapped channel with a 300-foot base width connects the control structure to West Canal. A log boom was provided at the channel inlet to discourage boats from entering the area (Figure 178).

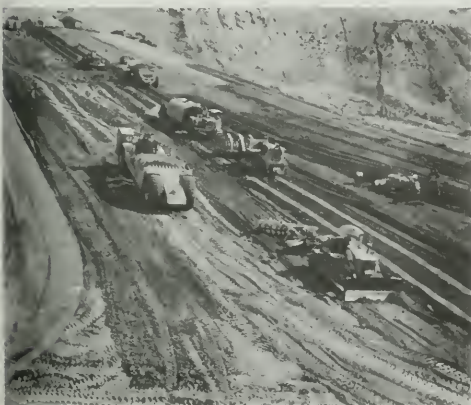
Figure 217. Embankment Construction

Table 26 shows the as-built relative compaction and in-place dry density of the various zones within the Dam. Placement and compaction of embankment materials is shown on Figure 217.

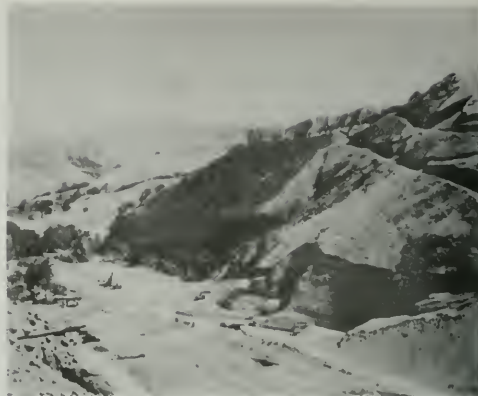
Figure 218. Combined Outlet Works

Outlet Portal. Excavation of the outlet portal of the conservation outlet works was started in April 1966. Because of the close proximity of the spillway tunnel outlet, the portals for the two tunnels were excavated at the same time (Figure 218).

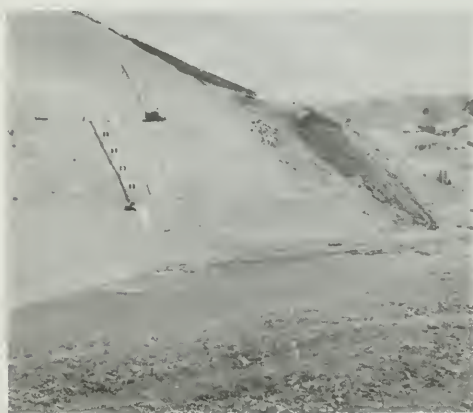
Figure 220. Sloping Intake Structure

Intake Structure. The trench for the intake structure (Figure 220) was excavated on a $1\frac{1}{2}$:1 slope and was 5 feet deep by 10 feet wide. The trench was excavated with a backhoe starting at the top. A dozer pushed the material down the slope where it was removed during foundation cleanup. Because the foundation was composed of highly fractured sandstone and shale, consolidation grouting was necessary to minimize the possibility of settlement and to prevent erosion of the foundation due to fluctuations of the water surface.

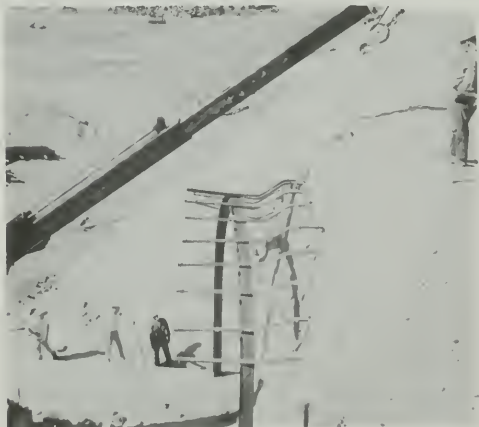
Figure 221. Tunnel Supports

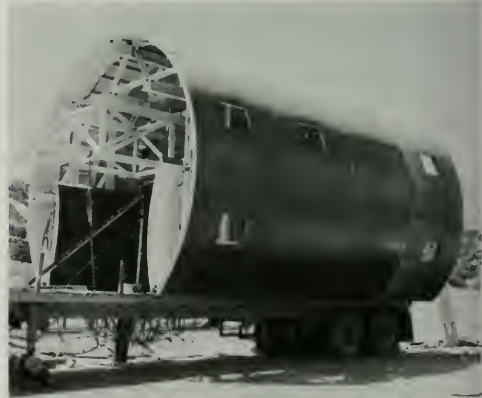
Figure 225. Tunnel Crown Placement Forms

Crown placements were formed with two identical 28-foot-long steel forms (Figure 225). The forms were moved on a rail-mounted jumbo and positioned to line and grade with hydraulic jacks and an electrically operated "Tugger" hoist.

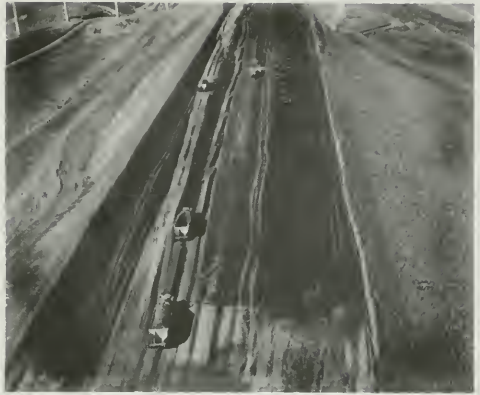
Figure 233. Placing and Compacting Embankment—San Luis Dam

San Luis. The 385-foot-high San Luis Dam is a zoned earthfill (Figure 232) with a rock face section on a 3:1 slope upstream above elevation 400 feet, and an 8:1 slope of random material below elevation 400 feet, steepening to 2½:1 below elevation 310 feet (Figure 233). The downstream slope is 2:1 above and 2½:1 below elevation 450 feet, flattening to a 6:1 slope below elevation 400 feet. The Dam incorporates a chimney drain below elevation 500 feet connected to a foundation blanket drain. This drain system terminates in toe drains. The dam crest is at elevation 554 feet.

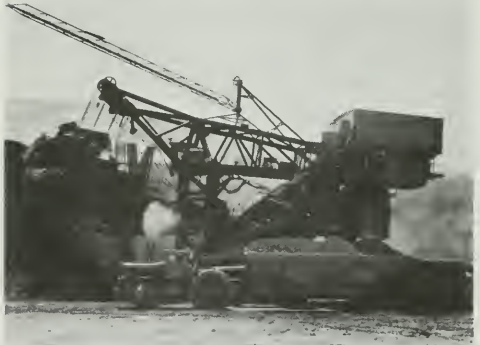
Figure 234. Wheel Excavator Cutting on 50-Foot-High Face

Embankment materials for Zone 1 were the alluvial valley fills from within both the San Luis and O'Neill reservoir basins. The largest portion was excavated by a large wheel-type loader (Figure 234). The sand, gravel, and cobbles of Zone 2 were obtained from channel deposits along San Luis Creek, beginning upstream of San Luis Reservoir. Zone 3 consisted of miscellaneous material, including that removed in foundation excavation which was moved directly to placement in the embankment. Material for rock fill, bedding, and riprap was quarried from Basalt Hill, high on the right abutment. It was separated at the 3-inch size with some of the material passed through a crusher to manufacture bedding for riprap (Figure 235). Zone 4 consists of the fraction less than 8 inches and Zone 5 that fraction greater than 8 inches.

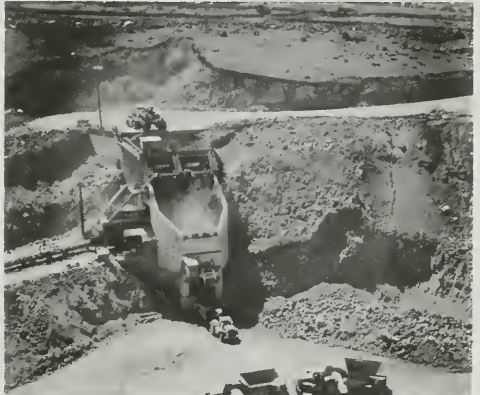
Figure 235. Basalt Hill Rock Separation Plant

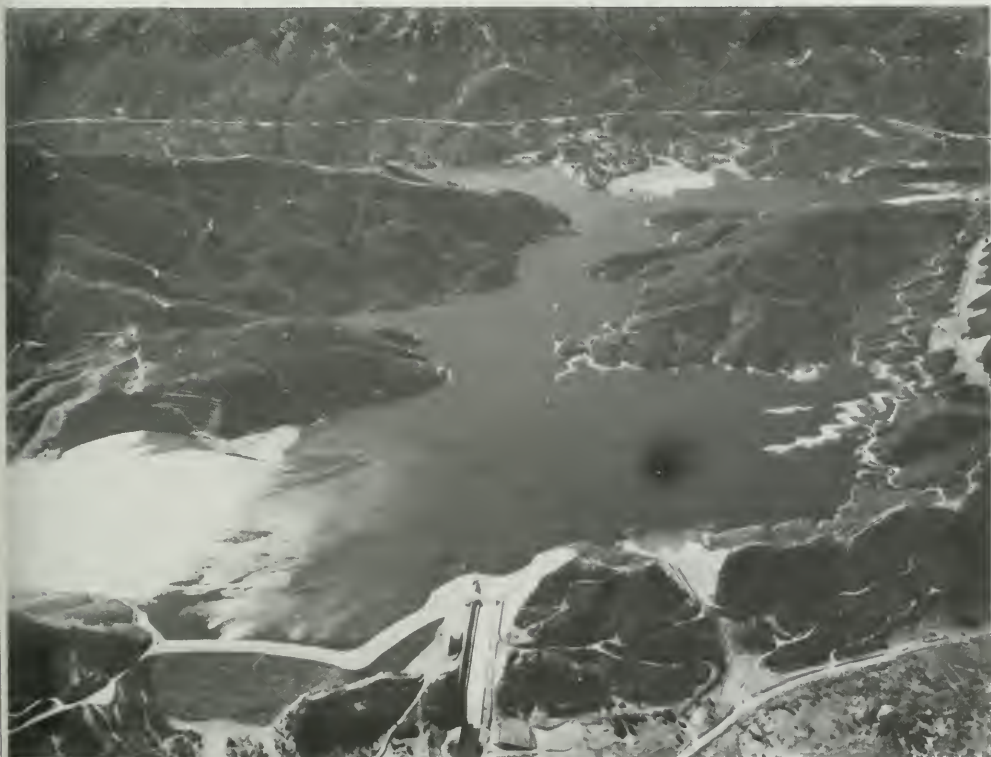
Figure 246. Aerial View—Cedar Springs Dam and Silverwood Lake

Cedar Springs Dam is a rolled earth and rockfilled dam with a structural height of 249 feet and a crest length of 2,230 feet. The spillway is an ungated concrete chute with the outlet works located in a tunnel directly beneath; both have a common energy dissipator. The reservoir is supplied project water from Mojave Siphon which terminates at the inlet structure on the left abutment of the Dam directly west of the spillway (Figures 245 and 246). Construction work on

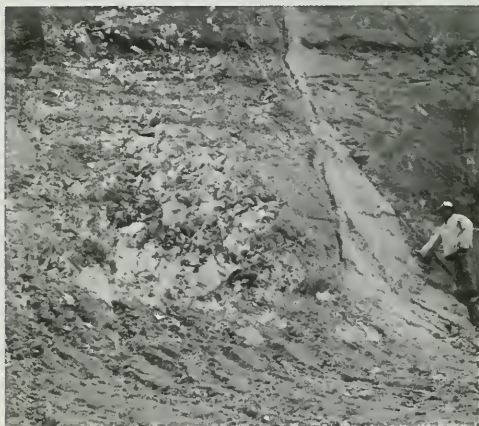
Figure 249. Fault Uncovered During Excavation

Two presumably active faults were discovered during excavation of the foundation material near the axis of Cedar Springs Dam (Figure 249) and have been traced a distance of from 1 to 3 miles. Vertical displacement of 3 to 5 feet has been measured at an exposed fault in the exploration trench. It is highly improbable during the life of the Dam that displacement along these faults in any direction will exceed 5 feet. Separation of the fault wall is not expected, even if movement should occur. The basis for these assumptions can be found in the Bibliography.

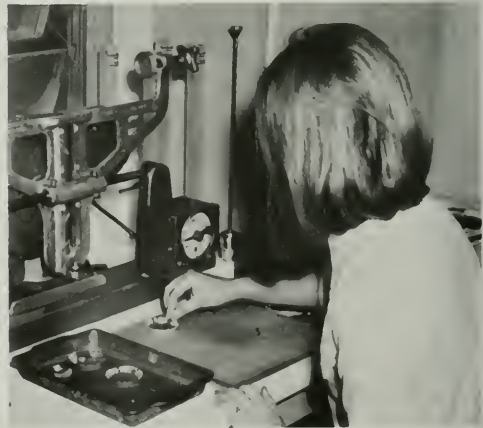
Figure 253. Determining the Plasticity Index Number of the Impervious Zone

Initial explorations showed that no clay material was located in the lake area. An extensive search was conducted to find suitable material that would have a Plasticity Index greater than 15 and have the Liquid Limits fall between 30 and 50. Bucket auger holes were drilled at Summit Valley and in dry lakebeds as far as 40 miles away. An unnamed lakebed 20 miles northeast of the Dam site was selected since it showed the desired clay quality (Figure 253).

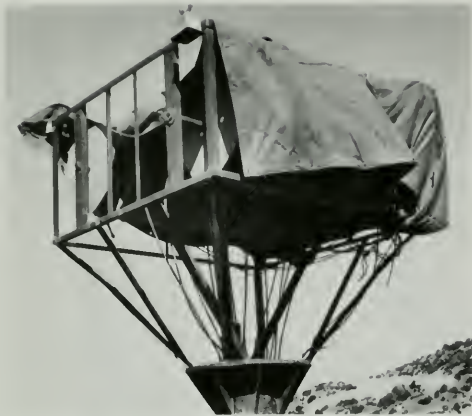
Figure 256. Instolltion of Piezometer Tubing

terminal well No. 2 (Figure 256).

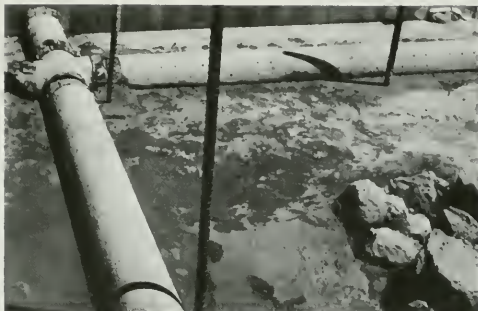
Figure 263. Perforated Drain Pipes in Spillway Chute

Drainage. A drainage system is located under the spillway floor slabs and along the wall heels in the chute and stilling basin to help relieve uplift. The chute drainage system consists of lateral-perforated drain pipes placed in a herringbone pattern with the perforations down and surrounded by drain material (Figure 263). In the stilling basin, the drainage system consists of perforated drain pipes bedded in concrete in a rectangular pattern, with the perforations up and drain material placed over the pipe.

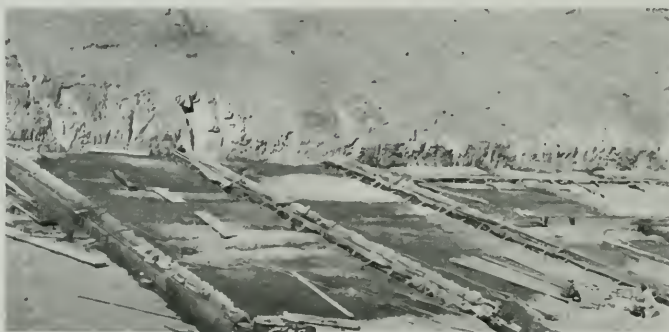
Figure 264. Shear Keys in Spillway Chute

Chute slabs are 15 inches thick and are anchored to the foundation. Where the chute crosses a local shear fault, shear keys are provided because grouted anchors alone would not be effective in the broken rock and soil (Figure 264). Longitudinal construction joints, with waterstop and continuous reinforcement, are

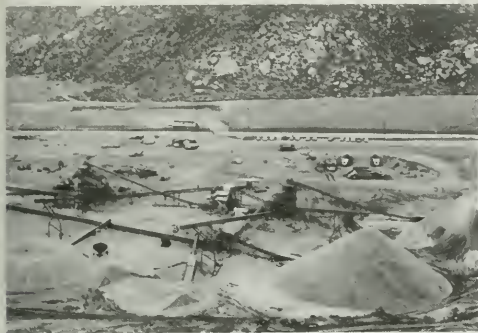
Figure 293. Rock Production

The rock source was laid out on benched faces extending from a maximum elevation of approximately 2,070 feet to the lowest level at approximate elevation 1,665 feet. The height of the faces varied from 50 feet to 30 feet. The rock was blasted from the quarry and hauled to the nearby rock-crushing plant located east of the quarry (Figure 293).

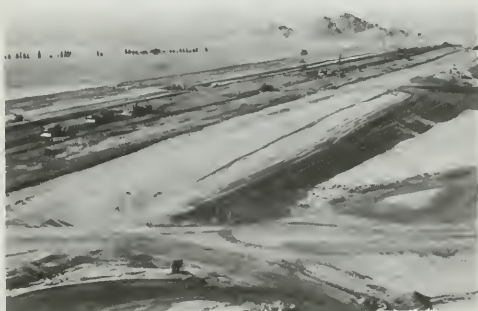
Figure 294. Embankment Construction Activity

The Dam was constructed in a series of three reaches. Embankment construction began at the lowest point along the foundation in the vicinity of Station 85+00. When the grouting was completed at the left abutment, efforts were concentrated in that area. Embankment construction then proceeded with a slight slope toward the north to enable loaded trucks to climb to the higher area where embankment was being placed. General embankment construction activity is shown on Figure 294.

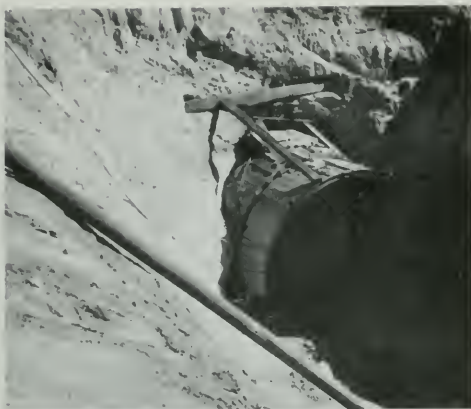
Figure 297. Tower Outlet Portal

Most of the outlet works tunnel was driven through hard, fresh, granitic rock, but some weathered and fractured rock was encountered in the vicinity of the portals. The tunnel was unsupported except for a few steel sets at each portal and a few rock bolts at several places in the tunnel (Figure 297). Ground water did not constitute any problem and only minor seepage was encountered.

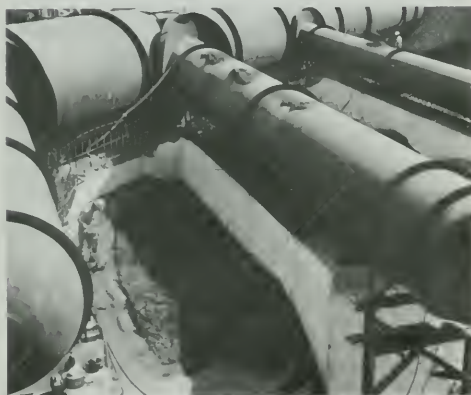
Figure 298. Outlet Works Delivery Manifold

The construction of this facility and associated appurtenances was performed in conjunction with other outlet works construction (Figure 298). No unusual construction methods were employed and no difficulties were encountered.

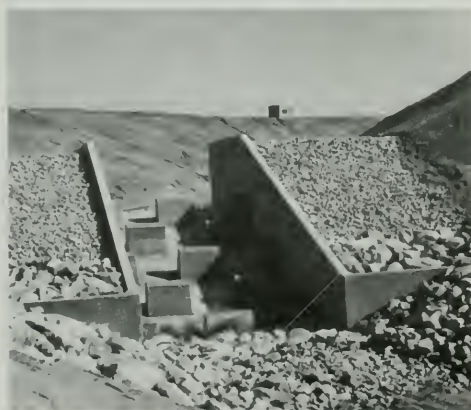
Figure 299. Concrete Placement in Spillway

Excavation for the spillway was made initially with a crawler crane equipped with a 5-cubic-yard dragline bucket and later with a small scraper. As excavation progressed, it became apparent that the original location of the foundation for the concrete-slab crest structure would be unsatisfactory. The crest structure was relocated 100 feet upstream where sound rock had been encountered. Approximately 100 cubic yards of concrete was placed in the spillway chute and weir (Figure 299).

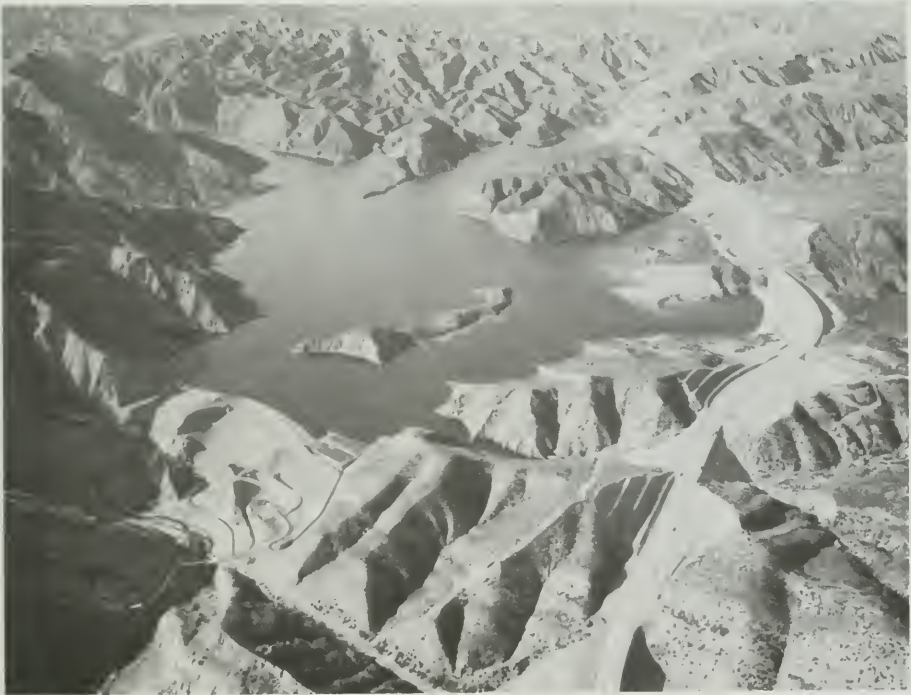
Figure 301. Aerial View—Pyramid Dam and Lake

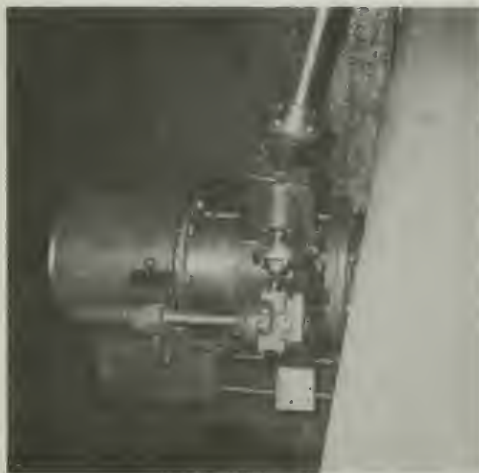
Figure 314. 8-Inch-Diameter Fixed-Cone Dispersion Valve

the deflector cone of the 8-inch- and 16-inch-diameter valves are overlaid with Stellite since they are in service most of the time. The deflector cone on the 8-inch valve (Figure 314) is fabricated of stainless steel. The valve gate seat, and downstream edge of the deflector cone of the 36-inch-diameter valves (Figure 315) are overlaid with stainless steel.

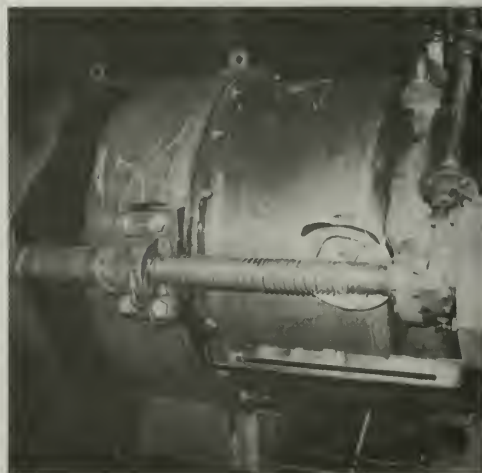
Figure 315. 36-Inch-Diameter Fixed-Cone Dispersion Valve

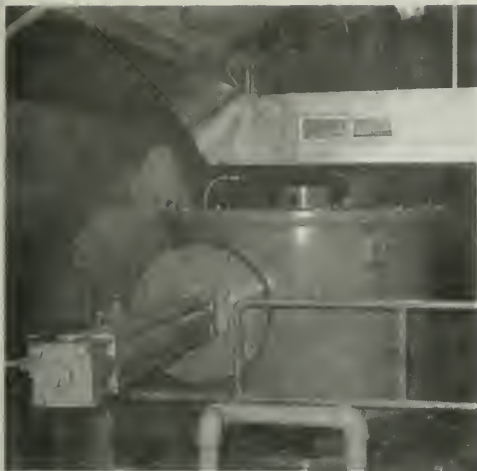
Figure 316. 42-Inch-Diameter Shutoff Valve

Shutoff Valves. Two 42-inch-diameter, one 24-inch-diameter, and one 12-inch-diameter, conical, plug-type, shutoff valves are located in the valve chamber (Figure 316). They serve as guard valves to the two 36-inch-diameter, one 16-inch-diameter, and one 8-inch-diameter, stream-release, fixed-cone dispersion valves. Each plug valve is equipped with an oil hydraulic-cylinder operator and dual seats for both

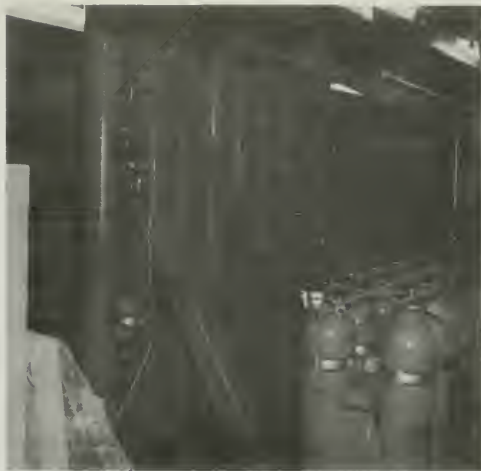
Figure 317. Shutoff Valves and Butterfly Valve—Accumulator System

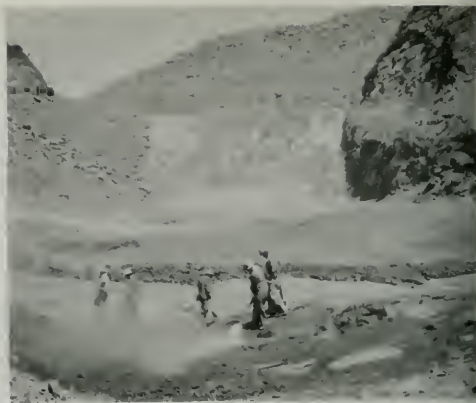
Figure 326. Air-Water Jet Cleanup of Foundation

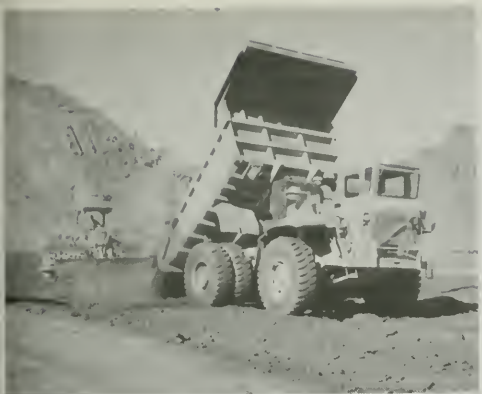
Figure 327. Dump Truck Used for Embankment Material Hauling

Two types of haul units were used: dump trucks (Figure 327), which could haul approximately 20 cubic yards bank measure, and tractors with rear-dump wagons that had a capacity of approximately 15 cubic yards (Figure 328). The haul route was downslope on old Highway 99 to the upstream toe of the Dam and then up a 15% grade on a 40-foot-wide haul road traversing the face of the Dam.

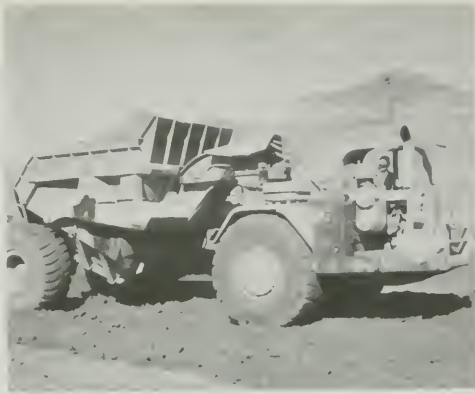
Figure 328. Rear-Dump Rock Wagon Used for Embankment Hauling

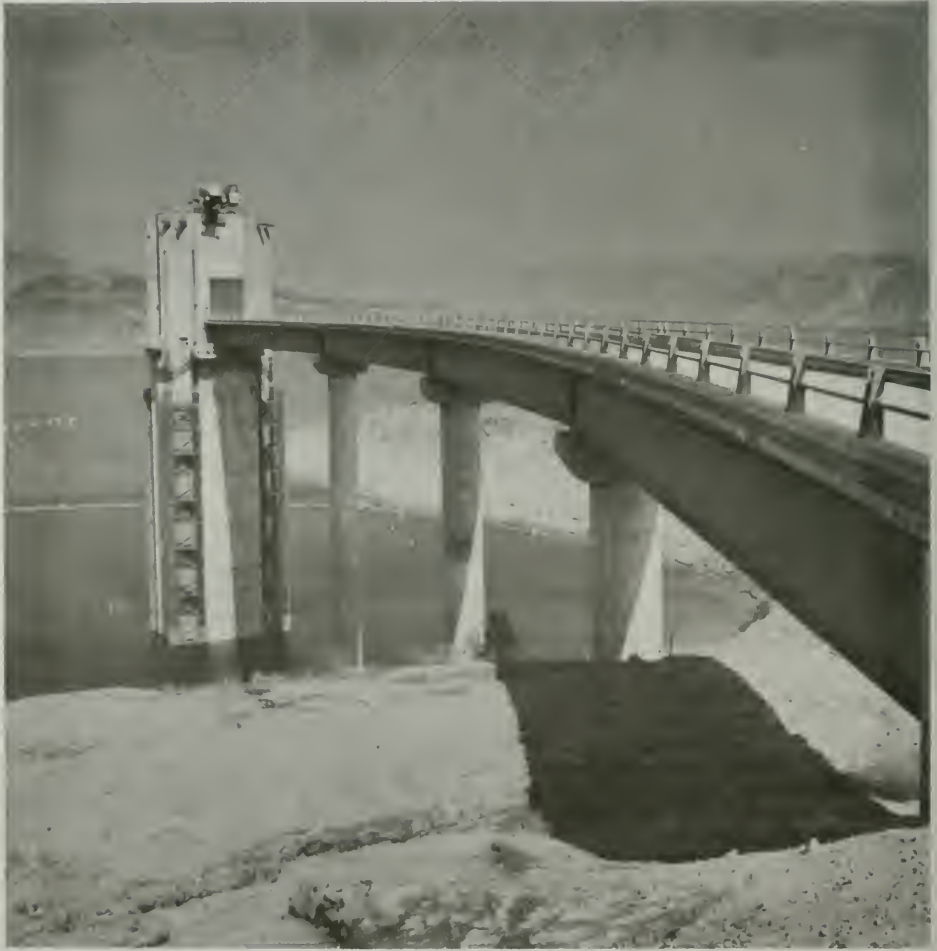
Figure 354. High Intake Tower and Access Bridge

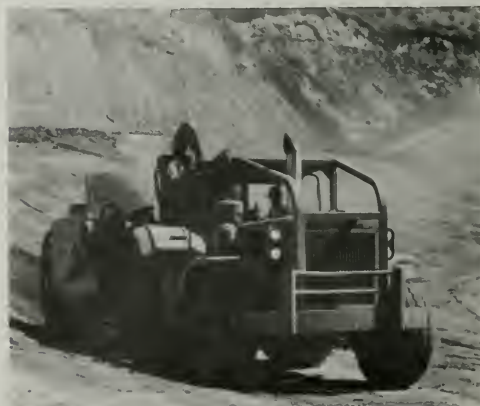
Figure 388. Scraper Spreading First Load of Embankment in First Approved Dam Foundation Area

Foundation Preparation. Initial excavation for dam embankment foundation was cut to within 12 inches of final grade. Removal of this final 12 inches and cleaning of surfaces was limited to a period of two days, within which time embankment placement was started (Figure 388). This was necessary due to the rapid deterioration of the Castaic formation, especially the shales, when exposed to air.

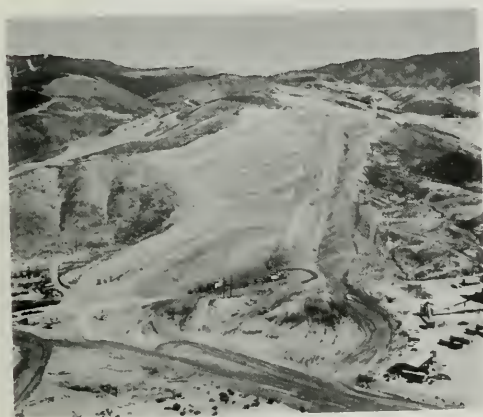
Excavation. Initial excavation (Figure 400) was carried to within 2 feet of final grade. Rebound gauges were installed and monitored. Depending upon the rate of rebound and the contractor's schedule for starting structural concrete, sections of the spillway were released for final excavation prior to expiration of the stipulated five months. Where the foundation had been cut and cleaned to final grade, protection requirements called for concrete placement or application of an asphaltic emulsion covering within 24 hours. Structural concrete was placed within 30 days in the areas protected with the asphaltic emulsion. Much of the early excavation material was stockpiled

Figure 400. Spillway Stilling Basin and Chute Excavation

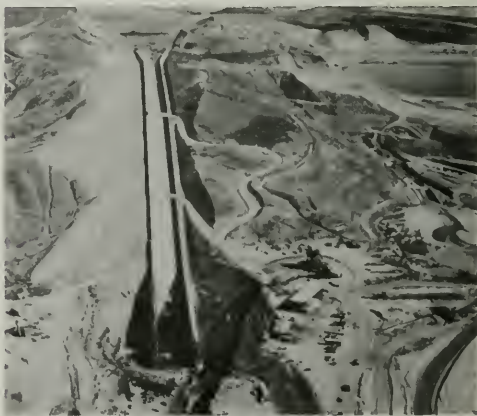
Construction of the spillway (Figure 401) progressed from Station 37+00, down the chute section to the flip bucket, and then from Station 37+00 back to the crest. The order of concrete placement, not including that placed for foundation protection, was (1) keyways, (2) wall footings, (3) gallery and invert slabs, and (4) walls. Placements were performed concurrently as conditions permitted.

Figure 401. Spillway Construction
