Evaluation and Monitoring of Seepage and Internal Erosion

Interagency Committee on Dam Safety (ICODS)

FEMA P-1032 / May 2015

Federal Emergency Management Agency

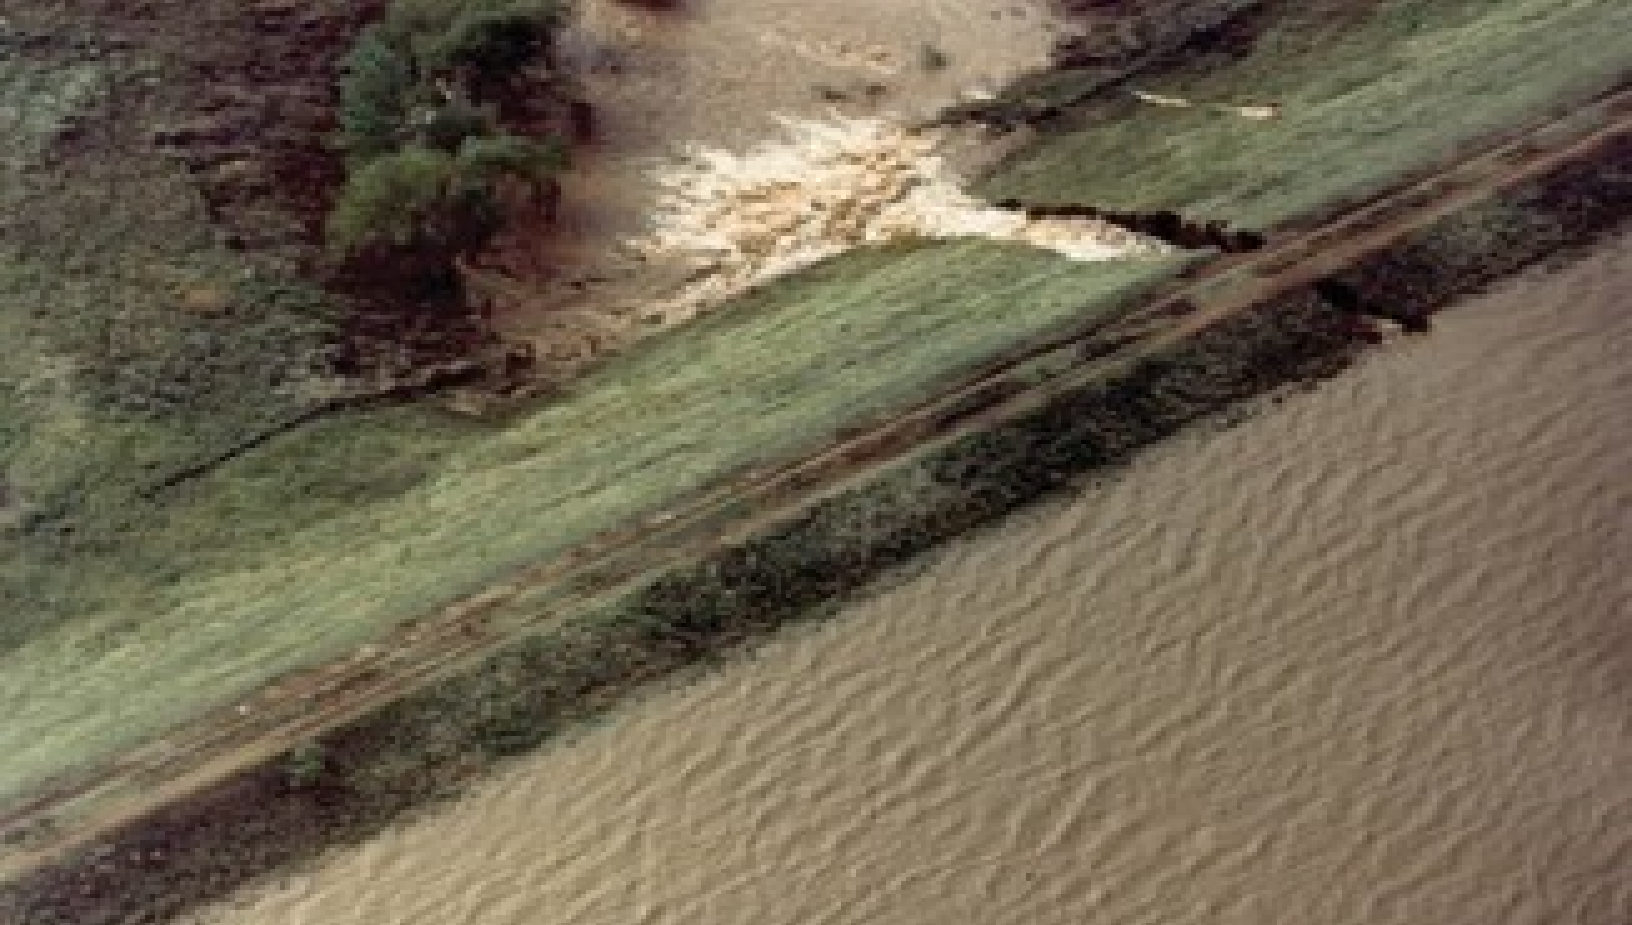
Cover photo: Upper Red Rock Site 20, Oklahoma – dam failure from seepage along poor lift joints in highly dispersive clay soil embankment.

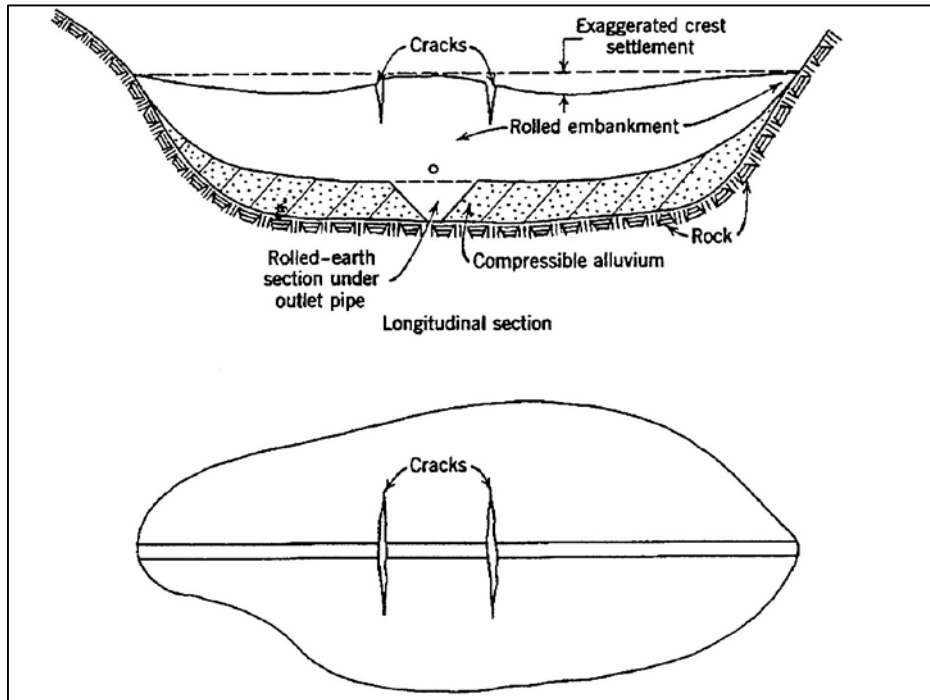
Figure 3-1c.—Cracking due to differential settlement between natural foundation soil and rolled-earth support under outlet pipe (or other discontinuity in the foundation).

deposits can settle after the reservoir fills. If wetting occurs during first filling, or during a flood event for flood control impoundments, the settlement can be large and dramatic. A good description of the mechanics of cracking in embankment dams was provided by Sherard (1963), and several figures adapted from that reference are included on figure 3-1(a–d).

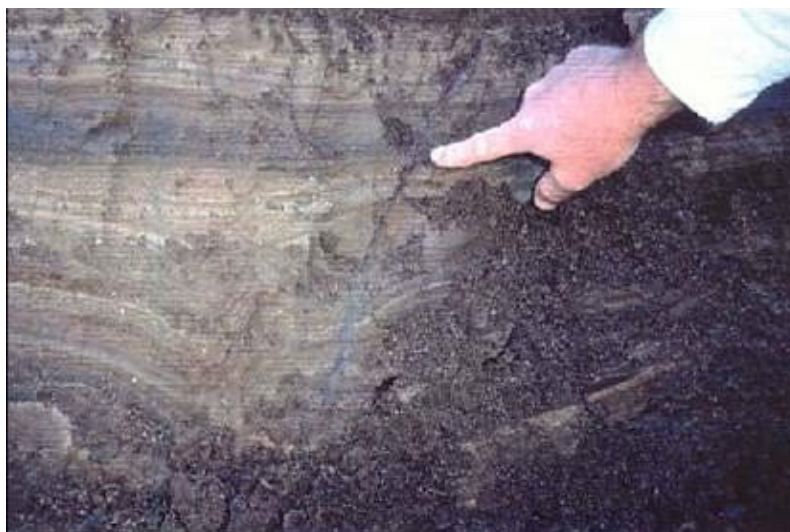
Figure 3-3.—Suspected hydraulic fracture at Ochoco Dam near the intake tower that was subsequently filled with reservoir sediments.

Hydraulic fracturing has been suggested to possibly have played a role in the failure of Teton Dam, which featured a very narrow, steep-sided cutoff trench backfilled with low plasticity soil.² It is believed that an example of hydraulic fracturing occurred at Ochoco Dam in Oregon (figure 3-3)³. The suspected hydraulic fracture was observed in an excavation near the intake tower and upstream portion of the outlet works conduit during dam safety modifications in the 1990s.

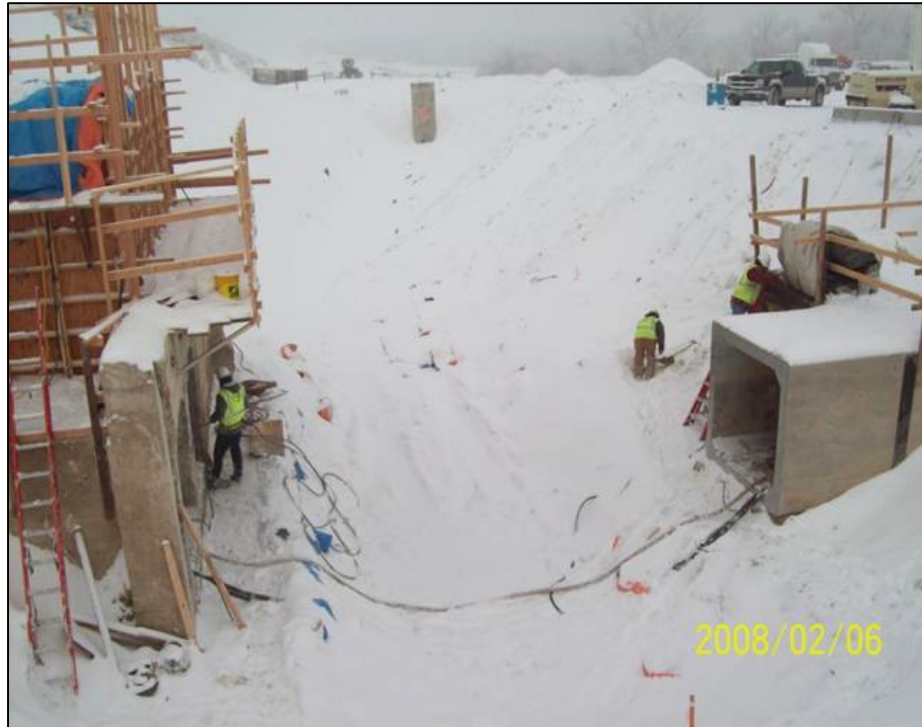
Figure 3-4.—Examples of winter construction at embankment dams prior to removal of snow and ice contamination. (Top) Blue blanket is insulated to prevent freezing of underlying soils. (Bottom) Placement of fill on improperly prepared frozen ground, snow, and ice.

In some cases, construction during winter is unavoidable. Similar to *Interruption in Fill Placement* described above, if the top lifts are allowed to freeze, a defect in the earthfill can result. Freezing may occur during temporary shutdown when the contractor chooses not to work until warmer weather returns or during winter shutdown when work is stopped for several months. Earthfill correctly placed and compacted originally will be damaged due to freezing action and will no longer have the properties of the specified lift. Ice and snow may also become mixed with the surface lifts of soil. Frost-damaged and ice-contaminated materials should be removed and replaced when better weather conditions return. Frost-susceptible soils such as silts and fine sands are of particular concern because ice lenses may form within them. Frost-damaged soils may be prone to development of preferential seepage paths and concentrated leaks. Examples of winter construction are shown on figure 3-4.

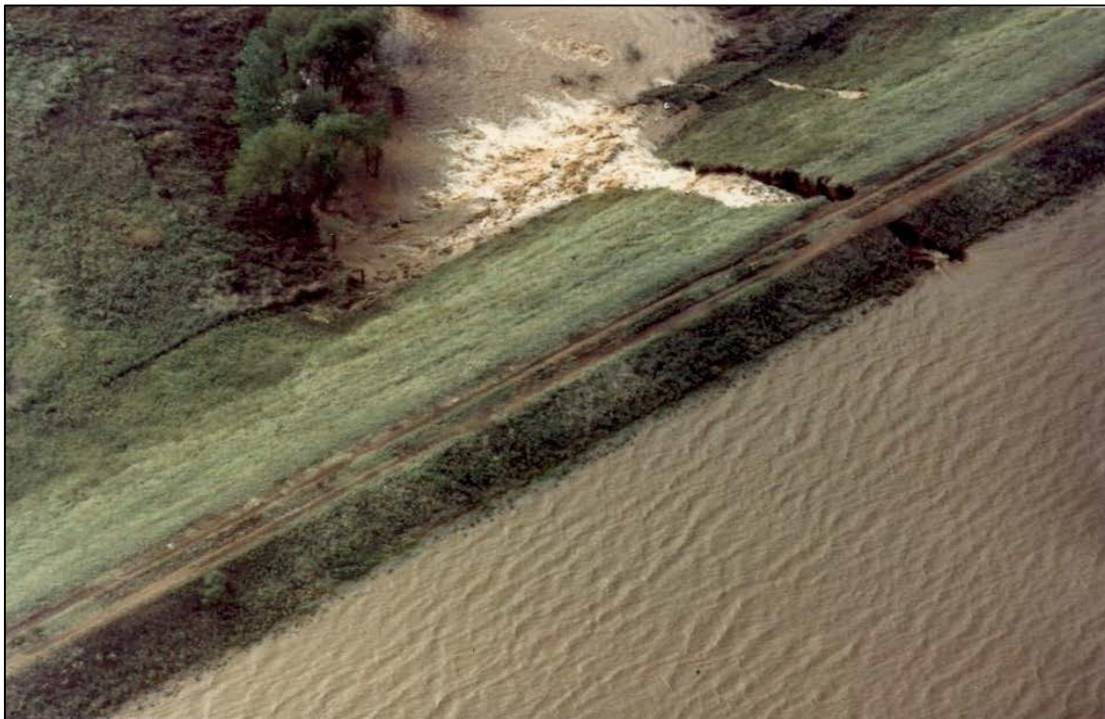
Figure 3-5.—Upper Red Rock Site 20 Dam internal erosion through dispersive soils.

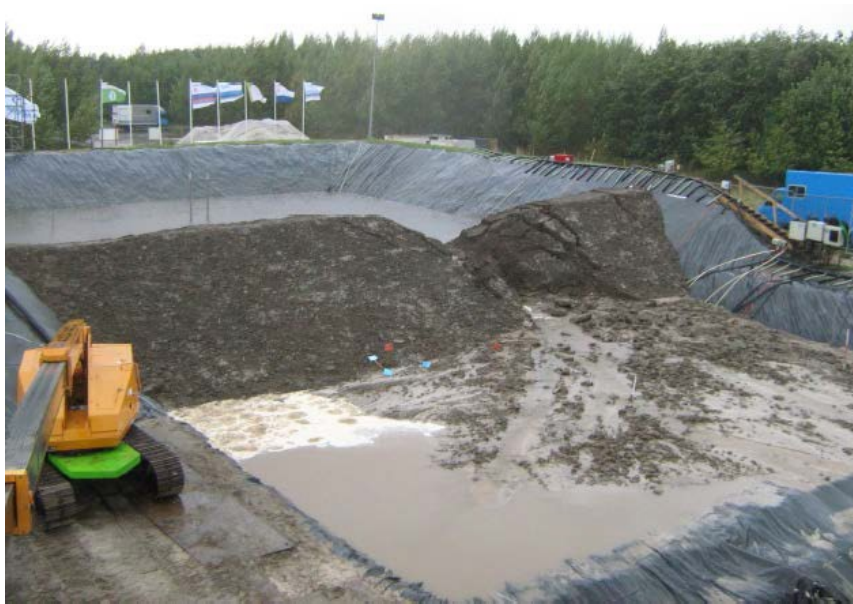
Figure 3-8.—Deltares large-scale field test (Van Beek).

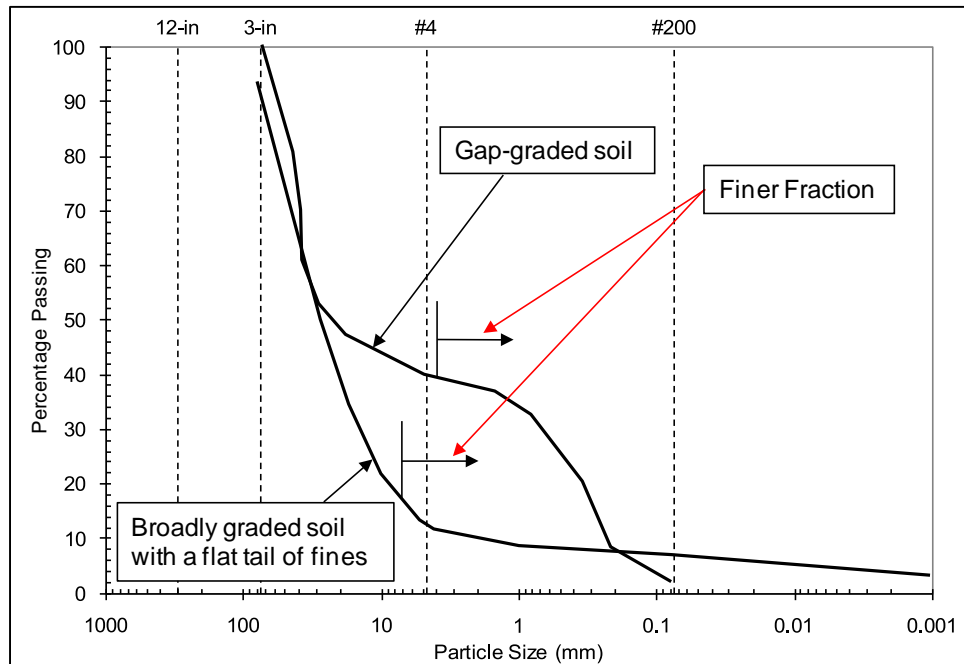
Figure 3-12.—Soils susceptible to suffusion (adapted from Wan and Fell 2004).

Coarse-graded and gap-graded soils, such as those shown schematically on figure 3-12, are susceptible to suffusion. They should be checked for self-filtering capability by comparison of the fine versus the coarse fractions using standard filter criteria (Kézdi 1979; Kovács 1981; Skempton and Brogan 1994).

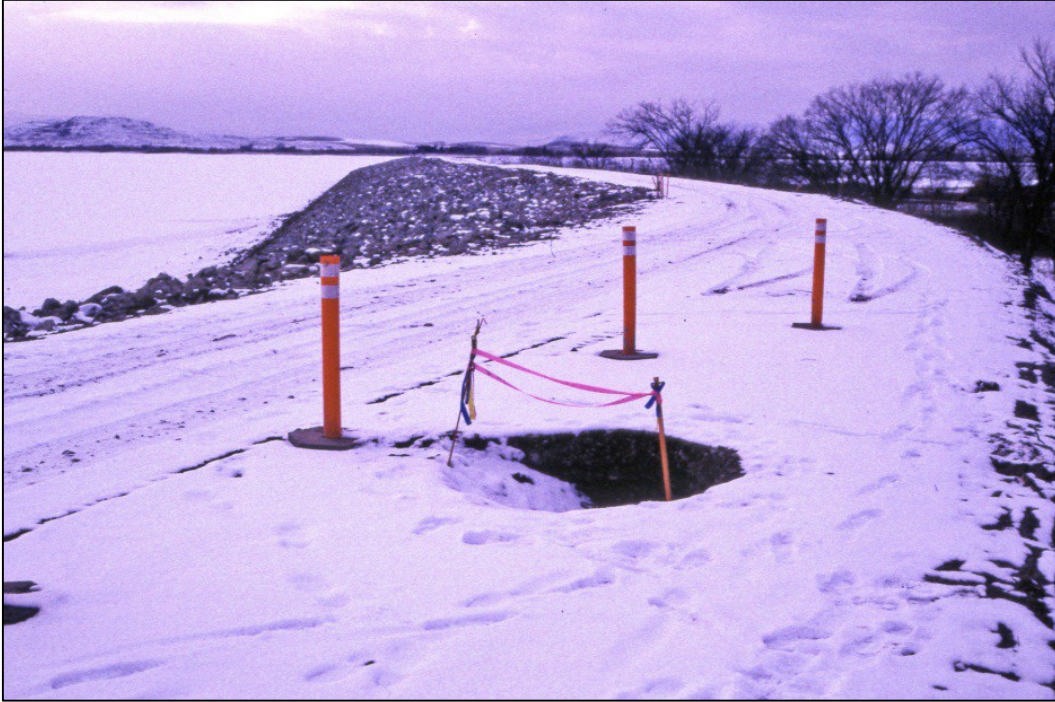
Figure 3-15a.—Sinkhole in crest of a dam in Montana.

There are many examples of stoping incidents. A large sinkhole (figure 3-14) developed suddenly in the crest of Willow Creek Dam⁸ due to this process, which took nearly 40 years to manifest. Another dam in Montana experienced a sinkhole on its crest due to internal erosion into a toe drain. The toe drain was original construction that was left in place after a downstream dam raise. The modified dam crest was located above the original toe drain, which served as an unfiltered exit (figure 3-15(a–b)).

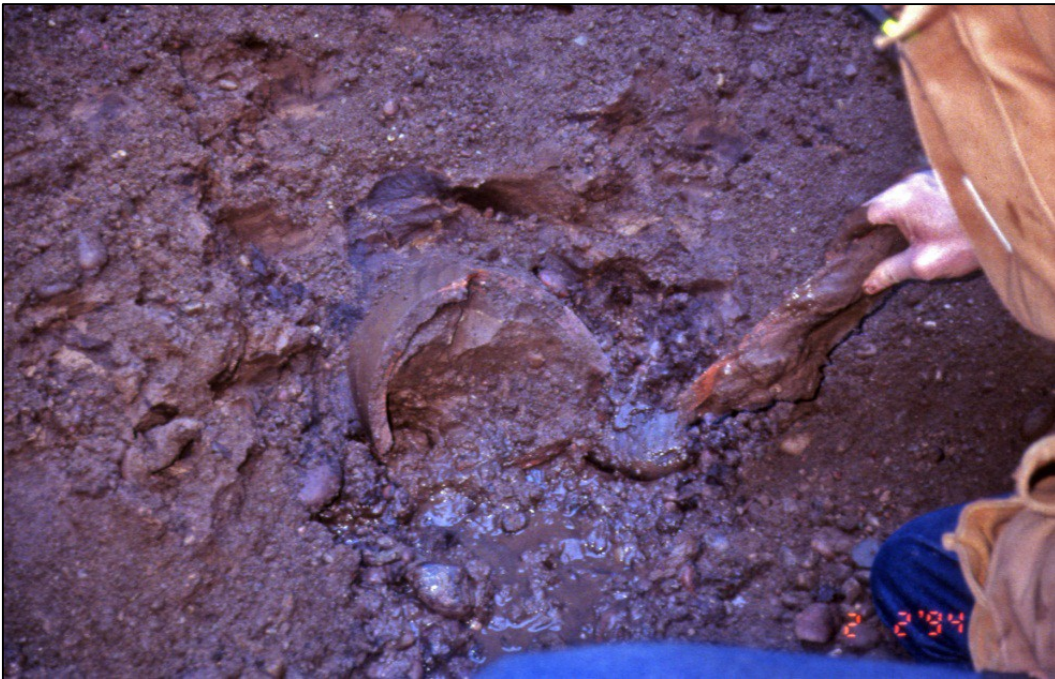
Figure 3-15b.—Excavation of the sinkhole shown in previous photograph revealed original toe drain below the sinkhole.

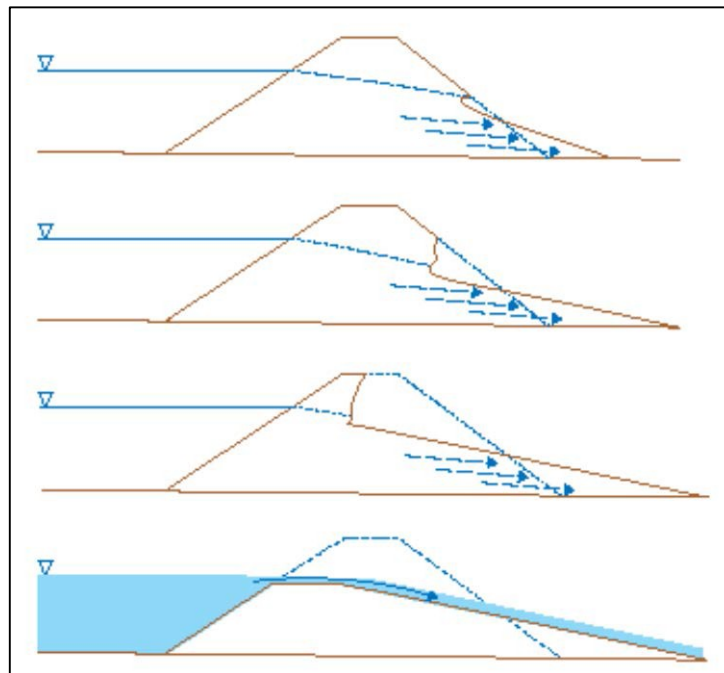
Figure 3-16.—Illustration of how downstream sloughing due to saturation could lead to dam failure.

Some embankment dams were constructed with relatively steep downstream slopes. Such slopes may remain stable for decades as long as the phreatic line remains low on the downstream face of the dam. However, if the reservoir level rises to an unprecedented level and the lower portion of the embankment becomes more saturated, moving the phreatic line higher up on the downstream face of the dam, the downstream slope may begin sloughing. This is common in sand embankments constructed by dumping or spreading the fill with a monitor during the original construction in which the final outer slopes may be near the unsaturated angle of repose. In such dams, when shallow sloughing occurs, it may concentrate flow within the embankment toward the sloughed area. If enough seepage is present within the slough, it may wash away the sloughed material, allowing the oversteepened scarp to slough again. The process may continue in a step-wise fashion toward the reservoir until a breach is formed through the dam. Figure 3-16 illustrates the process.

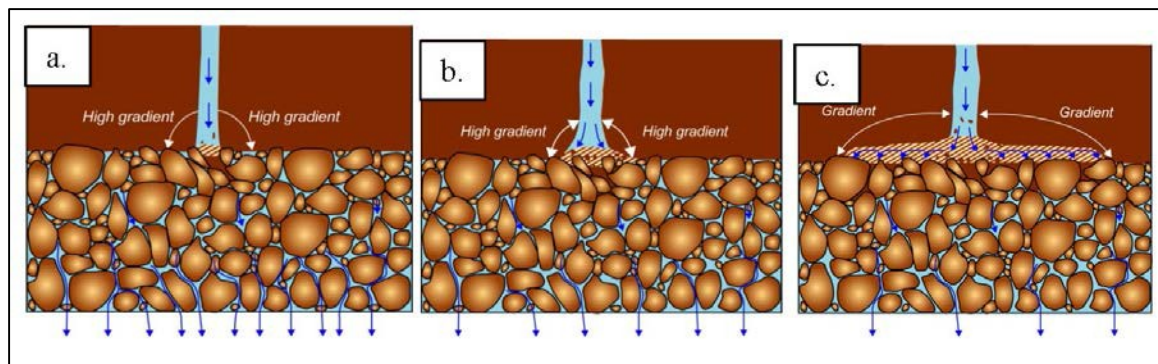
Figure 4-4.—Illustration of filtering at a crack.

The FEMA Filter Manual (2011) provides a thorough review of the subject of filter design and construction. Figure 4-4 illustrates the way in which a filter works to prevent internal erosion from a concentrated leak (Sherard et al. 1984). Figure 4-4(a) shows eroding soil in the crack is caught at the filter face, stopping flow in the crack. High gradients cause hydraulic fracturing from the crack to the adjacent filter. Figure 4-4(b) shows eroding soil from a crack has been caught at the filter face, and hydraulic fracturing from high gradients between water in the crack and the adjacent filter has caused some widening of the filter cake near the crack. On figure 4-4(c), eroding soil from the crack has been caught at the filter face, and hydraulic fracturing from the high gradients between water in the crack and the adjacent filter has caused further widening of the filter cake until the gradient is reduced. The filter cake having a very low permeability covers the width of the crack and some distance on each side of the crack. The

remaining filter is open for collecting seepage flow through the pores of the soil between cracks. The presence of filters and drains also helps to control pore pressures within the embankment and foundation.

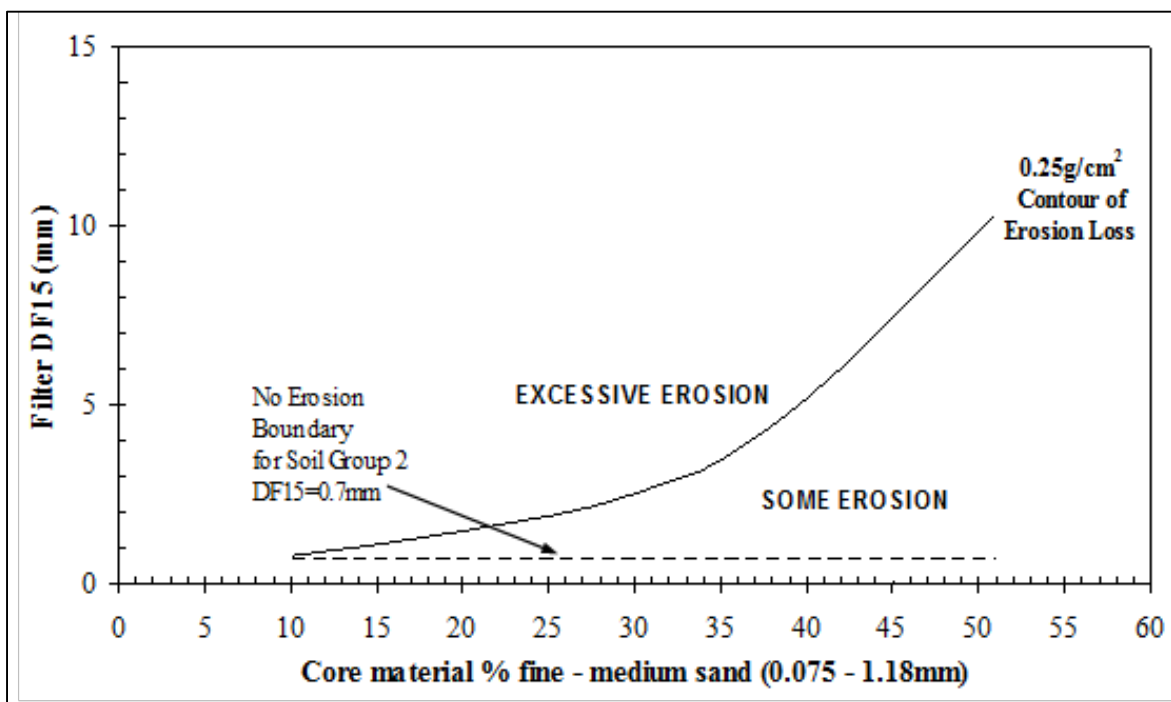
Figure 4-5.—Criteria for excessive erosion boundary (Foster and Fell 2001).

Base soil	Proposed criteria for excessive erosion boundary	Proposed criteria for continuing erosion boundary
Soils with $D_{95}B < 0.3 \text{ mm}$	$D_{15}F > 9 D_{95}B$	For all soils: $D_{15}F > 9 D_{95}B$
Soils with $0.3 D_{95}B < 2 \text{ mm}$	$D_{15}F > 9 D_{90}B$	
Soils with $D_{95}B > 2 \text{ mm}$ and fines content > 35%	$D_{15}F >$ the $D_{15}F$ value, which gives an erosion loss of 0.25 g/cm ² in the CEF test (0.25 g/cm ² contour line on figure 4-5)	
Soils with $D_{95}B > 2 \text{ mm}$ and fines content < 15%	$D_{15}F > 9 D_{85}B$	
Soils with $D_{95}B > 2 \text{ mm}$ and fines content 15–35%	$D_{15}F > 2.5 D_{15}F$ design, where $D_{15}F$ design is given by: $D_{15}F$ design = $(35 - \text{pp}\% 0.075 \text{ mm}) \times (4 D_{85}B - 0.7) / 20 + 0.7$

Criteria are directly applicable to soils with $D_{95}B$ up to 4.75 mm. For soils with coarser particles, determine $D_{85}B$ and $D_{95}B$ using grading curves adjusted to give a maximum size of 4.75 mm.

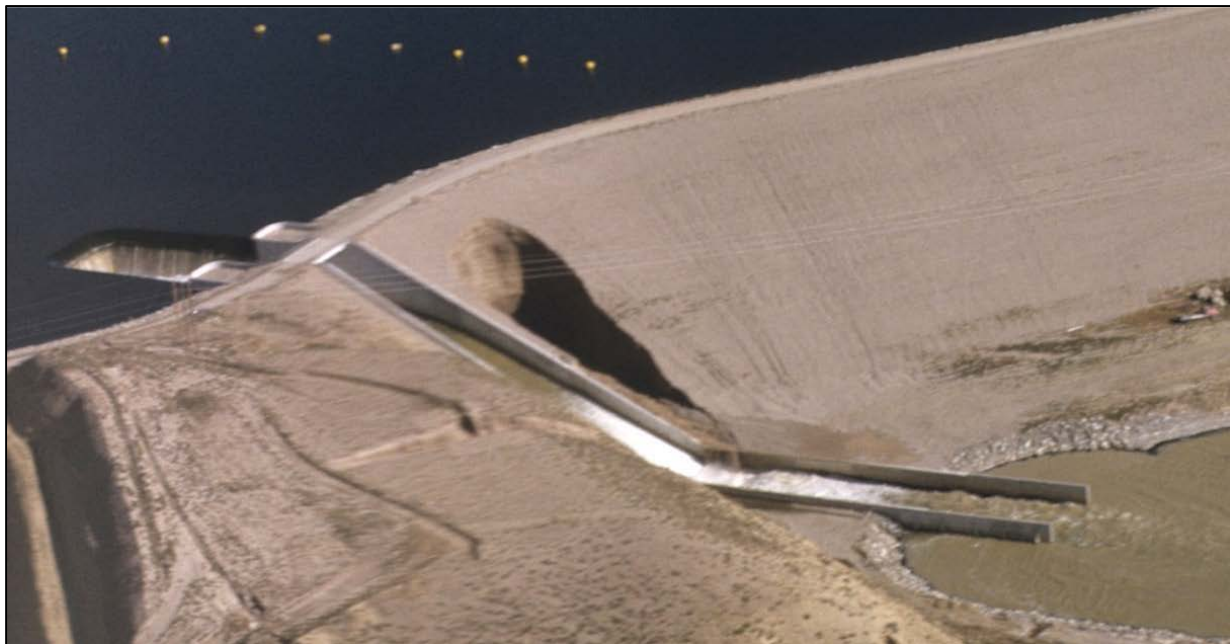
Figure 4-7.—Fontenelle Dam, which nearly breached by sloughing.

Reclamation's Fontenelle Dam in Wyoming nearly breached in 1965 by sloughing (figure 4-7), but the breach process occurred slowly enough so that the reservoir water surface was able to be lowered over the span of several days and arrest the breach. In contrast, Hell Hole Dam, a rockfill structure in California, failed from overtopping during construction in 1964, but handled a flow of about 13 cubic feet per second per foot before small slides and erosion began to progressively occur at the toe. Once this began, failure occurred within about 3½ hours (Leps 1973). The core of Reclamation's Minidoka Dam overtopped during construction (1904 to 1906), and the downstream rockfill zone withstood flows estimated up to 1,000 cubic feet per second. The water surface elevation was 8 feet below the normal water surface when the core overtopped. Figure 4-8 shows the maximum section of Minidoka Dam, which is approximately 80 feet high.

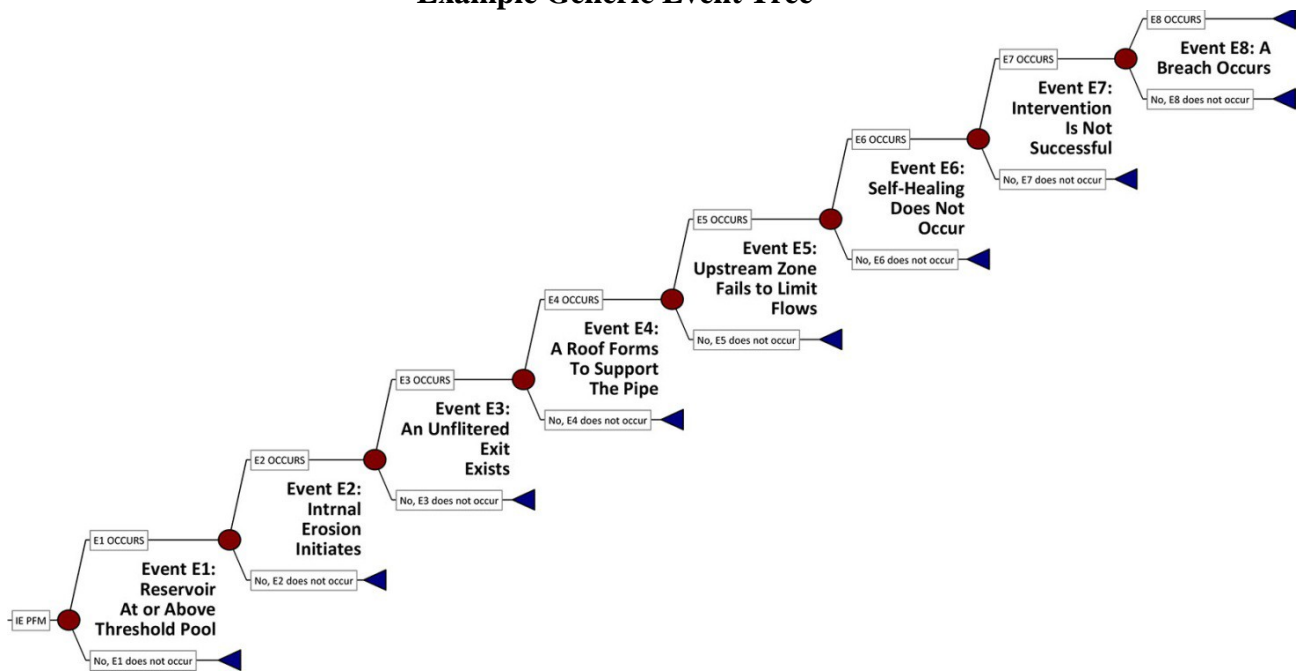
Example Generic Event Tree

Event 1 – Considered the “loading” event. An estimation is made for a given range of reservoir level, and the recurrence of that reservoir level is determined from historic reservoir operating history plotted as the reservoir level exceedance curve (chapter 4, *Dam Safety Risk Analysis Best Practices Training Manual*) (Reclamation-USACE 2011).

Event 2 – This event considers the likelihood that a continuous seepage path exists AND that erosion would begin or has occurred along the failure path. This is the “initiation” phase of internal erosion discussed in chapter 3. These probabilities can be based on historic initiation rates of a particular inventory of dams or on analytical methods. For example, Reclamation uses their database of dams, which are located in the Western United States, with some structures that have been in service for over 100 years. The reader is directed to chapter 24 of the *Dam Safety Risk Analysis Best Practices Training Manual* for a more detailed explanation of these data and considerations that are needed for the specific project that is under consideration. Other databases (private or public) may be available (Foster and Fell 1990).

Below is a short description of each event. Note that these events, with the exception of intervention, are thoroughly discussed in “Section 4.3, Conceptual Framework Conducive to Potential Failure Modes Analysis.” Also see chapter 24 of the Reclamation/USACE *Best Practices for Risk Analysis* document for a more detailed explanation of these events and typical considerations that are used for each.

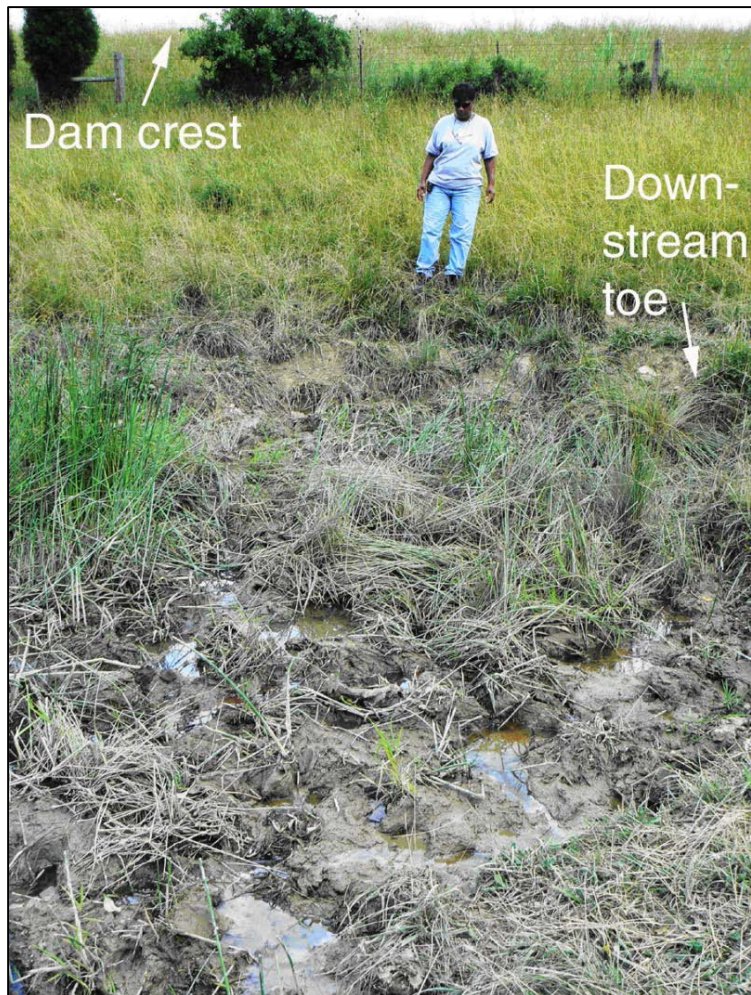
Figure 6-2.—Seepage discharge where the typical grass growth has been retarded in the saturated soil environment and where other vegetation species are becoming dominant.

Emerging surface seeps are harder to detect if there are no visual surface anomalies such as increased vegetation growth. Often a seep is indicated by a change in vegetation type (phreatophyte) or lushness. Non-visual techniques discussed later in this chapter may be performed to identify and delineate surface seeps if the perceived threat warrants additional investigation. Monitoring the surface seeps may be as simple as flagging their location and areal spread as illustrated on figure 6-4. In this illustration, the yellow flags mark the initial seepage discharge boundary, and subsequent lateral spreading is tracked with red flags. The location of the flags should be photographed, measured and mapped, and ultimately a decision made

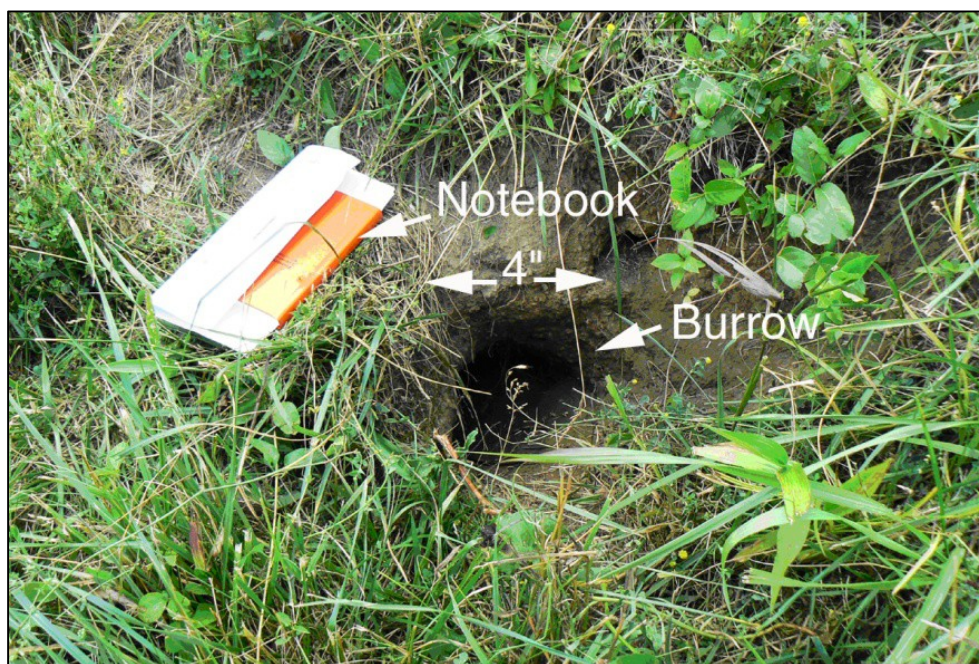
Figure 6-7.—Surface deformation indicative of animal activity observed on the downstream slope.

Figure 6-7 illustrates a small rodent burrow found in the downstream shell of an embankment dam. Figure 6-8 illustrates surface-erosion features (gullies) that also were not caused by internal seepage processes but could eventually become a preferential flow path if not repaired. A series or group of rodent holes may be an indication of low stress or cracked zones in the fill, as rodents tend to dig where it is easiest.

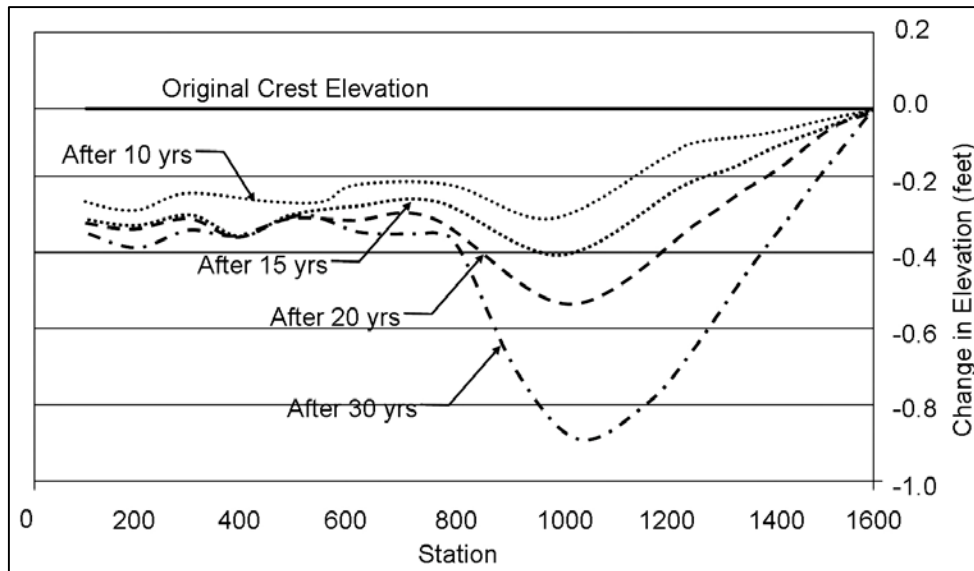
Figure 6-10.—Example of excessive or continuous crest settlement indicating a deteriorating condition likely due to piping or internal erosion.

shows an actual dam that had relatively minor settlement during the first 10 years of operation, but began to experience excessive settlement after 20 years. This information warned the dam owners and dam safety engineers that a serious internal erosion and piping issue was occurring. The dam was founded on a karstic foundation.

Surveys along the crest of an embankment can provide early warning of internal erosion and piping. Typically, a dam should not settle more than 1 percent of its height over the life of the structure. If the dam has settled more than 1 percent, this would indicate that possibly weak zones exist within the dam's foundation or that the dam was poorly constructed. Excessive settlement of the dam in the valley can lead to overtopping of the embankment, while large differential settlements can lead to cracking. Crest surveys are typically taken annually during the first several years after the dam has been constructed to monitor settlement. The rate of settlement should decay continuously with time. Once settlement has slowed or stopped, the surveys may be taken at reduced frequency, say every 5 years. However, if unexpected movement is suspected or begins to occur, then annual surveys may be needed. Figure 6-10

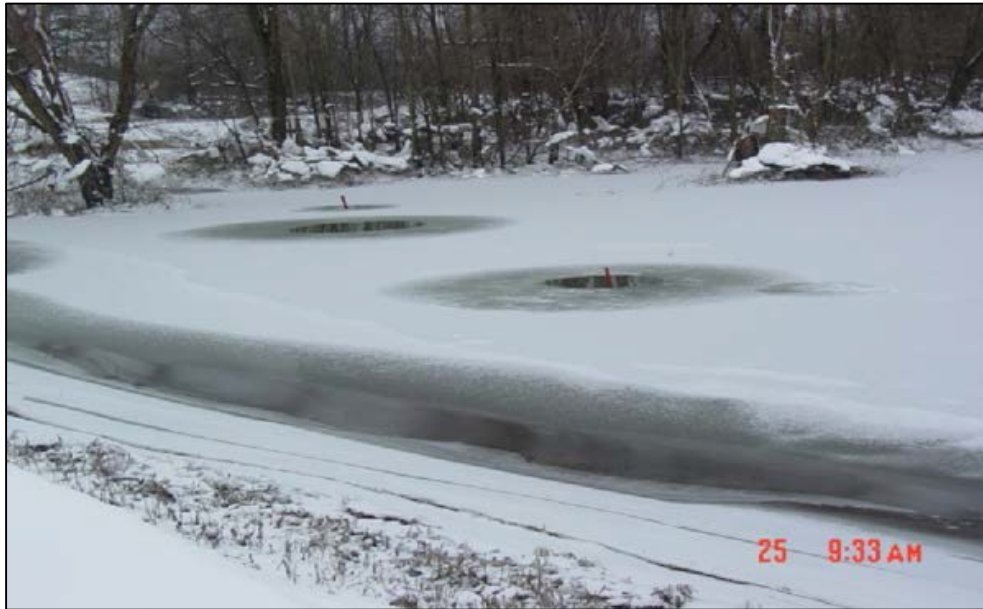
Figure 6-11.—Seepage water discharge locations (flagged with red markers) are more evident during the winter due to water temperature differences.

As water flows from its supply source into the dam or foundation materials, its temperature will change. Typically, deeper water is insulated from air temperature changes and remains at a relatively constant temperature. Influx of water from rivers or lakes will be reflected by temperature changes. Figure 6-11 shows seepage discharge locations that are easily identified during wintertime when the temperature difference between surface water and subsurface seepage is highest.

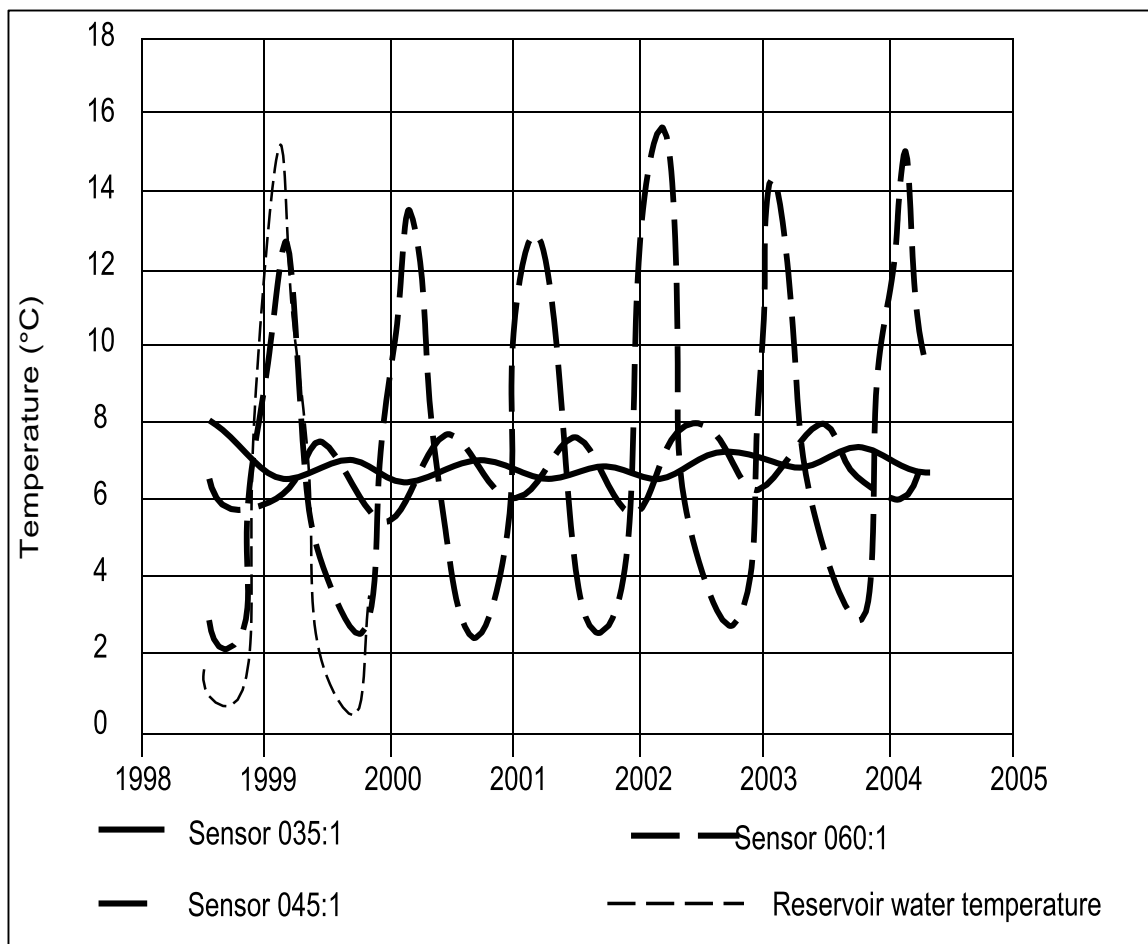
Figure 6-12.—Temperature measurements in piezometer sensors 035:1, 045:1, and 060:1 located in a Swedish dam foundation (bedrock). Temperature sensor 060:1 indicates seepage flow at this location due to its higher seasonal temperature variation (after Johansson et al. 2007).

Strain measurements are directly observed along the fiber length and need no further processing. Temperature measurements require more processing to identify areas of high seepage because temperature is an indirect measurement of seepage flow. Areas of high seepage can be identified by large seasonal temperature variations along the optical fiber. The seepage volume can be computed from thermal process calculations. Figure 6-12 illustrates how post-processed fiber optic data can readily indicate areas with seepage anomalies. On this figure, sensor 060:1 (bold dashed line) exhibits the highest seepage rate when compared to the other sensors.

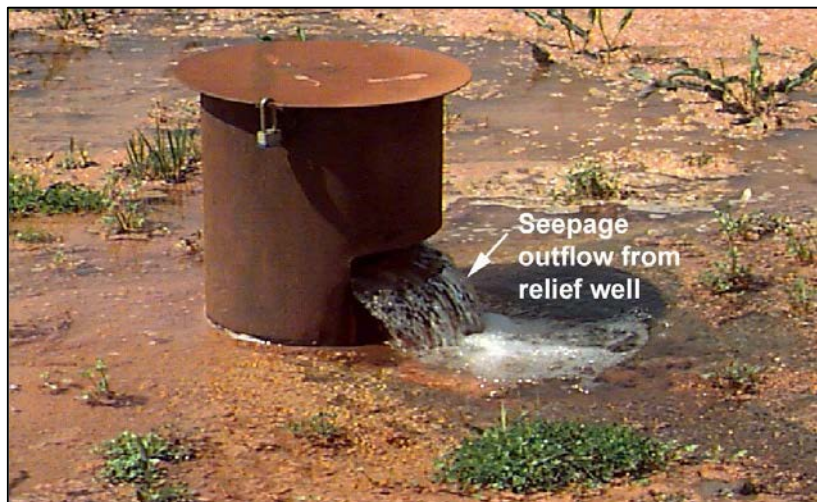
Figure 7-9.—Relief well seepage outflow. Although relief wells are not typically installed for the primary purpose of seepage water monitoring, their outflow can be collected, measured, and evaluated similar to open piezometers or observation wells.

Relief wells also function as observation wells, but their primary purpose is to reduce the hydraulic head at selected locations along the seepage flow path.³ Figure 7-9 shows a relief well discharge where the seepage water could be collected if necessary.

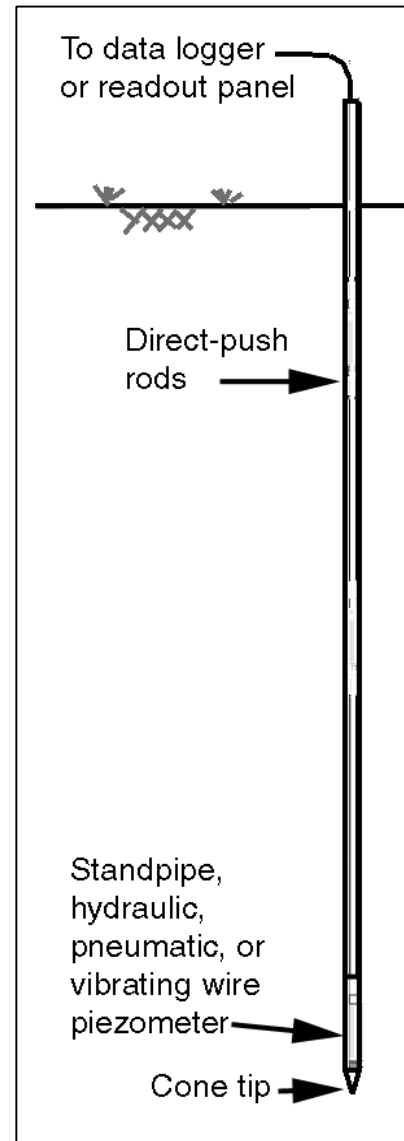
Figure 7-19c.—Single open- or closed-system piezometer installation using the direct-push method. Multi-level sensor installation is also possible with this method.

- (4) The ***push-in method*** uses a direct-push installation similar to a cone penetrometer and is used in soft cohesive soil. The piezometer must be monitored during installation to ensure that it is not over-pressured as it is pushed in. Figure 7-19c illustrates a piezometer installed by direct-pushing into the subsurface. The push is terminated when the sensor reaches the zone of interest.

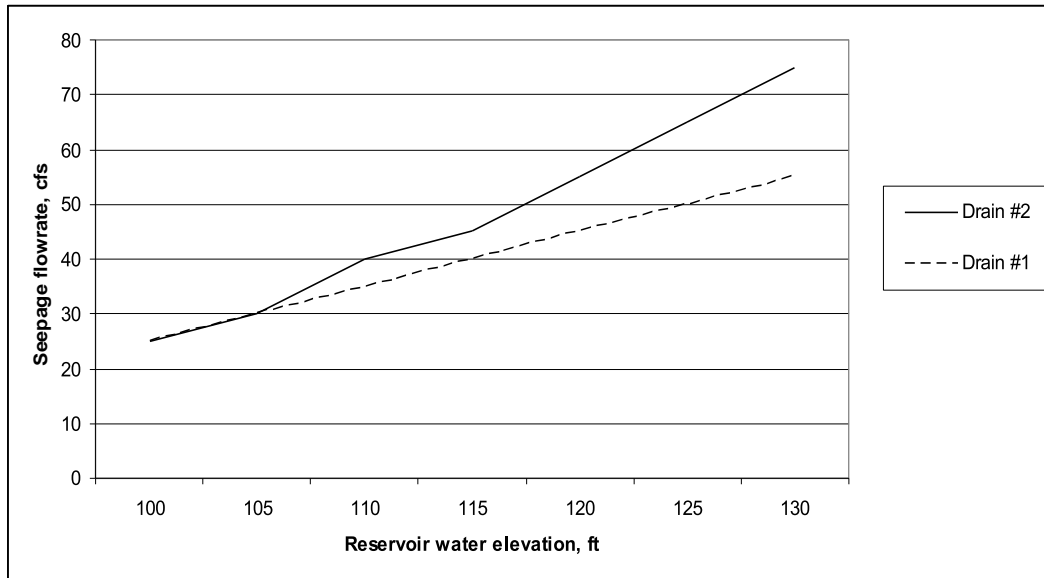
Figure 8-1.—Conceptual illustration of a seepage drain flow rate response plot. The flow rate from drain #2 varies significantly from that in drain #1 as the reservoir level increases, indicating a seepage anomaly or other phenomenon occurring in the drain#2 collection area.

A response plot displays the reservoir elevation versus the parameter change (e.g., the piezometric head may change as a function of reservoir elevation, and this data can easily be plotted on an XY chart). Drainage outflow volume is another parameter that may change with reservoir elevation. Figure 8-1 illustrates how such a graph enables detection of seepage trends as the reservoir elevation fluctuates.

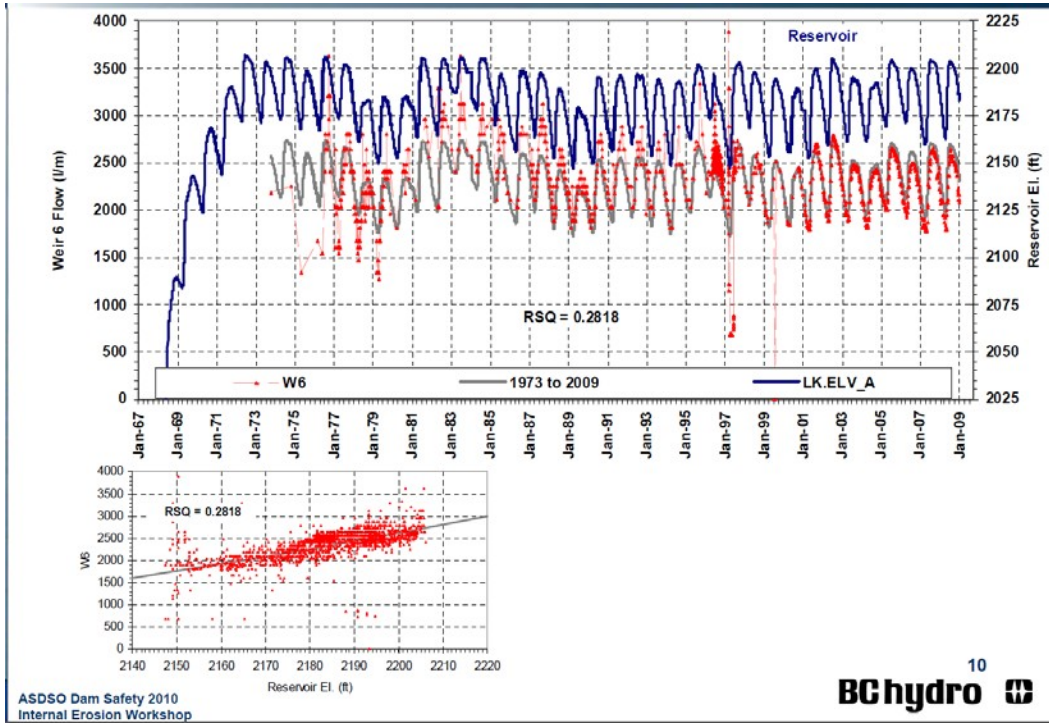
Figure 8-3.—Weir response and raw fit (ASDSO 2010).

The correlation and its usefulness in assessing performance is improved when the instrumentation data are parsed and corrected for lag and creep as shown on figures 8-3 through 8-6. In this example from the Association of State Dam Safety Officials (ASDSO) (2010), the raw fit of the weir flows over the entire period of record resulted in an R^2 value of 0.28 as shown on figure 8-3. Based on a review of the weir flows over time, three distinct periods of performance characteristics were observed: (1) flows increased at 76 liters per minute per year (L/min/yr) until July 1983, (2) flows decreased at 9.8 L/min/yr from July 1983 to May 1997, and (3) flows decreased at 6 L/min/yr from May 1997 to present. Flows increased slightly when the reservoir levels were above elevation 2180. Lag time was 15 days prior to 1983 and was unchanged at 23 days since 1983. By parsing the data into three time intervals as shown on figure 8-4, the R^2 values for the resulting correlations are improved to 0.64, 0.30, and 0.39, respectively. By correcting for lag as shown on figure 8-5, the R^2 values for the resulting correlations are improved to 0.65, 0.40, and 0.51, respectively. Lastly, by correcting for creep as shown on figure 8-6, the R^2 values for the resulting correlations are improved to 0.73, 0.41, and 0.52, respectively. With corrections for parsing, lag, and creep in the trends analysis, the weir flows correlated well with the reservoir levels.
