Evaluation and Monitoring of Seepage and Internal Erosion

Interagency Committee on Dam Safety (ICODS)

FEMA P-1032 / May 2015

Federal Emergency Management Agency

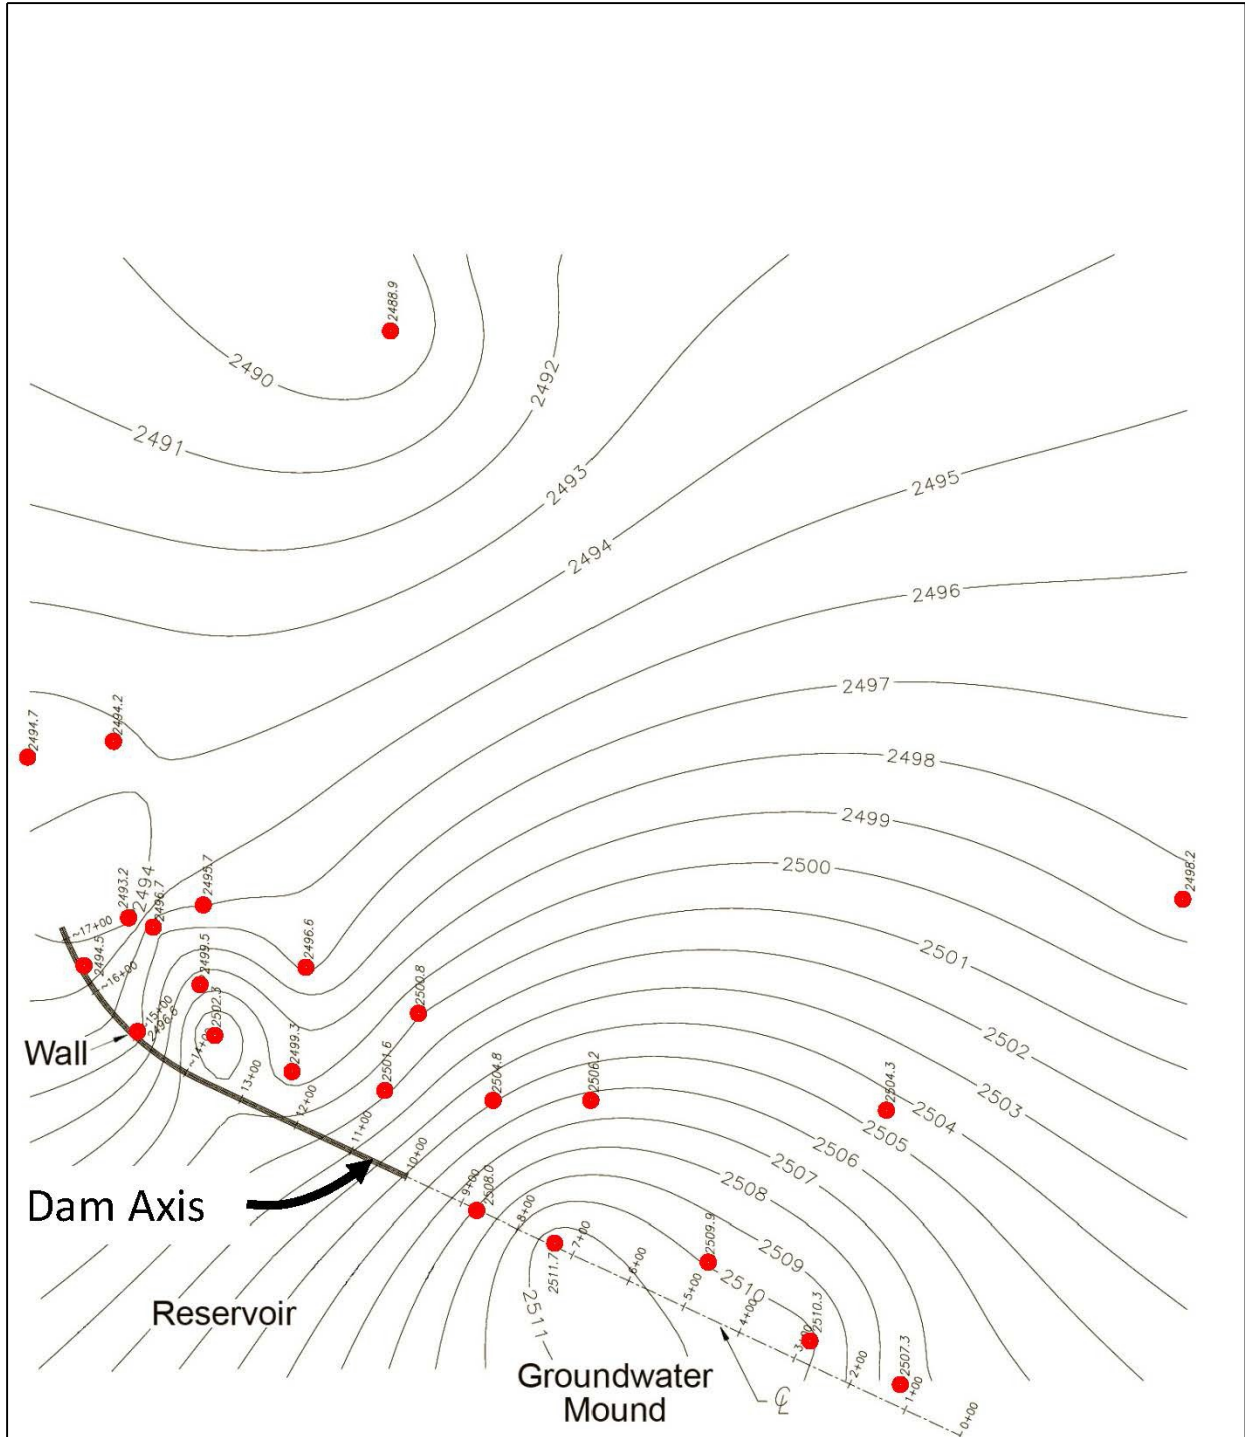
Figure 8-7.—Example groundwater contour map produced by mapping software from existing data collected from piezometers.

Piezometer data can also be used to delineate contours of the groundwater elevation, say, in the area downstream from the dam. The contours represent the phreatic surface within an unconfined aquifer or the potentiometric surface within a confined aquifer. A sufficient number of piezometers must be installed in the area of interest so that interpolations between data locations accurately represent actual conditions. Boundary conditions must also be understood to properly interpret the instrument readings and for input into seepage models. Also, care should be taken to ensure that all piezometers used to create the contours are located within the same stratum. Contour maps of groundwater elevation can be used to determine the direction and pattern of flow in plan view and to identify areas of high gradients, concentrations of flow, and potential problem areas (figure 8-7). After initial contour plots are developed, locations where additional piezometers are needed may become apparent.

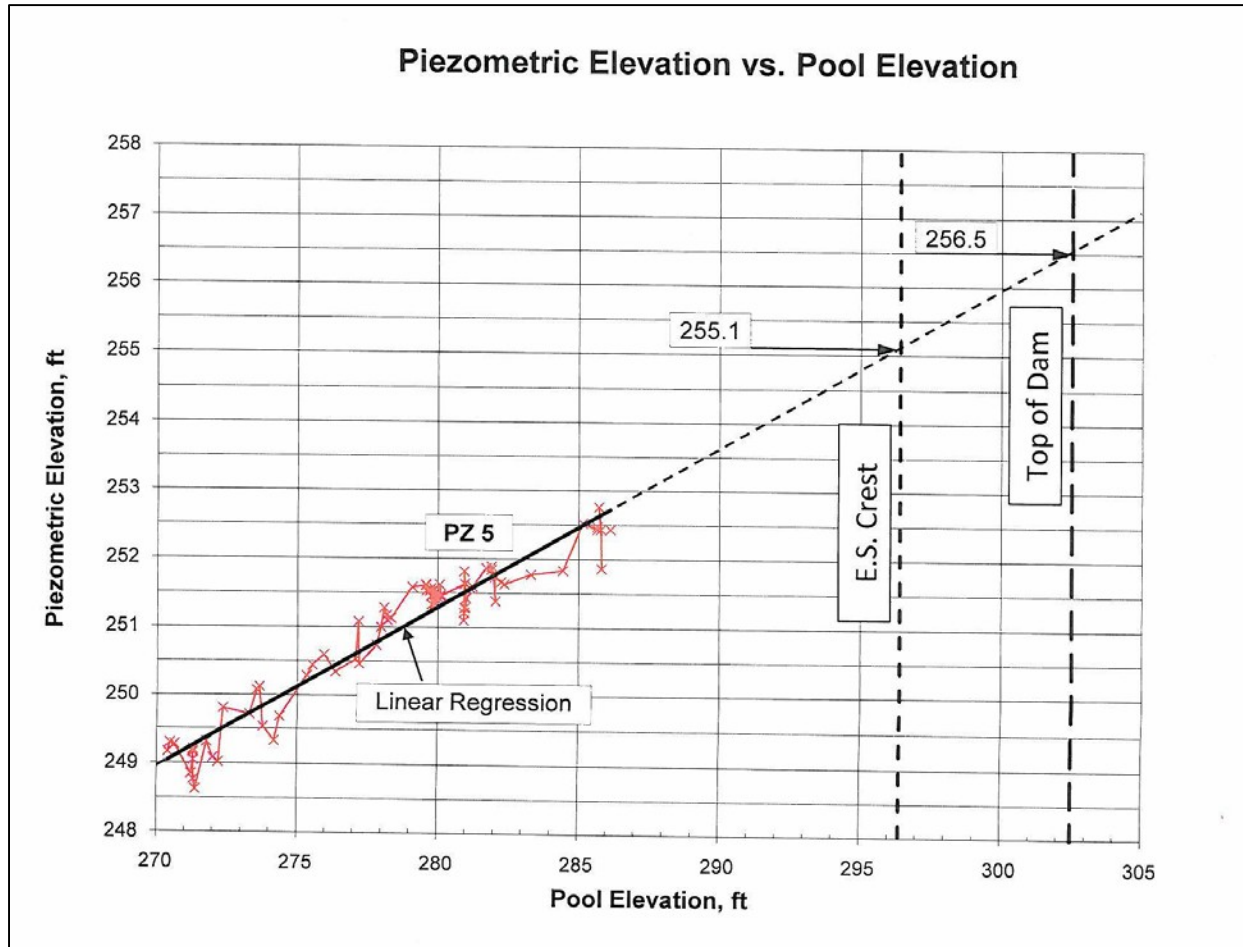
Figure 8-8.—Graphical extrapolation of piezometric elevation versus reservoir elevation plot.

The simplest method to predict piezometric elevations for higher reservoir levels from those observed at lower levels (e.g., during the first filling) is graphical extrapolation of a plot of piezometric elevation versus reservoir elevation. An example of such a plot is shown on figure 8-8, where the piezometric elevations at both the emergency spillway crest and at the top of dam are estimated. Obviously, this method cannot be used until enough piezometer readings at various pool levels have been obtained to permit reliable extrapolation of the data. Readings taken at initial pool levels may need to be disregarded until the plot takes on a linear trend, such as when a minimum pool level is required either to fully charge the dam foundation or to overcome regional artesian pressure in the foundation.

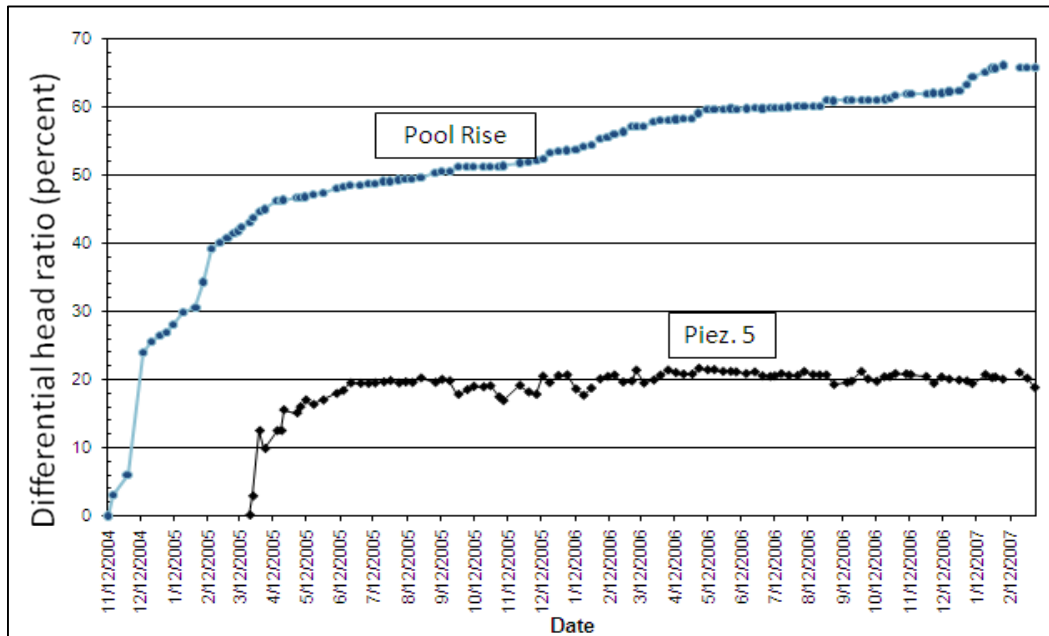
Figure 8-10.—Differential head ratio versus time for a piezometer during first filling (vertical axis units for “Pool Rise” curve are in feet.)

On figure 8-10, a plot of DHR (as percent) versus time for an actual piezometer (piezometer 5) is shown for the first filling of a reservoir. Once a certain reservoir level was reached and the foundation was fully charged, it can be seen that the DHR remained relatively constant at about 20.4 percent. The variation in the data may be the result of such environmental factors as precipitation and barometric pressure fluctuations. For a top of dam elevation of 302.5 and a corresponding tailwater elevation of 244.0, the piezometric elevation in piezometer 5 when the pool is at the top of dam is calculated as follows:

$$\text{Piezometric elevation} = (20.4/100) (302.5 - 244) + 244 = 255.9$$

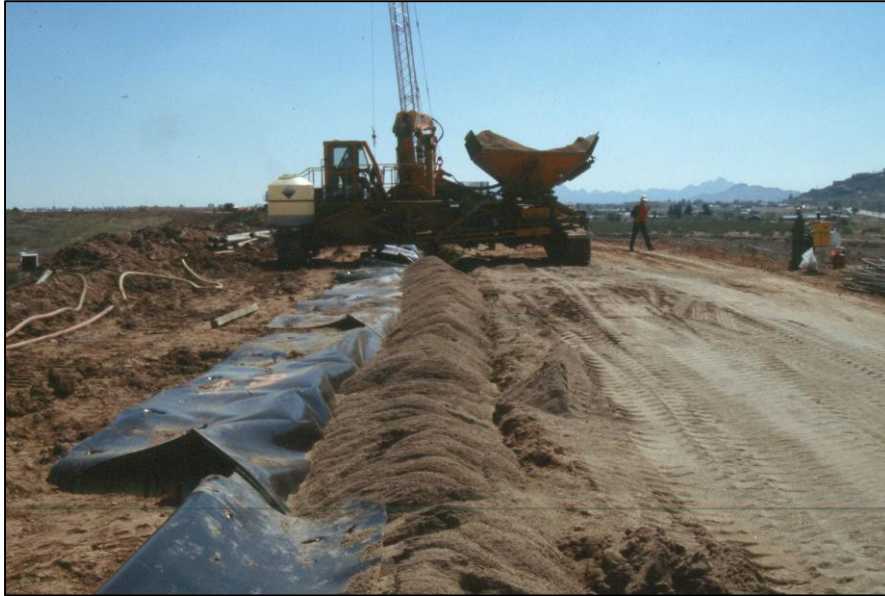
Figure 10-1.—Geomembrane cutoff with sand filter on Reach 11 Dike, Arizona.
(Photo courtesy of Reclamation)

Reclamation constructed a geomembrane cutoff wall at Reach 11 Dikes⁵ in Arizona. The cutoff consisted of both an impermeable barrier and a sand filter to mitigate the potential for internal erosion failure of the cracked flood protection dikes (figure 10-1). A trench was excavated

through the crests of the embankments, supported by biodegradable slurry. Stiff geomembrane panels of 80 mil high-density polyethylene were lowered into the trench. Interlocks similar to those on sheet piles enabled the construction of a continuous wall. The trench was then backfilled with filter sand (by tremie pipe) as an extra measure of protection against internal erosion. In principle, the biodegradable slurry completely decomposes and leaves no trace of an impermeable filter cake, thus permitting a filter to be an effective second line of defense. Since Reach 11 is a flood control feature, it is not loaded on an annual basis. As of the preparation of this manual, the structure had not been loaded; therefore, the performance of the repair has not been evaluated.

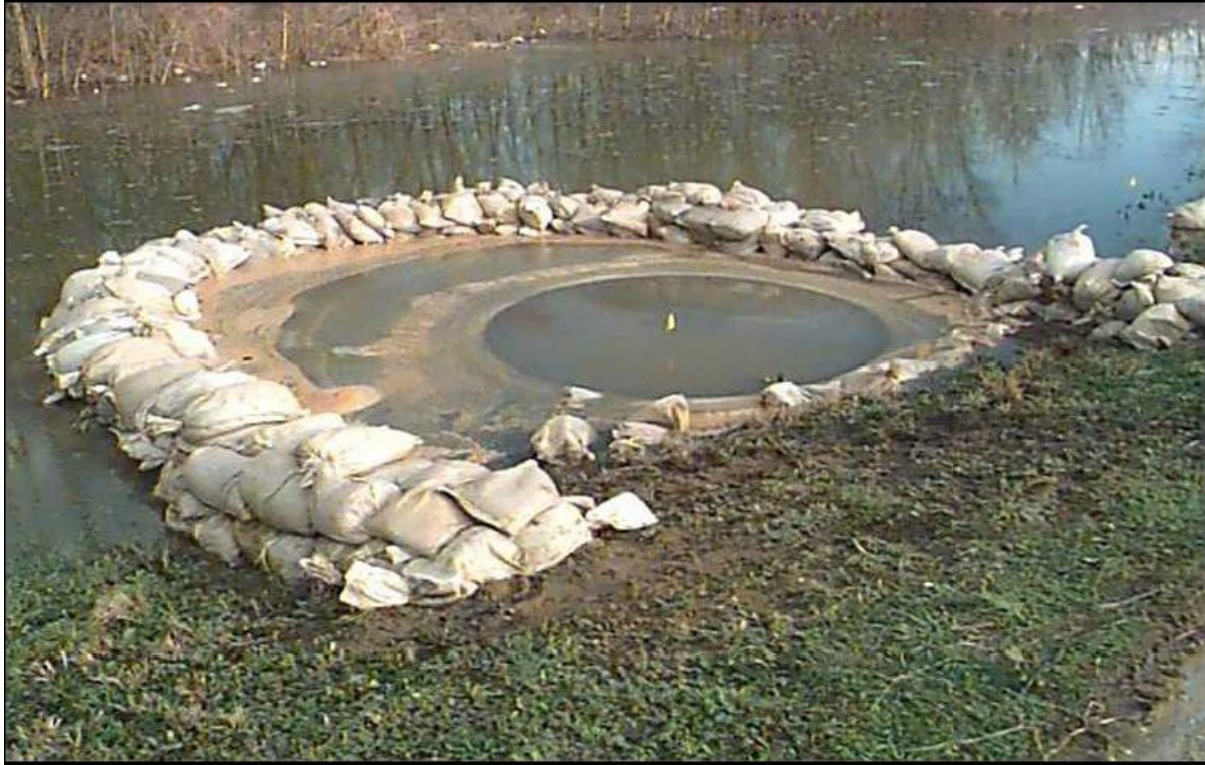
Figure 10-14.—Sandbags placed around a sand boil to increase tailwater level as part of a temporary risk reduction measure. (Photo courtesy of USACE, Missouri Valley Division)

Increasing the tailwater level on the downstream side of a dam reduces the potential for piping by decreasing both the exit gradient in the downstream area as well as the overall gradient under the embankment. Placing sandbags around a sand boil to elevate the tailwater level on the boil (figure 10-14) is a common flood-fighting practice. If the outlet channel of a dam is a critical location for uplift, then installing a hydraulic structure in the channel to permanently raise the water level can be a non-invasive, low-cost measure to control uplift. The effects of greater submergence on the conduit and any outlet structures must be considered in the remediation design. The water control structure must also be designed to survive the highest flows to which it may be subjected.

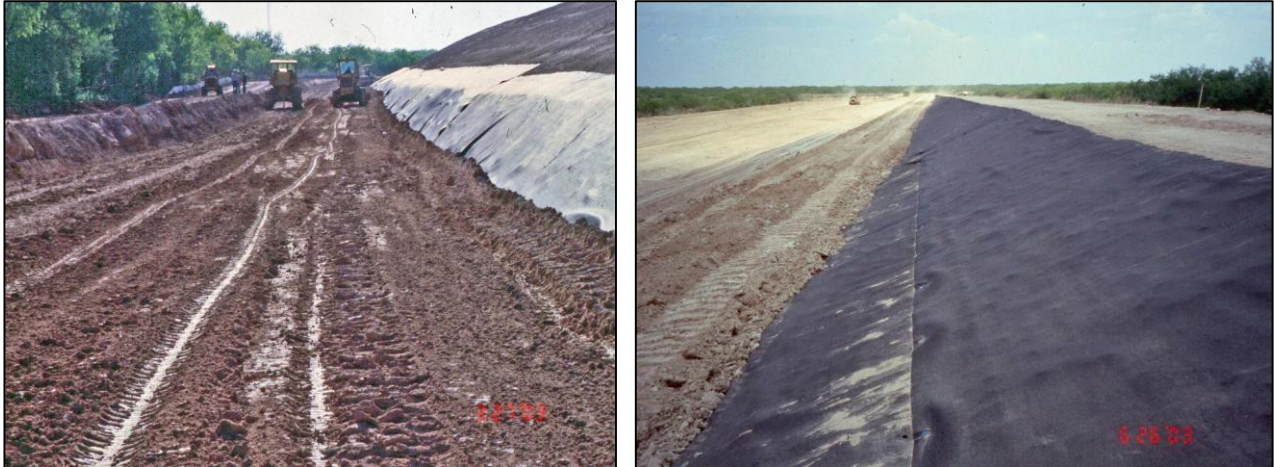
Figure 10-18.—Construction of geotextile barrier in Olmitos-Garcias No. 2 Dam in south Texas. The downstream side of the embankment is shown. Left – geotextile being backfilled in foundation trench. Right – geotextile on back slope of dam prior to backfilling. (Photos courtesy of NRCS, Texas)

Under certain circumstances, barriers for remediation have also been constructed using geotextiles in place of granular filter materials (Doerge 2010). If a geotextile is used as the sole element in the barrier, then it must be designed to be able to span any open cracks in the fill. Figure 10-18 shows a geotextile barrier under construction in the Olmitos-Garcias No. 2 Dam⁷ in south Texas. A heavy (16 ounce per square yard) non-woven geotextile was used in this project.

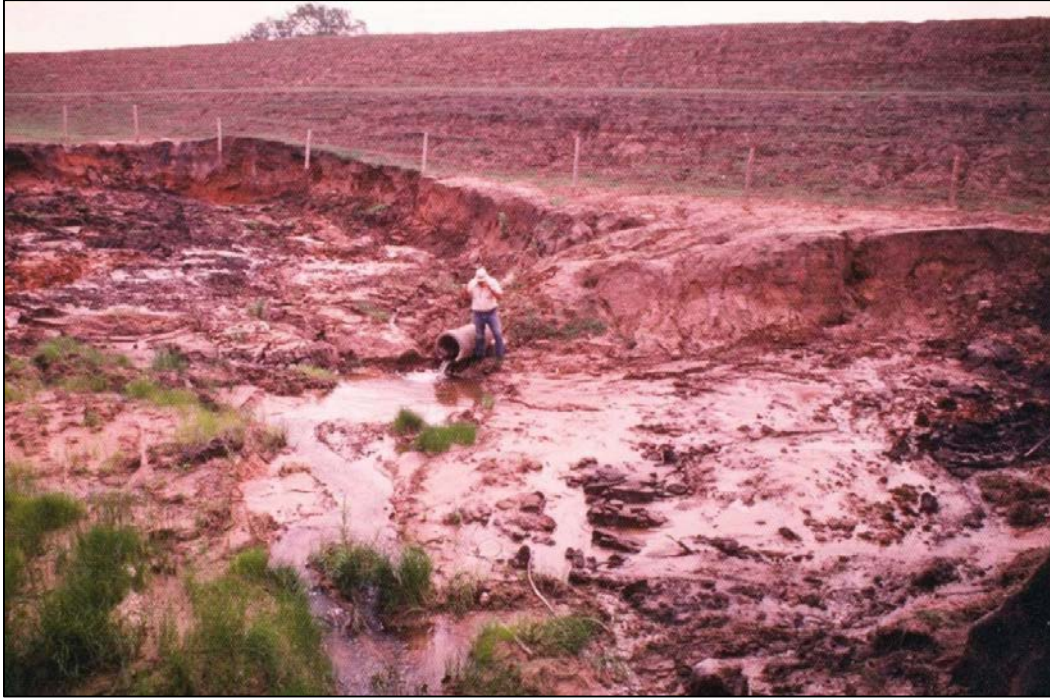
Figure 10-21.—Seepage-caused slope instability near outlet of principal spillway conduit, Little Washita No. 13, Oklahoma (1979). (Photo courtesy of NRCS, Oklahoma)

An example of a dam that was decommissioned to remediate seepage problems is Little Washita No. 13 Dam,¹⁰ a flood control dam in Oklahoma with gypsiferous foundation soils. The homogeneous earth embankment was 34 feet high and was constructed in the late 1970s. Following initial construction, the seepage resulting from the impounding of the reservoir began to dissolve the gypsum salts present in the foundation. This process greatly increased the seepage through the foundation and caused slope stability problems in the outlet basin and on the downstream slope of the embankment (figure 10-21). Various remedial actions were taken, including flattening slopes, installing drainage features, as well as several rounds of foundation grouting. The measures were temporarily effective, but the seepage problems reappeared following continued solutioning within the foundation. Sinkholes have been observed in the reservoir area on many occasions (figure 10-22). Finally, it was decided that the only permanent solution was to breach the dam and decommission it.

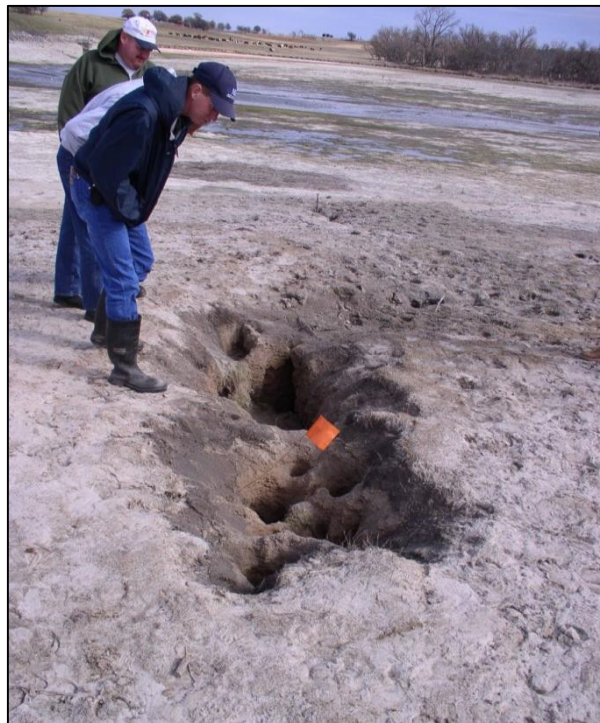
Figure 10-22.—Sinkhole in reservoir area of Little Washita No. 13, Oklahoma. (Photo courtesy of NRCS, Oklahoma)

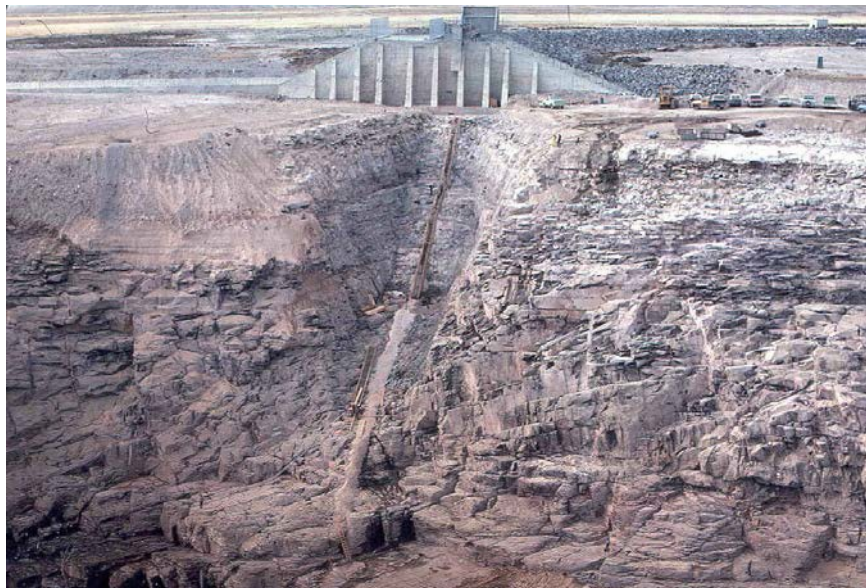
Figure 5.—Deep, highly fracture zone under the right abutment cutoff trench. Joints were generally open, some as much as 2 inches.

It is critical to recognize that the joints, fractures, and openings in the downstream wall of the cutoff trench and the remaining foundation downstream from the trench were severely incompatible with respect to filtering and retention of the very fine-grained, erodible core

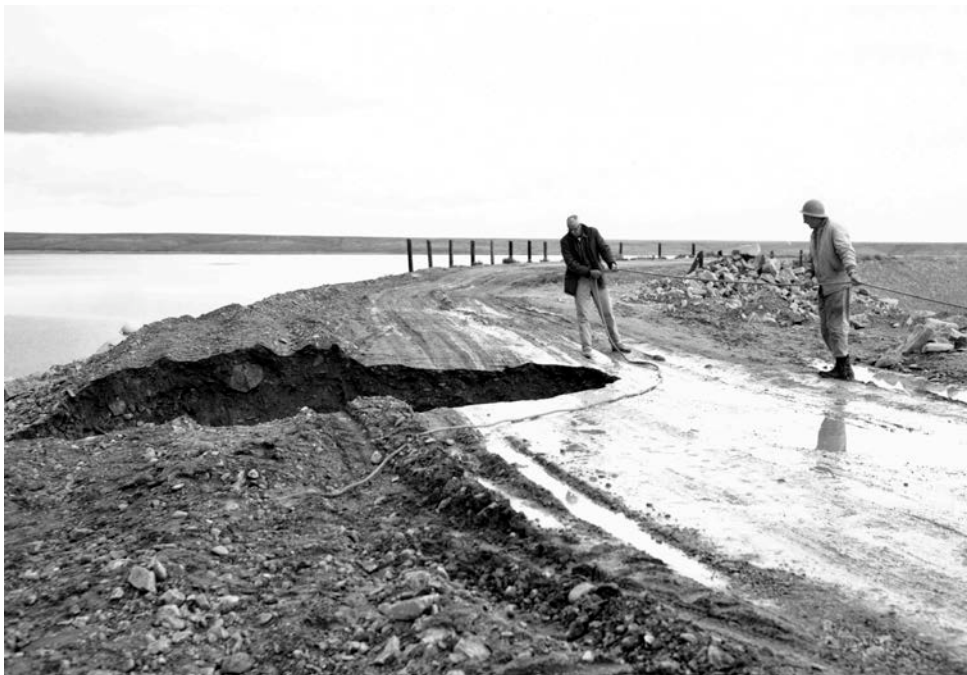
Figure 4a.—20-ft-diameter sinkhole on upstream side of dam crest. (Standing near the edge of a large sinkhole while hanging onto a rope is considered extremely dangerous and is not recommended.)

On the morning of September 6, the flow remained stable. However, later that afternoon, an area on the dam crest about 20 ft in diameter, with its center near the upstream edge of the crest, suddenly collapsed with a drop of approximately 33 ft (figure 4a). Bedrock was exposed on the abutment side of the newly created cavity, and water appeared to be issuing from cracks in the rock. Heavy rock was dumped into the hole to stabilize the area against further collapse (figure 4b). A cross section at the sinkhole locations is shown on figure 4c.

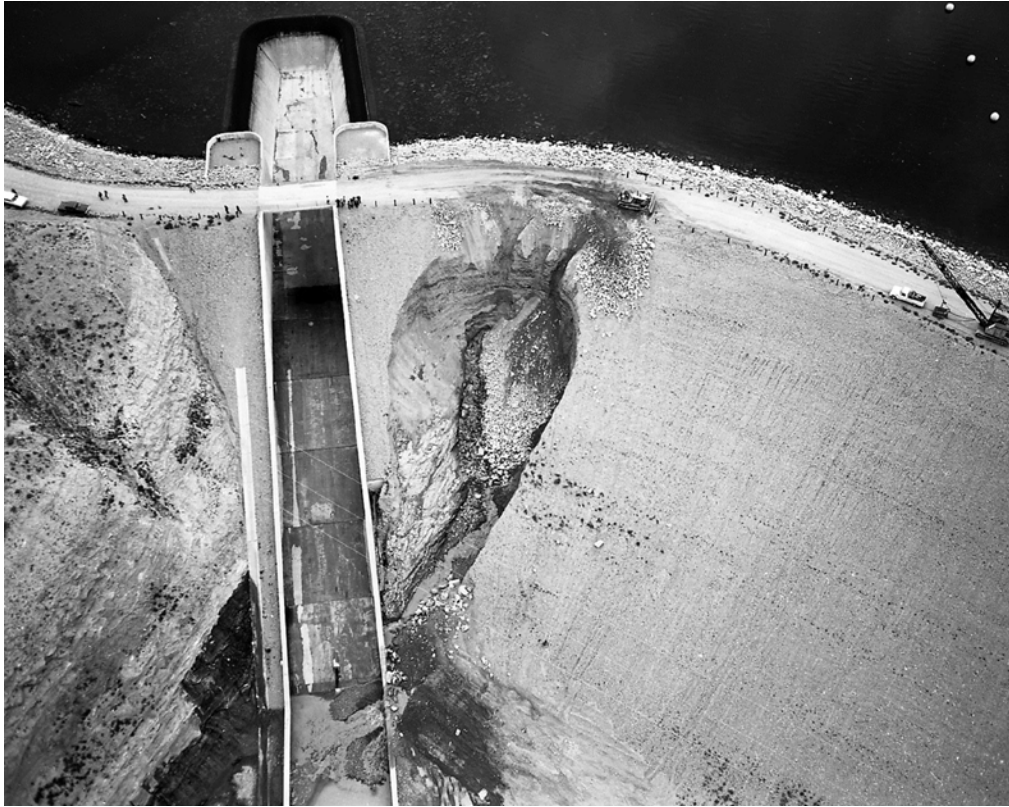
Figure 4b.—The sinkhole migrated in the upstream direction, expanding in size, as material progressively caved from the sides and was washed out of the bottom (stopping).

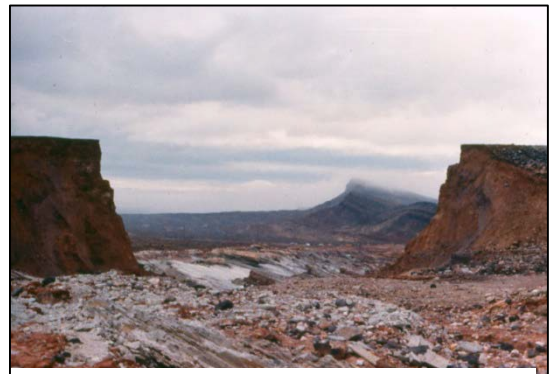
Figure 1b.—Breach through Quail Creek Dike.

The maximum height of the dike is about 78 ft with a crest width of 20 ft and an overall length of about 1,980 ft. The breach was approximately 140 ft wide and 80 ft deep (figure 1b). The foundation for this earthen dam consisted of dipping beds of sedimentary rock that strike almost perpendicular to the axis of the dike (figure 2). The construction of Quail Creek Reservoir took place in 1984, about 8 yr after the failure of Teton Dam, yet there were few additional measures taken to address the potential for concentrated leakage from constructing an earthen embankment on a rock foundation. The dam was constructed as a zoned earth embankment with a 10-ft cutoff trench (figure 3).

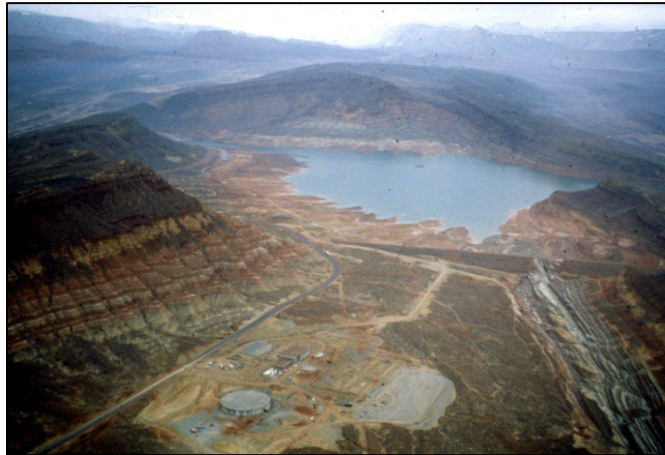
Figure 2.—The breach of the dike is located on the right limb of a large anticline where the rock outcrop extends beneath the dam in an upstream- downstream orientation.

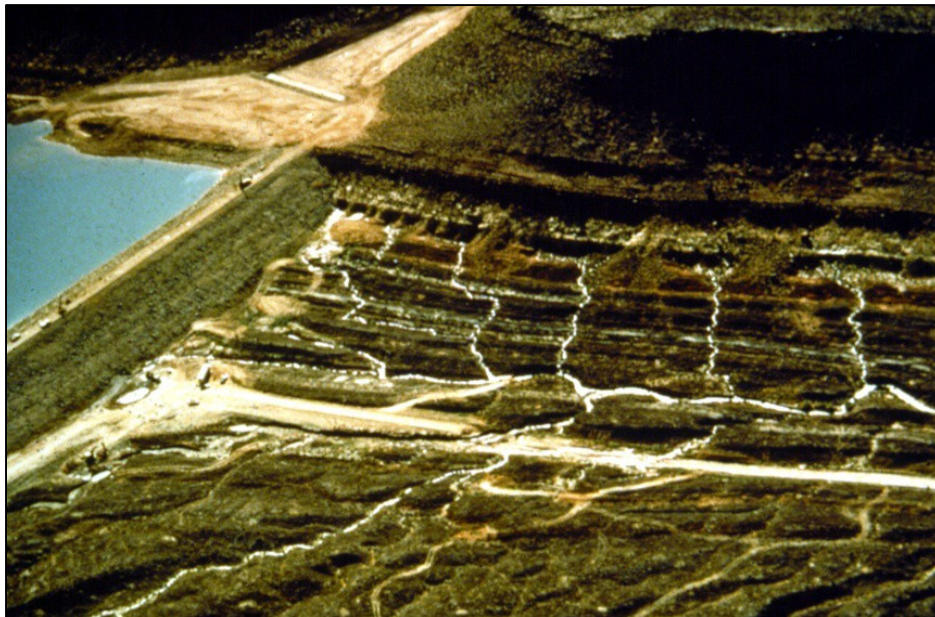
Figure 5.—Excessive leakage during first filling.

Foundation grouting was the selected remediation after excessive leakage occurred during first filling in 1985, 4 yr prior to the breach (figure 5).

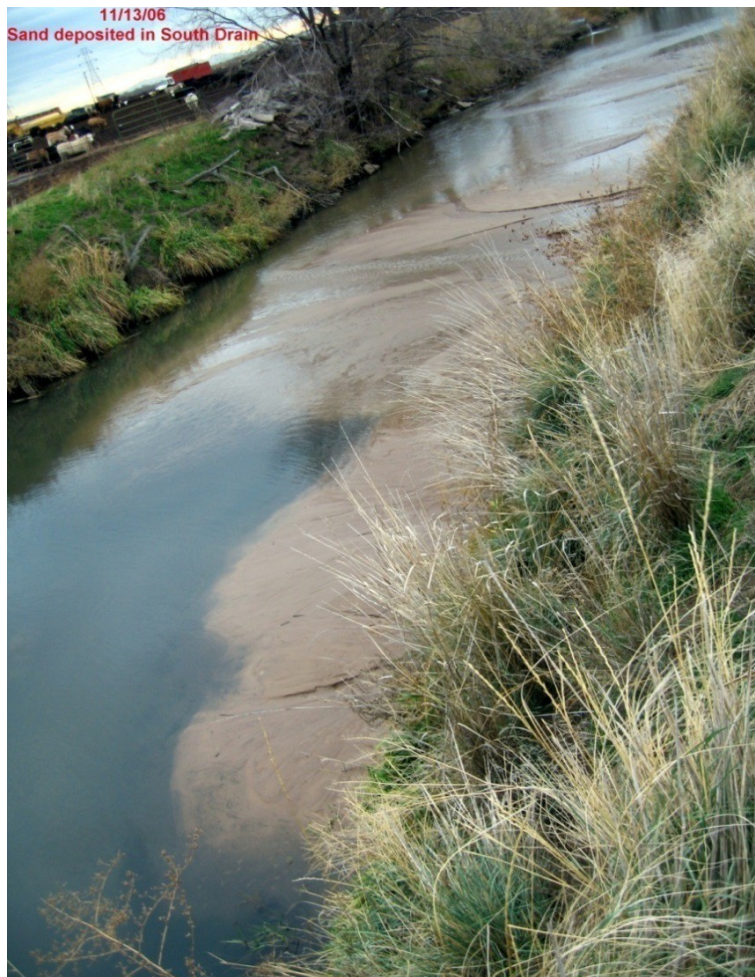
Figure 3.—Eroded sediments in South Drain first noticed by neighboring landowner.

In November 2006, a local landowner riding a horse noticed seepage and soils exiting from the cut slope of the South Drain. He called authorities, and Reclamation began emergency drawdown of the reservoir and 24-hr monitoring. Figure 2 illustrates the failure mode that was in progress when the first responders arrived, and figure 3 shows sediments eroded into the South Drain. Figure 4 is an aerial view of the western portion of the dam that indicates the incident location.

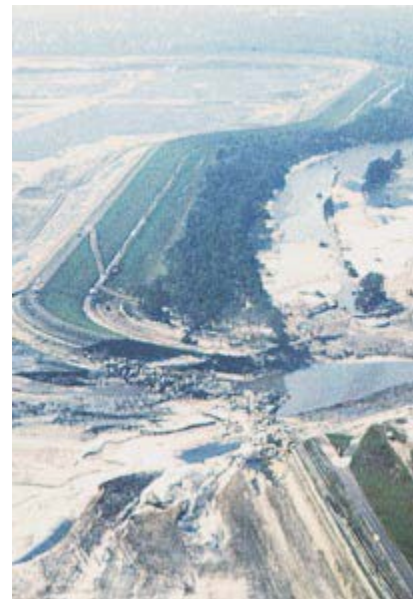
Figure 5.—Same area after breach.

Important to note is the presence of a railroad borrow pit and the L65 Canal in the southwest quadrant of the project site. The layout of these features, and the breach that occurred there, are shown on figures 4 and 5.

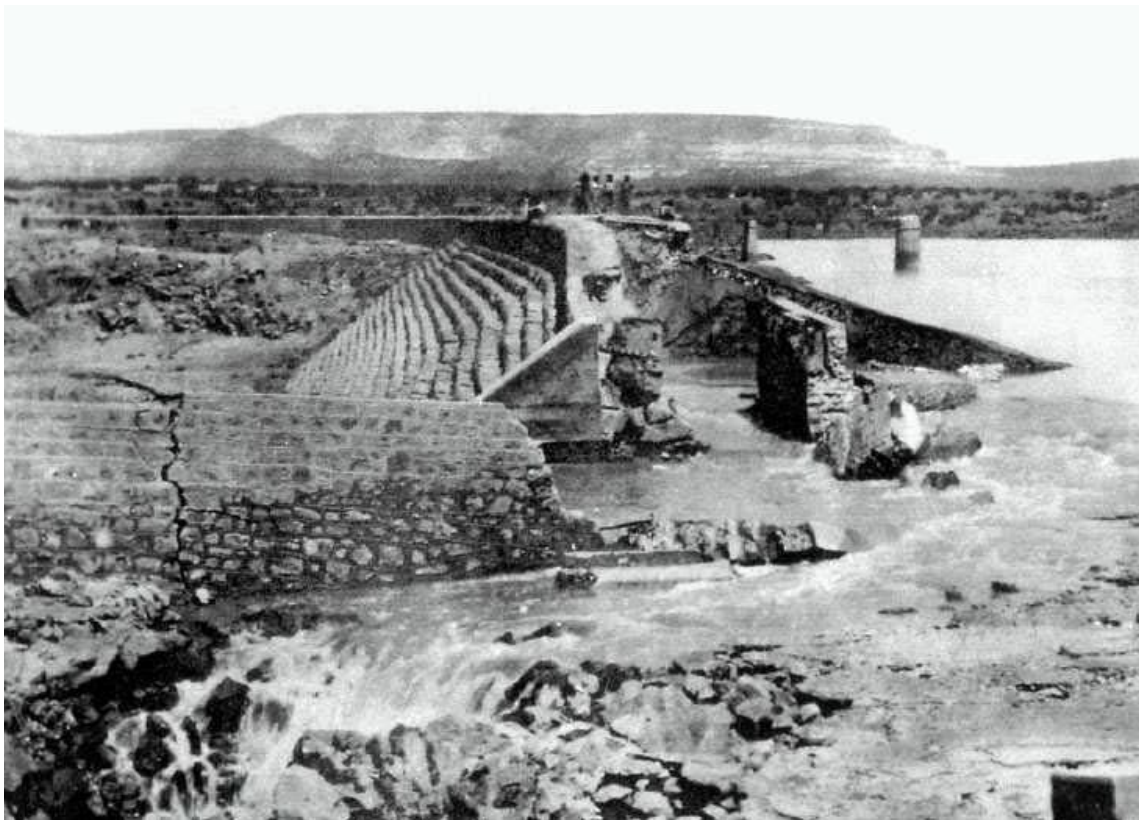
Figure 2.—Black Rock Dam near failure, 1909; spillway is in the foreground.

Seepage of reservoir water through fractures in the basalt in the upper portions of the abutments, and the subsequent erosion of underlying soil, had caused near failure of the dam on at least two occasions (figure 2). Preventing water from entering the basalt is a key consideration for improving the safety of the dam. The left and right abutment stratigraphy is similar and consists of several feet of eolian silty sand deposits over 15 to 30 ft of fractured basalt, over interbedded alluvial sands and gravels, and clays (figure 3). At normal storage levels, most of the basalt is exposed to reservoir water. The valley between the abutments was eroded into the material below the basalt.

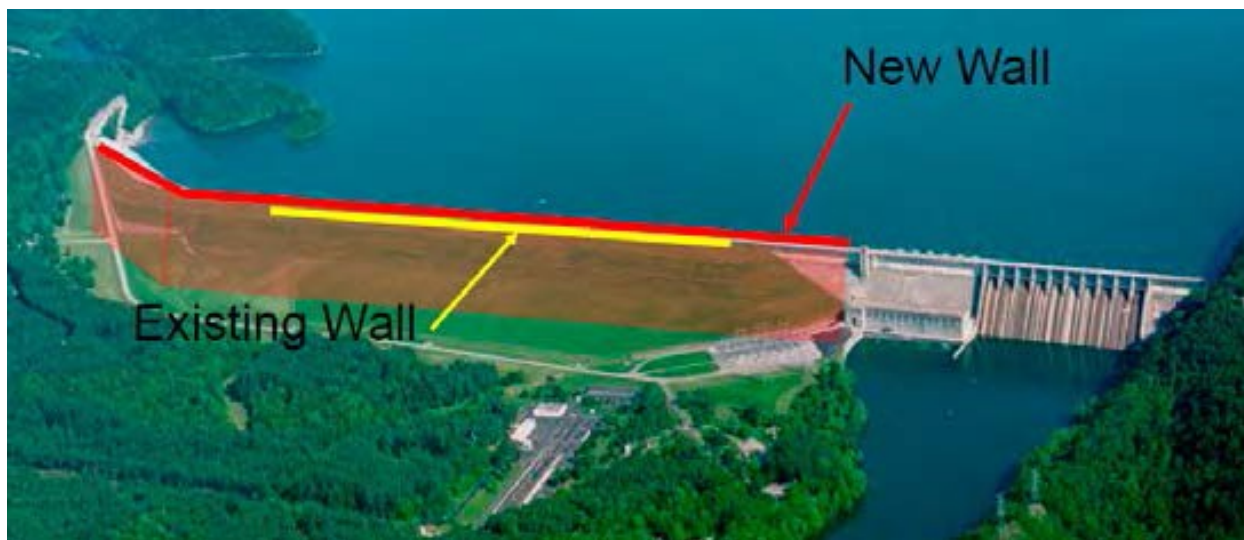
Figure 2.—Overall view of the dam showing extent of the existing and new cutoff walls.

turbines rated at 45,000 kW each. From the end of the concrete gravity section, a non-zoned compacted clay embankment with a maximum height of 215 ft above top of rock extends 3,940 ft across the valley to the right abutment. U.S. Highway 127 traverses the dam. There are limited outlets (six penstocks and six sluices) for emergency drawdown of the reservoir. An overview of the dam is shown on figure 2.

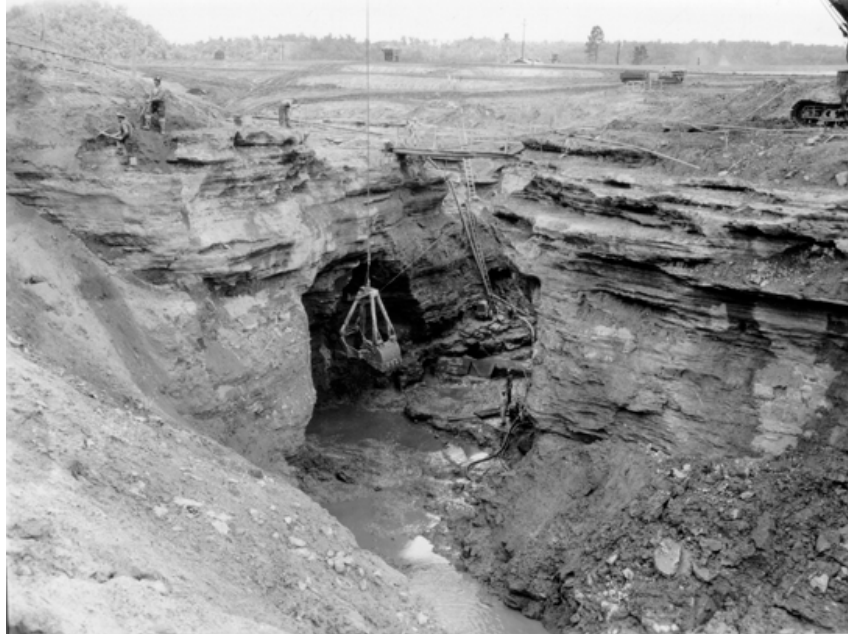
Figure 3.—View of solution feature in cutoff trench excavation.

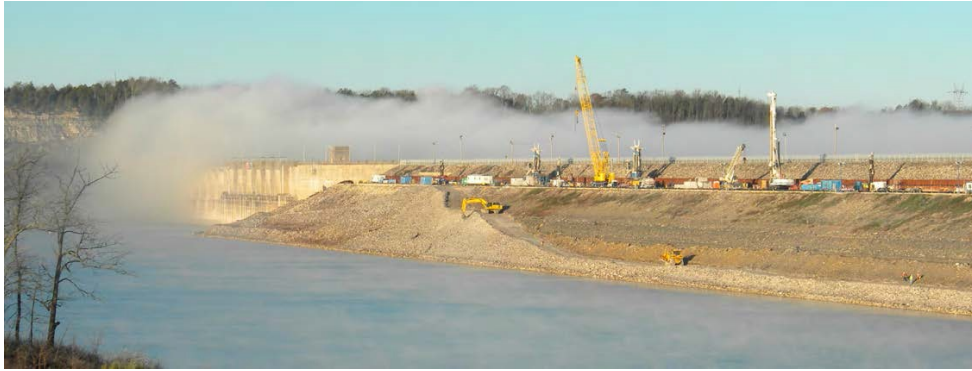
Figure 6.—View of working platform on upstream slope.

The new wall is being installed from a work platform constructed on the upstream face of the dam as shown on figures 6 and 7. The top elevation of the platform is 750 ft, and the design depth of the wall is to elevation 475 ft, making a total depth of wall in embankment and foundation rock of 275 ft. As much as 110 ft of that length is in the limestone foundation.

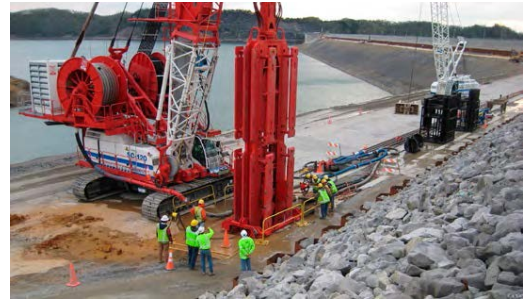
Figure 9.—View of hydromill construction.

To protect the earth embankment against the effects of construction activities, a 6-ft-wide protective concrete embankment wall was first constructed along the entire length of the embankment as shown on figure 8. Ranging from 110 to 225 ft deep, this wall was installed through the embankment and keyed 2 ft into rock. It is 40 ft upstream of the original wall completed in 1979 and defines the alignment of the new barrier wall. This wall was built in 9-ft segments using a hydromill as shown on figure 9.

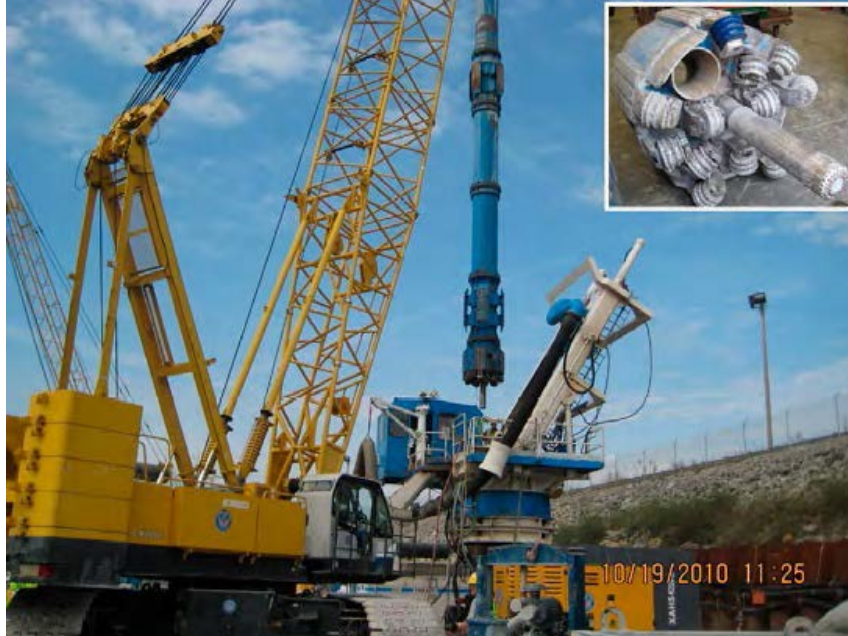
Figure 12.—Secant pile wall construction with reverse circulation drill.

From the bottom of the embankment wall, reverse circulation drill rigs drill the remainder of the 50-in-diameter piles into the underlying limestone rock as much as 100 ft for total wall depths reaching 275 ft as shown on figure 12.

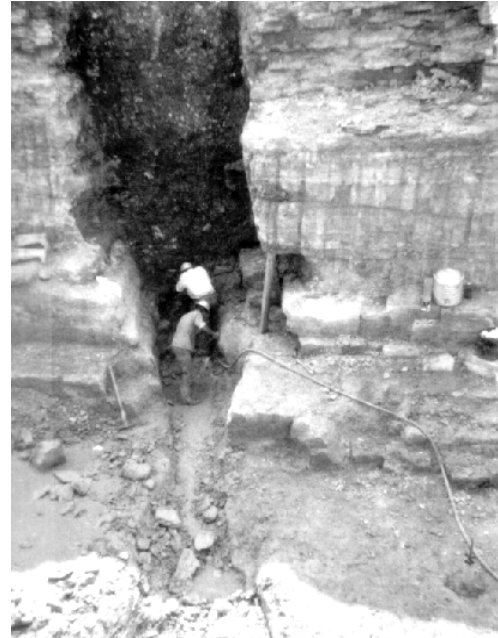
Figure 4.—View of solution feature in cutoff trench of the left abutment.

In response to the solution channel found in the conduit excavation, a 30-ft-wide cutoff trench was added to the design. In October 1964, the cutoff trench was begun between dam centerline Sta. 50+80 to Sta. 57+50 and excavated 7.0 ft into bedrock. In addition, the solution channel uncovered during conduit construction was excavated on both sides of the conduit and was found to be over 600 ft long (figure 4) and at an approximate 15-degree angle to the dam centerline. A second solution channel of similar vertical depth was excavated for nearly 200 ft before exiting the side of the vertical bedrock face. All exposed solution channels were blasted, cleaned, filled with concrete, and topped with select fill. After these large solution channels were uncovered, the original cutoff trench was extended to Sta. 75+00. This trench extension was 15.0 ft wide down to top of rock with no removal of weathered rock. No further solution channels were uncovered.

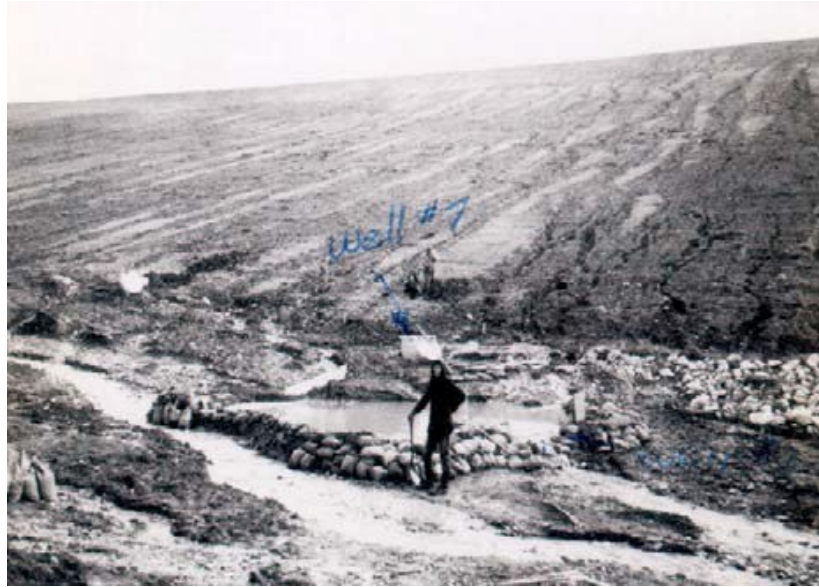
Figure 5.—Conditions during the boil event of 1966.

During the course of 2 weeks, the pool reached its highest elevation to that point (elevation 741.9), and the boil had become 12- to 14-in diameter. During this time, muddy water and mud balls ranging from a 3/8- to 1/2-in diameter were carried by a flow of 20–25 gpm (figure 5). Seepage was also noted in a gravel pit located approximately 400 ft downstream from the embankment toe. An area of approximately 2 acres on the right riverbank about 700 ft downstream from the toe was saturated with seepage water.

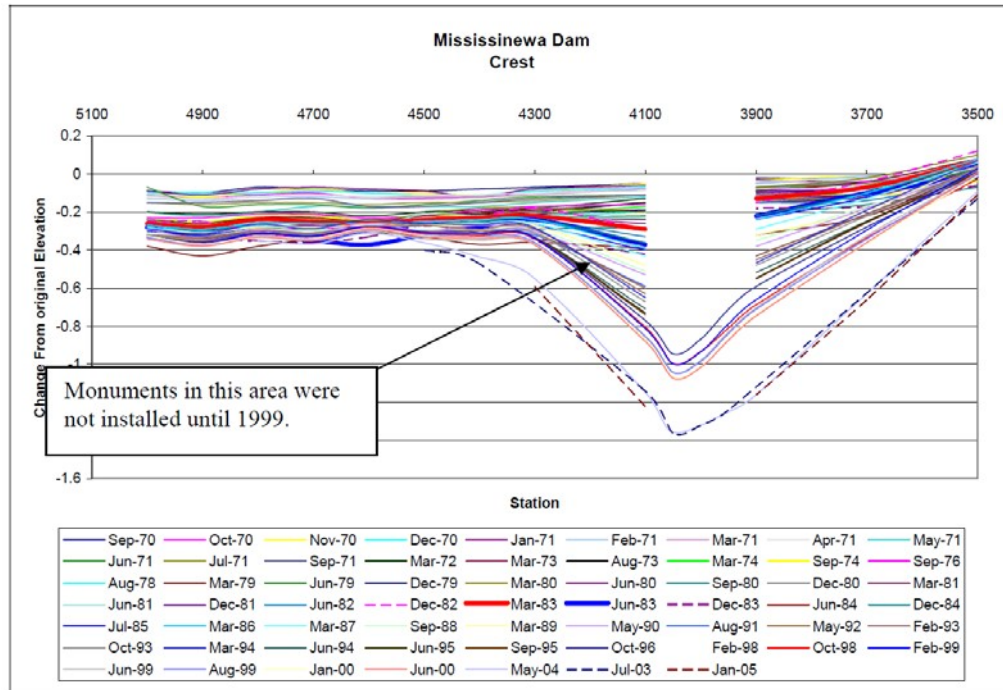
Figure 6.—Plot of survey elevations showing reach of high differential settlement.

along the county road on the crest had a slight dip in it. This area was surveyed and inspected and was in fact significantly lower than the rest of the crest. This area of differential settlement was contained in a 400-ft stretch between Sta. 38+00 to Sta. 42+00. By 1999, a total of 0.85 ft of settlement had been experienced in the area, as compared to the 0.25 ft of post-construction settlement in the rest of the crest (figure 6). Also by 1999, two slope inclinometers, which had been placed in the settlement area to capture lateral movement, had been destroyed (figure 7). The instruments had been crushed by internal stresses developing in the embankment due to the settlement and deformation.

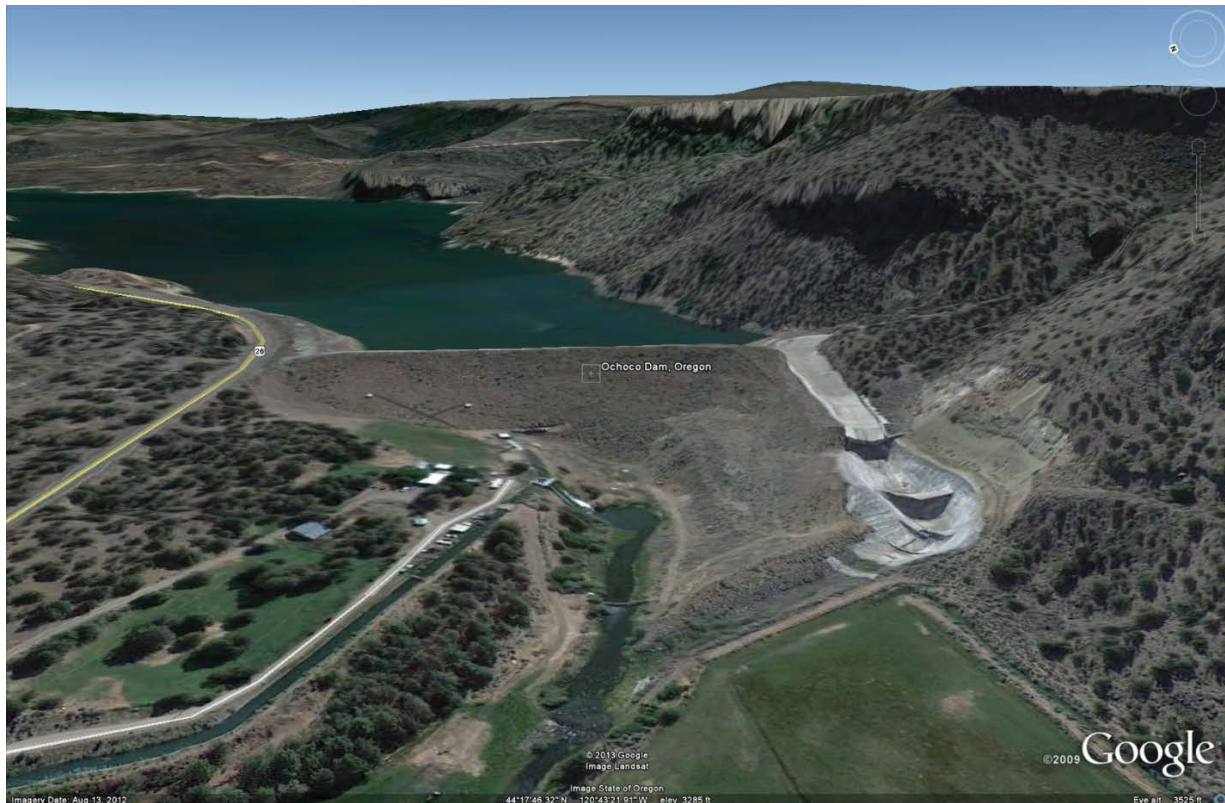
Figure 1.—Oblique view of Ochoco Dam, Oregon.

Ochoco Dam impounds a 46,500-acre-ft reservoir on the Crooked River near Prineville, Oregon (figure 1). The dam was constructed of hydraulic fill from 1918 to 1920. The dam is 120 ft high and 950 ft long with an inlet-tower and a cut and cover tunnel outlet works arrangement. An excavated, uncontrolled, concrete-lined emergency spillway is provided on the left abutment adjacent to the fill section. The left abutment is composed of alluvial fan/talus complex, and the right abutment and center-right portions of the dam were founded on an ancient landslide complex. The landslide complex contains open joints in rock blocks and coarse, open-work rubble zones with voids varying in size from 1/4 to 6 in and free of infilling. Post-construction excavations into the dam confirmed the dam was constructed with a fine-grained, laminated puddle core with an interlayered sand and gravel shell on the downstream side of the core. Outer zones of the embankment fill contain coarse-grained rock from 3- to 12-in diameter.

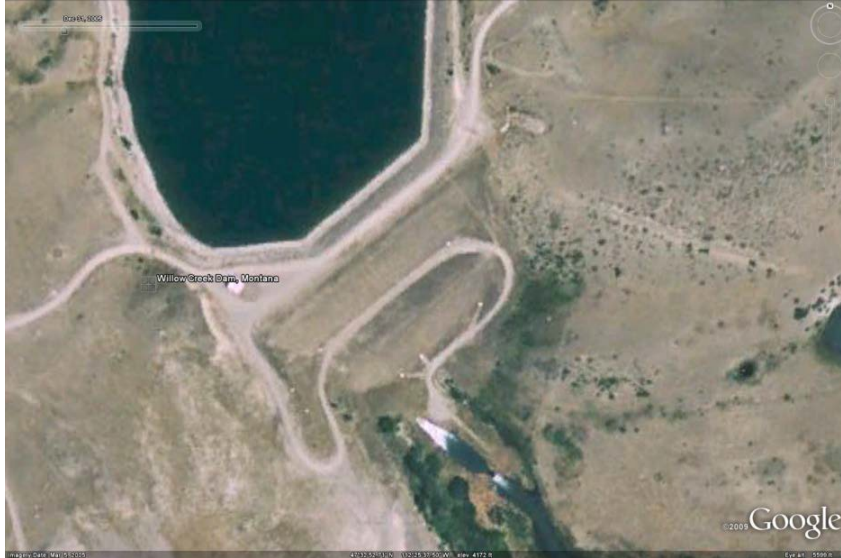
Figure 2.—Willow Creek Dam after 1996 and 2000 repairs (Google Earth, December 31, 2005).

Dam safety modifications were completed in 1996 and 2000. The 2000 modifications included removal of the downstream rockfill slope protection, excavation of potentially liquefiable foundation materials at the downstream toe, and construction of a downstream filtered berm buttress with toe drain system to control seepage and reduce liquefaction concerns during a major seismic event. The downstream face of the modified dam now has a grass cover, with a slope of 2H:1V above and below the top of the berm, at elevation 4116.0 (figure 2). A portion of the downstream tunnel was lined with CIPP in 1997 following a piping incident (see below). A new air vent pipe and concrete gate house were also provided for the outlet works at that time.

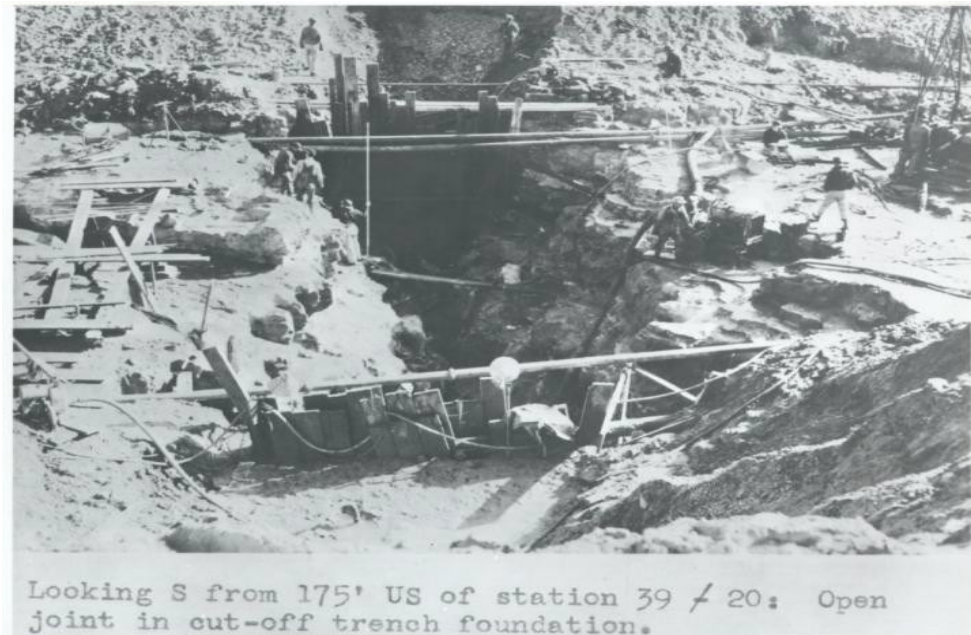
Figure 3.—Solutioned dolomite observed in cutoff trench.

Clearwater Dam is located on the Black River in Wayne and Reynolds Counties in southeast Missouri (figure 1). It is a 154-ft-tall and 4,225-ft-long embankment dam that was completed in 1948 (figure 2). During construction, a cutoff trench was excavated to the foundation rock. Some large solution features (figure 3) were revealed and treated with dental concrete and grouting. Only the rock in the cutoff trench was exposed and treated.
