Evaluation and Monitoring of Seepage and Internal Erosion

Interagency Committee on Dam Safety (ICODS)

FEMA P-1032 / May 2015

Federal Emergency Management Agency

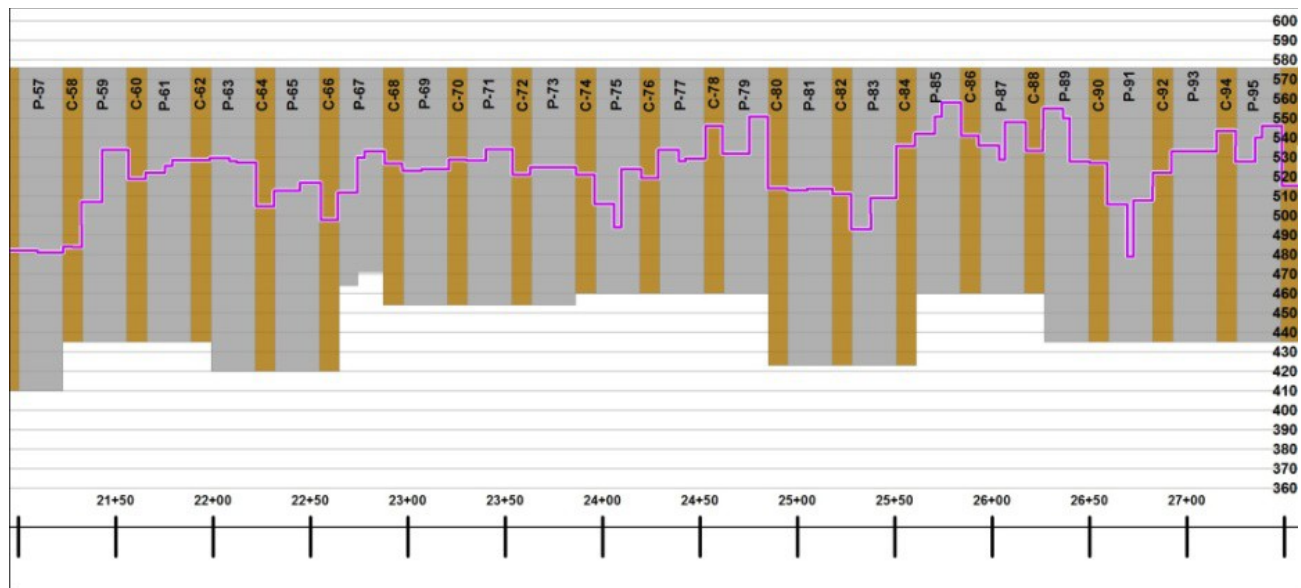
Figure 8.—Total depths for installed cutoff panels.

The concrete cutoff wall was placed along the centerline of the dam using a hydromill, at a total depth of 230 ft over a length of 4,300 ft of the dam, with a minimum 6-in overlap between panels (figures 7 and 8).

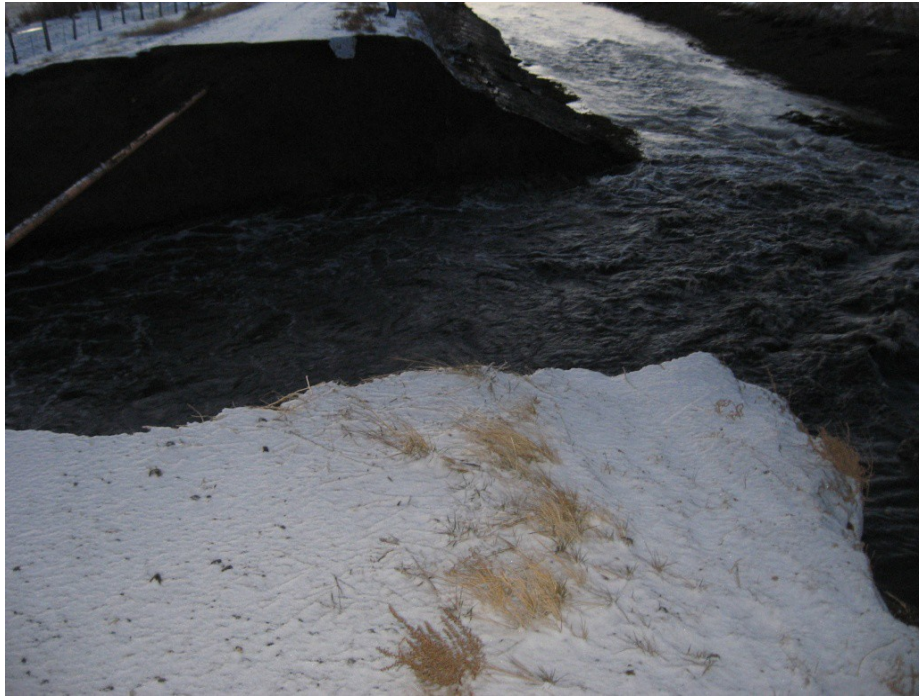
Figure 5.—Earliest photos showing breach (estimated time about 6:30 a.m. on January 5, 2008) (photos by Walt Winder, TCID).

Based on the verbal report of the project engineer, the dimensions shown on figure 6 were substantially wider than that first noticed upon his arrival at the breach site at least 45 minutes after the breach had occurred (figure 5), which would suggest the widening to the final size occurred sometime between 4:45 and 6:30 a.m.

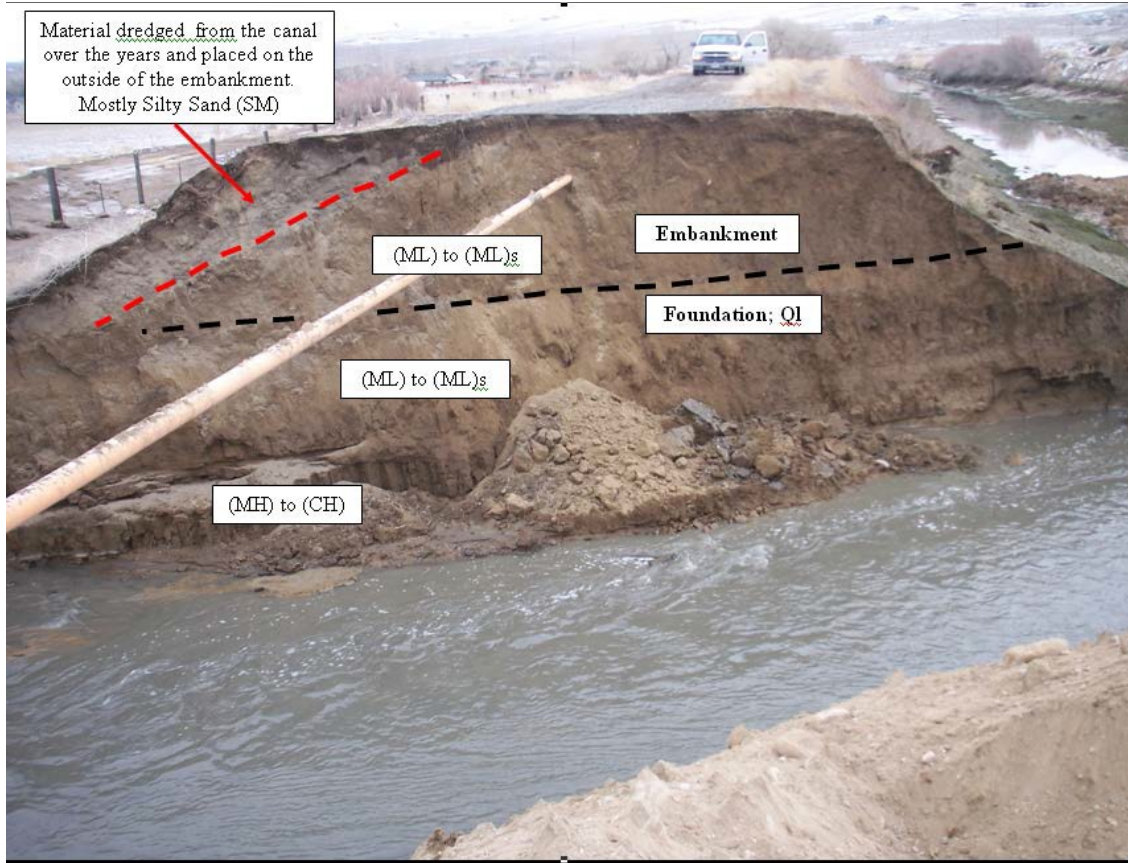
Figure 7.—Downstream view of the Truckee Canal breach. Dashed, black line is the approximate contact between the canal embankment and in-place lakebed deposits (Q1) composed primarily of silt with sand (ML)s and elastic silt (ML) with minor sandy lenses. Center-left is an abandoned Sierra Pacific Power gas pipeline.

noted during recent geologic studies, it appeared that some material had been excavated from within the canal over the last 100 yr and deposited on the crest and landside slopes of the embankment (noted as “dredged” materials on figure 7).

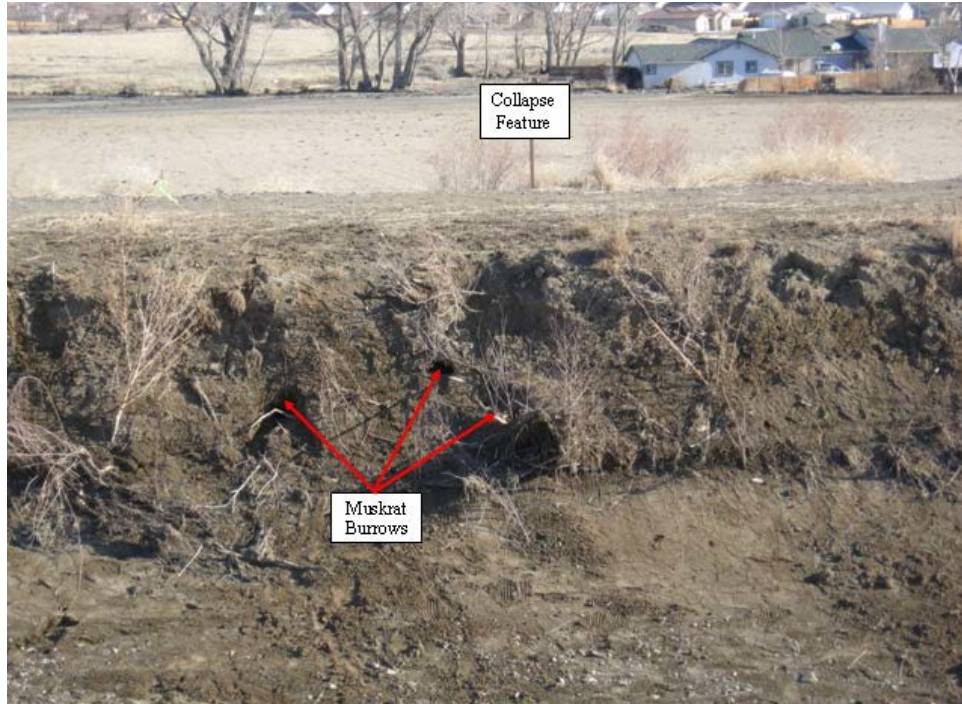
Figure 11.—View of canal embankment prior to investigations showing three muskrat burrow entrances on the waterside and the location of a collapse feature (feature not visible) on the landside. The burrow entrance appeared to be located a foot or so below the approximate 350 ft³/s flow line.

A few days after the breach, an informal inspection of the canal embankment revealed a series of animal burrows located a few hundred feet downstream from the breach. A tape inserted into one of the burrows penetrated to an approximate horizontal distance of 11 ft. On the landside of the canal, almost directly across from the burrow, a fresh delta of sand was found with a collapse feature noted on the canal face.

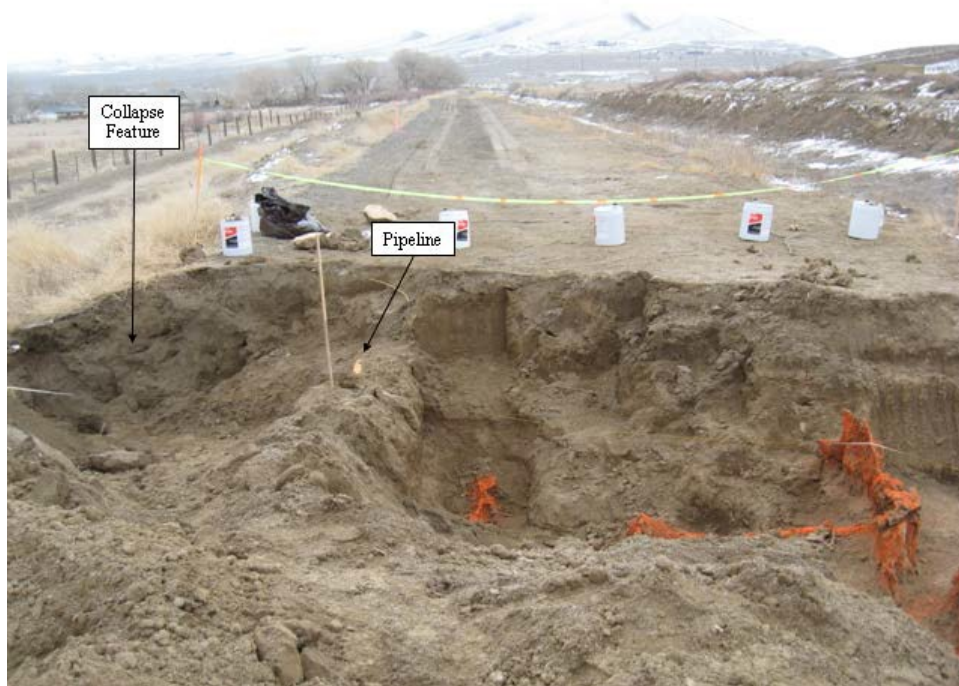
Figure 10.—View of partial excavations of canal embankment crest following grouting with Stratathane™. Features that were found grouted have been painted with orange paint.

To determine the conditions in the crest of the canal embankment, investigations conducted of the muskrat activity were documented in a report. As discussed in that report, a grout program was implemented that injected a Stratathane™ and water mixture under low pressure into the burrow area. The area was later excavated. Observations indicate that a “cast” of portions of a burrow warren had been made. It indicated that the series of burrows, dens, and voids had penetrated to within a few feet of the landside of the canal bank very close to the collapse feature area. From all of this, it can be reasonably surmised that the burrowing had been occurring in the months prior to the failure when the canal had been flowing at an approximately steady rate of about 350 ft³/s. When the canal flows were sharply increased the morning of January 5, the burrows would have flooded with a few feet of hydraulic head. This increase in water head likely caused concentrated seepage from the landside face of the canal embankment, which started the erosion process. The fresh deposit of sand below the collapsed feature and nearly directly in line with the animal burrows appears to be evidence that erosion had started. It is likely that the erosion would have progressed and caused a failure if the breach had not happened just upstream with the resulting drop in water surface.

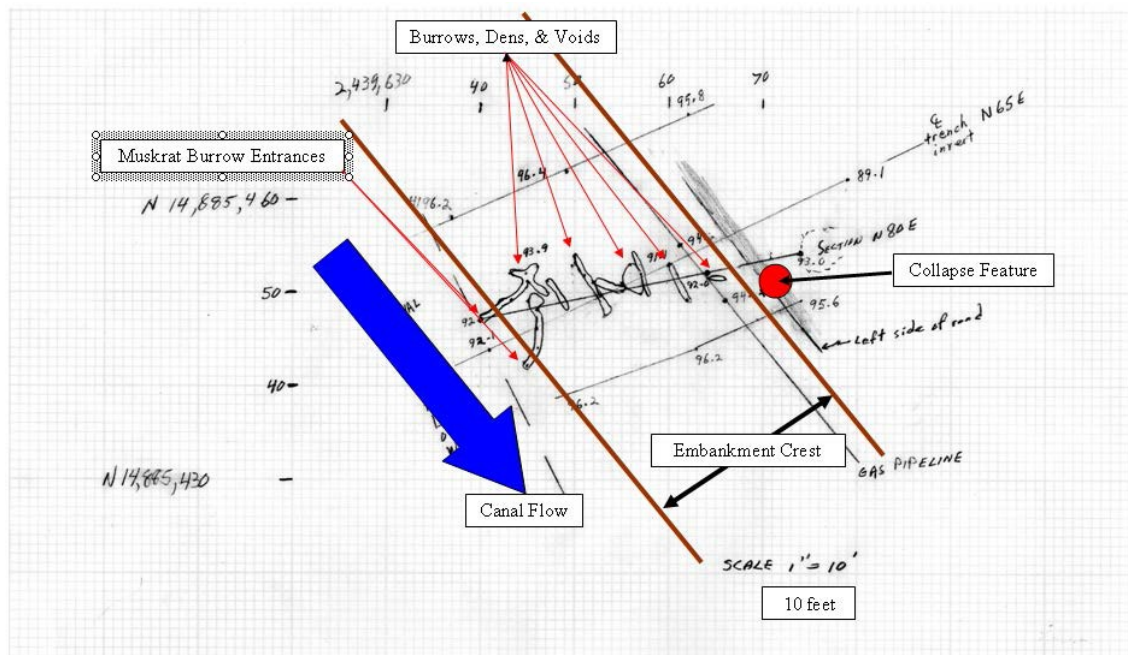
Figure 11.—Map of features found during muskrat investigations.

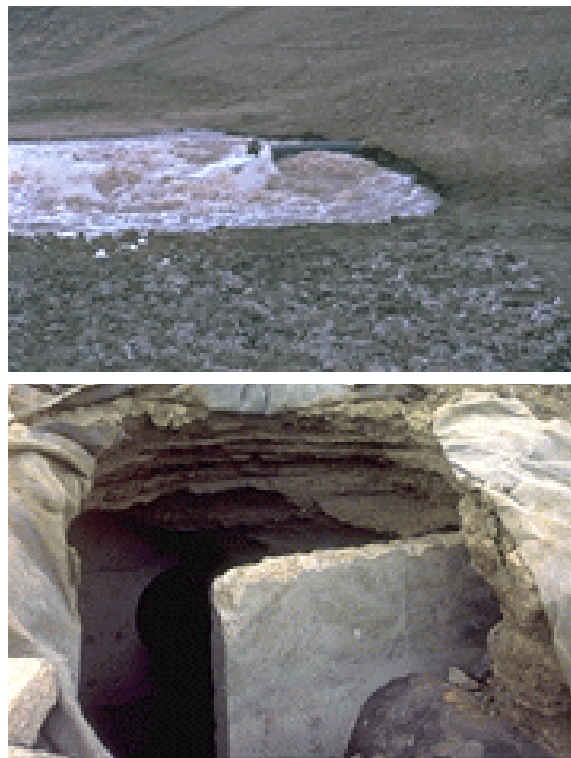
Figure 2.—Discharge of water from internal erosion adjacent to conduit (top photograph) and erosion of fill from around seep collars at upstream end of conduit (bottom photograph) taken after the reservoir emptied.

The reservoir is not on a live stream, and was anticipated to be filled over a 3-yr period. But a large snowpack and warm weather throughout the area and into Canada caused the reservoir to be filled in only 4 days. Before the principal spillway (a standpipe) began flowing, water piped through the embankment along the outlet works and caused rapid failure of the dam (figure 2). Although the embankment did not collapse, it was necessary to open the outlet gate and drain the reservoir. BLM personnel were onsite monitoring the situation until the reservoir was drained.

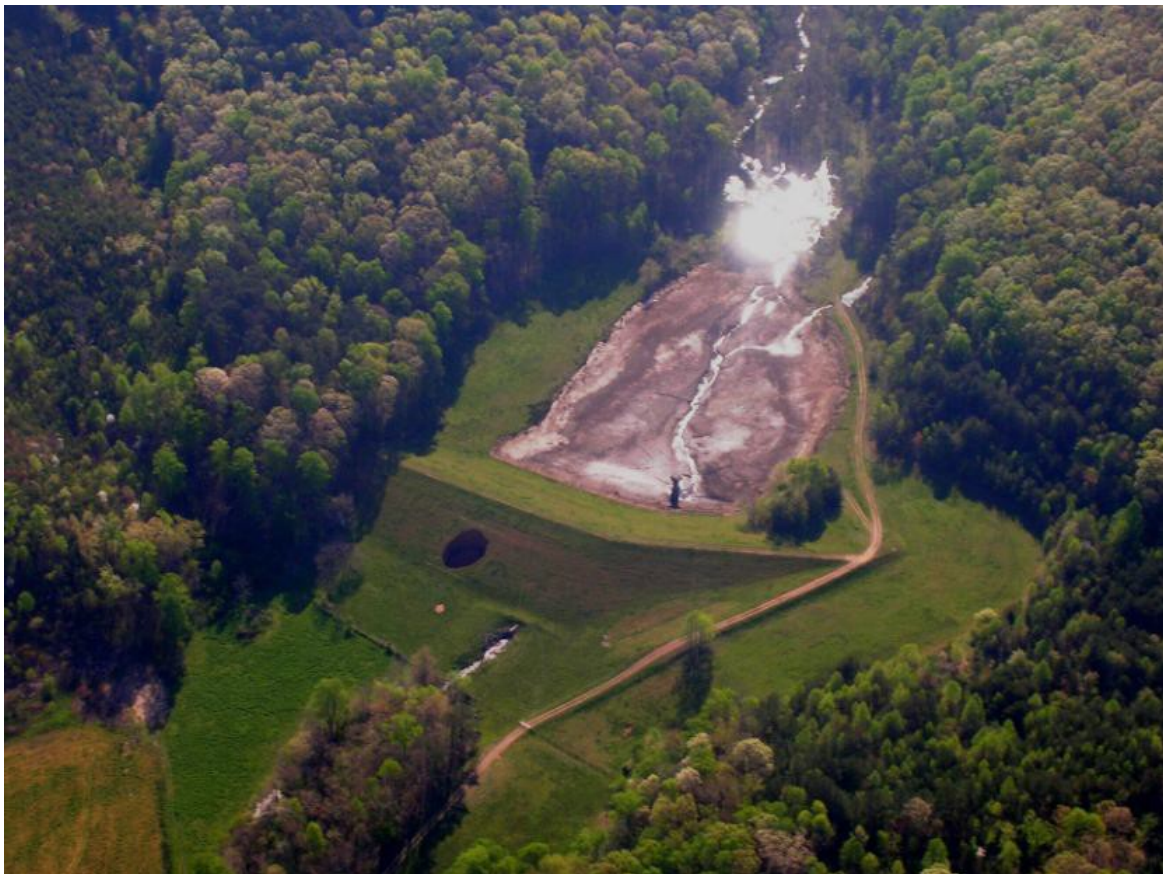
Figure 2.—Aerial view of the sinkhole on the downstream slope of the dam. Photo was taken after the reservoir had been drained.

After 35 yr of operation, a large sinkhole developed very suddenly on the downstream slope of the dam (figure 2). On April 10, 2008, the dam was observed to be in normal condition. On April 11, a landowner downstream from the dam noticed a large “brown spot” on the downstream slope of the dam near the eventual location of the sinkhole. On April 12, the presence of the sinkhole was confirmed. Upon examination of the structure by engineers and emergency personnel, the low stage gate was opened to drain the reservoir as a precautionary measure.

The sinkhole was approximately 65 ft in diameter and 40 ft deep. It was located about 100 ft to the right (looking downstream) of the principal spillway conduit. Groundwater was present in the bottom of the sinkhole, and the elevation of the bottom was several feet below the invert of the core trench and therefore was in in-place bedrock. The bottom of the sinkhole was about 10 ft below the collector pipe in the foundation trench drain. The pipe showed no signs of flow.

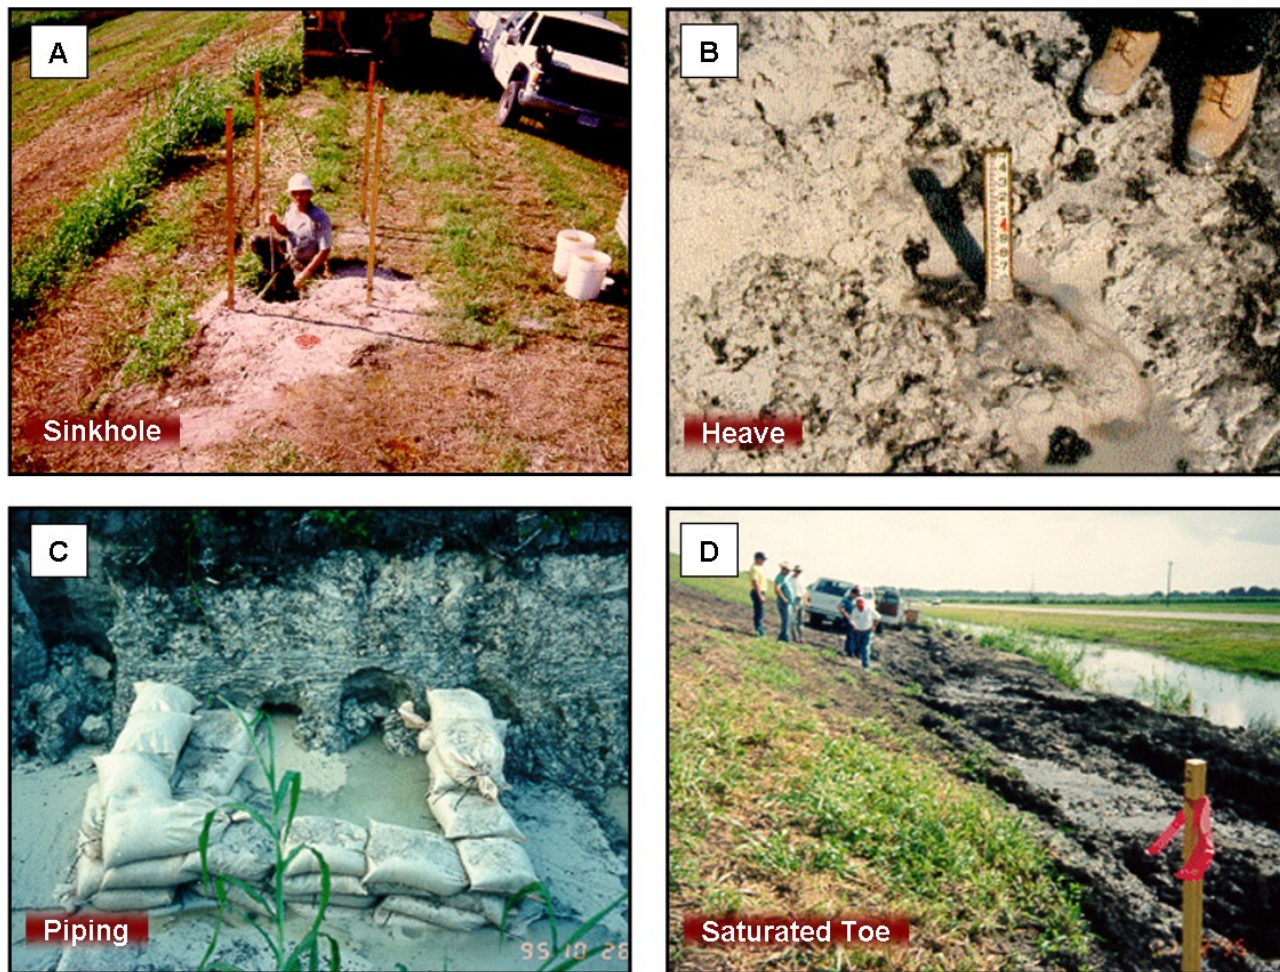
Figure 3.—Representative photographs of prior seepage erosion conditions at HHD near Lake Harbor. Downstream area seepage distresses were observed during events having a ~30-yr return period: (A) sinkhole formation in crest, (B) heave of downstream toe caused by upward seepage flow - surveyrod was easily embedded 4 ft deep, (C) piping at downstream toe of dike, and (D) saturation of landward toe and embankment slope.

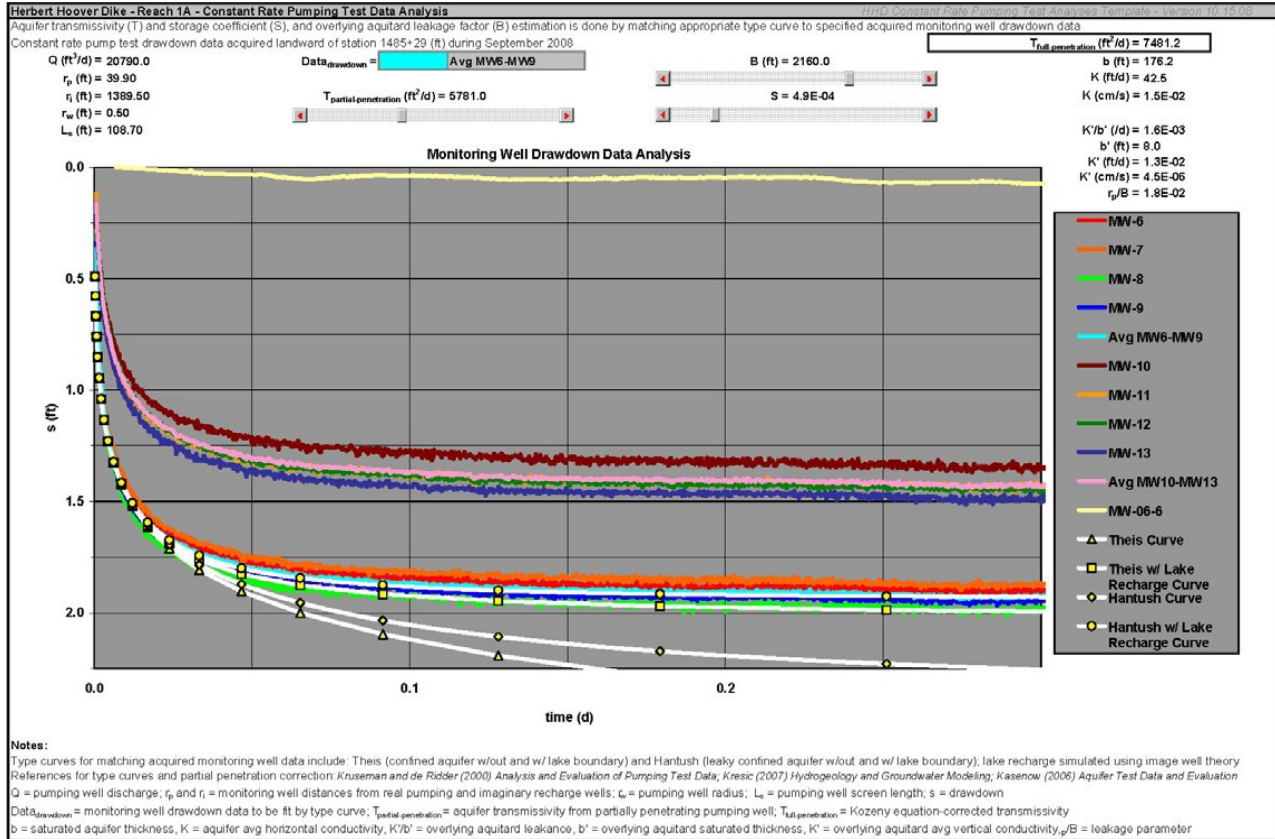
Figure 5.—Data analysis from a constant rate pumping test conducted at Sta. 1485+29, with a resultant aquifer transmissivity of 7,481 square feet per day). Monitoring wells MW-6 through MW-9 were located 40 ft from the pumping well in orthogonal directions. Radial distances of MW-10 through MW-13 were 100 ft, while MW-06-6 (background well) was 1,825 ft from the pumping well. Lake recharge effects were modeled with the hydraulic boundary (effective seepage entrance location) 700 ft from the pumping well.

To assist in the selection of hydraulic design properties for the Reach 1A foundation materials, a constant rate pumping test was performed landward of Sta. 1485+29 during September 2008 when the lake was at a constant elevation. The pumping well was installed 250 ft landward of the dike crest, and lines of three monitoring wells were installed in four orthogonal directions at increasing radial distances of 15, 40, and 100 ft. Pumping was conducted at a constant rate of 108 gpm for 1.25 days, with drawdown data recorded in all wells. Measured drawdown data are shown on figure 5; monitoring wells MW-6 through MW-9 were located

40 ft from the pumping well, while MW-10 through MW-13 were located 100 ft from the pumping well. Different theoretical drawdown curves were attempted to be matched to all drawdown data to estimate average hydraulic properties (with foundation transmissivity being the parameter of most interest for Reach 1A seepage analyses). As seen on figure 5, which focuses on a curve representing the average drawdown at a radial distance of 40 ft, at a time of less than 0.1 day drawdown, data begin to depart from the theoretical Theis and Hantush-Jacob (labeled as Hantush) solutions, which is indicative of recharge and leaky system effects. Such effects have historically been noted during pumping tests performed along the southern perimeter of Lake Okeechobee (USGS 1971).

Using image well theory and superposition, the lake recharge boundary was considered to create modified (“lake recharge”) Theis and Hantush curves (note that the Hantush curve also considers leakage from the overlying blanket with a standing water table), which are seen to more closely approximate observed drawdown (figure 5). Prior to testing, ambient groundwater gradients, measured across the monitoring well layout, when back-projected, indicated that the location of the effective hydraulic recharge boundary was 700 ft upstream of the pumping well (which

equates to the location of the borrow pit dredged during initial dike construction). It was concluded that the drawdown data were best modeled by fitting the (“lake recharge”) Hantush curve to acquired drawdown data. The calculated average transmissivity value was adjusted (using the Kozeny approach) to account for partially penetrating characteristics of the well network to yield an average foundation transmissivity of 7,481 square feet per day. This transmissivity equates to an average foundation hydraulic conductivity of 42.5 feet per day (or 0.015 centimeter per second). Previously, the average hydraulic conductivity of the shallow (surficial) aquifer in Palm Beach County, Florida, was estimated (based on correlation of subsurface geophysical and lithologic logs with aquifer and lab tests data) to range from 1.0 to 130.0 feet per day (USGS 1977). The average value determined during the Reach 1A pump test lies within this range, and more specifically lies within a range of 10.0 to 60.0 feet per day, which was referred to as a relatively moderate to high conductivity range for the shallow aquifer in the USGS study. This range was further described in the study to be typical for the shallow aquifer where it consisted of sand and gravel, well-sorted coarse sand, sandy shell beds or sandy coquina, and/or solutionalized calcareous sandstone or limestone with openings filled with sand.

The average transmissivity obtained from pump testing (see figure 5) is considered more reliable than the other available hydraulic conductivity estimates (e.g., from other field tests, lab tests, and correlations with grain size); however, it can be directly used only at the pump test location and possibly at other locations where borings indicate very similar conditions. Subsurface conditions vary considerably over Reach 1A as indicated by the geologic cross section shown on figure 4.

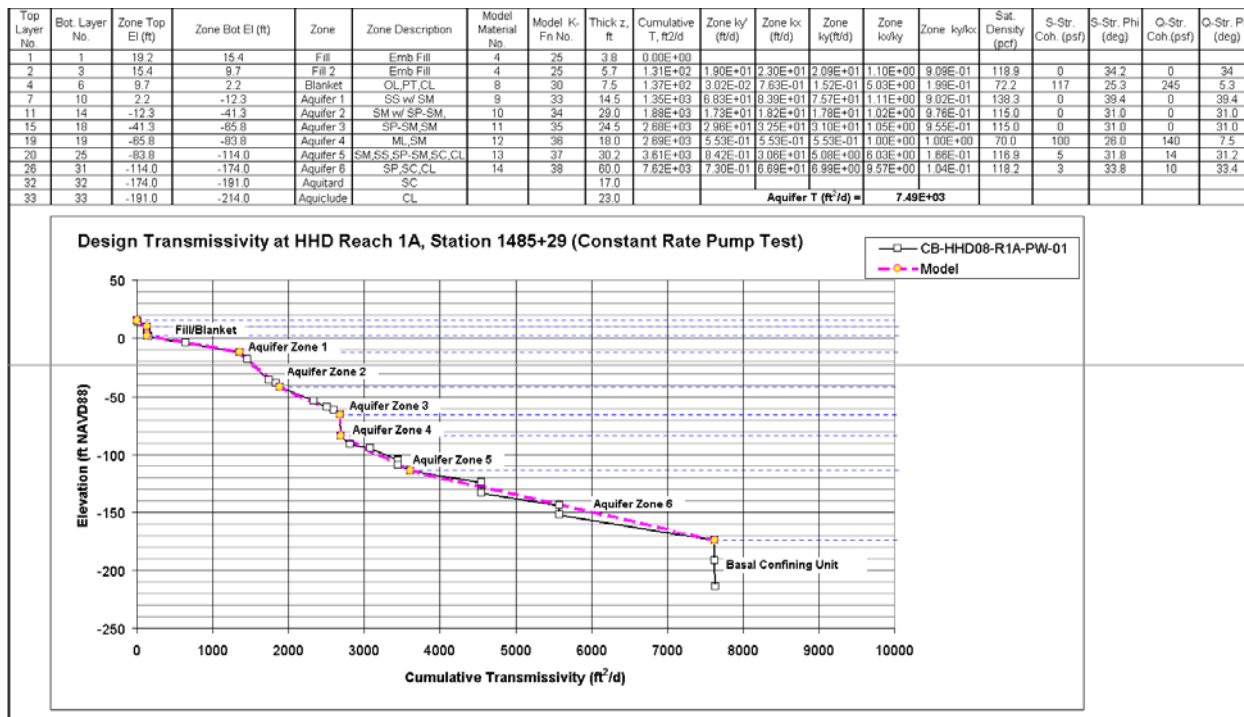
Figure 6.—Soil properties and model regions summary at Sta. 1485+29. The cumulative aquifer transmissivity (T) curve is based on classifications of soils logged in the pumping well used for constant rate testing (see figure 5). It was constructed primarily based on existing conductivity data from field tests and grain size correlations, with the soil distributions’ design percentile value adjusted such that the cumulative T at this station matched that determined from pump testing. A model curve was fit to the cumulative T curve in order to select vertical limits of foundation strata and their composite hydraulic properties.

On figure 6, a cumulative foundation transmissivity curve has been generated utilizing material classifications from the Reach 1A pumping well along with material conductivity distributions in the project database. The percentile value of all existing (lognormal) soil conductivity distributions employed was adjusted to 65 in order to yield a cumulative transmissivity value equivalent to that determined through pump testing. Once this calibration was achieved, a second model curve (figure 6) was manually fit to the initially generated cumulative transmissivity curve. The points defining this model curve were positioned at the major slope inflection points of the initial curve; sharp breaks in the curve slope represent significant changes in foundation conductivity occurring with depth and the horizon elevations of regions to be used in seepage models. The inverse of model segment slopes is indicative of relative hydraulic conductivity. Each “aquifer zone” or foundation stratum approximated by this model curve is typically comprised of multiple (logged) material classifications having similar effective conductivity, which are now represented for design analysis purposes as a single homogeneous layer. Conductivities for each idealized stratum were then calculated by employing typical equations used for determining the effective horizontal and vertical conductivities of an equivalent homogeneous and anisotropic formation (the aquifer zone) from an input array of assumed layered homogeneous and isotropic formations (the individual logged material classifications comprising each aquifer zone). Once this approach was developed and calibrated for the pumping well material classifications and field-measured cumulative transmissivity, the 65 percentile value for soil conductivity distributions was then utilized (with location-specific boring data) for the development of the other Reach 1A analysis profiles and their design hydraulic conductivity values. Additional pump tests are being conducted at other Reaches of the HHD project. Material classifications from borings made at the pumped wells for these tests will be evaluated with the above method to compare and hopefully further verify that the approach can be effectively employed to predict the site aquifer transmissivity with reasonable accuracy from borings, with only a few pump tests needed for verification.

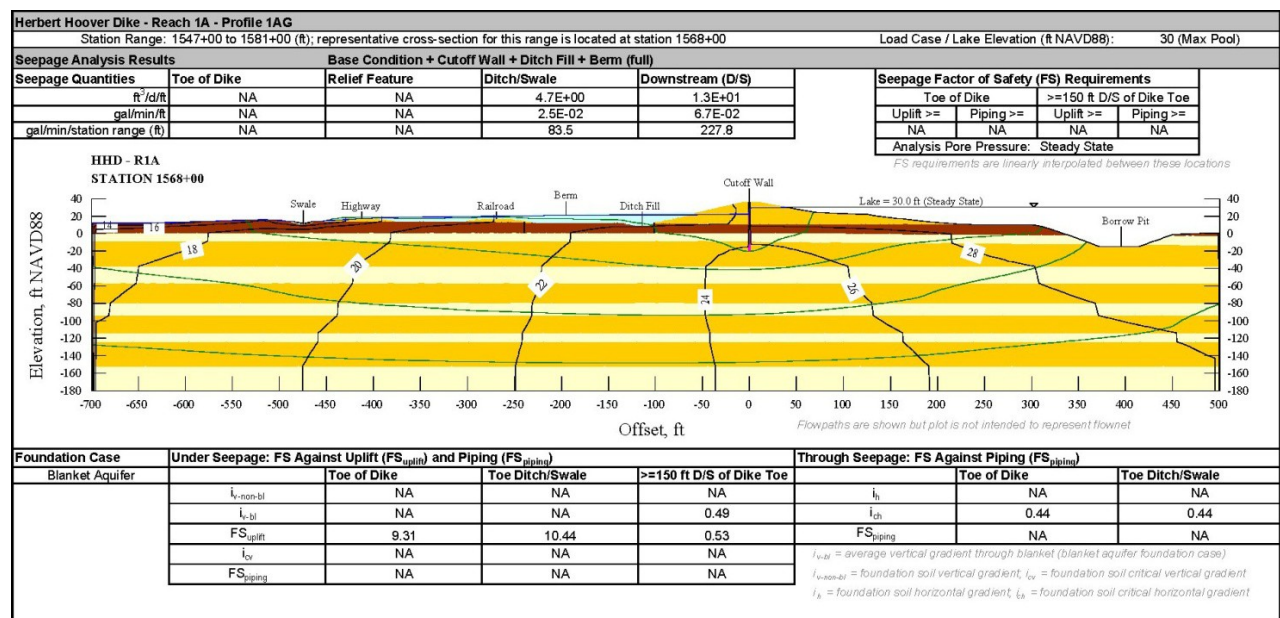
Figure 9.—Sta. 1568+00 soil profile and seepage modeling results (using design values on figure 7) for the maximum possible static pool. The profile includes a partial-depth seepage/piping barrier through the embankment and a 400-ft-long seepage berm. The resultant factor of safety against subsurface erosion initiation beyond the berm toe is less than unity.

The discussion of details from results of all design analyses is beyond the scope of this paper. However, for illustrative purposes of why a remedy component providing pore pressure relief is necessary for blanket aquifer conditions at HHD, deterministic modeling results from Sta. 1568+00 for the full-length seepage berm option at the maximum possible static pool are shown on figure 9.

These results show that while desirable FS values are obtained at the dike toe and former (now filled in) toe ditch location, an FS value against subsurface erosion initiation of less than unity still exists beyond the berm toe. The thickness and relatively impervious nature of the continuous organic-rich blanket does not allow enough dissipation of foundation head with increasing distance downstream such that the relatively light weight of the blanket can provide adequate resistance to remaining uplift pressure beyond the berm toe. It could be argued that a

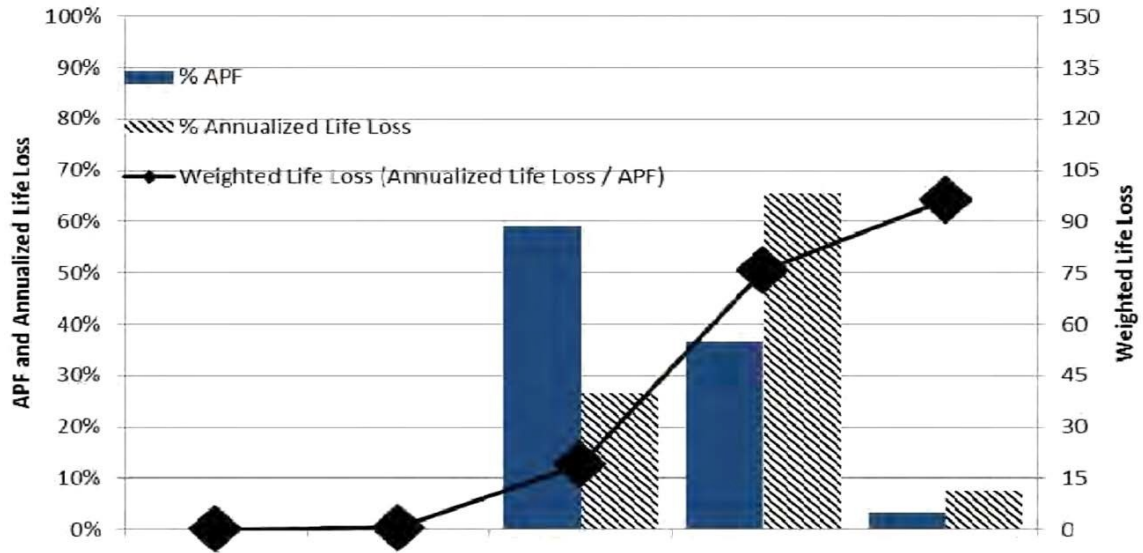
Risk Contributions by Reservoir Range
 Reach 3 Segment 1
 PFM R3-3 Internal Erosion Through Embankment (FIA)

Figure 7.—Typical risk contribution by reservoir range.

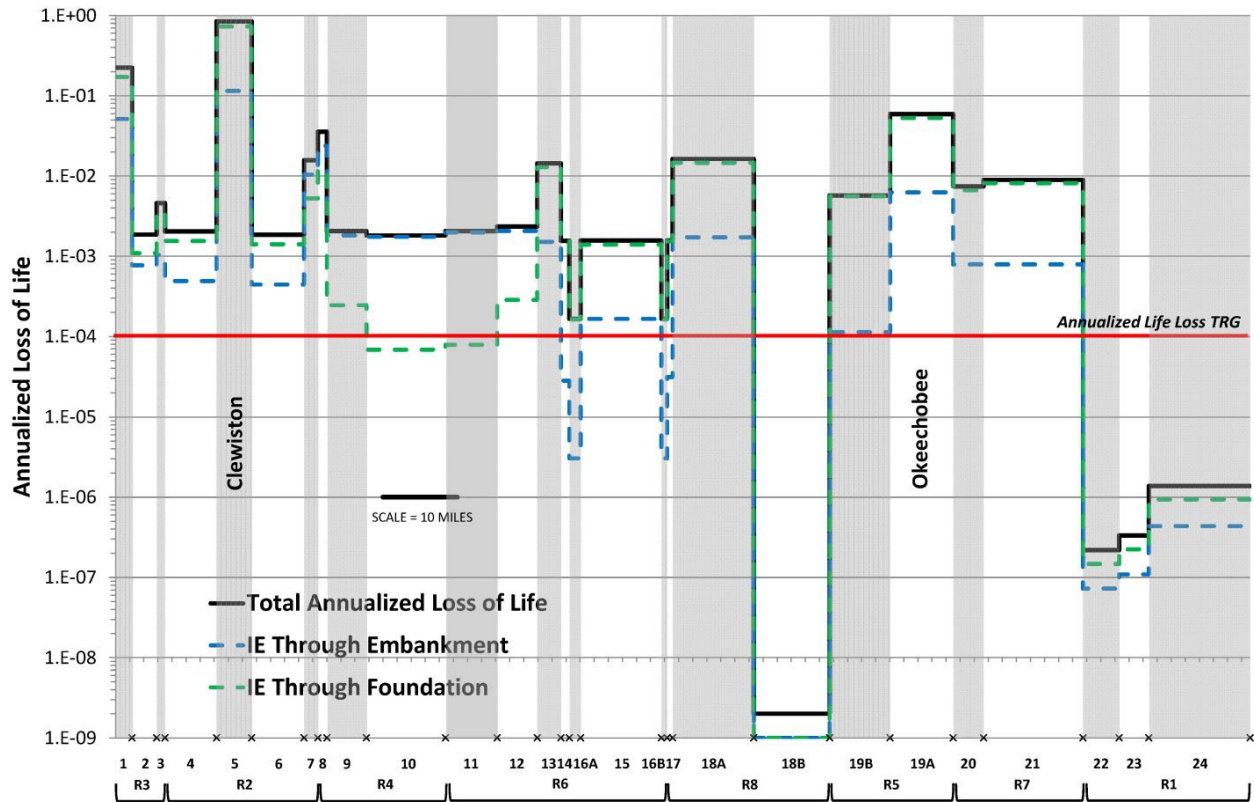
Figure 8.—Risk results by failure mode along dam alignment.

Total estimated risk for HHD was not computed because it is erroneous to accumulate risk across multiple downstream populations. Therefore, each segment was considered by the team as an individual risk entity, and risks were summed only within each segment. Risk was plotted though along the dam alignment to evaluate differences among the various segments. Figure 8 shows the annualized loss of life risk along the alignment plotted separately for each of the two primary failure modes: internal erosion through the embankment and internal erosion through the foundation. Also plotted on this figure is the total annualized loss of life risk for each segment, which is the sum of the annualized life loss risks for the two primary failure modes. This figure demonstrates how the risk varies along the alignment. It also shows which failure mode dominates the risk in each segment. It can be seen that internal erosion through the foundation generally controls the risk, with the exception of segments 9–12, where the sandy foundation and lack of a cohesive shallow layer reduces the probability of roof support within the foundation.

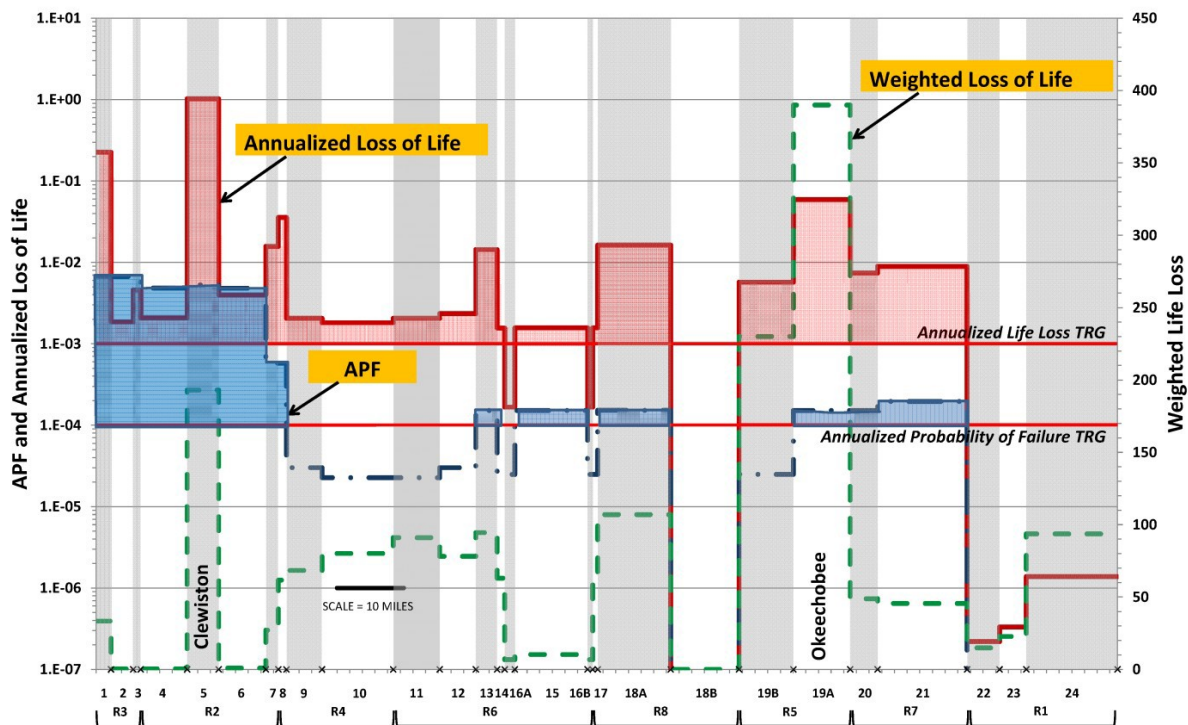
Figure 9.—Risk analysis results by segment along dam alignment.

Figure 9 presents the variations of three values along the dam alignment: APF, annualized loss of life (“risk”), and weighted loss of life.⁵ The weighted loss of life was computed by dividing the total annualized loss of life by the APF, thus producing a weighted average for all reservoir levels. As can be seen on figure 9, baseline risk estimates for 21 of the 26 segments exceed the defined TRGs for either APF or annualized loss of life risk. Risk was very sensitive to consequence estimates and boundaries. Several of the segments were more heavily influenced by life loss estimates than by the condition of the dam. This is demonstrated where APFs are below the TRG, while annualized life loss exceeded the TRG.

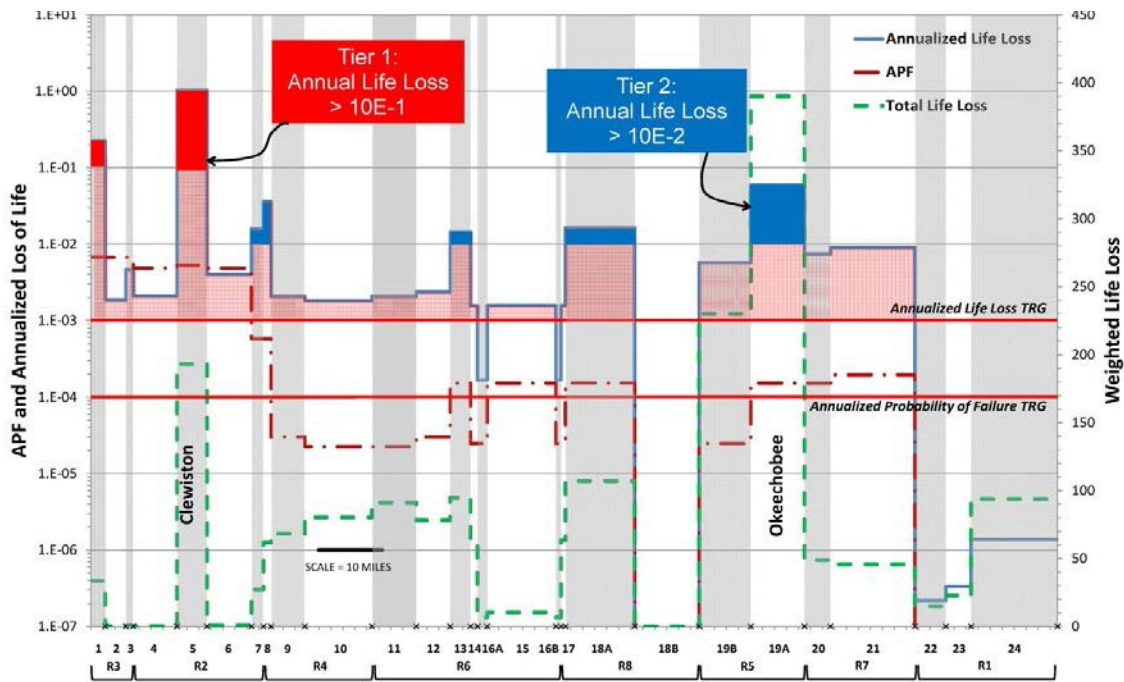
Figure 10.—Risk prioritization for 143-mi Long Dam.

It is not practical to undertake repair of the more than 120 mi of dam with risks exceeding TRGs due to annual budget limitations. Therefore, the segments needed to be prioritized. The quantified risk results were compared in relative terms to prioritize the segments. That is, the areas with the greatest potential for risk reduction can be identified for decisionmakers. Although TRGs for both APF and annualized loss of life have been established, the annualized loss of life risk is generally considered the priority for decisionmaking. Segments were divided into risk tiers based on highest to lowest annualized loss of life, which aided in the determination of where risk reduction efforts would be most effective. For example, segments with annualized loss of life above 10^{-1} were considered tier 1, and segments with annualized loss of life between 10^{-2} and 10^{-1} were considered tier 2, and so on. The segments falling within these top two tiers are shown graphically on figure 10 and in plan view on figure 11. Remaining segments with risks above TRGs are prioritized in lower tiers.

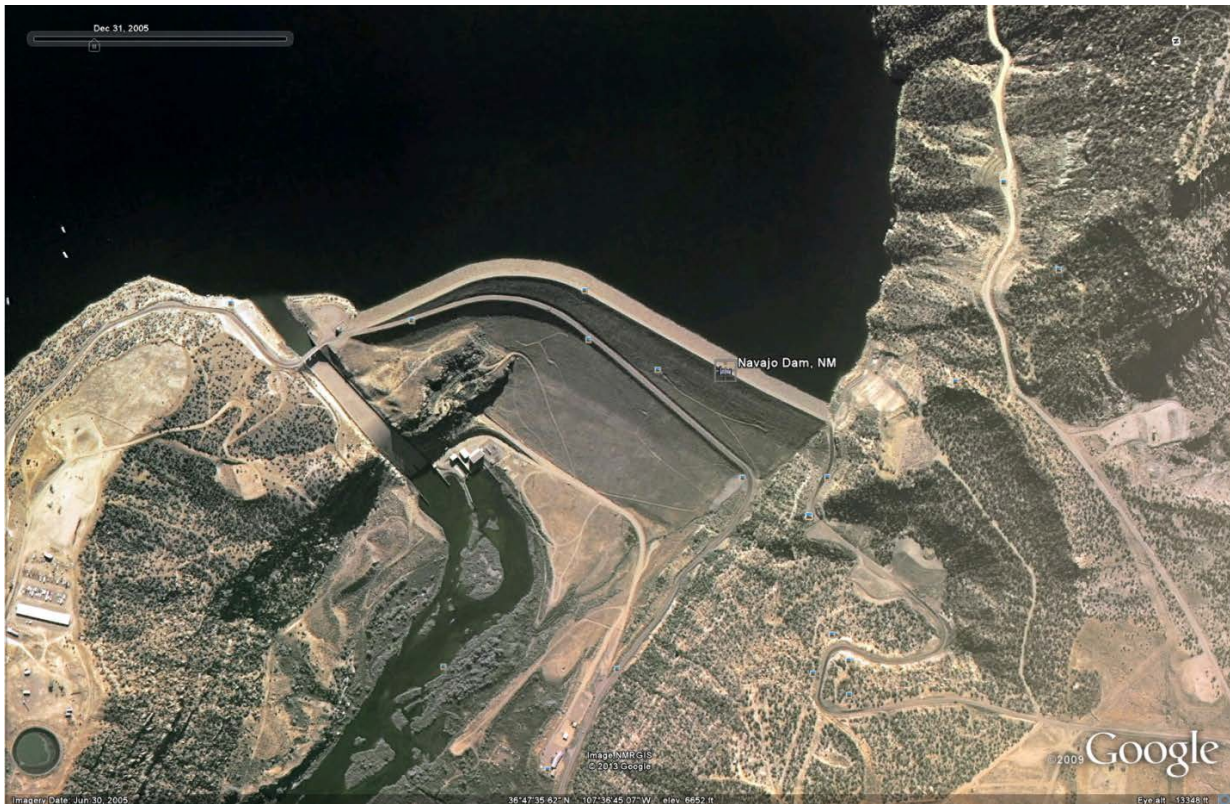
Figure 1.—Navajo Dam and spillway (Google Earth, June 30, 2005).

Construction of Navajo Dam began in July 1958, and it was dedicated on September 15, 1962. The nearly 3/4-mi-long dam (figure 1) stands 402 ft (123 m) high with a crest length of 3,648 ft (1,112 m). Nearly 26 million yd³ (19.8 million m³) of selected cobbles, gravel, sand, and clay taken from 16 borrow areas beside the San Juan River and along valley benches were used in construction of the rolled earthfill embankment. Navajo Reservoir extends 35 mi (56 km) up the San Juan River, 13 mi (21 km) up the Pine River, and 4 mi (6 km) up the Piedre River. When full, the surface area of the reservoir is 15,610 acres (6,317 hectares), with a total capacity of 1,708,600 acre-ft (2,107 million m³).

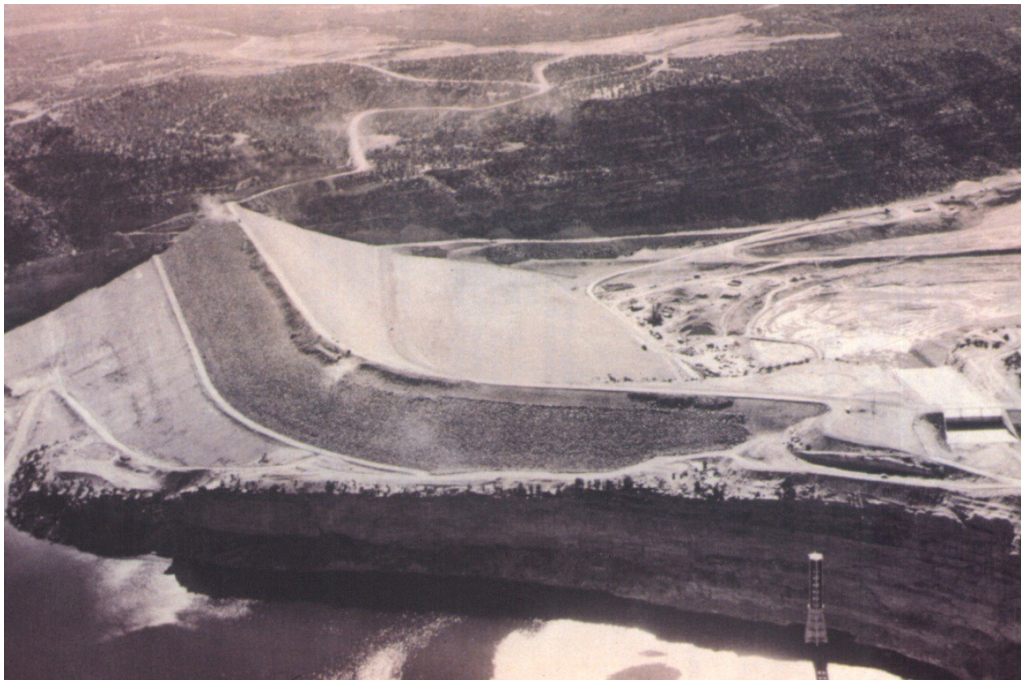
Figure 2.—Right abutment of Navajo Dam, looking downstream.

Navajo Dam was constructed across a sharp incised meander of the San Juan River. The left abutment is formed by the erosion of the outside edge of the meander. The differential erosion of the interbedded shale and sandstone on the left abutment causes step-like cliffs common to both abutments. The right abutment is the narrow weathered bedrock nose of the inside of the meander and is directly exposed to the reservoir. The upstream side of this bedrock nose is near vertical and moderately jointed at 5- to 10-foot intervals. As shown on figure 2, the right abutment foundation extends for a significant distance beneath the embankment. Regional fracturing at the dam site is generally widely spaced. Local fracturing is relief jointing caused by lateral stress relief due to downcutting of the San Juan River, ranging from intermediate to closely spaced. Additionally, there are bedding planes, which form joints. Fractures and joints interconnect, creating a highly permeable secondary seepage system beneath the embankment.

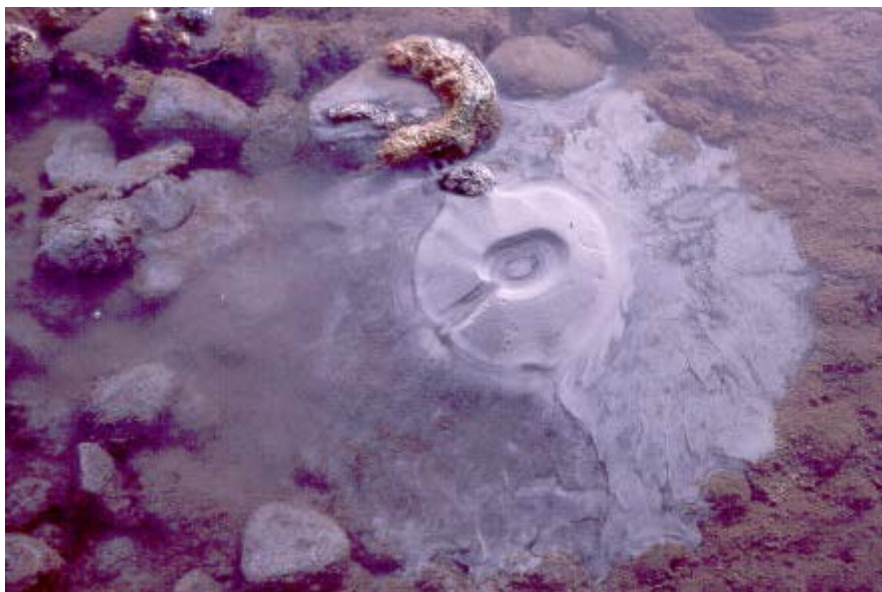
Figure 2.—Boils in outlet channel at Canby Creek, R-1 Dam, Minnesota.

In 1994, a deep slurry trench cutoff was installed along the front embankment toe. The slurry trench cost was in excess of \$1 million. While somewhat effective, it did not reduce the piezometric levels downstream enough to provide adequate safety factors against heaving. The slurry trench caused the combined flow in relief wells to decrease by about 50%, but sand boils still developed in the channel downstream when the relief wells were shut off for testing (figure 2).

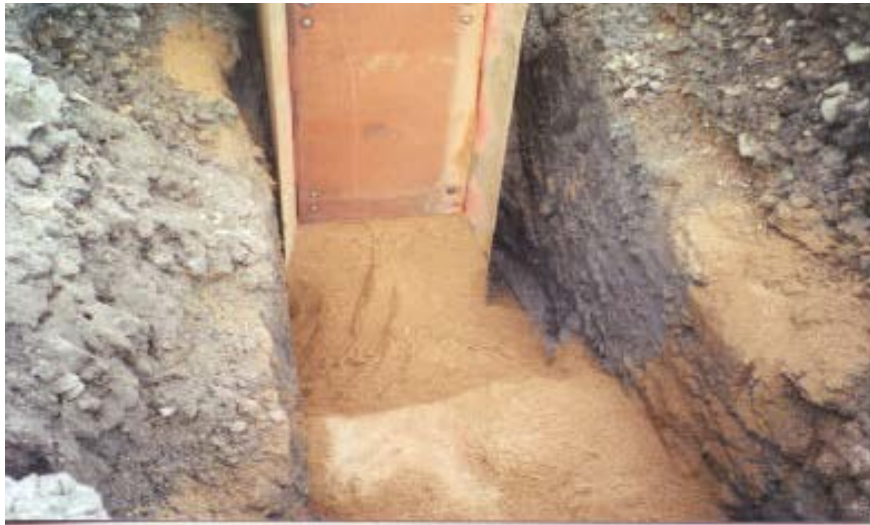
Figure 3.—Trench drain installation at Canby Creek, R-1 Dam.

through the clay blanket was a deep trench drain installed along the outlet channel of the dam (figure 3). The trench penetrated through the clay blanket at least 2 ft into the underlying sand aquifer and was as much as 15 ft deep. It extended about 250 feet downstream from the embankment toe. Installing the trench drain required well points to dewater the excavation without lowering the pool. Piezometric levels dropped appreciably after installing the trench drain and have remained at lower levels even though the relief wells have not been further rehabilitated since 1998. The repair is considered a success.

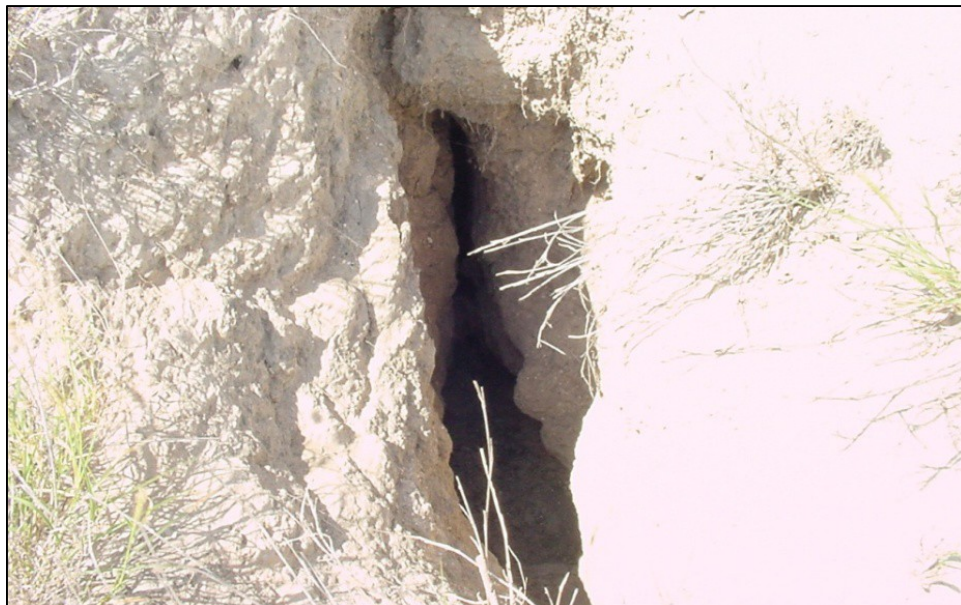
Figure 2.—Large crack in embankment, Olmitos-Garcias No. 2 Dam.

Olmitos-Gracias No. 2 Dam is located in Starr County in the southern tip of Texas (figure 1). Numerous cracks and sinkholes were discovered in the embankment during a 1999 inspection. The cracks were both transverse and longitudinal. The sinkholes had formed through erosion of soil into cracks and were found on both the upstream and downstream slopes and on the crest (figure 2). One 3-in-diameter hole was measured to be over 25 ft deep. Insects and animals, including badgers, were using the cracks and holes to facilitate burrowing into the embankment. Numerous mesquite trees were found growing on the embankment, and mesquite roots had penetrated into many open cracks to considerable depths.
