Evaluation and Monitoring of Seepage and Internal Erosion

Interagency Committee on Dam Safety (ICODS)

FEMA P-1032 / May 2015

Federal Emergency Management Agency

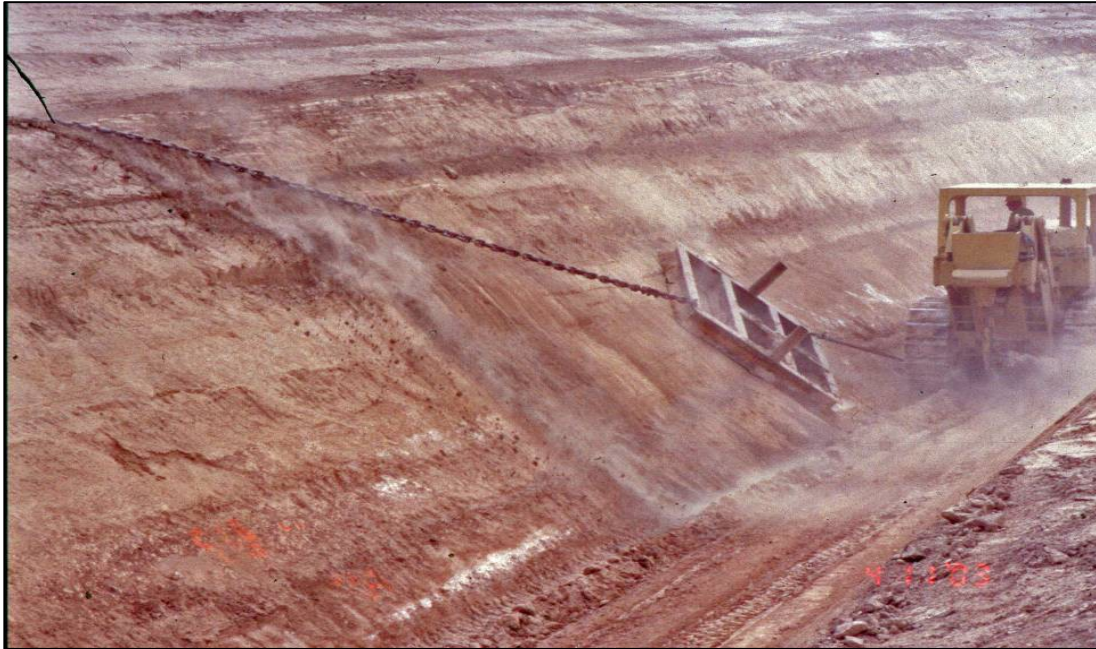
Figure 4.—Smoothing geotextile subgrade with metal frame, Olmitos-Garcias No. 2 Dam.

The outside 12 ft (measured horizontally) of the 2.5H:1V downstream slope were removed, and a trench with a 12-ft bottom width was excavated down to competent claystone. The subgrade for the geotextile was smoothed by dragging a flat metal frame over the slope surfaces using a tractor and cables (figure 4). Then, the geotextile was placed on the slope, beginning at the bottom of the foundation trench and extending to within 1 ft of the top of the dam. Finally, the trench was backfilled, and the slope and stability berm were constructed with compacted earthfill (figures 5 and 6). In the vicinity of the principal spillway conduit, the geotextile within the foundation trench was replaced with a vertical trench filled with flowable fill (figure 7).

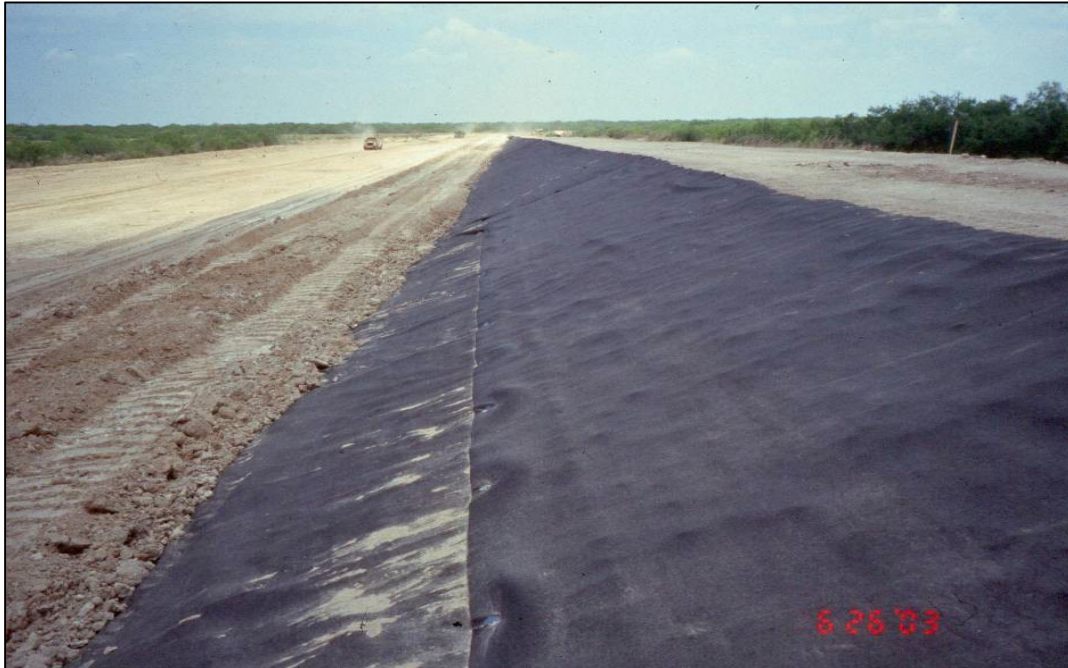
Figure 6.—Fill placement against geotextile, Olmitos-Garcias No. 2 Dam.

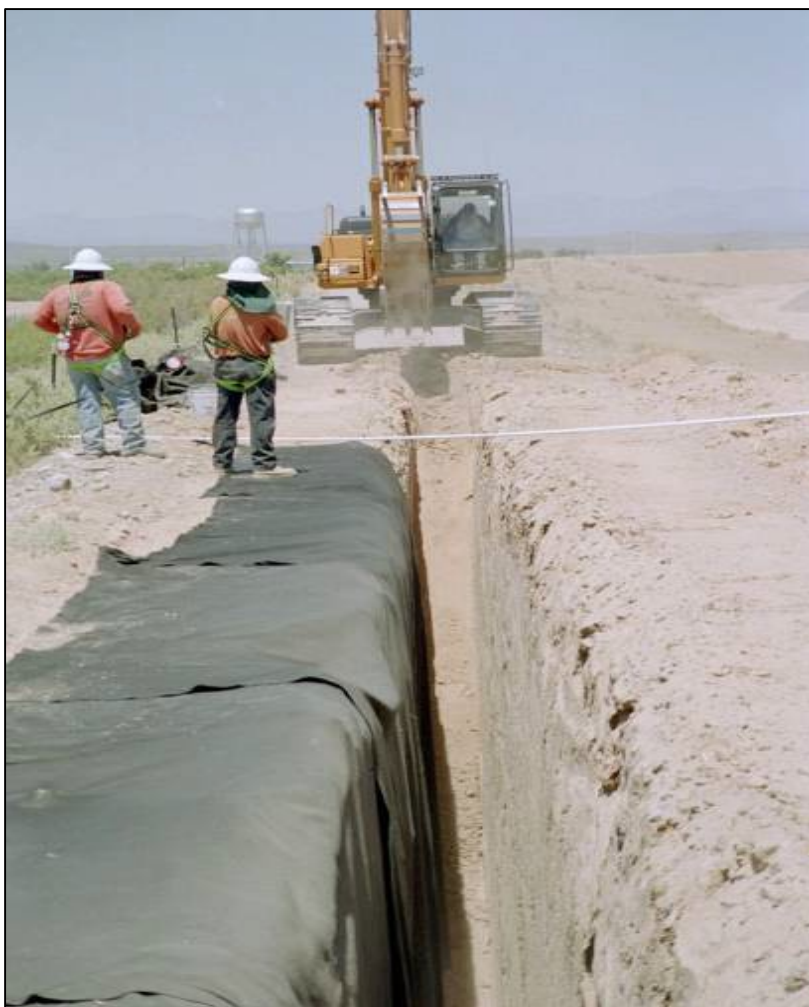
Figure 3.—Trenching and operation, Florence Dam.

of the filter material in the trench to within 1 ft of the top, and (4) placement of 1 ft of compacted earthfill over the trench and covering the embankment crest with 3 in of gravel. The two major challenges with construction were excavation of the 25-ft-deep trench in dry, partially cemented earthfill and blending and placing the broadly graded filter material without segregation. The trench was successfully excavated with both hydraulic excavators (figure 3) and a Case CX 290 trencher. No instability of the trench occurred between trench excavation and placement of the filter material. The gradation of the filter material was equivalent to a 50-50 mix of ASTM C33 Fine Aggregate for Concrete and ASTM C33 No. 57 gravel. The grading and blending of the filter material was accomplished using a screening machine and an auger-type mixer/elevator (figure 4). Placement of the filter material in the trench was performed using a tremie pipe to control segregation (figure 5). An 18-in overlap between adjacent sections of geotextile was used.

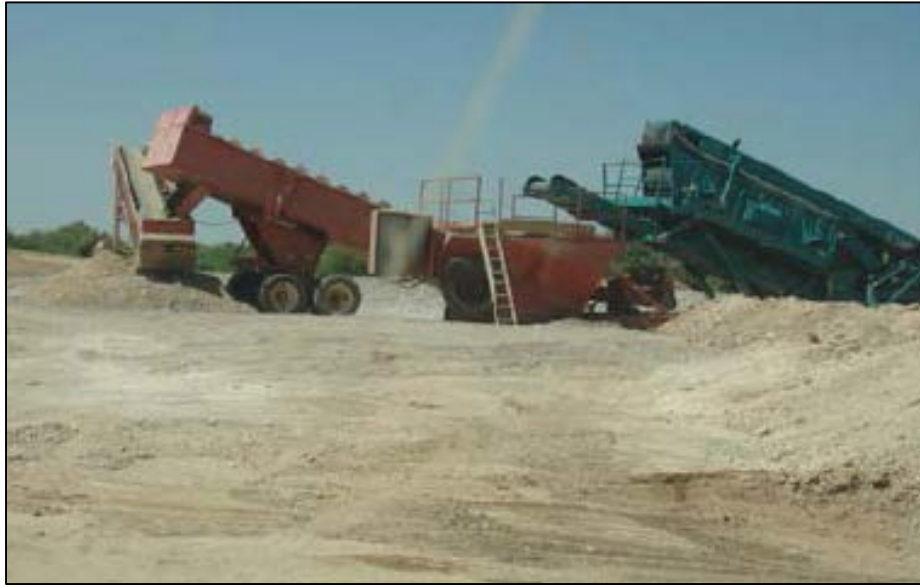
Figure 4.—Screening machine (right) and mixer/elevator (left) for processing filter material, Florence Dam.

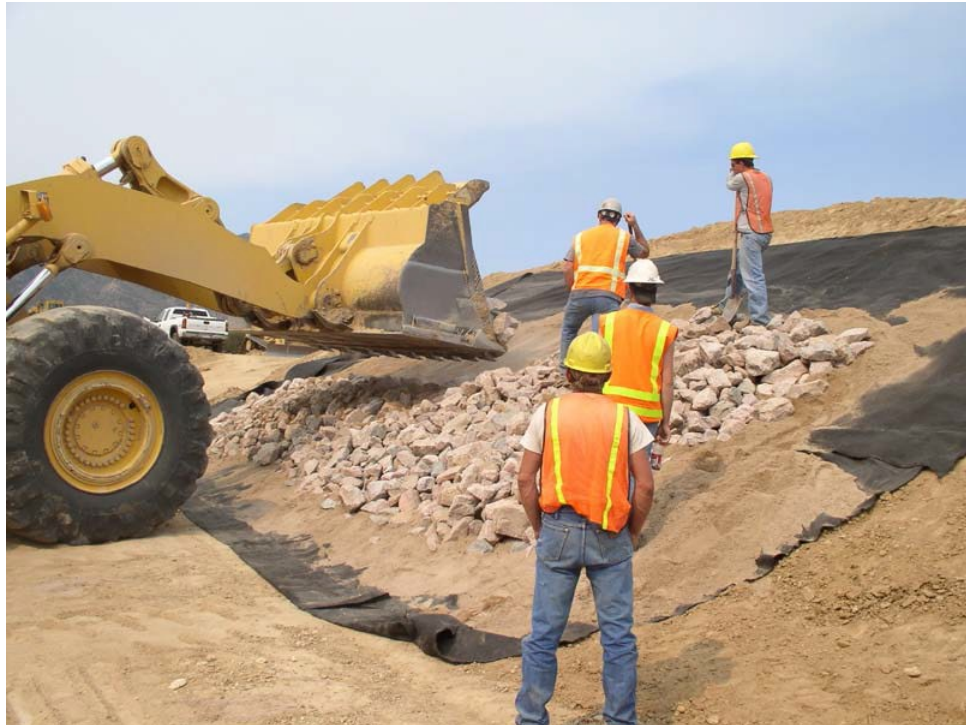
Figure 7.—Constructing the mockup.

Several mockups were constructed before one finally received approval (figure 7). The contractor's method of choice for building the composite zone was to mix and place proportions of cobble and sand using a front-end loader. The use of vibrating equipment and hand placement were found to be unnecessary. The approved composite zone had a cobble to sand ratio of

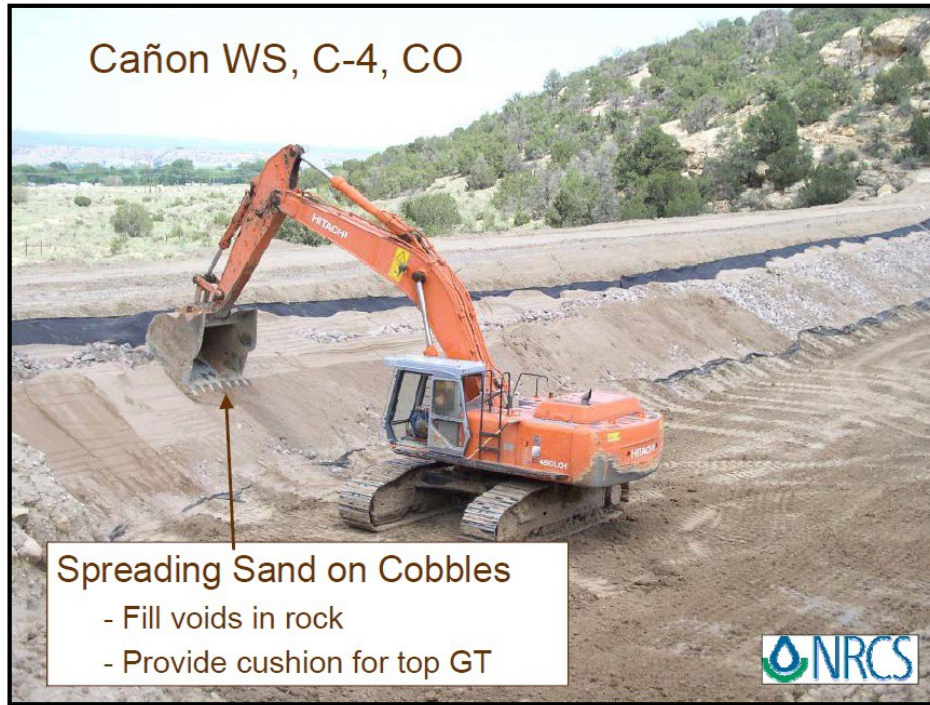
Figure 8.—Placement of geotextile, rockfill, and sand on upstream face (prior to placement of overlying geotextile).

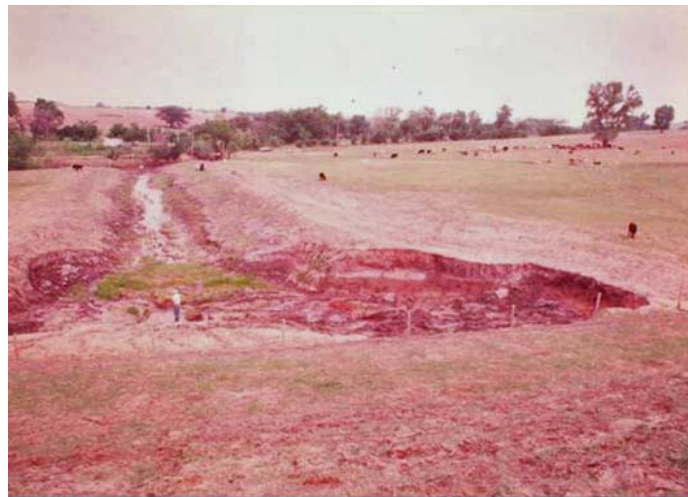
Figure 2.—Sloughing of plunge pool in May 1979.

The sloughing problem reoccurred, and problems were noted in a trip report by Mavis Jones, dated May 4, 1979. Figures 2–4 show the problems observed in May 1979. After this, the area downstream was apparently reworked, and a more extensive foundation drain was installed. Documentation is lacking on the details of the repairs done at this time, but apparently the main effort was directed at providing a drain on the right side of the plunge pool, extending up the right abutment. The drain may have wrapped around the plunge pool and may have extended some distance to the left of the pool. The pictures of the failure shown below indicate that the damaged foundation area was to the right of the plunge pool, but documentation on this repair is minimal. It is well known that a drain was added on the left side of the flood plain area in the 1993 repair discussed in following sections.

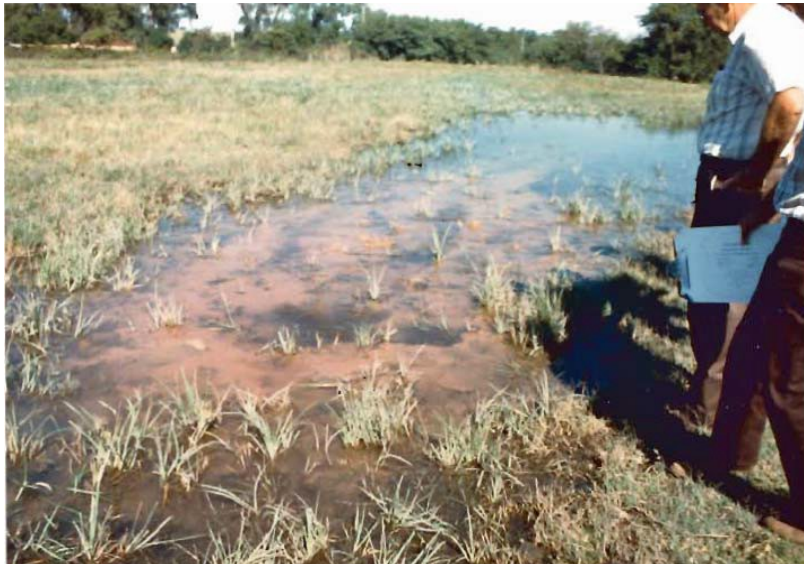
Figure 5.—Seepage occurring downstream from embankment in September 1987.

Subsidence was observed in the upstream berm, which aligned with a concentrated seepage area downstream from the embankment. Figure 5 shows seepage observed downstream from the embankment in September 1987.

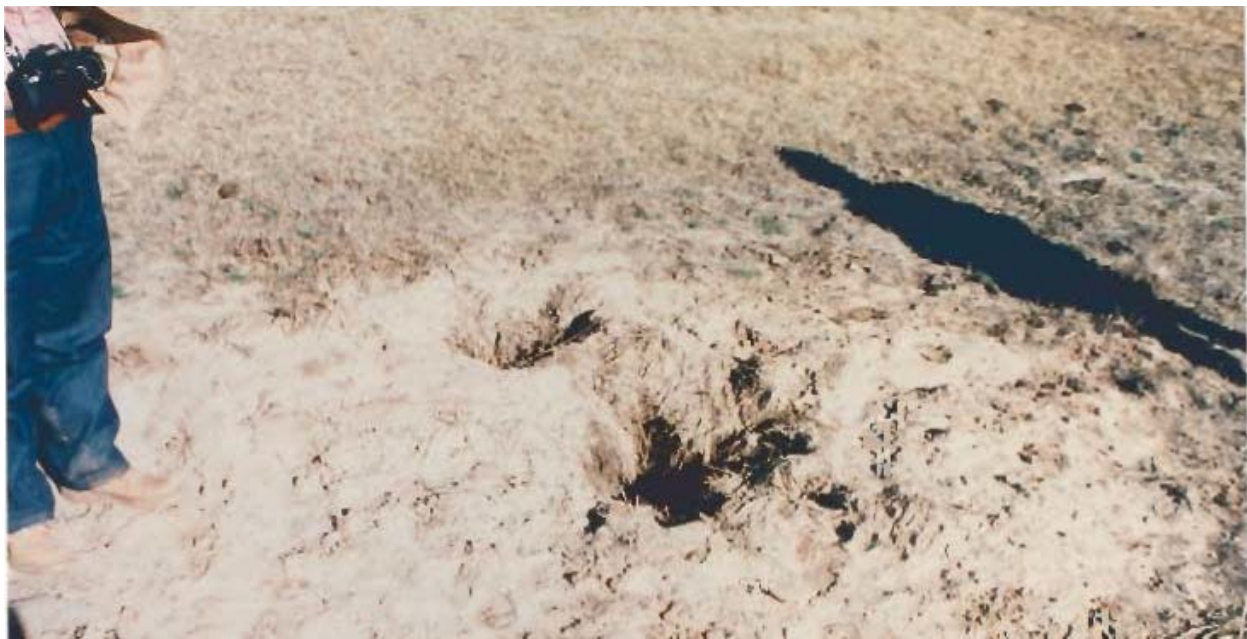
Figure 6.—Tunnel outlet downstream from Sta. 5+50, March 8, 1988.

An engineering report was prepared in August 1988. The report attributed the excessive seepage to preferential flow paths developing through the gypsiferous foundation soils (figure 6). It was determined that development of flow paths occurred from dissolution of the soluble salts in the foundation. The report recommended a cutoff barrier extending downward to at least elevation 1246 (about 6 ft below the zone of lost circulation in the 1988 investigation), a foundation drain, and repair of the sinkholes.

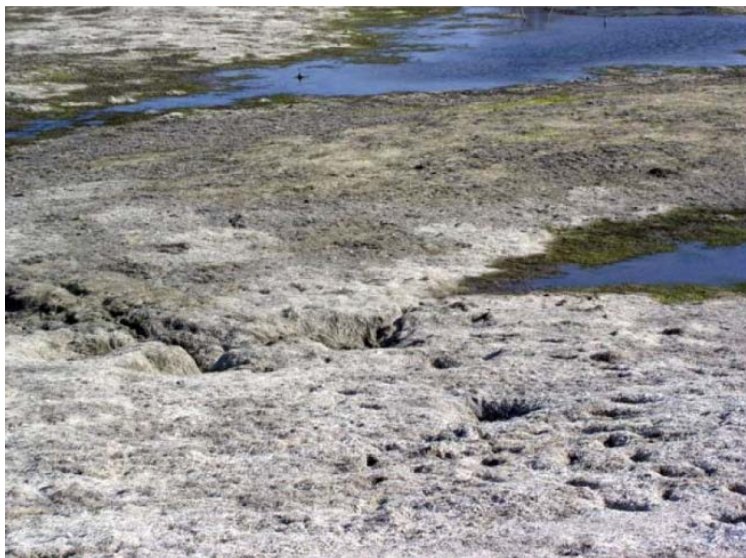
Figure 9.—Sinkholes in reservoir bottom.

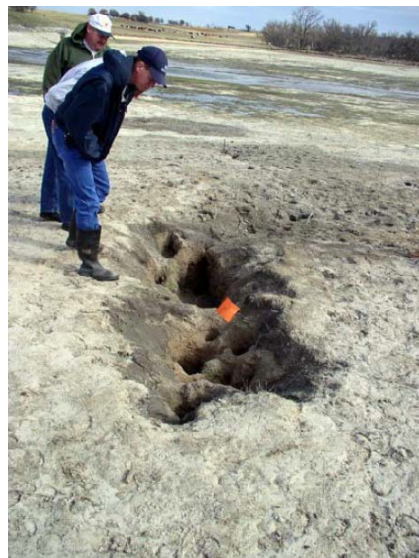
Figure 10.—Large sinkhole in reservoir.

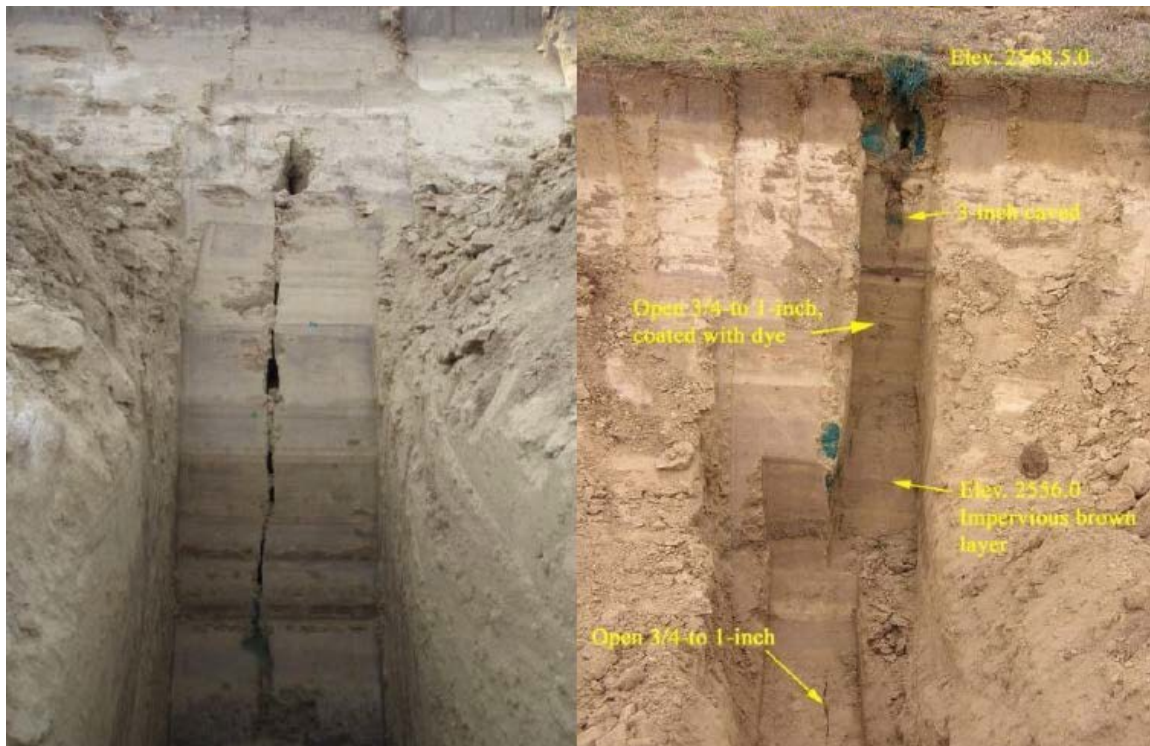
Figure 5.—Representative cracking in the embankment observed in test pit #2. Dye was poured into the sinkholes to aid in tracing the cracks. Cracks were typically 1/4 to 1 in wide.

interim risk reduction measures included stockpiling sand and gravel materials for use as potential emergency filters, 24-hr monitoring, and lowering the reservoir by approximately 20 ft to the dead pool elevation. Figure 5 shows the typical cracking observed.

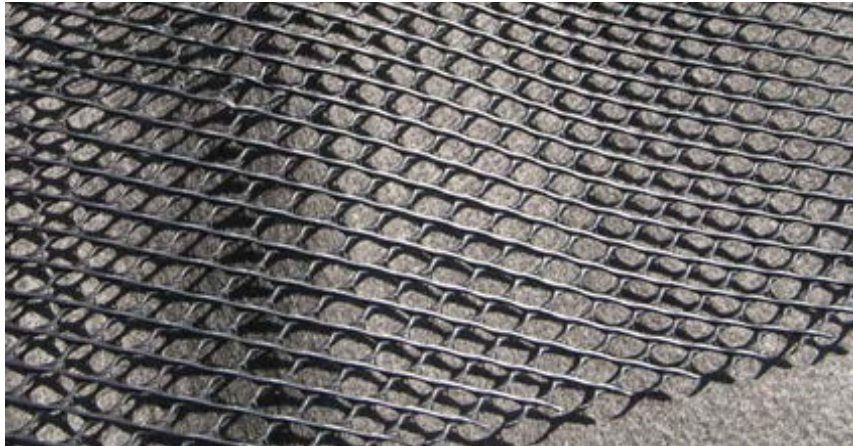
Figure 8.—Geo-net composite – 5-mm biaxial HDPE geo-net, 16 ounces per square yard (oz/yd^2) geotextile bottom layer, 6 oz/yd^2 geotextile top layer (photo above does not show the top [downstream] geotextile).

The double-sided geo-net composite was installed over the entire excavated slope for the full length of the embankment. The material was anchored into a trench along the crest and then rolled down the excavated slope to the base of the excavation. Figure 8 below is a photo of the geo-net composite used in the modifications, and figure 9 shows the typical installation, rolling the panels from the dam crest.

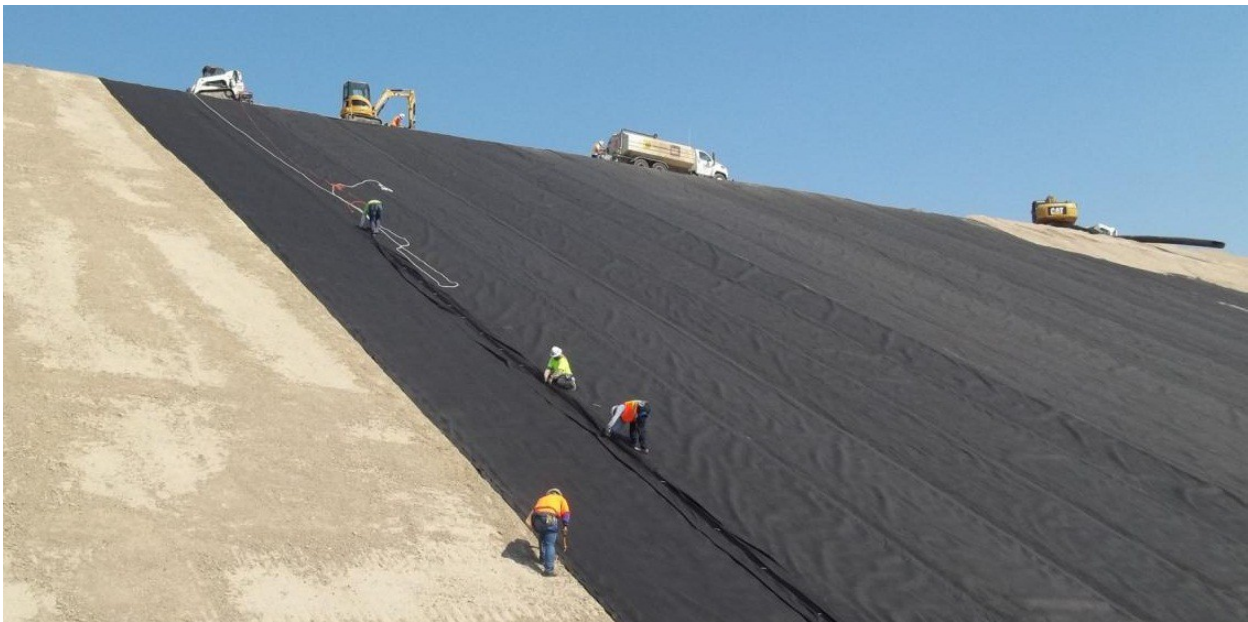
Figure 9.—Typical installation of geo-net composite on downstream face of embankment.

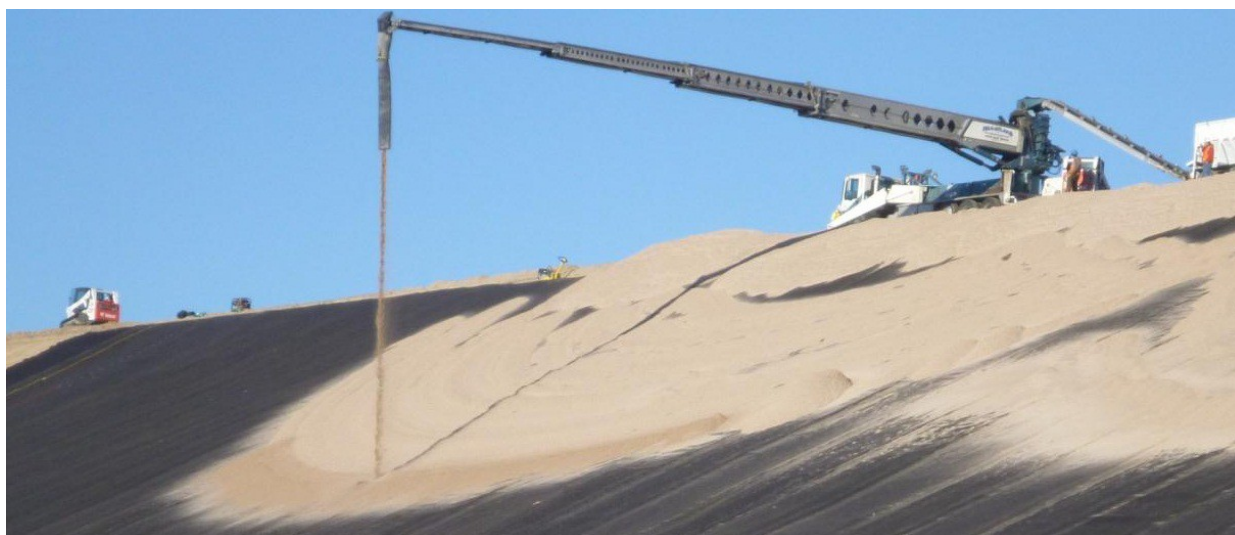
Figure 10.—Telebelt used from dam crest to protect geo-net composite.

In order to prevent degradation of the geo-net composite due to ultraviolet breakdown, it was specified that the geo-net be covered within 30 days of placement. This posed a unique problem due to the embankment construction sequence and large area of geo-net composite materials to be covered. Ultimately, the contractor used a 6-in layer of sand to protect the exposed geo-net. A telebelt conveyor system was used to ensure coverage of the entire exposed composite as shown on figure 10.

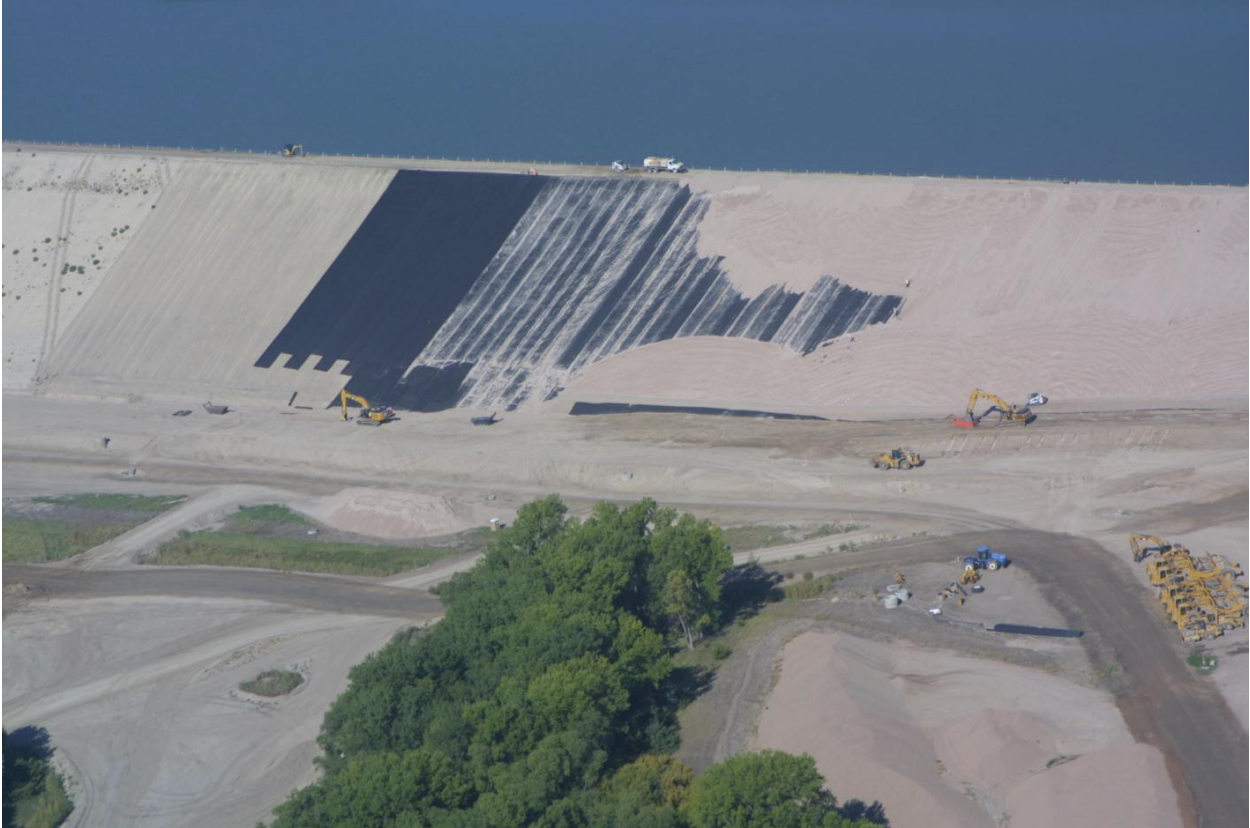
Figure 11.—Aerial photo of Red Willow Dam showing geo-net installation and protection with sand.

The use of geo-net composite materials in Reclamation dams is not common practice. Red Willow Dam is the first Reclamation dam to use the geo-net composites as identified. Federal guidelines prohibit the use of geosynthetics as a primary filter/drain. For this reason, a two-stage filter/drain was constructed below elevation 2615 to serve as the primary filter/drain. The use of a geo-net composite as the primary filter/drain above elevation 2615 is unconventional, but due to the low likelihood of the reservoir exceeding this elevation, the designers decided there was very little risk in not continuing the chimney filter/drain above this elevation. Because the drain materials were imported from a long distance, stopping the two-stage filter at this elevation also had an economic benefit for the project – by limiting quantities, a cost savings was achieved. A total of 70,000 square yards of geo-net composite was installed of the downstream excavation as shown on figure 11 below.

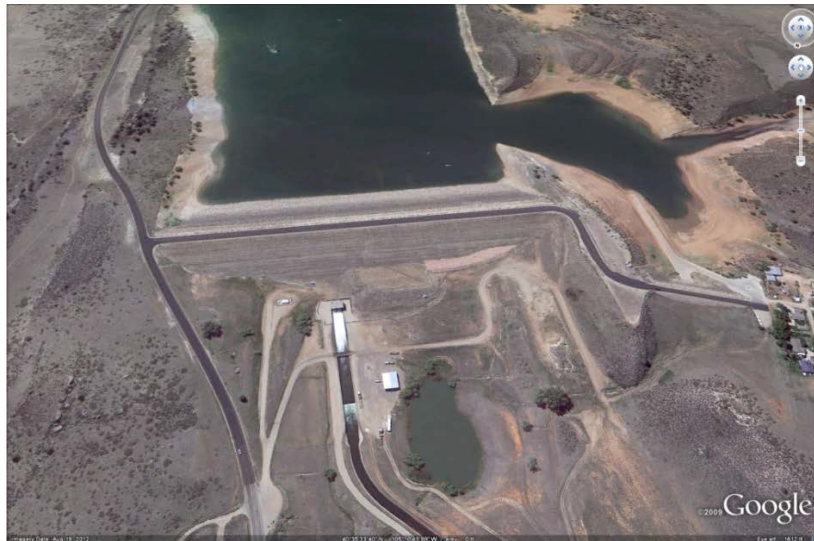
Figure 2.—Oblique view of Horsetooth Dam and Satanka Dike (looking south).

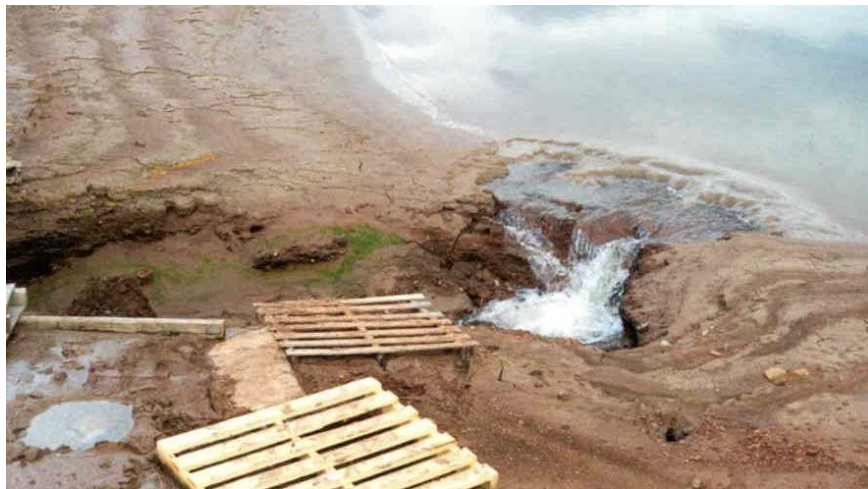
Figure 5.—Observed sinkhole at upstream left groin of Horsetooth Dam.

During the summer and fall of 2000, the reservoir water surface was drawn down to investigate conditions along the upstream toe of Horsetooth Dam and to lower the reservoir water surface in preparation for construction of the filter and drain modification. Because of embankment stability concerns during construction, the reservoir water surface was restricted. As the reservoir drawdown reached elevation 5335, a sinkhole was observed on the upstream left abutment groin as shown on figure 5. As the reservoir water surface decreased below this elevation, the piezometers showed significantly decreased water levels in the foundation. To test the effects of the seepage entrance on the piezometric levels in the foundation, a gravity head water test was conducted. Water was pumped from the reservoir to the sinkhole. The purpose of the test was to estimate the flow capacity of the conduit/fracture network and to provide an indication of the continuity of the entrance condition to the Forelle limestone member. The vibrating wire piezometers were connected to data loggers that recorded readings every 15 minutes. The piezometers with influence zones in the Forelle limestone responded immediately, indicating a direct connection to the seepage entrance point. Water testing for a 24-hr period with the reservoir drawn down indicated that the seepage conduits could sustain a steady flow of approximately 2.2 ft³/s.

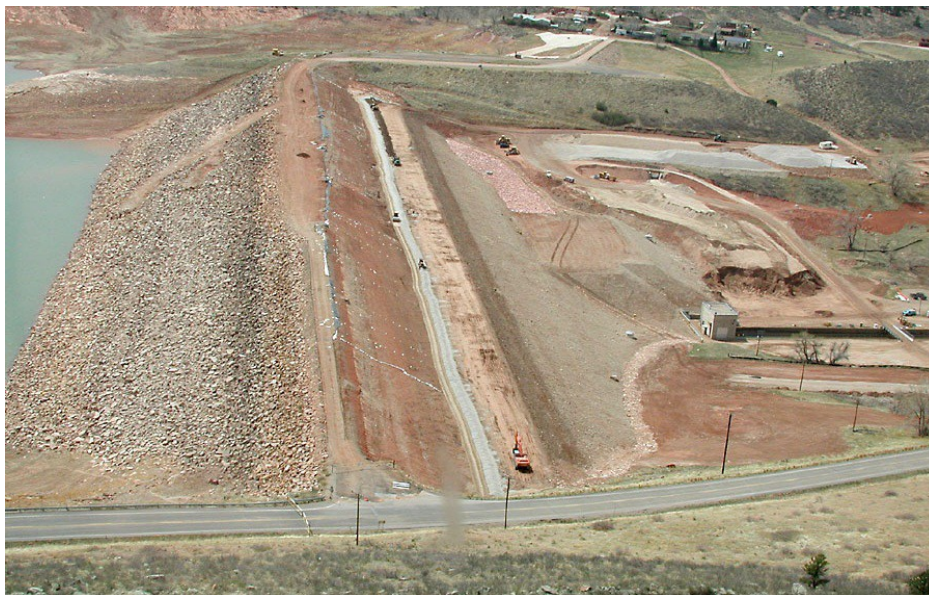
Figure 7.—Construction of downstream filter and berm at Horsetooth Dam.

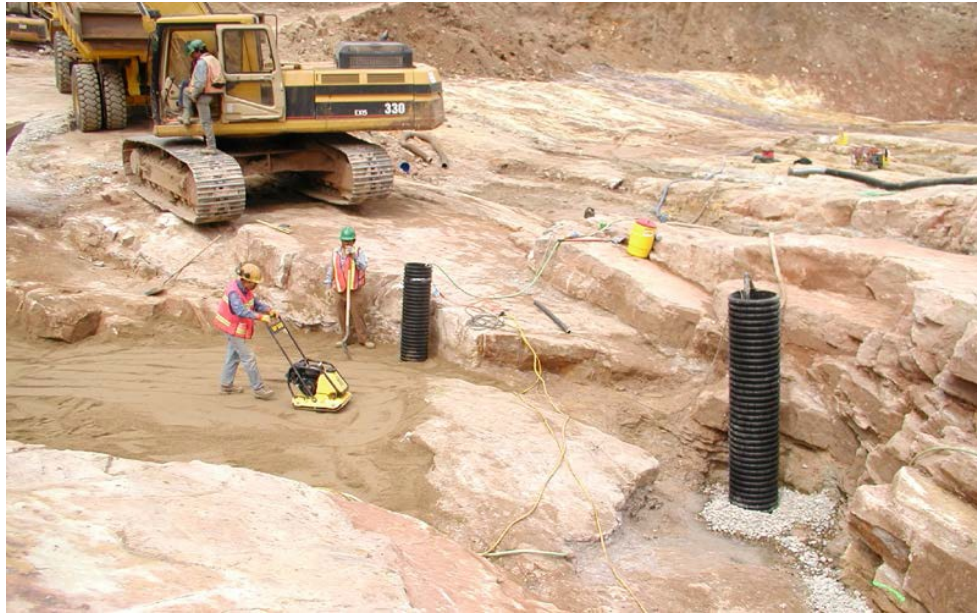
Figure 8.—Foundation cleanup and construction of downstream filter and berm at Spring Canyon Dam.

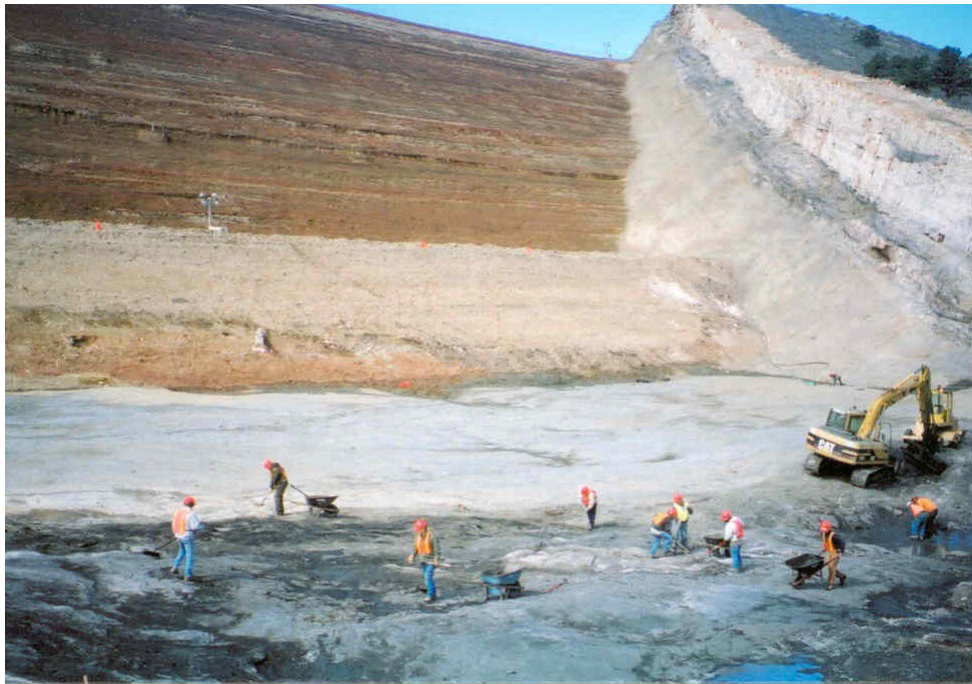
Figure 9.—Excavated downstream embankment and foundation at Soldier Canyon Dam.

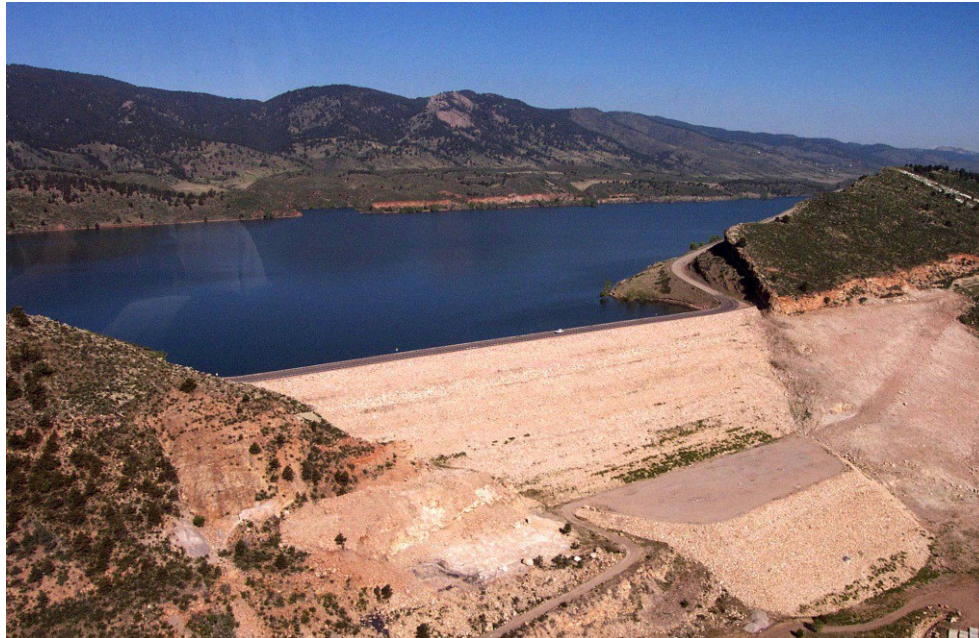
Figure 10.—Completed downstream modification at Dixon Canyon Dam.

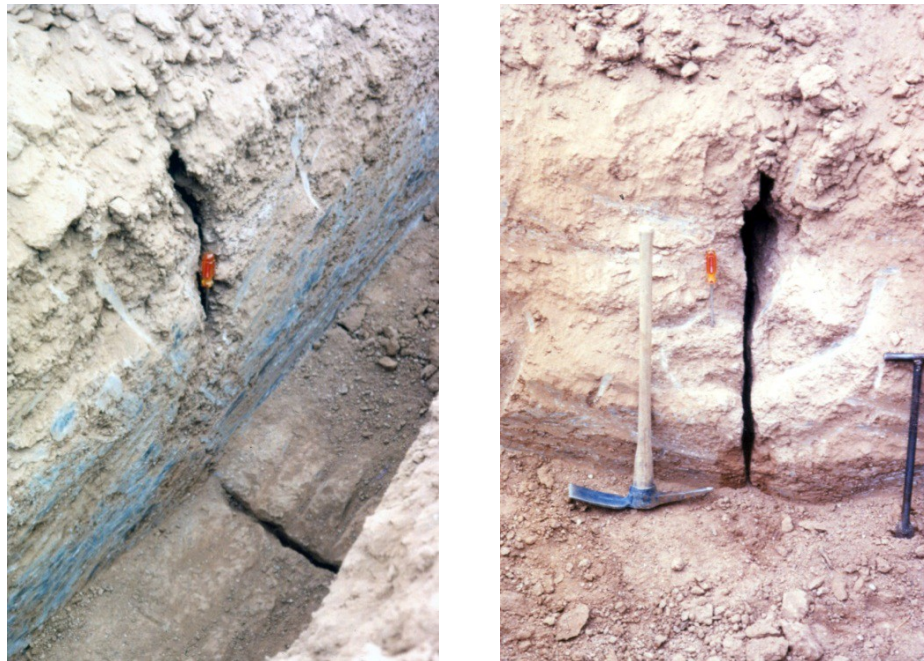
Figure 4.—Transverse cracks observed in test pits.

3. Large, deep, longitudinal, diagonal, and transverse cracks in Dikes 1, 2, and 3 were caused by differential settlement of foundations due to low in-place densities and infiltration of water (figure 4). Longitudinal cracks can be correlated to areas having retained water during past rains.

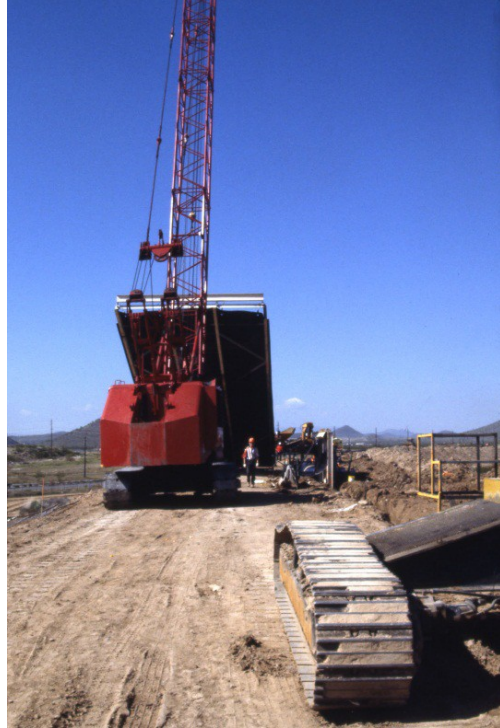
Figure 8.—Transport of geomembrane panel by crane using steel frame.

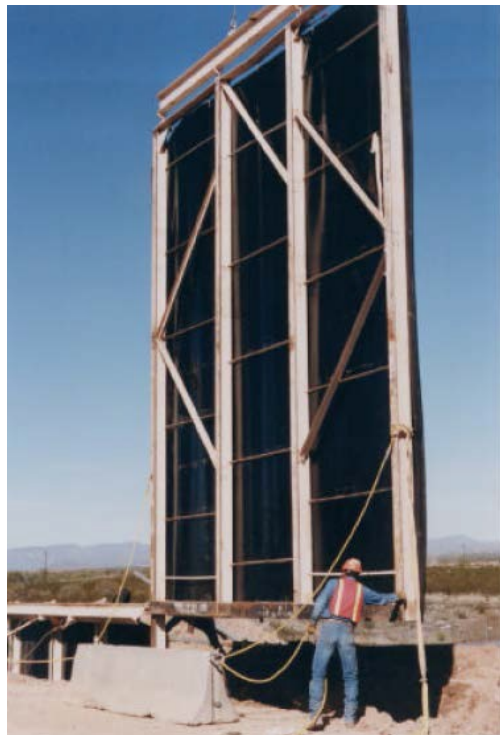
Figure 9.—Installation of geomembrane panel in the trench adjacent to previously placed panel.
