Water Quality Report Card		Copper and Zinc in Horse Creek and Town Creek	
Regional Water Board:	Central Valley, Region 5	STATUS	<input checked="" type="checkbox"/> Conditions Improving
Beneficial Uses Affected:	WARM, COLD		<input type="checkbox"/> Data Inconclusive
Implemented Through:	NPDES Permits, WDR Permits		<input type="checkbox"/> Improvement Needed
Effective Date:	2012	Pollutant Type:	<input checked="" type="checkbox"/> Point Source <input checked="" type="checkbox"/> Nonpoint Source <input checked="" type="checkbox"/> Legacy
Attainment Date:	To Be Determined	Pollutant Source:	Abandoned Mines

### Water Quality Improvement Strategy

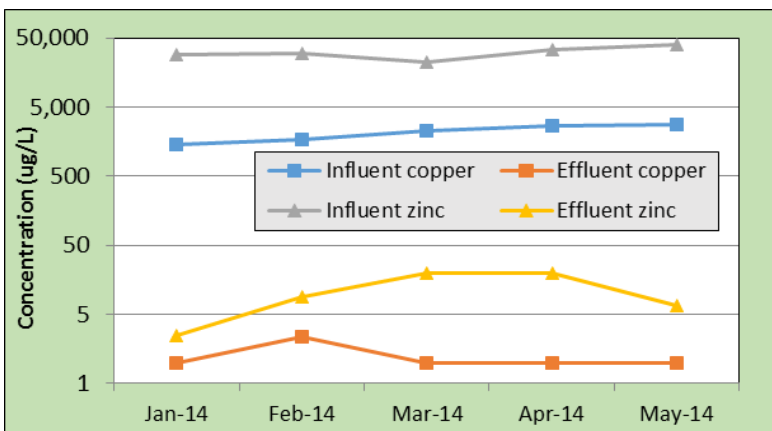
### Treatment Efficiency at Rising Star Mine

- All mine portal discharges, and their associated copper and zinc loadings, are routed to treatment systems and are no longer discharging to surface waters.
- Copper and zinc loads, from the treatment systems, have been reduced almost completely (greater than 99 percent).
- The pH in the treated water is trending toward neutral, averaging about 7 in the effluent, which is up from 5.01 and 3.36 in the respective influent to each treatment system.
- Next steps will be to continue operation of the treatment systems, other remediation activities, and the collection and analysis of water quality data.
