**STATE OF CALIFORNIA  
REGIONAL WATER QUALITY CONTROL BOARD  
CENTRAL COAST REGION**

**STAFF REPORT FOR REGULAR MEETING OF MARCH 18, 2010**

**SUBJECT:** **Perchlorate Cases Update**

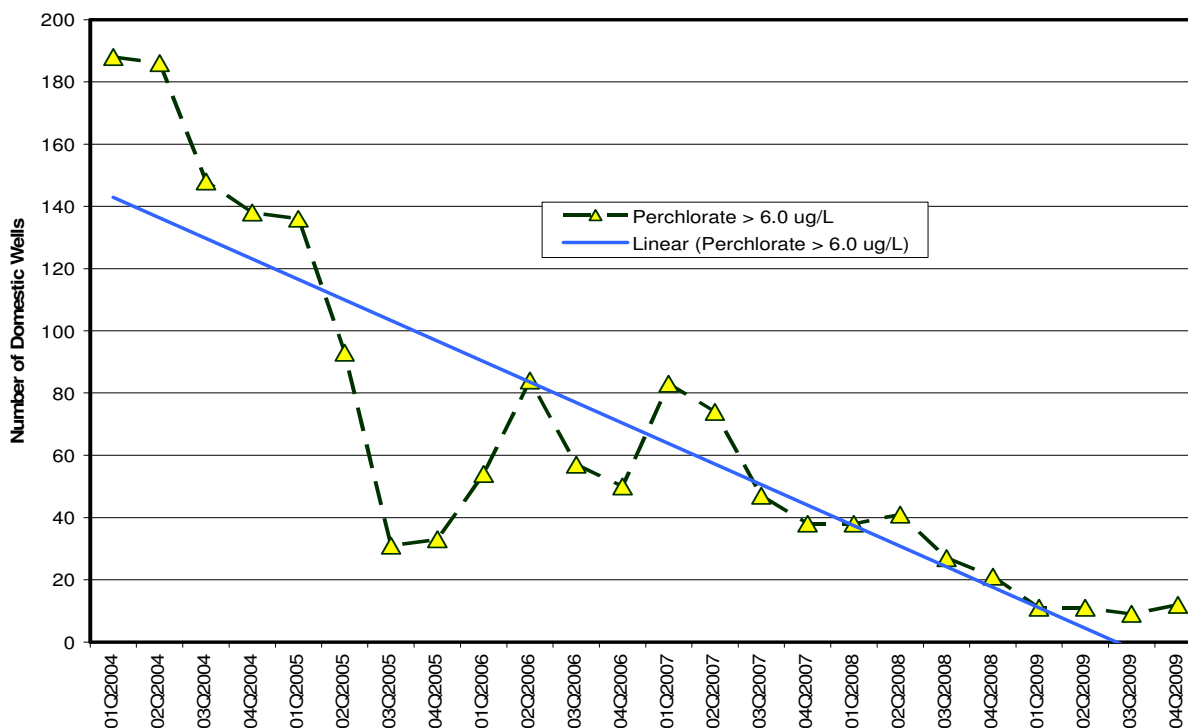
wells began, perchlorate concentrations have decreased throughout the Subbasin, particularly south of Middle Avenue (approximately 1.5 miles south of the site). Historically, over 800 domestic supply wells, predominantly screened in the intermediate aquifer, exhibited perchlorate impacts. In the first quarter of 2004, 188 domestic supply wells had perchlorate concentrations greater than the MCL. During the fourth quarter of 2009, there were 12 domestic supply wells above the MCL. Of these 12 domestic supply wells, eight wells are within 1.5 miles of the former Olin site near the plume core. Below is a graph that shows the decreasing trends in perchlorate concentrations in the number of domestic supply wells above the MCL over the past six years. The decreasing trends demonstrate that attenuation by natural physical processes such as dilution, successful onsite soil remediation, and onsite groundwater containment have resulted in decreasing perchlorate concentrations throughout the Llagas Subbasin over the last six years.

**Attachments 2 and 3** of the staff report show perchlorate groundwater plumes in the intermediate aquifer (70 – 200 feet below the surface) for the first quarter 2006 and the fourth quarter of 2009. These figures reveal a significant reduction in the size of the perchlorate plume outside the area of the plume core (south of the area with perchlorate concentrations above 24.5  $\mu\text{g/L}$  within 1.5 miles south of the site). We expect these decreases in perchlorate concentrations will continue, particularly when offsite hydraulic control and treatment of Priority Zones A and B (perchlorate concentrations greater than 11  $\mu\text{g/L}$ ) is initiated with intermediate aquifer extraction well IEW-1. However, as concentrations approach lower levels (around 4  $\mu\text{g/L}$ ), concentration declines may slow down due to the influence of other potential background perchlorate sources and typical asymptotic behavior of groundwater cleanup systems. Going forward, there may be short-term increases in perchlorate concentration during high precipitation years due to increased mobilization of perchlorate in the unsaturated zone and flushing through the A-B aquitard.
