Humboldt Redwood
COMPANY, LLC

Subject: Enrollment of THP 1-10-070 HUM in the Elk River WWDR, "Tier II"

HRC is requesting Tier II enrollment under Watershed-Wide Waste Discharge Requirement (WWDR) Order No. R1-2006-0039 for THP 1-10-070 HUM. This Tier II portion of the unit proposed for enrollment is comprised of 376.3 acres of group selection (188.9 clear-cut equivalent acres). Total acres currently enrolled or proposed for enrollment under Order No. R1-2006-0039 Tier II is shown in the Attached Pre-Harvest Planning Report. The Erosion Control Plan (ECP), Form 200 and an annual waste discharge enrollment fee have already been submitted for this THP. Revisions have been made to the ECP as per my response to D. Engle's email of 1/14/11. A copy of the email correspondence is attached.

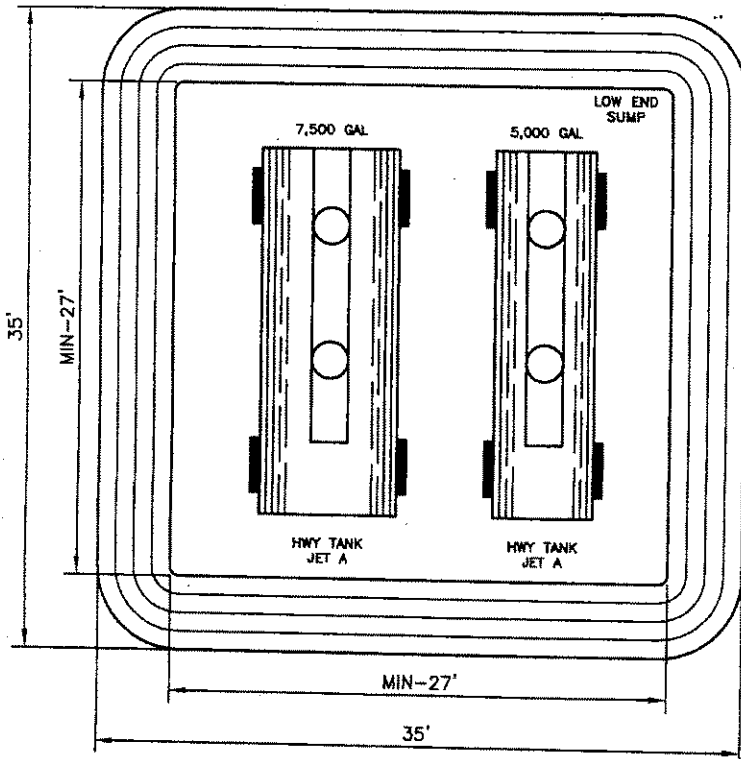
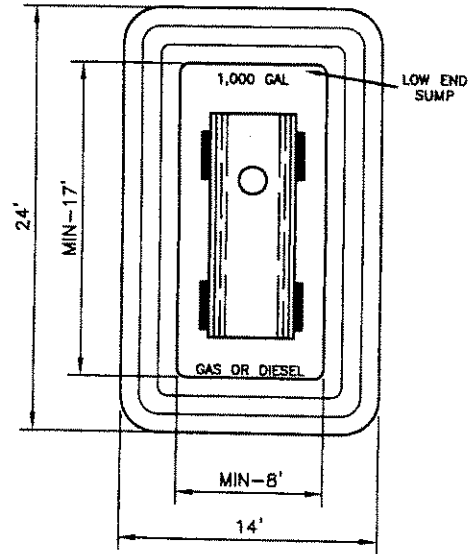
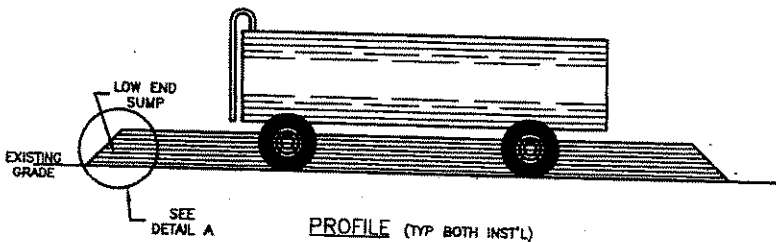
MIN. ENCLOSURE = 1,750 FT³ = 13,088 GAL

MIN. ENCLOSURE = 326 FT³ = 2,441 GAL

DETAIL A
TYPICAL CROSS SECTION

SECONDARY CONTAINMENT FACILITIES SHOWN IN THIS DRAWING CONFORM TO EPA 40 CFR PART 112.8(c)(2)

THE PACIFIC LUMBER COMPANY HELICOPTER LOGGING OPERATIONS	
FIGURE 1	
SECONDARY CONTAINMENT DESIGN FOR PETROLEUM STORAGE TANKS	
PROJECT: 240033	DATE: 10/22/04
REV:	BY: MH CHECKED: FC
MFG, Inc. consulting scientists and engineers

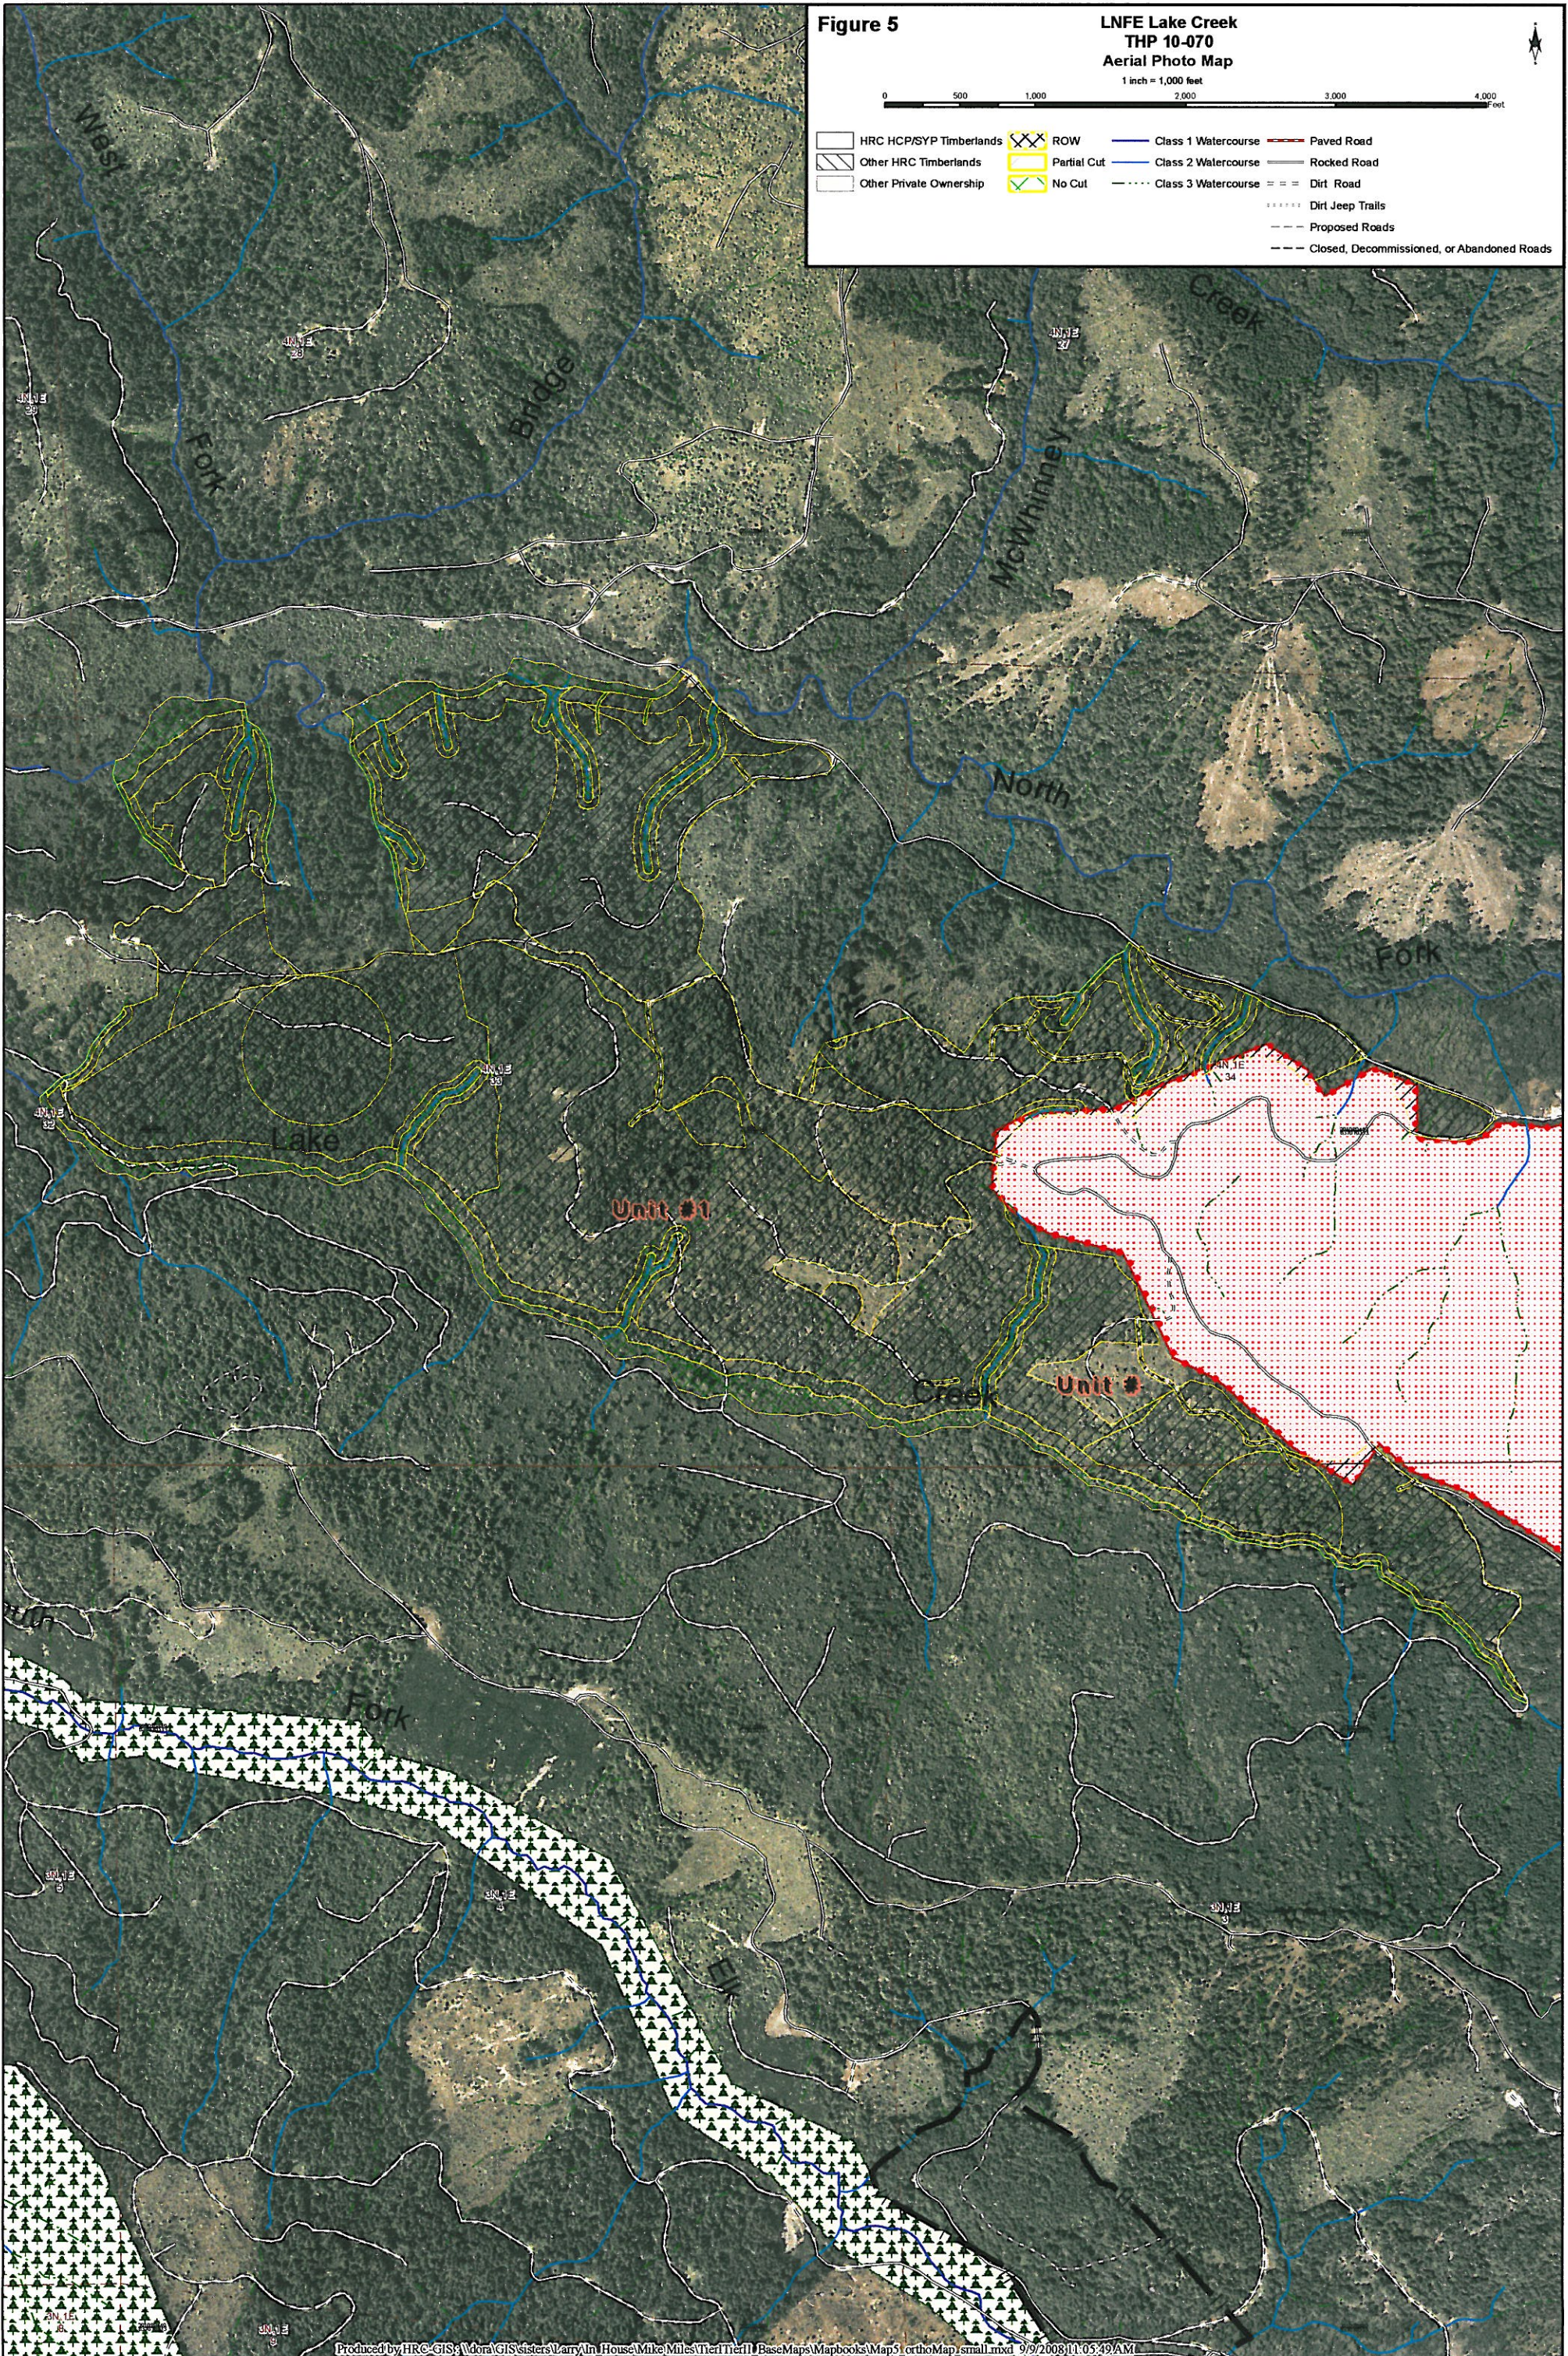
LNFE Lake Creek
THP 10-070

Figure 6 shows 3 areas of deep-seated mass wasting within the unit. These areas correspond with low to moderate Mass Wasting Potential shown on Figure 4.
