2.3.2 J.L. Iovenitti, Weiss Associates, and J. Wessman, Mount Diablo Mine Surface Impoundment Technical Report

Mount Diablo Mercury Mine

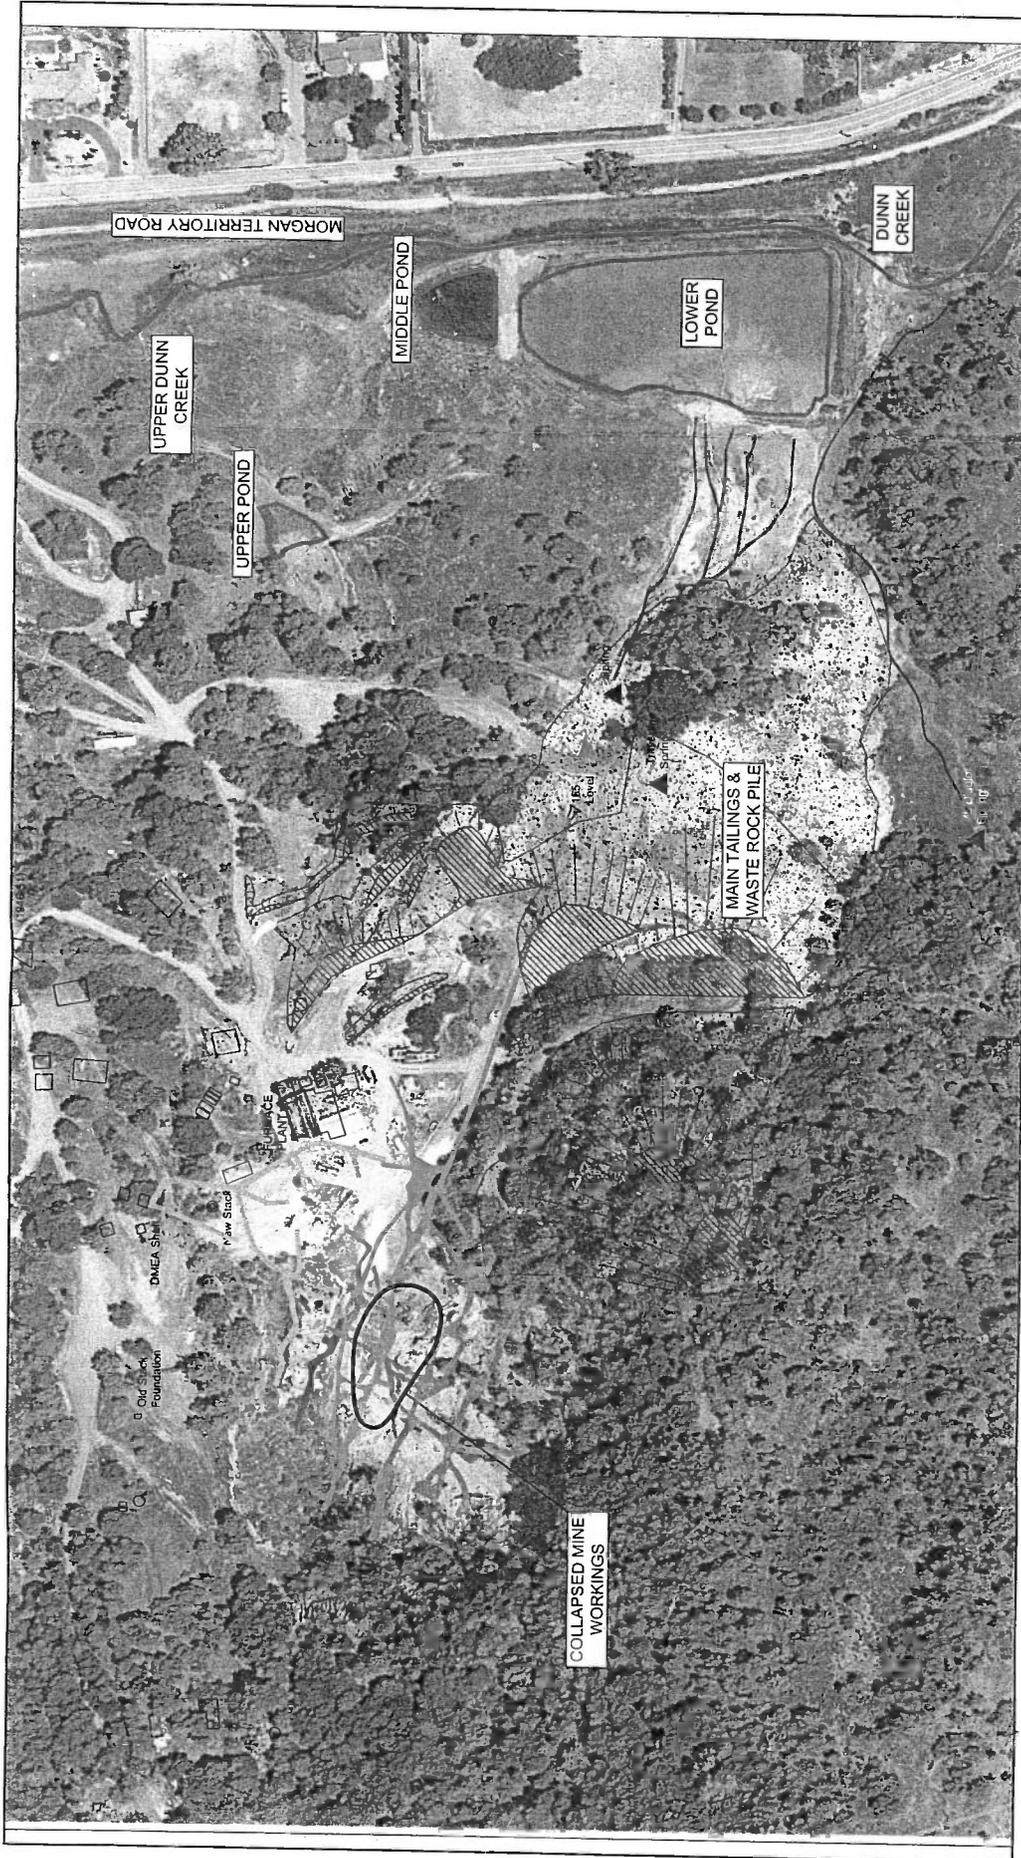
- Mine Structure (1953)
- Pond (2004 Outline)
- Tailings/Waste Rock (BRADLEY)
- Adit Level
- 80-ft Level
- 165-ft Level
- 270-ft Level
- 360-ft Level

MOUNT DIABLO MERCURY MINE 2430 MORGAN TERRITORY ROAD CONTRA COSTA COUNTY, CA		2004 AERIAL PHOTO WITH MINE FEATURES	
PROJECT NO:	DATE:	APP. BY:	FIGURE
01-SUN-055	05/08/12	GT	2-2

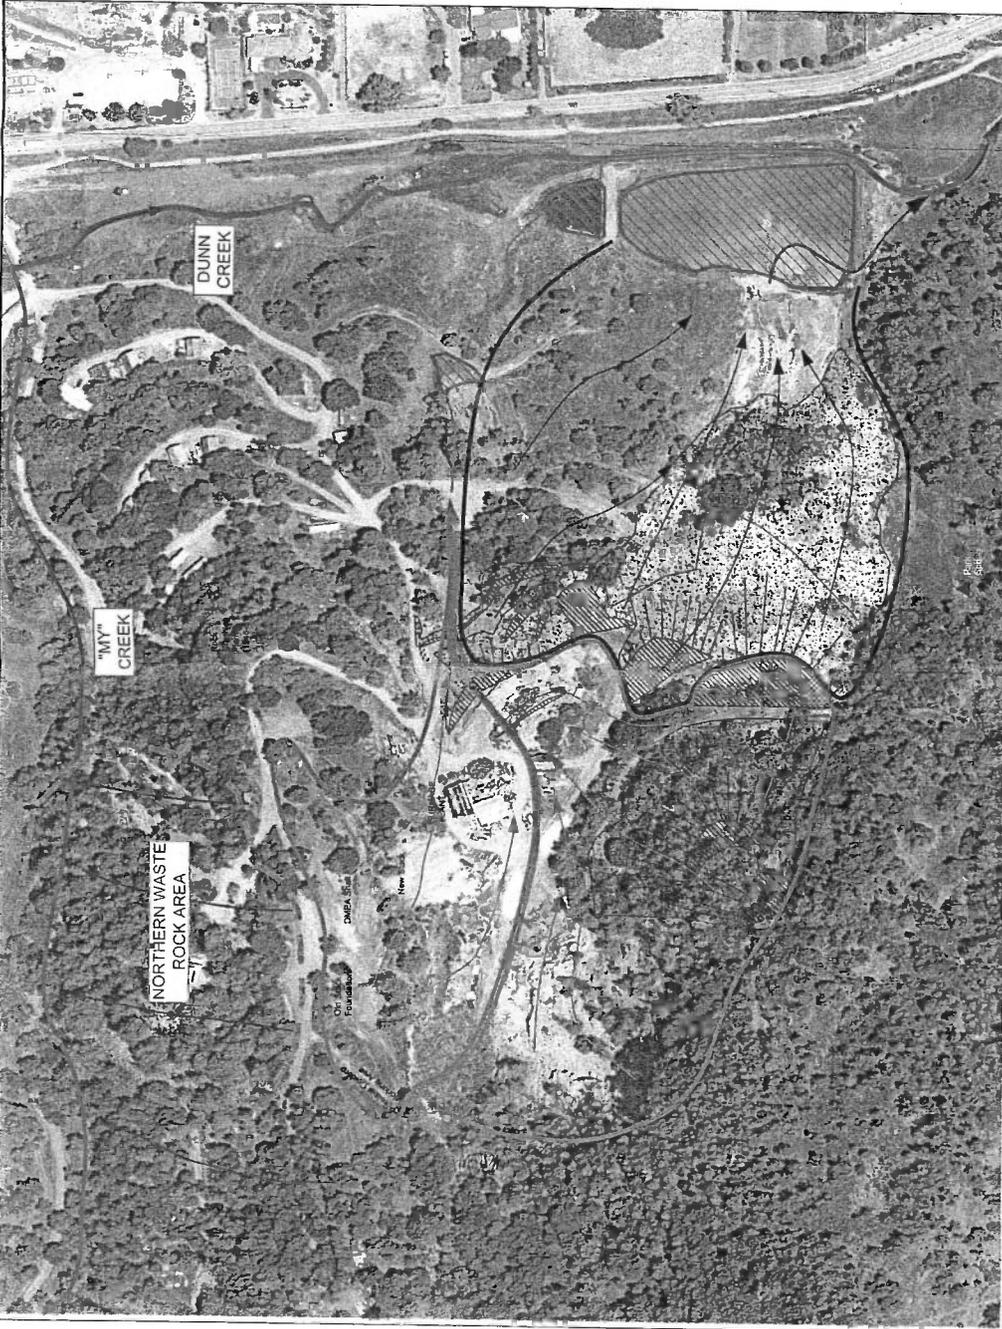
<p>LEGEND</p> <ul style="list-style-type: none"> Mine Structure Spring Pond (2004 Configuration) Tailings/Waste Rock (Bradley) Surface flow Surface flow 		<p>PROJECT NO. 01-SUN-055</p>		<p>DATE 05/03/12</p>		<p>DRAWN BY: GT</p>		<p>APP. BY: PH</p>			
<p>MOUNT DIABLO MERCURY MINE 2430 MORGAN TERRITORY ROAD CONTRA COSTA COUNTY, CA</p>				<p>SGI THE SOURCE GROUP, INC. Environmental 3478 BLISKIRK AVE, SUITE 100 PLEASANT HILL, CA 94523</p>				<p>SURFACE WATER DRAINAGE AND FLOW PATTERNS</p>		<p>FIGURE 2-6</p>

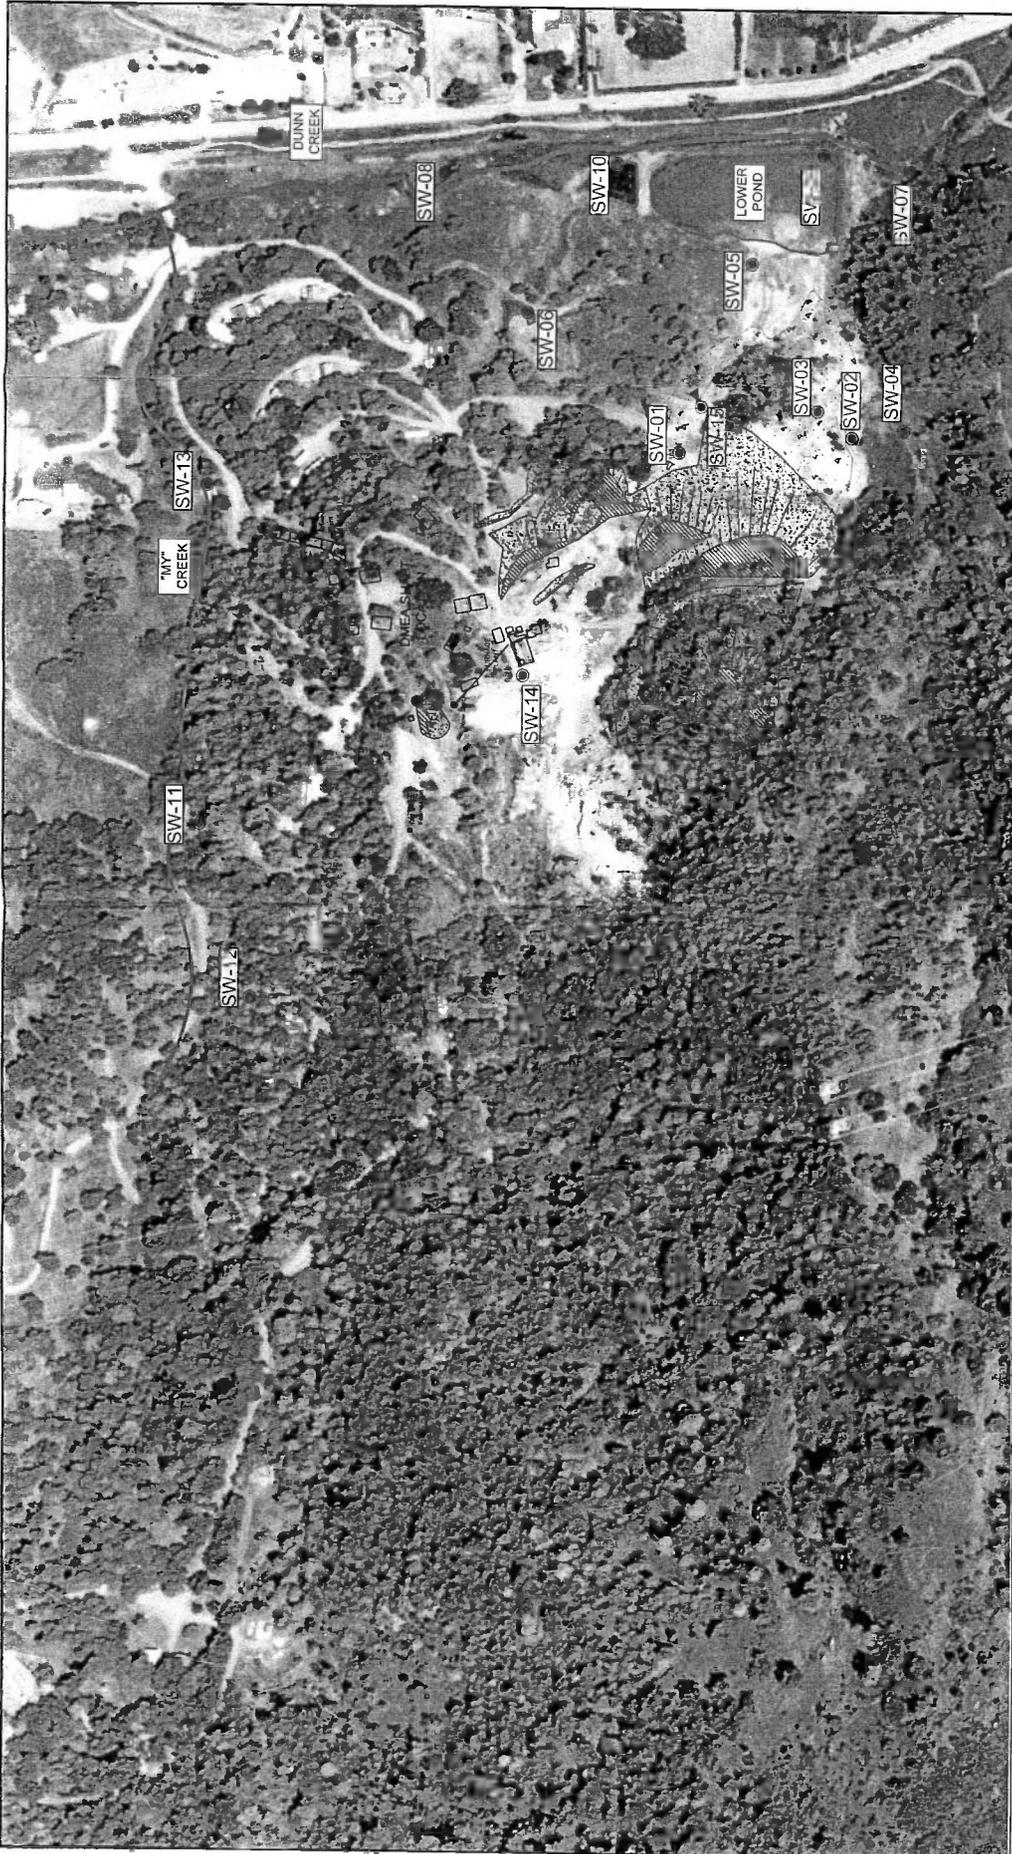
SGI SURFACE WATER SAMPLING LOCATIONS 2010

- Mine Structure (1953)
- Tailings/Waste Rock (BRADLEY)
- Surface Water Sample Locations

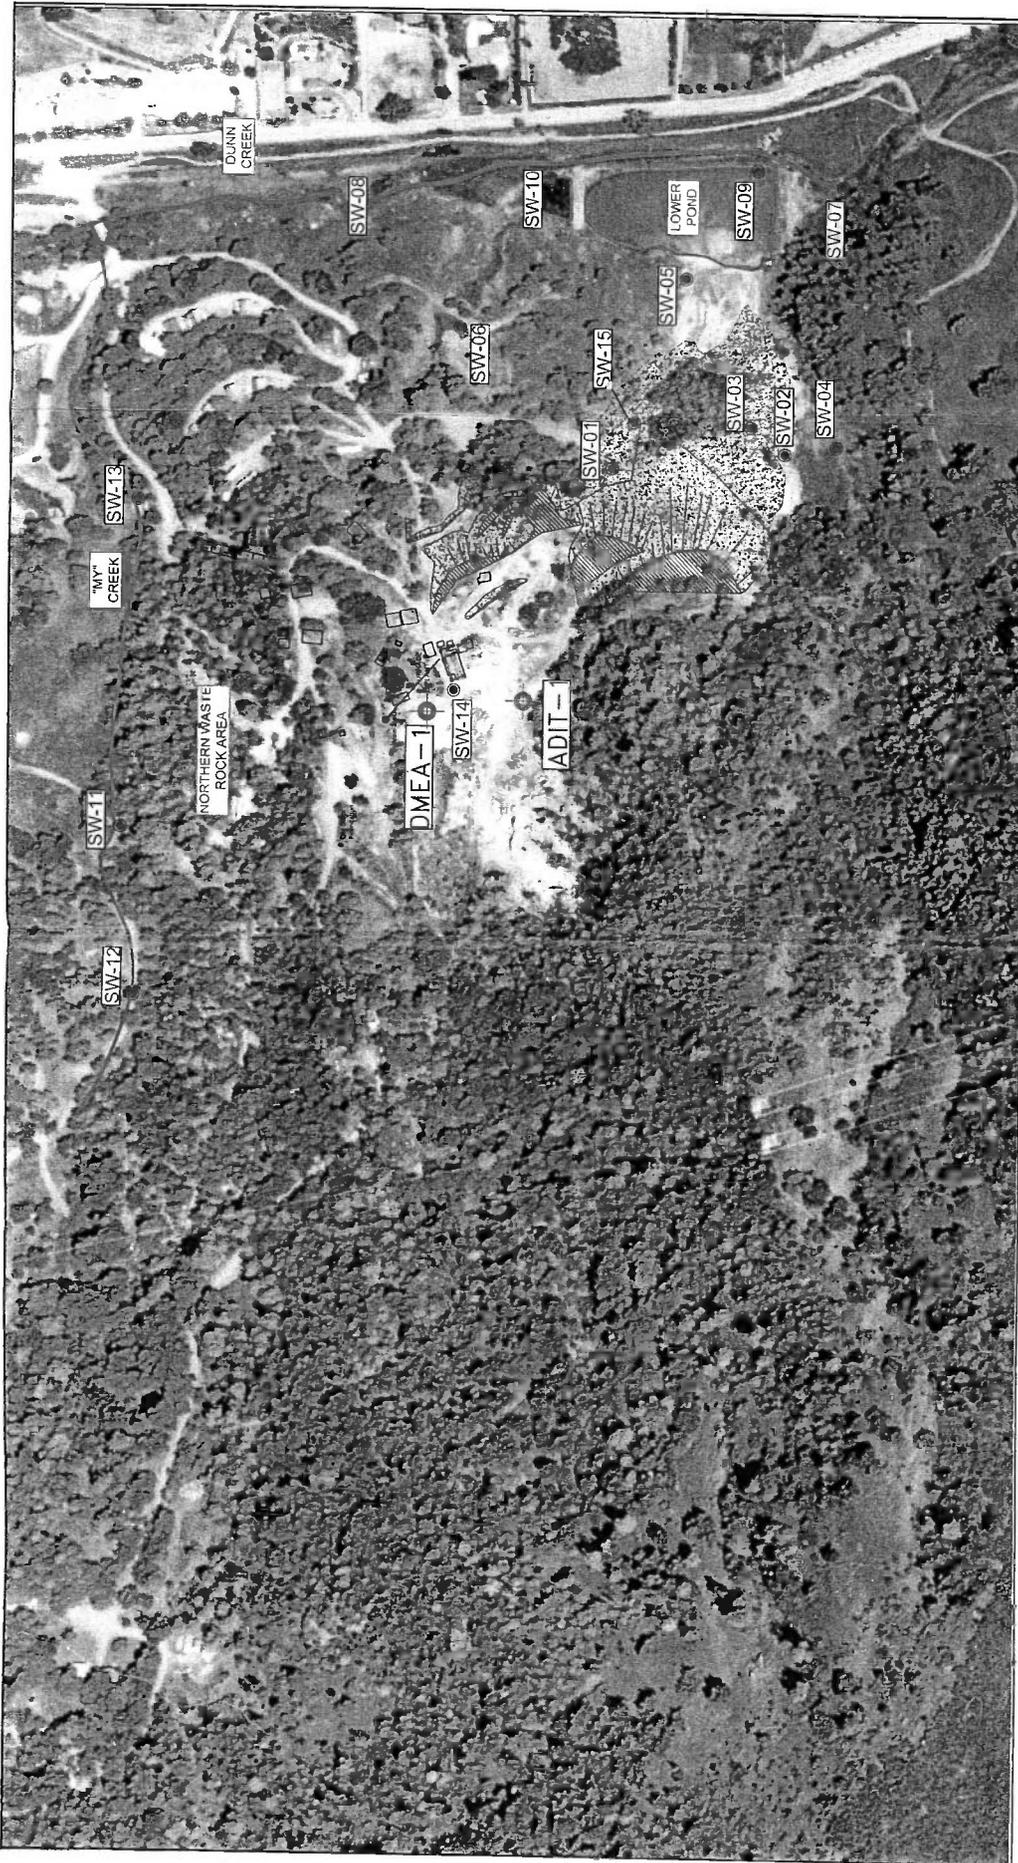
Surface Water Sample Location 		<p>SGI SURFACE WATER SAMPLING LOCATIONS 2011</p>	
<p>MOUNT DIABLO MERCURY MINE 2430 MORGAN TERRITORY ROAD CONTRA COSTA COUNTY, CA</p>		<p>THE SOURCE GROUP, INC. 3478 BUSKIRK AVE, SUITE 100 PLEASANT HILL, CA 94523</p>	
PROJECT NO.	DATE	DRAWN BY:	APP. BY:
01-SUN-055	08/03/12	GT	PH
<p>0 250 500 HORIZONTAL SCALE IN FEET</p>		<p>FIGURE 2-8</p>
