Summary of Cucamonga Creek as described in January 12, 2012 Staff Report Section 5.6.6. [UAA Analysis Cucamonga Creek](#) and [CDM UAA Technical Report for Cucamonga Creek](#)

Summary of UAA Cucamonga Creek (Continued)

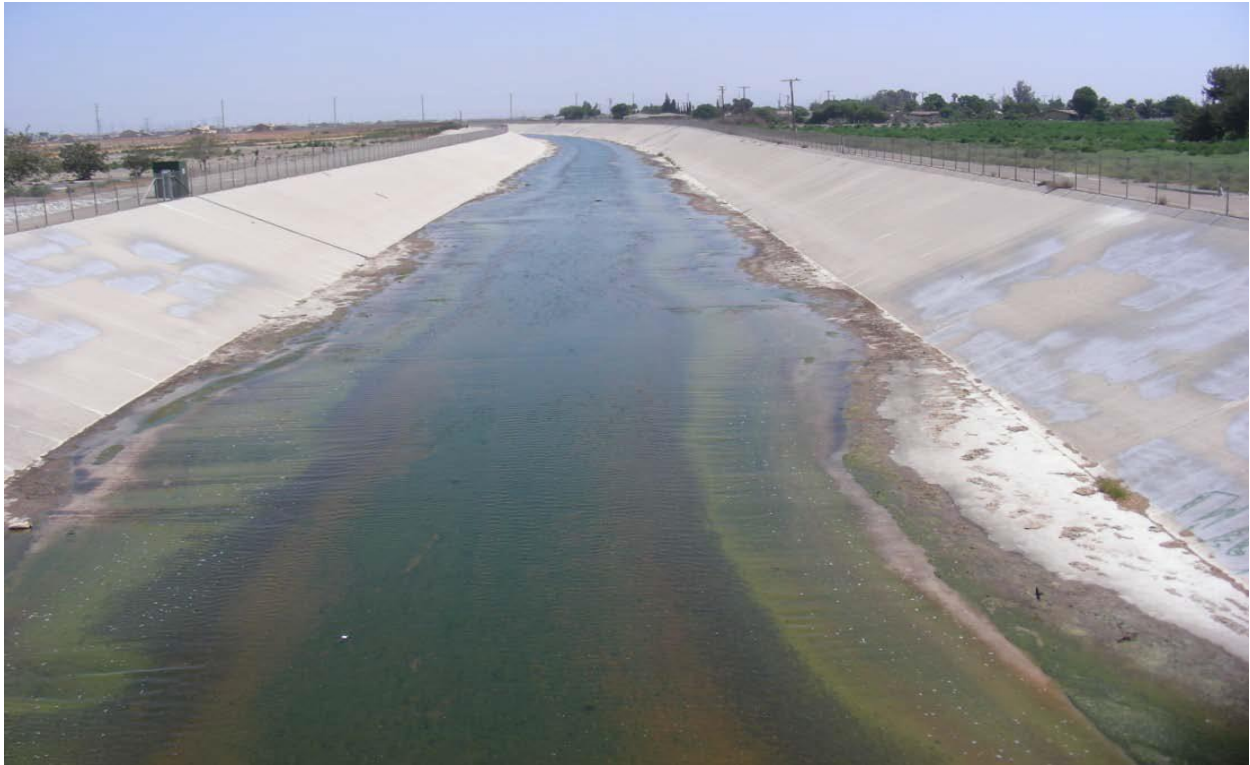
Figure CC-5. Reach 1. Photo REC Survey Location; looking upstream at Hellman Avenue. REC 1 and REC 2 are not attainable in Reach 1. (UAA Analysis CC)
Figure 2-8. Reach 1. (CDM UAA Technical Report CC)

Cucamonga Creek	REC1	REC2	40 CFR 131.10(g) Factors	
			131.10(g)(2) Low Flow	131.10(g)(4) Hydrologic Modifications
Reach 1	u	u	Depth <2ft 98% of time; <1.5ft 93% of time 5 inches deep at most downstream section at Hellman Ave as observed by RB staff on February 2, 2011. Observed channel to be dry at most upstream section, RB staff in May 2011.	Concrete vertical wall (~12-15 ft height) channel 11 miles in length. Concrete trapezoidal channel (2:1 side slope) 4 miles in length.
Representative Photographs				
Reach 1	See Figures CC-5, CC-6, CC-7, CC-8, CC-9, CC-13, CC-20 UAA Analysis CC. See Figures 2-8, 2-9 of the CDM UAA Technical Report, CC.

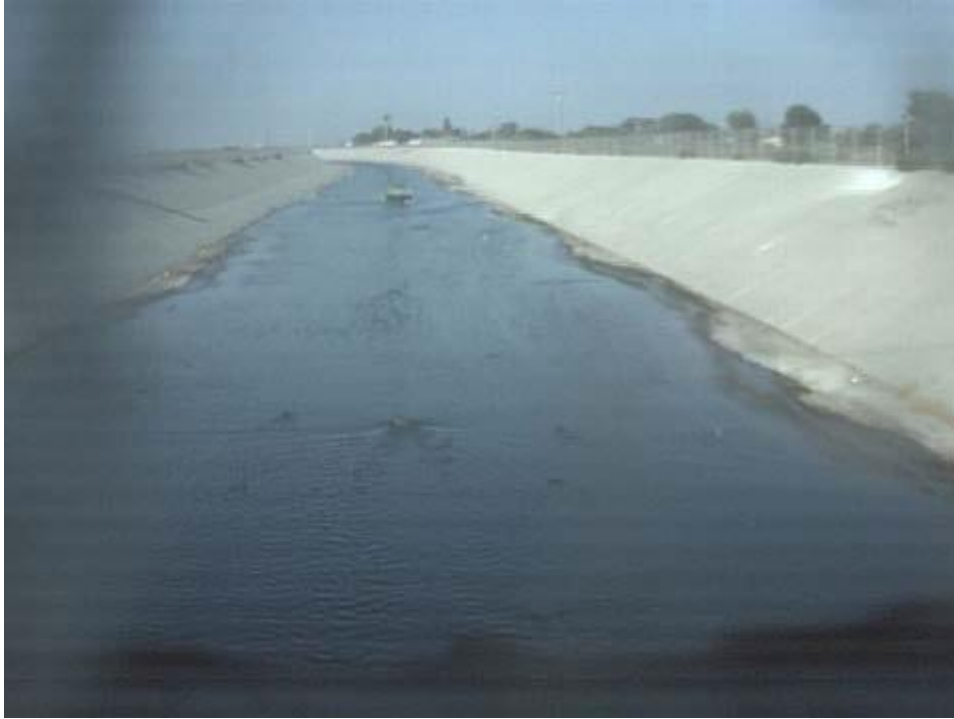
Figure CC-21, Reach 1: Photo REC Survey Location; only photo of individual (presumably driving the vehicle in distance) in Reach 1. (UAA Analysis CC)

In addition to the results of field and photographic surveys, adjacent land use, channel morphology, accessibility and fencing or other barriers to viewing the channel (such as vegetative cover) were considered in recommendations regarding REC2 designations. Based on this evidence, de-designation of REC2 was found appropriate. Much of the Reach runs through an agricultural area with limited public access or visibility; access/visibility is also limited in commercial/industrial and residential areas adjacent to the vertical-walled channel. Channel morphology severely limits wildlife habitat and viewing opportunities. Of the 29,668 photographic images captured for Reach 1, there were no observations of people in or near the channel (apart from a vehicle, which may have been a county flood control maintenance vehicle.)

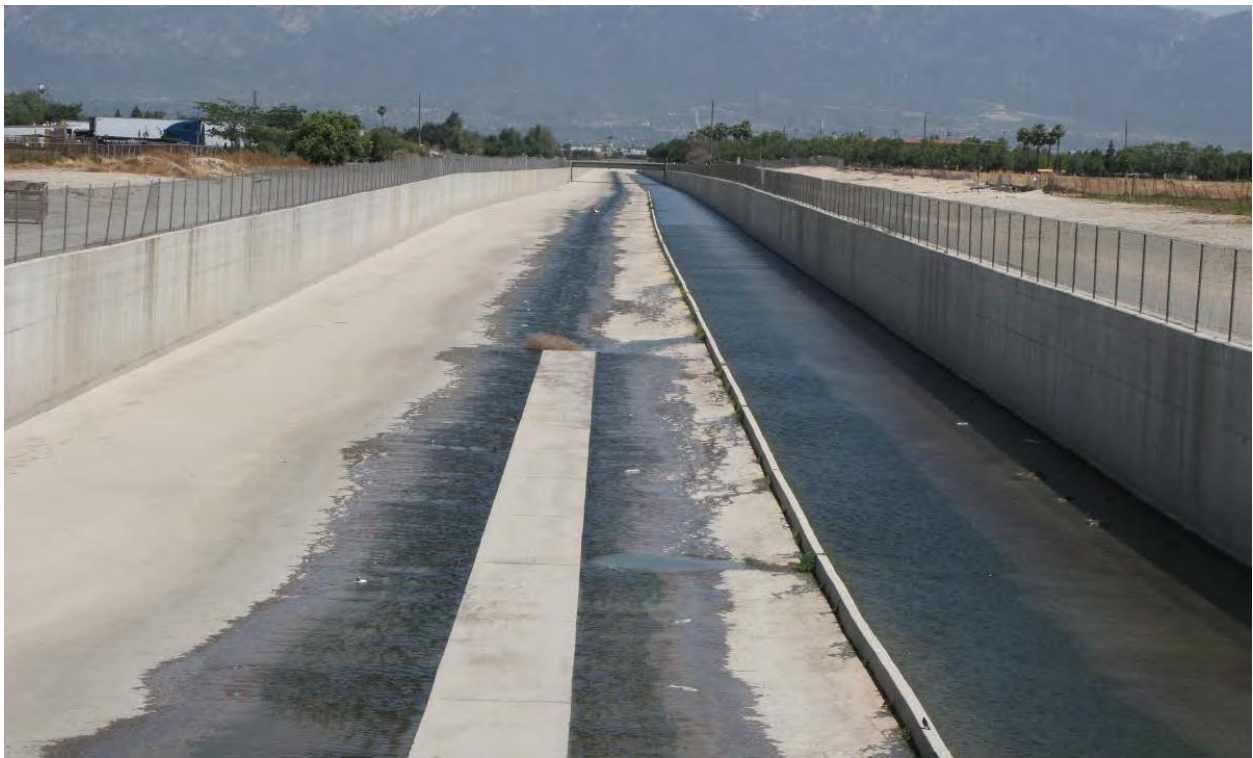
Figure CC-6. Reach 1 looking upstream. Eleven miles of the total 15 mile length of Reach 1 is contained by concrete vertical walls at 12-15 ft in height. (UAA Analysis CC)

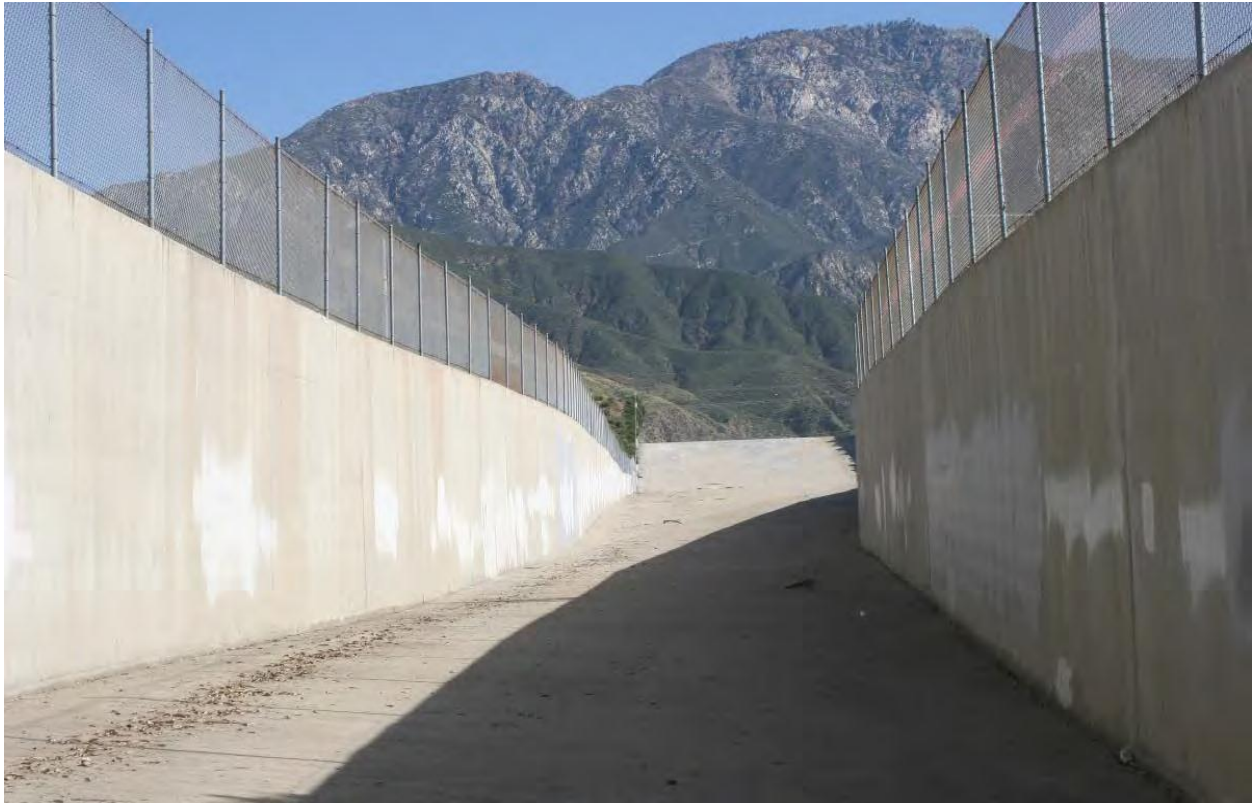
Figure CC-7. Reach 1, looking at upstream terminus (Cucamonga Canyon Dam) of Reach 1.

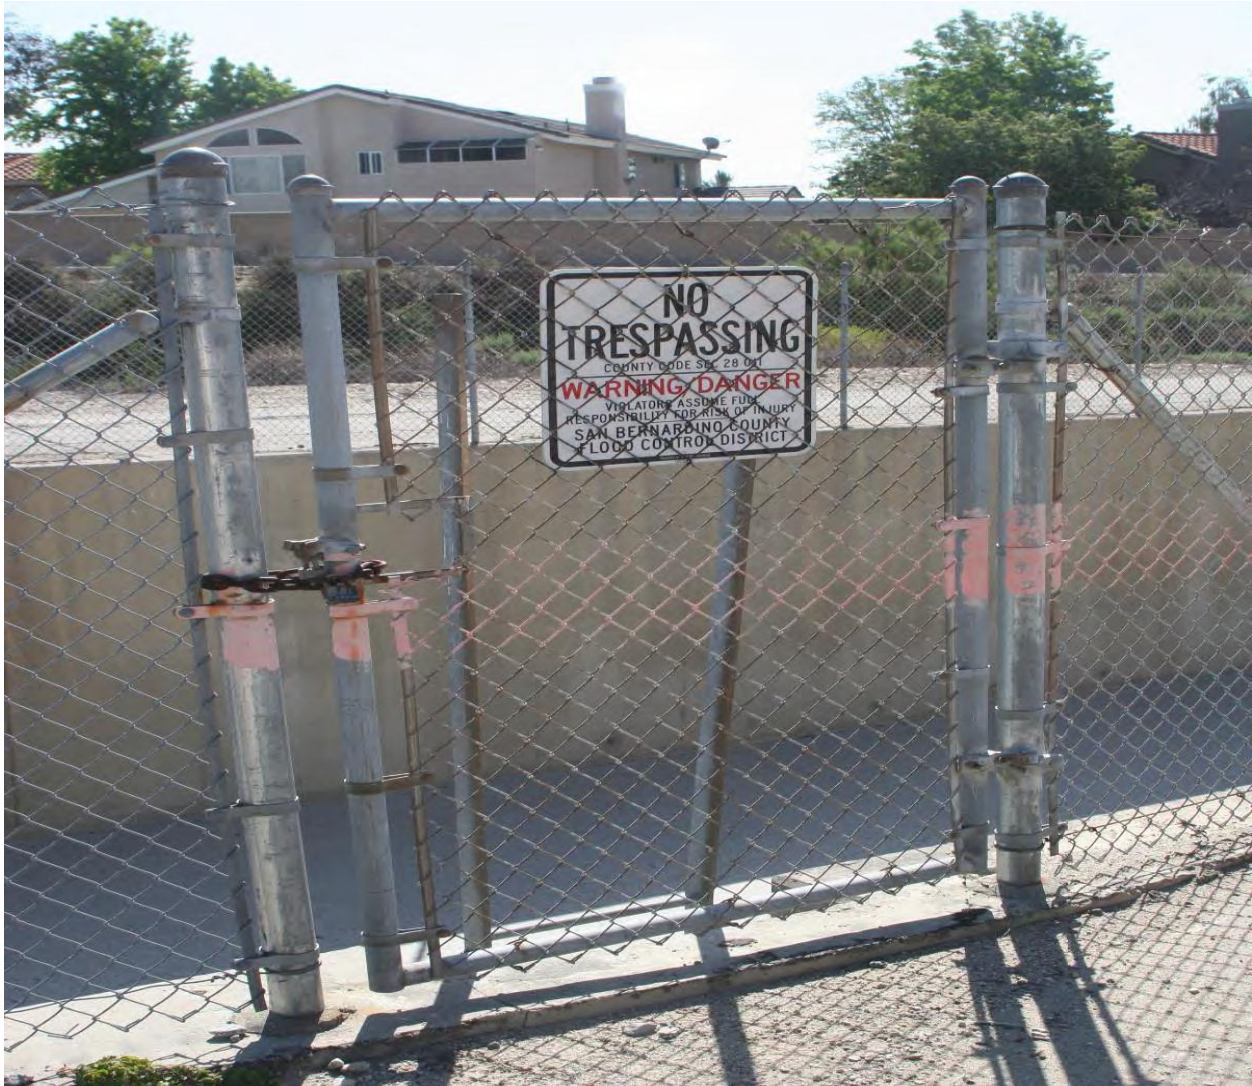
Figure CC-13. Reach 1, showing locked gate, fencing, and no trespassing/warning sign. The entire Reach is fenced with locked gates and posted to keep individuals out. All of the UAA waters are fenced and posted in a similar fashion to prohibit access.

i) Channel considered unsafe for public access
